**SERIOUS INCIDENT**

<b>Aircraft Type and Registration:</b>	Fan Jet Falcon 20E, G-FRAI
<b>No &amp; Type of Engines:</b>	2 General Electric Co CF700-2D-2 turbofan engines
<b>Year of Manufacture:</b>	1972 (Serial no: 270)
<b>Date &amp; Time (UTC):</b>	9 August 2012 at 0915 hrs
<b>Location:</b>	Runway 23, Durham Tees Valley Airport
<b>Type of Flight:</b>	Commercial Air Transport (Passenger)
<b>Persons on Board:</b>	Crew - 2                      Passengers - 1
<b>Injuries:</b>	Crew - None                      Passengers - None
<b>Nature of Damage:</b>	Foreign object damage to engines
<b>Commander's Licence:</b>	Airline Transport Pilot's Licence
<b>Commander's Age:</b>	39 years
<b>Commander's Flying Experience:</b>	3,066 hours (of which 1,005 were on type) Last 90 days - 78 hours Last 28 days - 27 hours
<b>Information Source:</b>	AAIB Field Investigation

**Synopsis**

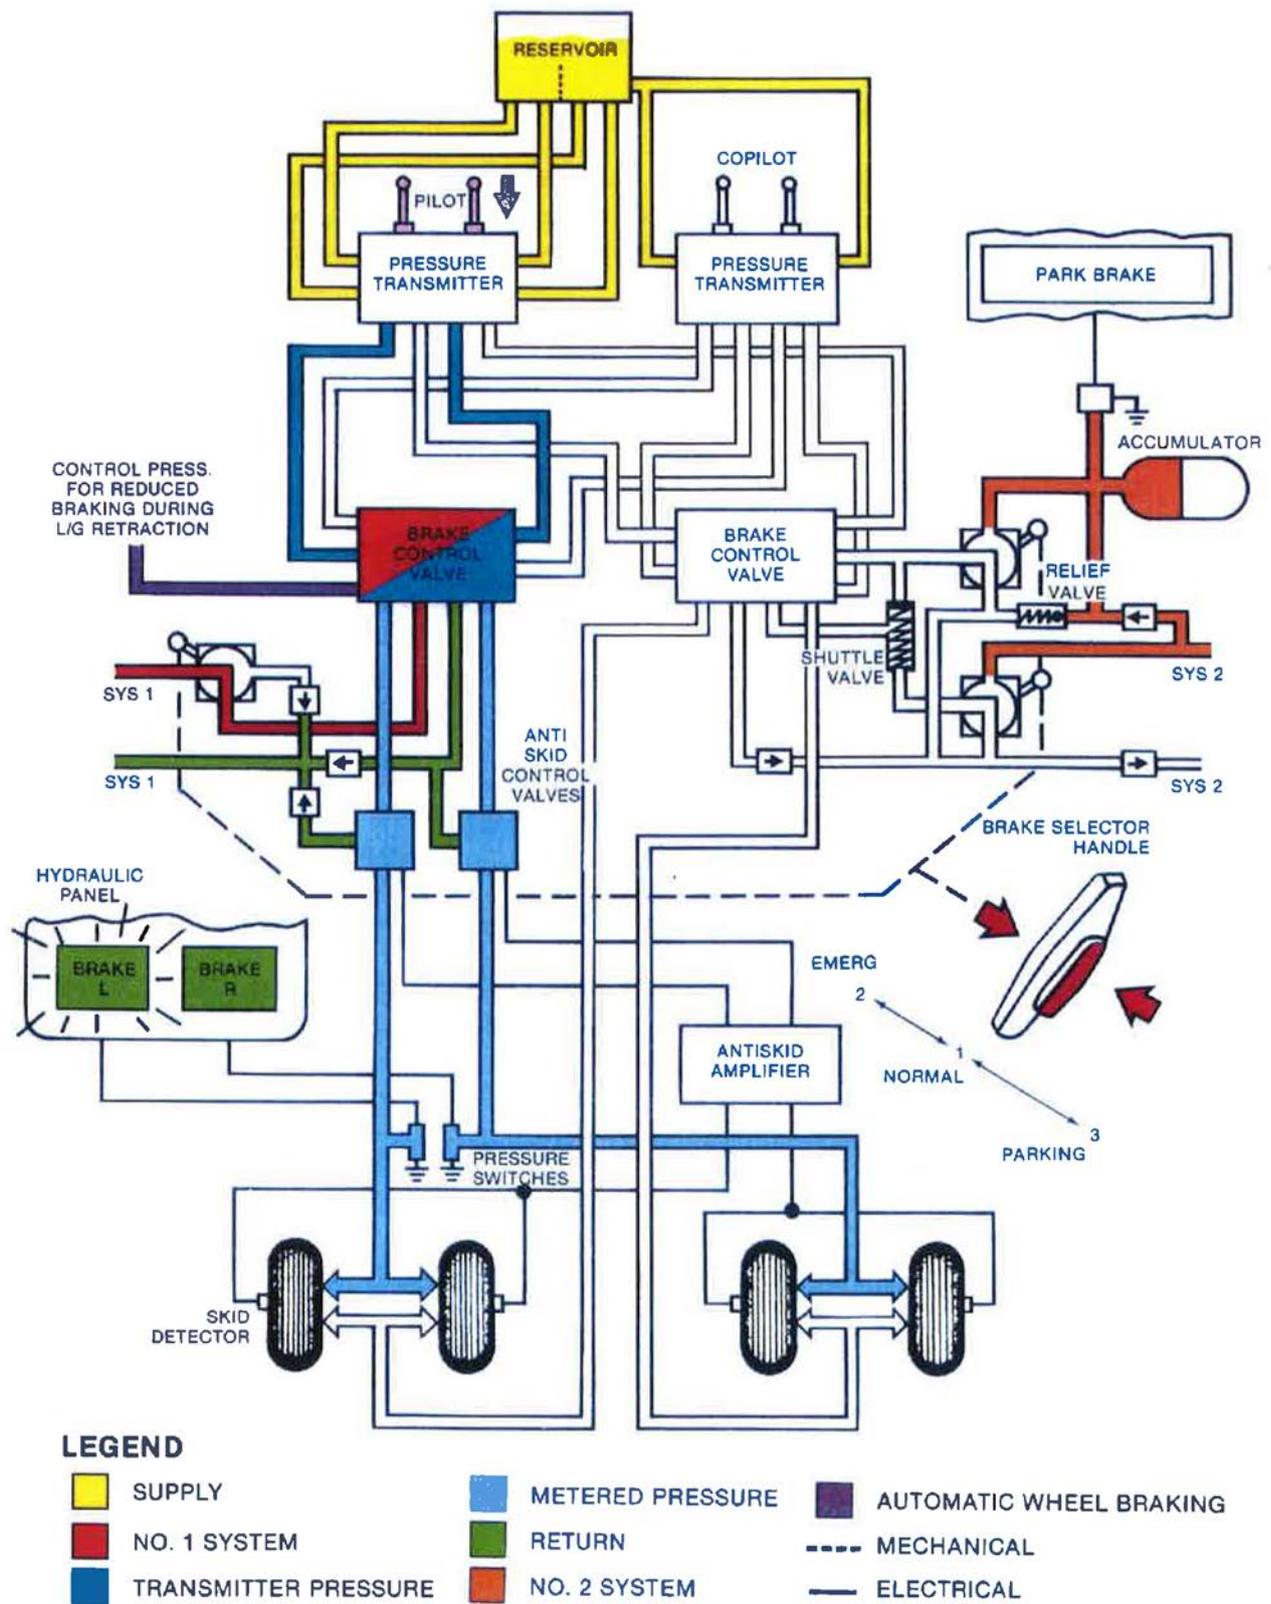
Figure 3

The aircraft has twin-wheel main landing gears (Figure 3) and each mainwheel is equipped with a three-rotor disk brake assembly. The brake rotors are keyed such that they rotate with the mainwheels and are coated with a friction lining on both faces. The fixed section of the brake assembly consists of a housing plate accommodating ten brake pistons in addition to

Falcon 20E braking system operation in the normal mode
