**Deviation below manoeuvring airspeed on final, go-around,
triggering of Alpha Floor protection**

| Aircraft | Airbus A320-214 registered F-HEPE |
| Date and time | 3 April 2012 at 12 h 56 ⁽¹⁾ |
| Place | Tel Aviv Ben Gurion Airport (Israel) |

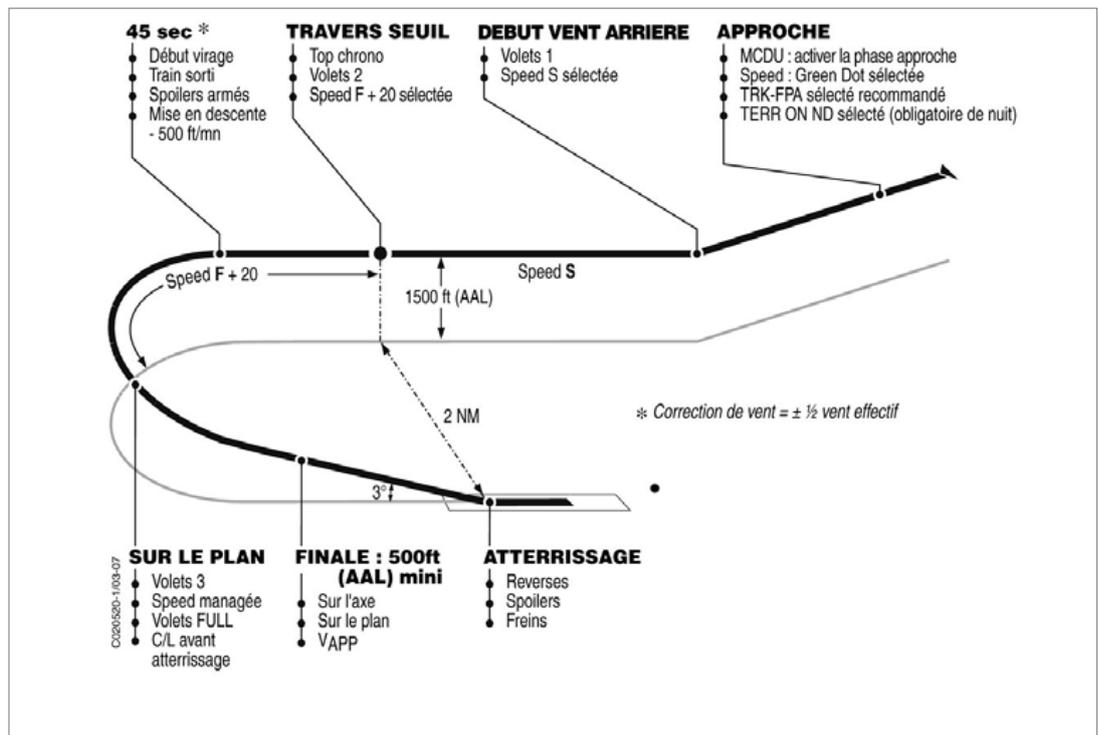
Standard visual approach procedure recommended by Air France on the day of the event

The standard visual approach procedure recommended by Air France and the manufacturer provides for changing to configuration 3 then FULL once established on the glide path, just before lining up on final.

As the speed was managed, the target speed became approach speed V_{app} during the change to FULL configuration. In this configuration the stall margin is lower than at target speed "F" in configuration 3. The aeroplane therefore had a lower energy level to carry out the last turn.
