AS332L Super Puma, G-TIGB

AAIB Bulletin No: 8/2003	Ref: EW/C2002/2/6	Category: 2.1
Aircraft Type and Registration:	AS332L Super Puma, G-TIGB	
No & Type of Engines:	2 Turbomeca Makila 1A turboshaft engines	
Year of Manufacture:	1982	
Date & Time (UTC):	28 February 2002 at 1130 hrs	
Location:	70 nm northeast of Scatsa, Shetland Islands	
Type of Flight:	Public Transport	
Persons on Board:	Crew - 2	Passengers - 18
Injuries:	Crew - None	Passengers - None
Nature of Damage:	Damage to tail pylon and tail rotor blades	
Commander's Licence:	Airline Transport Pilot's Licence	
Commander's Age:	51 years	
Commander's Flying Experience:	11,100 hrs (of which 2,000 were on type)	
	Last 90 days - 130 hrs	
	Last 28 days - 45 hrs	
Information Source:	AAIB Field Investigation

Synopsis

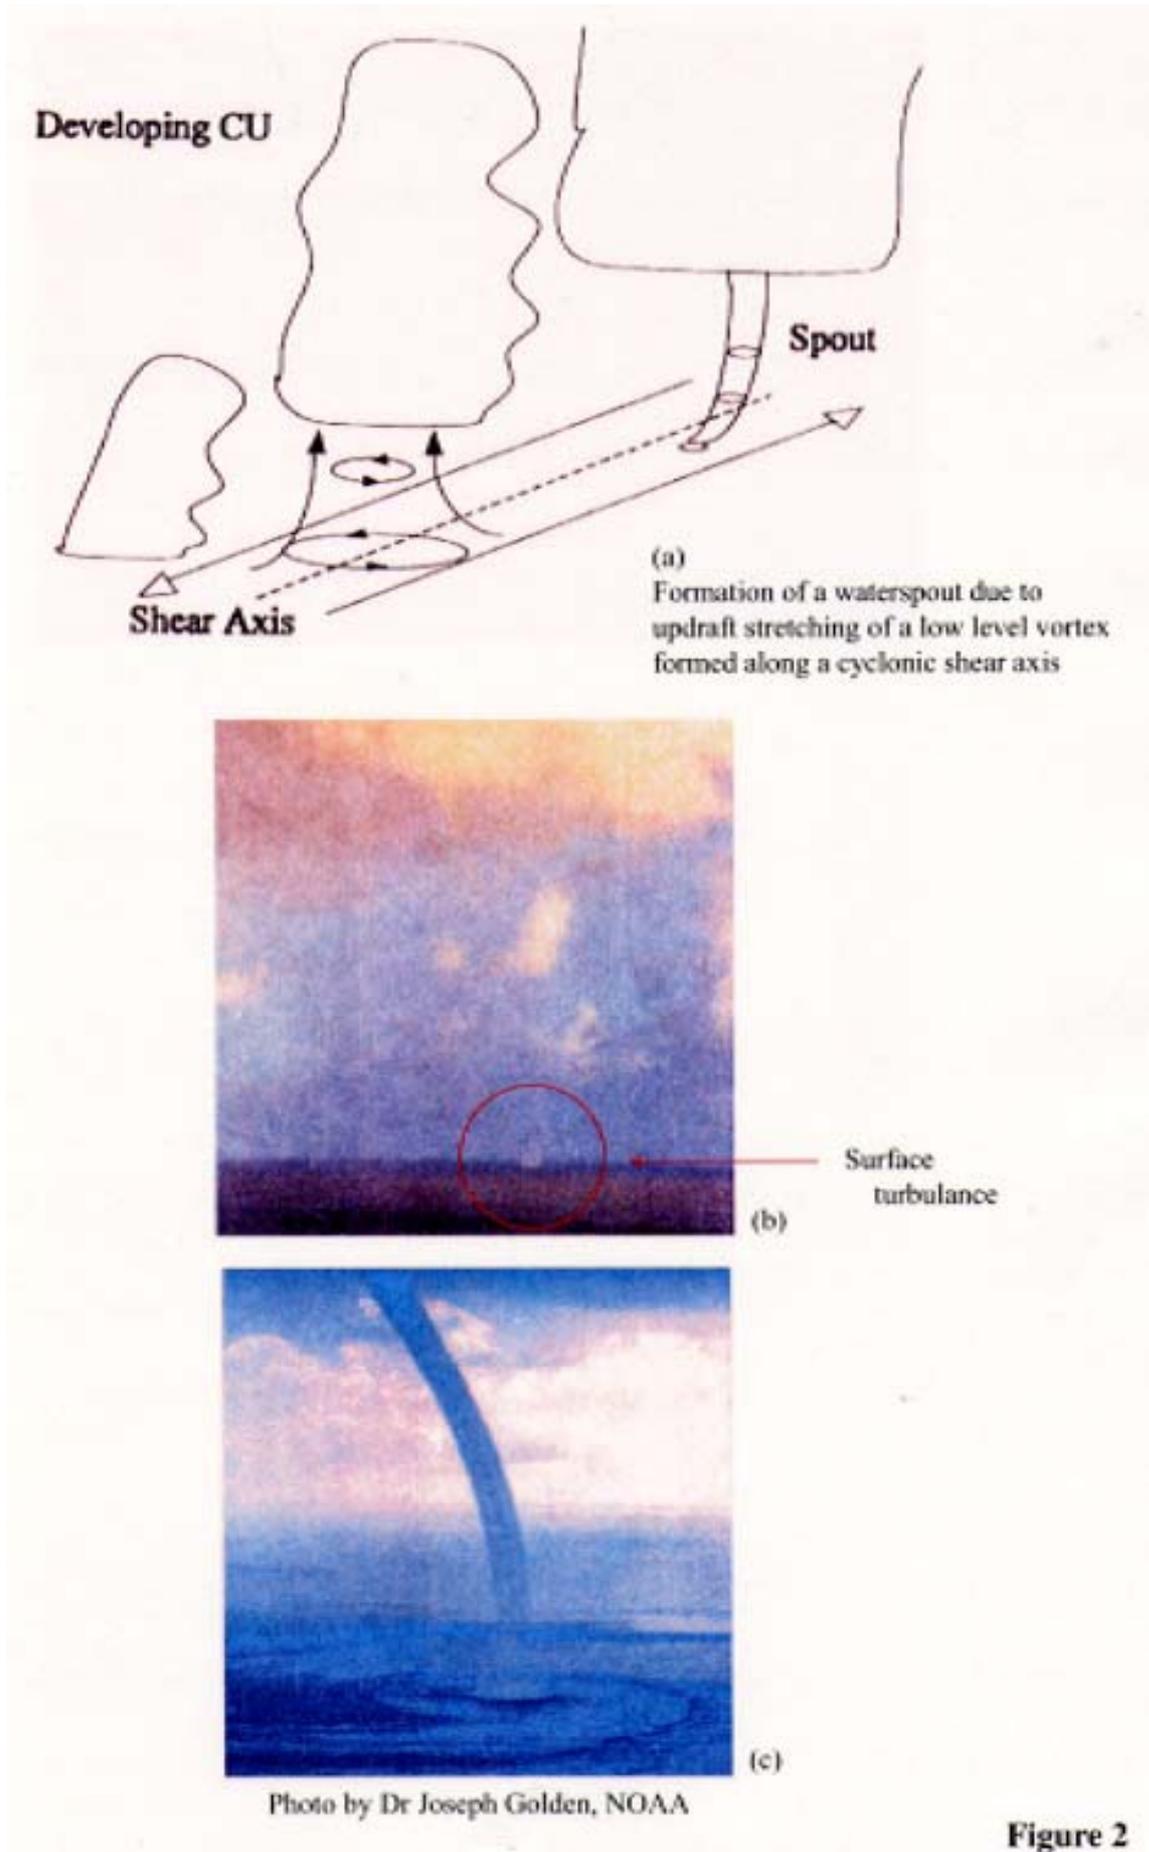
Figure 2b is a photograph of a waterspout related disturbance on the surface of the sea, before becoming fully developed, and is included as it is considered to be similar to that described by the crew of 802.

Figure 2c is a photograph of a developed waterspout and illustrates a large area of disturbed water, caused by the mass of rotating air that will be present around a waterspout. In addition, it shows that a waterspout is unlikely to be a truly vertical feature.

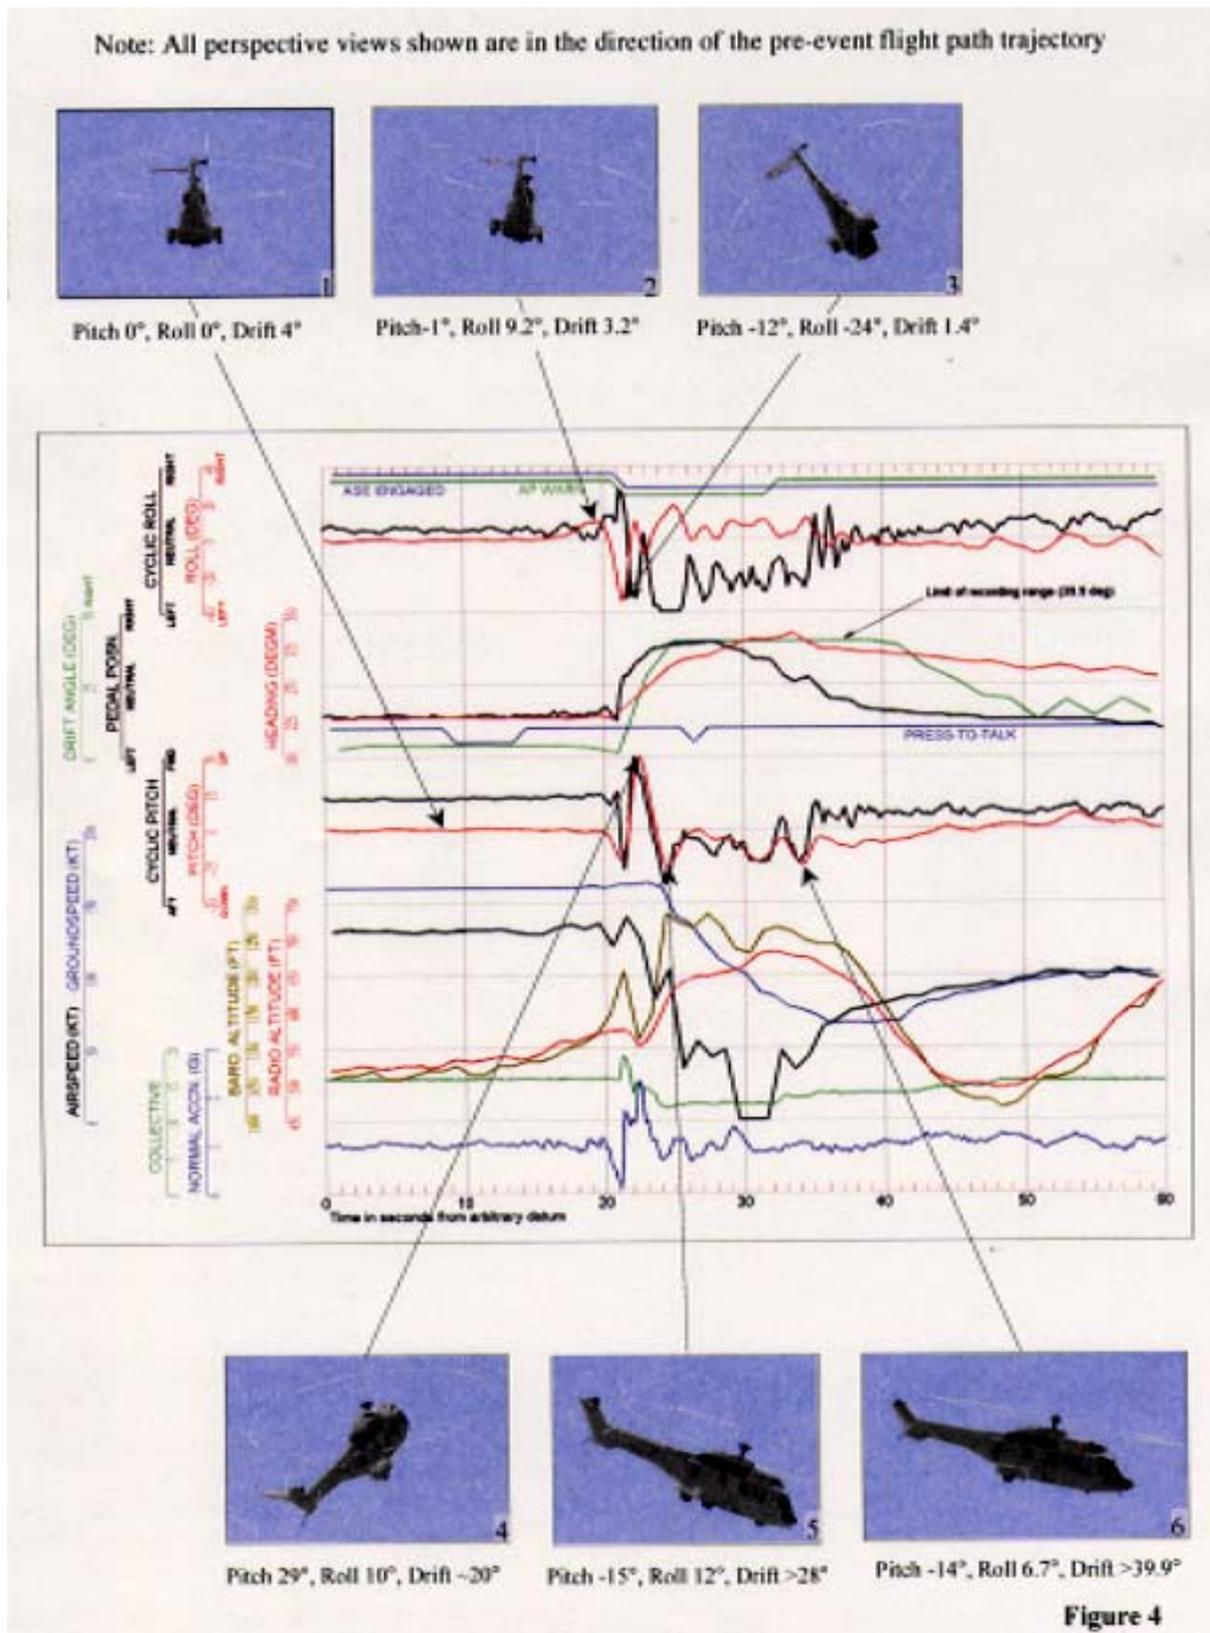
The onset of the event, at position N 60° 57.4' E 000° 54.2', was marked by a gradual increase in both recorded radio height and pressure altitude. The pressure altitude increased at a faster rate than radio altitude and indicated that atmospheric pressure was reducing at that point. Towards the end of this increase, the helicopter rolled to 9.5° right and, in just under 2 seconds, to 34° left whilst pitching 13.4° nose down and yawing to the right. All three channels of both autopilot lanes disconnected, the autopilot FAULT amber caption illuminated for 10 seconds as a result, and normal acceleration values varied from 1g to zero and up to 1.7g over the same period. Right and aft cyclic was applied together with right yaw pedal. Over a period of 0.75 seconds, the helicopter's heading increased through 250°M (21° to the right of the original heading) and, as it continued to yaw right and roll to 10° right, the pitch attitude increased to 29.8° nose up. The helicopter began to climb and a maximum normal

Over the following three seconds, its heading increased through 300°M and it continued to climb and yaw to the right. Pitch attitude then reduced to a minimum of 15.9° nose down, before being corrected with aft cyclic, whilst the roll attitude varied from 8° left to 18° right, each excursion being opposed by lateral cyclic inputs. The collective pitch was lowered from 15° to 12°, and right yaw pedal was maintained. With this right yaw input applied, the corrective lateral cyclic movements ranged from full left to half of full left travel. Also, during this time, recorded airspeed values fluctuated between 123 kt and 83 kt and the ground speed reduced by 20 kt to 120 kt. (Airspeed values recorded would have been affected significantly by pitot / static system errors, as aircraft drift² angles in excess of 39.9° were evident at that time. The maximum recording range capability of the CVFDR system for drift angle is +/-39.9° and this capability was exceeded during the upset).

The flight traces shown in Figure 3 are repeated in Figure 4, but with selected snapshot representations of the helicopter's attitude during the encounter.

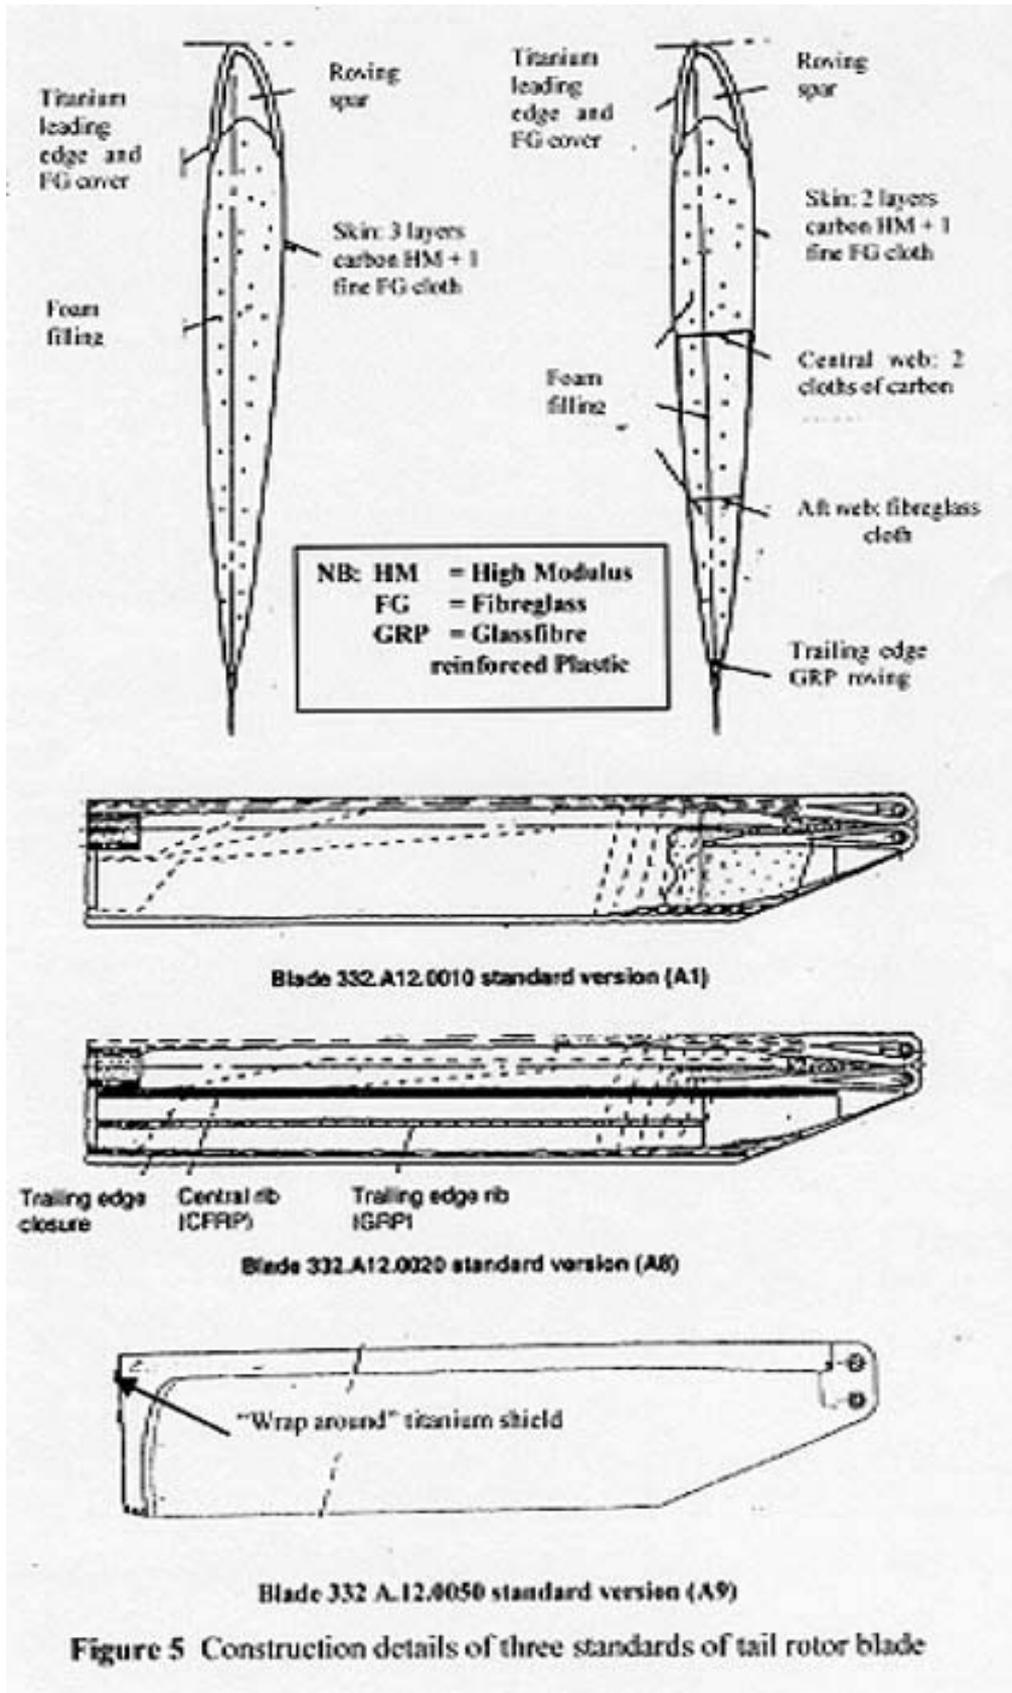
The aircraft was initially certificated, in 1981, with the A1 standard of tail rotor blade. An A8 standard was developed in 1989, in order to improve impact resistance, and this introduced two span-wise webs: a CFRP one at the mid chord position, and a glass-fibre reinforced plastic (GRP) web at the approximate three-quarter chord point. A 'half' roving at the trailing edge was also introduced. On 19 January 1995 an accident to a Super Puma, registration G-TIGK, resulted from severe tail rotor blade damage following a lightning strike. (See Air Accidents Investigation Branch Report No 2/97). Improved electrical bonding was subsequently incorporated into the blade structure and this included extending the titanium erosion shield around the blade tip. This became the A9 standard and was introduced by Service Bulletin (SB) 01.00.59 issued in November 1999. The SB was subsequently mandated by a French Consigne de Navigabilité (Airworthiness Directive), No 2000-003-075(A), in January 2000. Thus, the blades on this aircraft were of the A9 standard. (An A10 standard is also available, which is identical to the A9, except for the addition of anti-ice heating elements). Cross-sections of the A1 and A9 standard blades are shown in Figure 5.

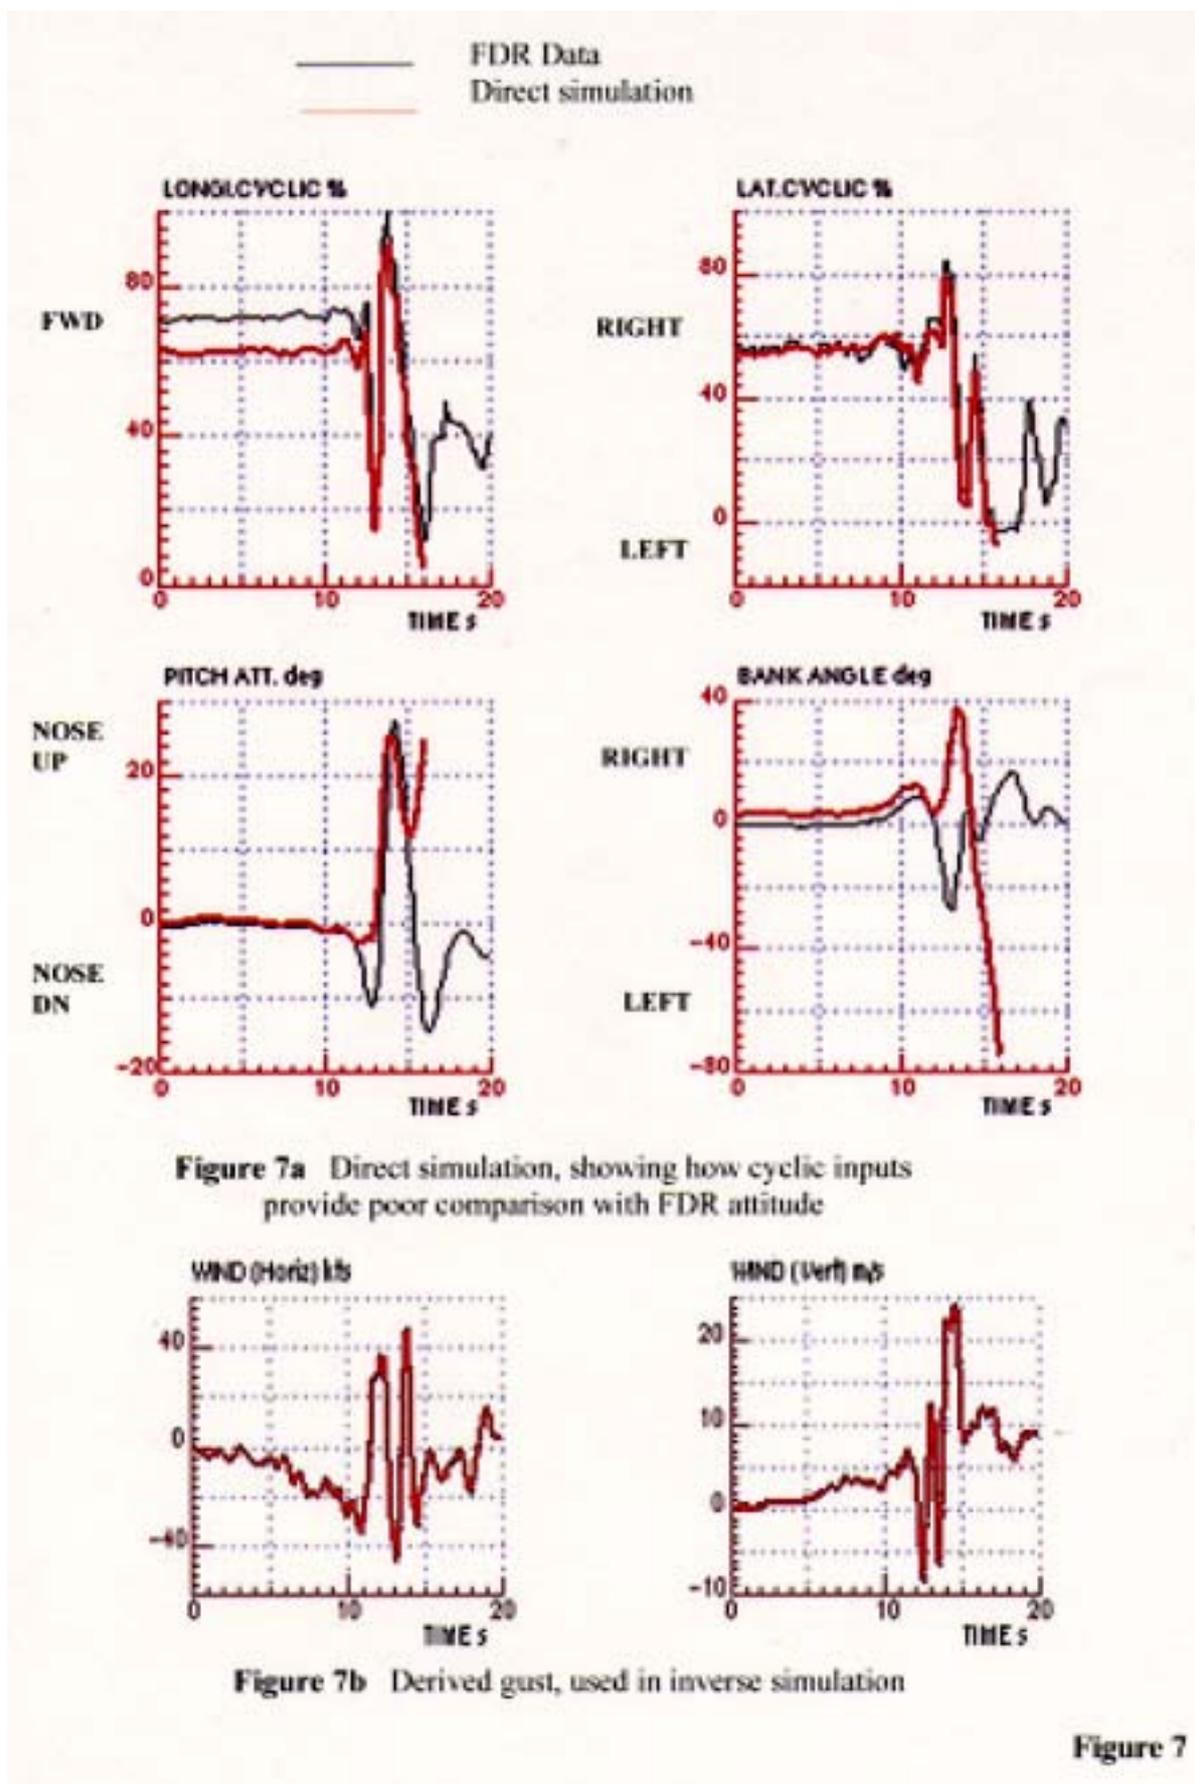
Figure 7

Data from the CVFDR was used to provide inputs to the helicopter manufacturer's in-house computer simulation model of an AS332L. This is known as HOST, and it was configured with the same weight and centre of gravity position that applied to G-TIGB at the time of the incident. The first stage of this simulation was to input the recorded lateral cyclic, longitudinal cyclic and yaw pedal control displacements and compare the simulation results of helicopter attitude with that recorded by the CVFDR. A sample of the results is shown in Figure 7a, where it can be seen that the simulation, not surprisingly, predicted a roll to the right whereas in reality there was a violent roll to the left. In each of the simulator evaluations, a 20 second section of data was used in which an arbitrary datum of time equal to zero was set approximately 11 seconds prior to the event.

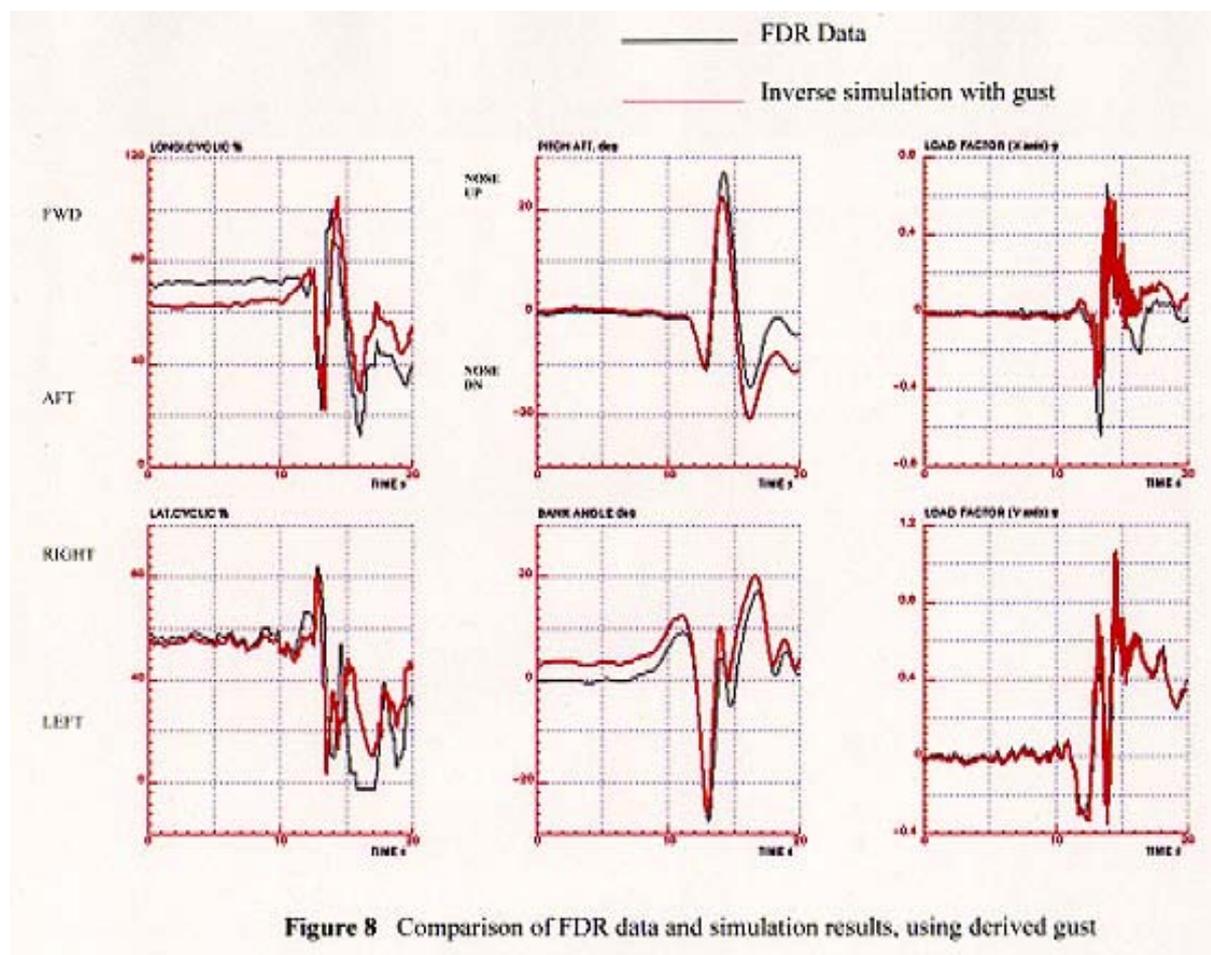
After a number of iterations, a gust profile was derived, Figure 7b, that resulted in a reasonable match for the calculated and observed aircraft attitudes, control inputs and accelerations. These are shown at Figure 8. This showed the magnitude of the gust variation in the horizontal plane, over the first two seconds of the event, to have been around ± 24.6 m/s (40 kt). In the vertical plane, variations of -9 m/s (17.6 kt) to +24 m/s (46.8 kt) were experienced. These gust variations induced load factors in the fore and aft (x) axis of around -0.52 g to +0.654g, and -0.36 g to +1.06 g over the same period in the lateral (y) axis. These gradually reduced to normal values over the next 16 seconds.

The gust induced load factors were extreme and caused by gust variations well outside the Joint Aviation Authorities (JAR) maximum gust load requirements for helicopter certification. JAR 29.341 states that *'Each rotorcraft must be designed to withstand, at each critical airspeed including hovering, the loads resulting from vertical and horizontal gusts of 9.1 metres per second (30 ft/s)'*
