**SERIOUS INCIDENT**

<b>Aircraft Type and Registration:</b>	1) Boeing 737-800, EI-FJW 2) Airbus A320-214, OE-IVC
<b>No &amp; Type of Engines:</b>	1) 2 CFM56-7B26E turbofan engines 2) 2 CFM56-5B4/3 turbofan engines
<b>Year of Manufacture:</b>	1) 2016 2) 2016
<b>Date &amp; Time (UTC):</b>	13 August 2018 at 0948 hrs
<b>Location:</b>	Runway 06 at Edinburgh Airport
<b>Type of Flight:</b>	1) Commercial Air Transport (Passenger) 2) Commercial Air Transport (Passenger)
<b>Persons on Board:</b>	1) Crew - 7                  Passengers - 159 2) Crew - 6                  Passengers - 180
<b>Injuries:</b>	1) Crew - None              Passengers - None 2) Crew - None              Passengers - None
<b>Nature of Damage:</b>	1) None 2) None
<b>Commander's Licence:</b>	1) Airline Transport Pilots Licence 2) Airline Transport Pilots Licence
<b>Commander's Age:</b>	1) 42 years 2) 37 years
<b>Commander's Flying Experience:</b>	1) 6,800 hours (of which 6,650 were on type) Last 90 days - 160 hours Last 28 days - 30 hours  2) 10,000 hours (of which 9,000 were on type) Last 90 days - 200 hours Last 28 days - 70 hours

<b>Information Source:</b>	AAIB Field Investigation

**Synopsis**

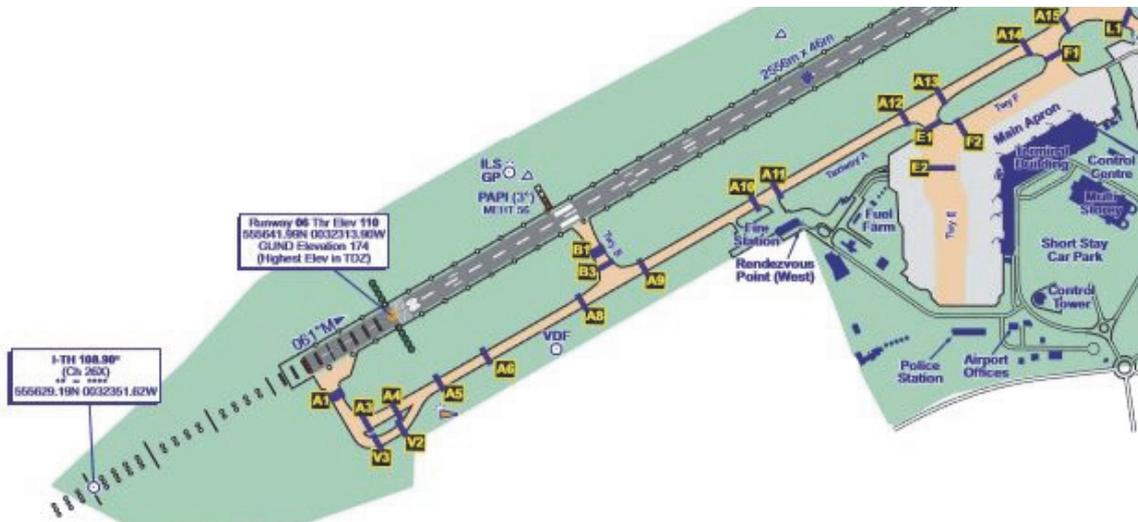
**Figure 1**

At 0936 hrs, OE-IVC began its pushback from the parking stand and started engines. The commander, who was to be PM for the flight to LTN, called for taxi and was given clearance to taxi down taxiway A to hold at A1 for Runway 06 (Figure 1).

Taxiway layout for Runway 06

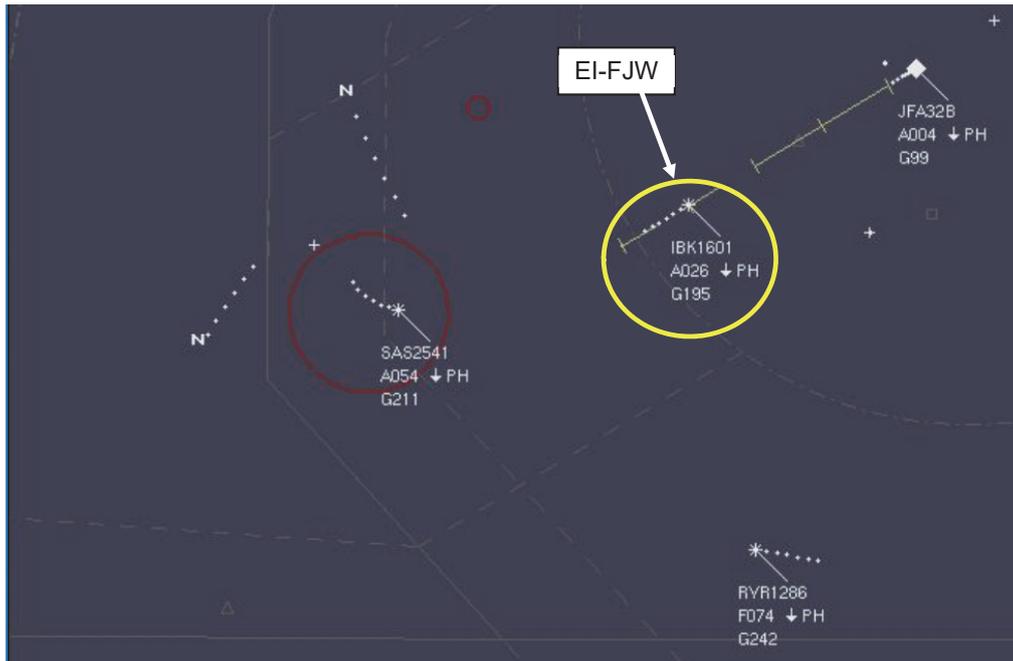
**Figure 3**

EDI is equipped with a radar-based approach surveillance capability. This shows the tower controller the arriving traffic, and other traffic near the airport, with a textual information block for relevant aircraft showing their callsign, altitude above airfield elevation (in hundreds of feet) and groundspeed (GS) in kt (prefixed with the letter G). In addition, the display shows local airspace boundaries, areas of airspace with restrictions (circled in dark red) and a distance scale aligned with the runway axis marked at 2 nm intervals. Part of this display is shown in Figure 3 depicting EI-FJW, as IBK1601 and circled in yellow, on approach at 8 nm.

Approach surveillance at EDI, showing EI-FJW on approach at 8 nm

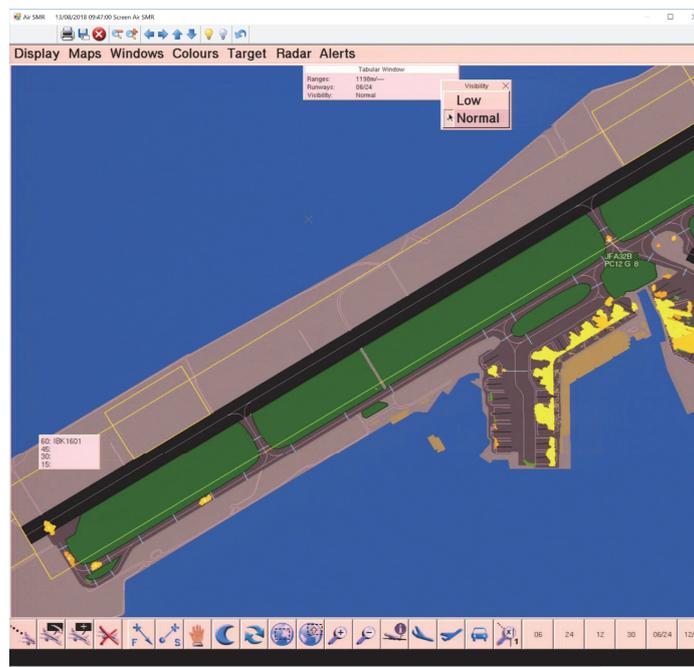
**Figure 4**

EDI also has a Surface Movement Radar (SMR) which shows radar imagery, updated once per second, overlaid on plans of the airport's taxiways and runway. Figure 4 shows an example of a typical SMR display at EDI. All radar data and ATC communications at EDI are recorded.

A typical SMR display at EDI

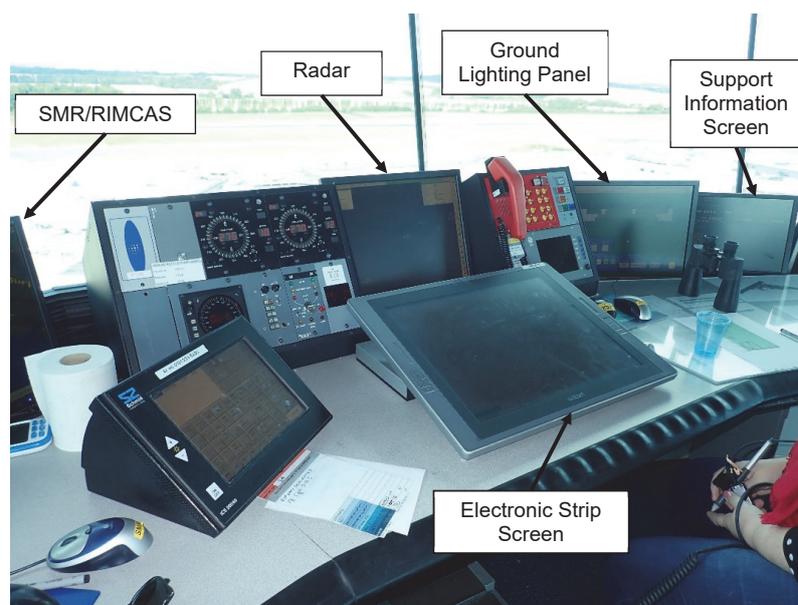
**Figure 8**

The tower control workstation is the middle of the three workstations. It has an unobstructed view of the runway and the approaches at both ends. This workstation is shown at Figure 8. In front of the controller, mounted on the desk, is an interactive screen which displays information about the flights, both on the ground and on approach to the airport. Each flight has a 'strip' which contains details of the flight and the controller amends the strip as the flight progresses through a departure or an arrival. Mounted vertically in front of the controller is a screen showing the radar picture of the arriving and departing traffic. This allows the controller to see the sequence and spacing of the aircraft on the approach (see Figure 3 earlier in this report).

On the right of the controller are two screens which are the ground lighting panel and the support information screen; the latter shows ancillary information such as the latest weather at the airport. To the left of the radar screen is a wind direction and speed display. Further to the left is the SMR/RIMCAS display screen (see Figure 4 earlier in this report).

Tower controller's workstation at Edinburgh as viewed from the OJTI's approximate position

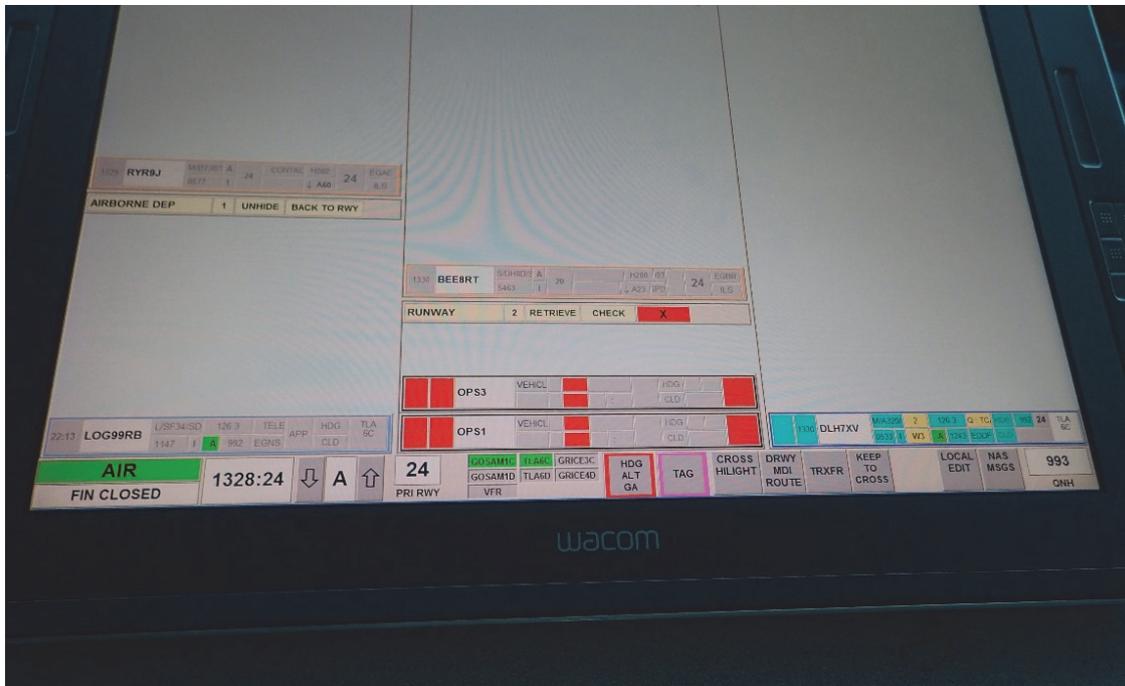
Figure 9 shows the electronic strip screen. When an approaching aircraft is issued a speed instruction by the radar controller, the instructed speed is shown on the strip as shown on Figure 10.

**Figure 9**  
Electronic strip screen

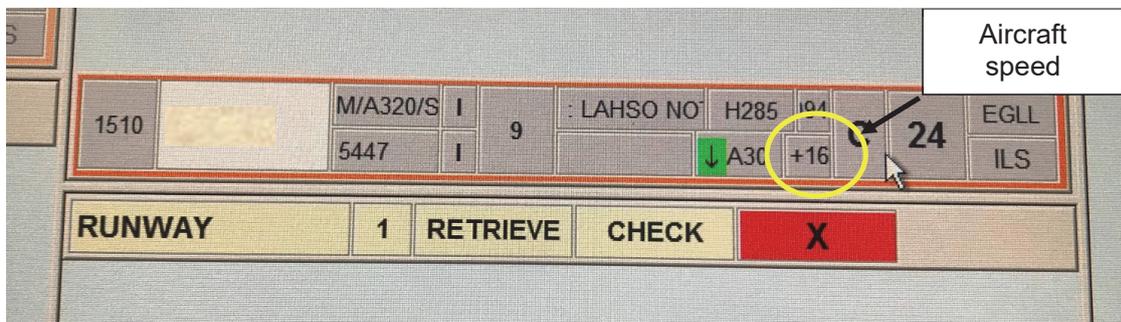
**Figure 10**  
Electronic strip showing an instructed speed of 160 kt or greater

The trainee controller had not been aware of EI-FJW’s groundspeed on approach or the speed instruction that had been issued to EI-FJW by the Edinburgh radar controller. During the second individual interview, the trainee controller reflected that the speed instruction was on the strip and the groundspeed was on the radar display but, being unfamiliar with the conditions, the trainee’s strategy still focussed most attention out of the window instead of using information on the screens.

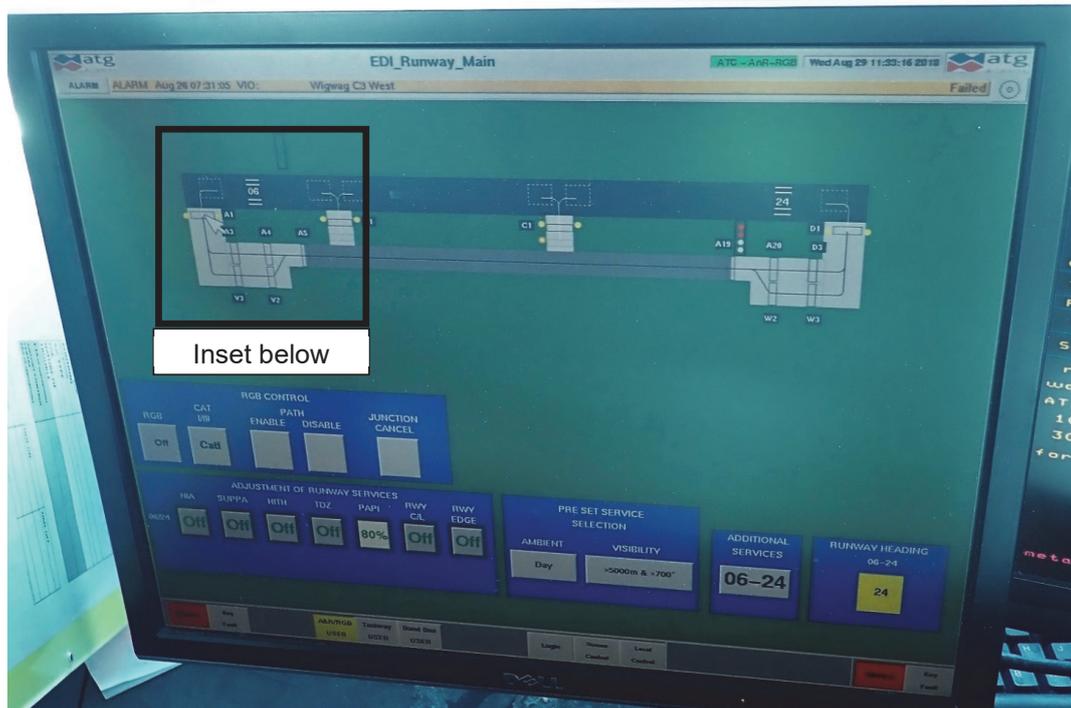
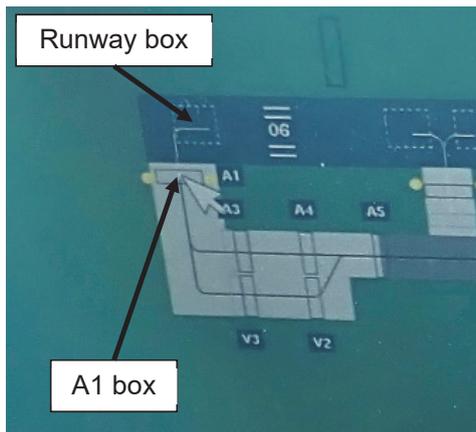
**Figure 11**

The lighting control panel is interactive. The controller selects different boxes on the screen using a mouse to turn on and off lights and change the intensity of some. Turning off the Stop Bar for the holding point A1 for Runway 06 requires the controller to click accurately inside the A1 box followed by a click in the box at the start of the runway.

Lighting control panel
