**SOUTH AFRICAN CIVIL AVIATION AUTHORITY
(SACAA)**

SERIOUS INCIDENT INVESTIGATION REPORT

FINAL REPORT

**Boeing B747-400
G-BYGA
Group 'A' L/E Flaps retracted on Takeoff
from O.R. Tambo Airport,
SOUTH AFRICA.
11 May 2009**

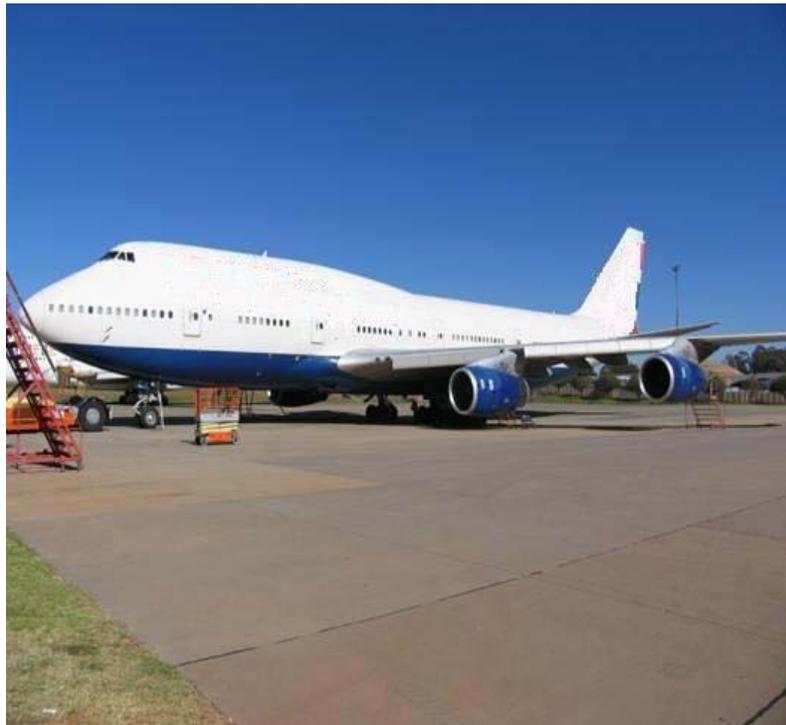
VIEW OF THE B747-400 G-BYGA WITH GROUP 'A' LEADING EDGE FLAPS EXTENDED ON THE LEFT HAND WING (RIGHT HAND WING LE FLAP CONFIGURATION IS SIMILAR).

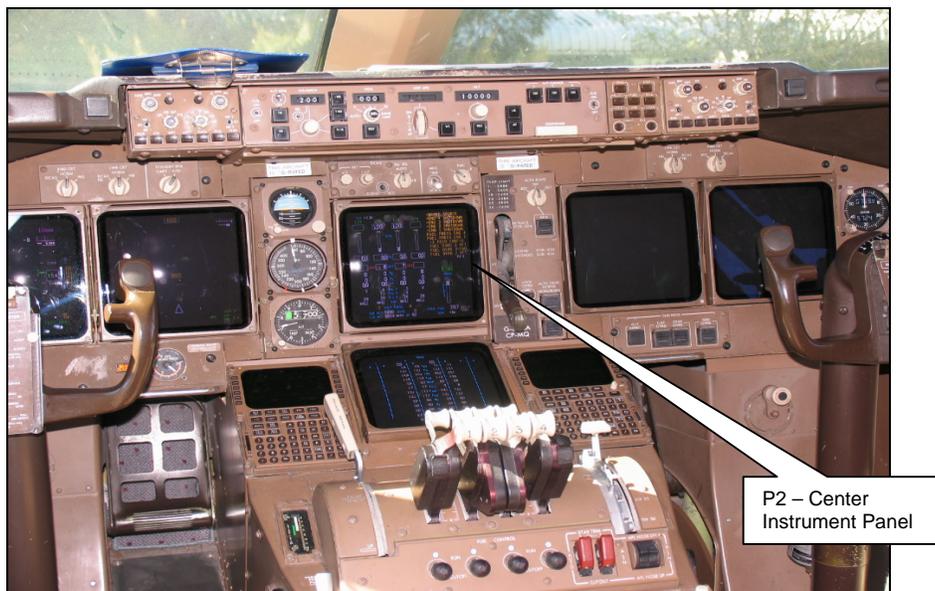
- a) During the takeoff roll the No. 3 'REV' amber EICAS message displayed on the P2 – Pilots Center Instrument Panel. Some seconds later, a No. 2 engine 'REV' amber EICAS message displayed on the P2 – Center Instrument Panel.
- b) The 'REV' amber EICAS message indicated to the flight deck crew that the specific thrust reverser was out of the stowed and locked position and in transit [Note that in this case both engines #2 and #3 had one TR gearbox unlock, however the other locking gearbox and the air motor brake remained engaged and neither reverser deployed].
- c) The aircraft air/ground logic then signaled the Group 'A' LE flaps to re-deploy (extend) and this occurred automatically.

PHOTO 3: VIEW OF FLIGHT DECK LAYOUT OF G-BYGA INSTRUMENT PANELS
