INCIDENT

Aircraft Type and Registration:	Boeing 777-200ER, AP-BGL	
No & Type of Engines:	2 GE 90 turbofan engines	
Category:	1.1	
Year of Manufacture:	2004	
Date & Time (UTC):	1 March 2005 at 0910 hrs	
Location:	Manchester Airport, Manchester	
Type of Flight:	Public Transport (Passenger)	
Persons on Board:	Crew - 12	Passengers - 332
Injuries:	Crew - 0	Passengers - 31 (Minor)
Nature of Damage:	Slight damage to fuselage skin adjacent to door 3R, heat damage to the No 10 tyre and hydraulic hoses on the left main landing gear	
Commander's Licence:	Airline Transport Pilot's Licence	
Commander's Age:	54 years	
Commander's Flying Experience:	13,000 hours (of which 600 were on type) Last 90 days - 176 hours Last 28 days - 36 hours	
Information Source:	AAIB Field Investigation

Synopsis

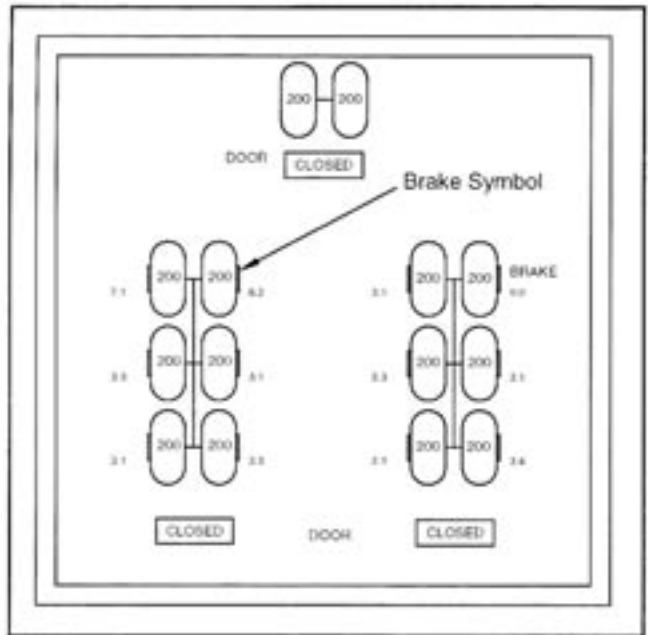
Figure 2

Each of the two MLGs on the Boeing 777 has six wheels on a three axle truck, each wheel being equipped with a hydraulically actuated multi-disk carbon brake. They are numbered across the aircraft, No 1 wheel being the front left unit on the left MLG, No 12 being the right rear unit on the right MLG. Each main wheel is also fitted with a thermal wheel fuse plug, a thermocouple, a wheel speed transducer and pressure transducer. The brake temperature and tyre pressure is displayed on the landing gear synoptic and brake and steering maintenance pages, see Figures 2 and 3.

Landing Gear Synoptic Display
