**Statens haverikommission**  
Swedish Accident Investigation Board

## ***Report RL 2007:23e***

**Aircraft accident to YK-AHB at Stockholm/  
Arlanda airport, AB county, Sweden, on  
11 December 2006**

Case L-30/06

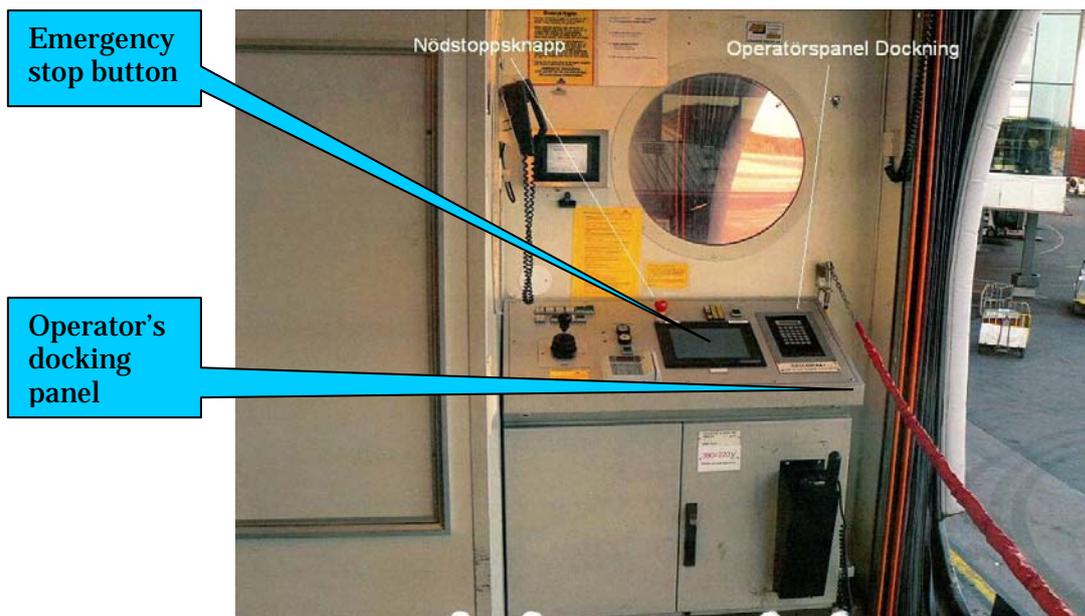
At the same moment that "STOP" appeared on the LED display the aircraft collided with the airbridge. The top of the aircraft left wing struck the underside of the airbridge housing and continued a little further, to become wedged in place. A large hole was made in the structure of the top of the aircraft wing. The airbridge also suffered damage. When the engines had been shut down the cabin services manager went into the cockpit and said that the aircraft had run into the airbridge, and that there was a hole in the top of the left wing. No-one was injured, and all the passengers could leave the aircraft in a normal manner.

Damage to the airbridge. No known environmental effects.

*Fig. 3. Airbridge*
