**Australian Transport Safety Bureau**

**ATSB TRANSPORT SAFETY REPORT**  
Aviation Occurrence Investigation  
AO-2009-012  
Final

**Tailstrike and runway overrun  
Melbourne Airport, Victoria  
20 March 2009  
A6-ERG  
Airbus A340-541**

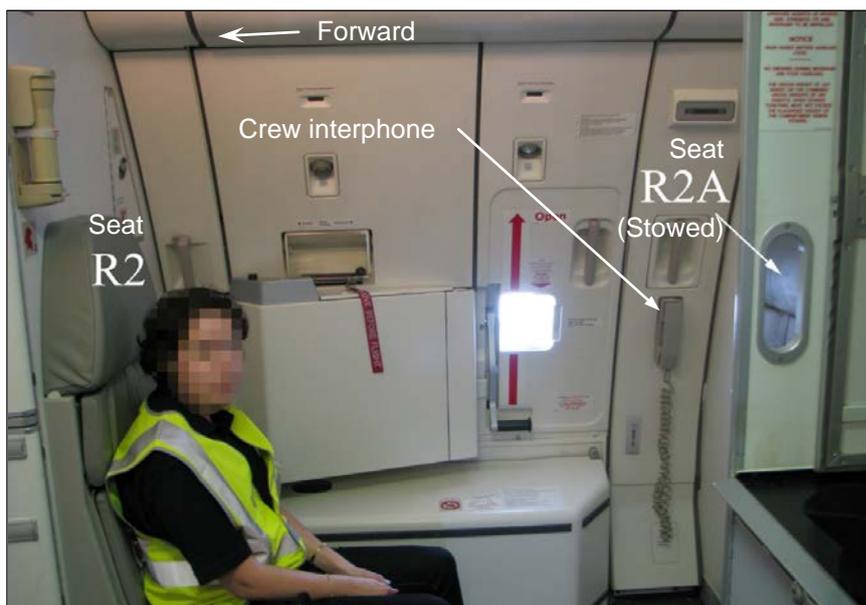
**Figure 22: Door R2 interphone**

The captain requested that the cabin crew remain seated for the duration of the flight and that all communication between the cabin crew was via the interphone system. The only report of any difficulty with the interphone system was from the cabin crew member who was seated at door R2 who reported that she was unable to reach the interphone from her door operator position at R2 (see Figure 22).

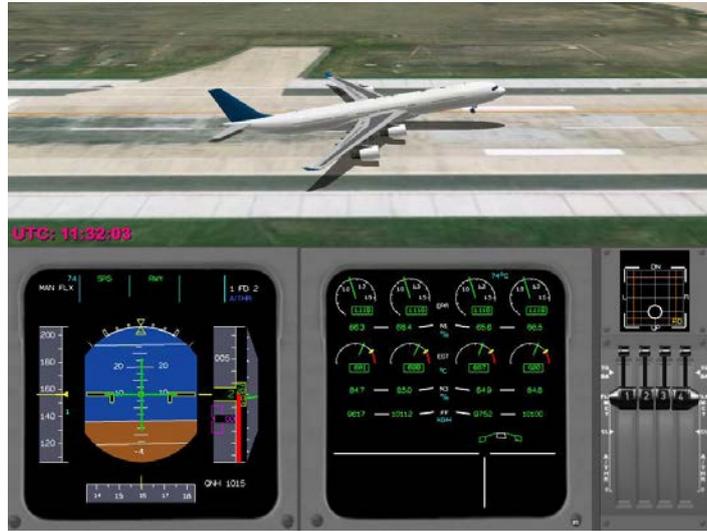
2232:03 The tail made first contact with the runway surface.  
CAS: 156 kts Distance to runway end: 265 m

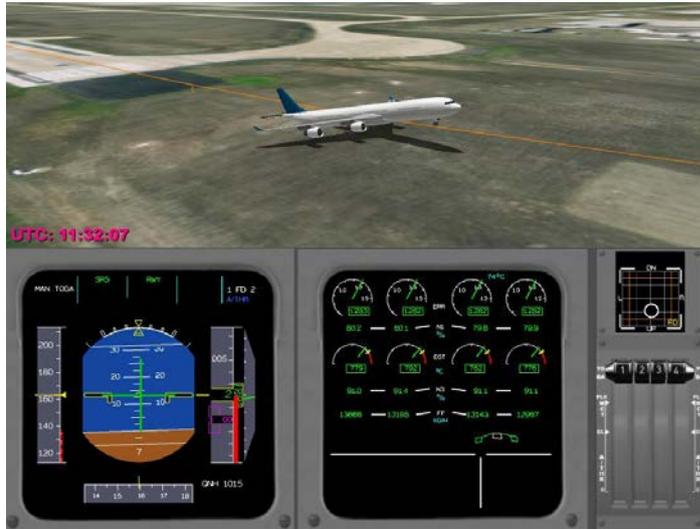
2232:07 The tail lifted off from the ground.  
CAS: 161 kts Radio altitude: -1 ft<sup>90</sup>

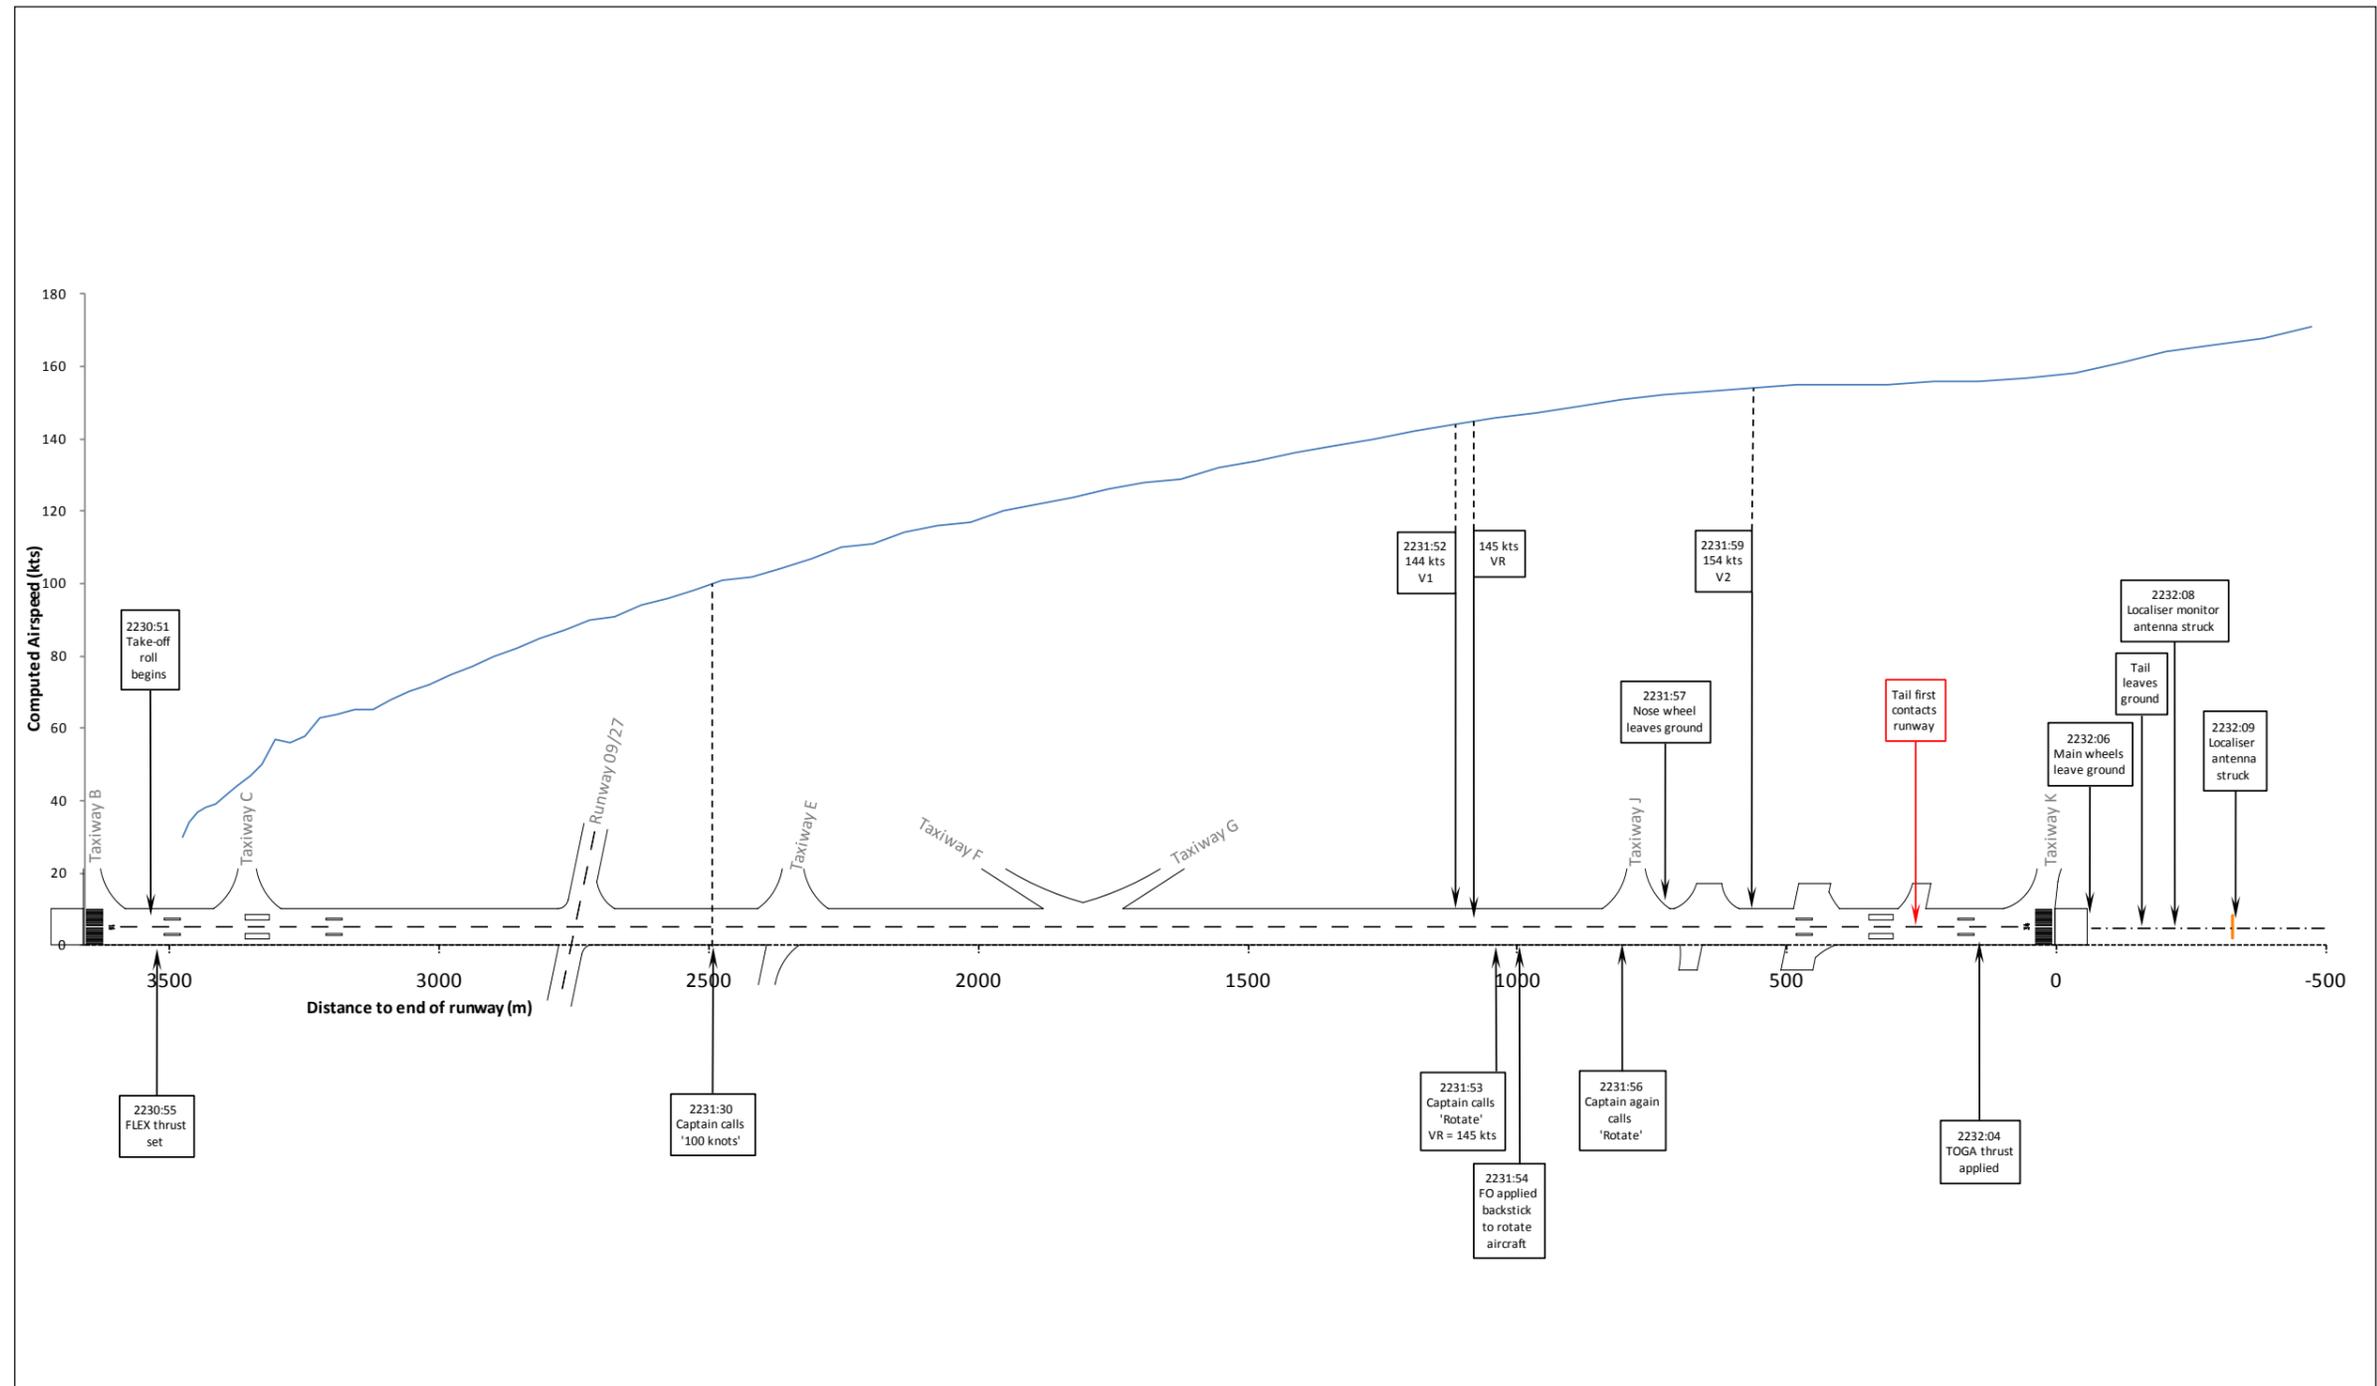
Figure 32: Take-off events

The following is a chronology of the events during the takeoff and initial climb. The aircraft's location and airspeed along the runway during this sequence of events is presented in Figure 32.

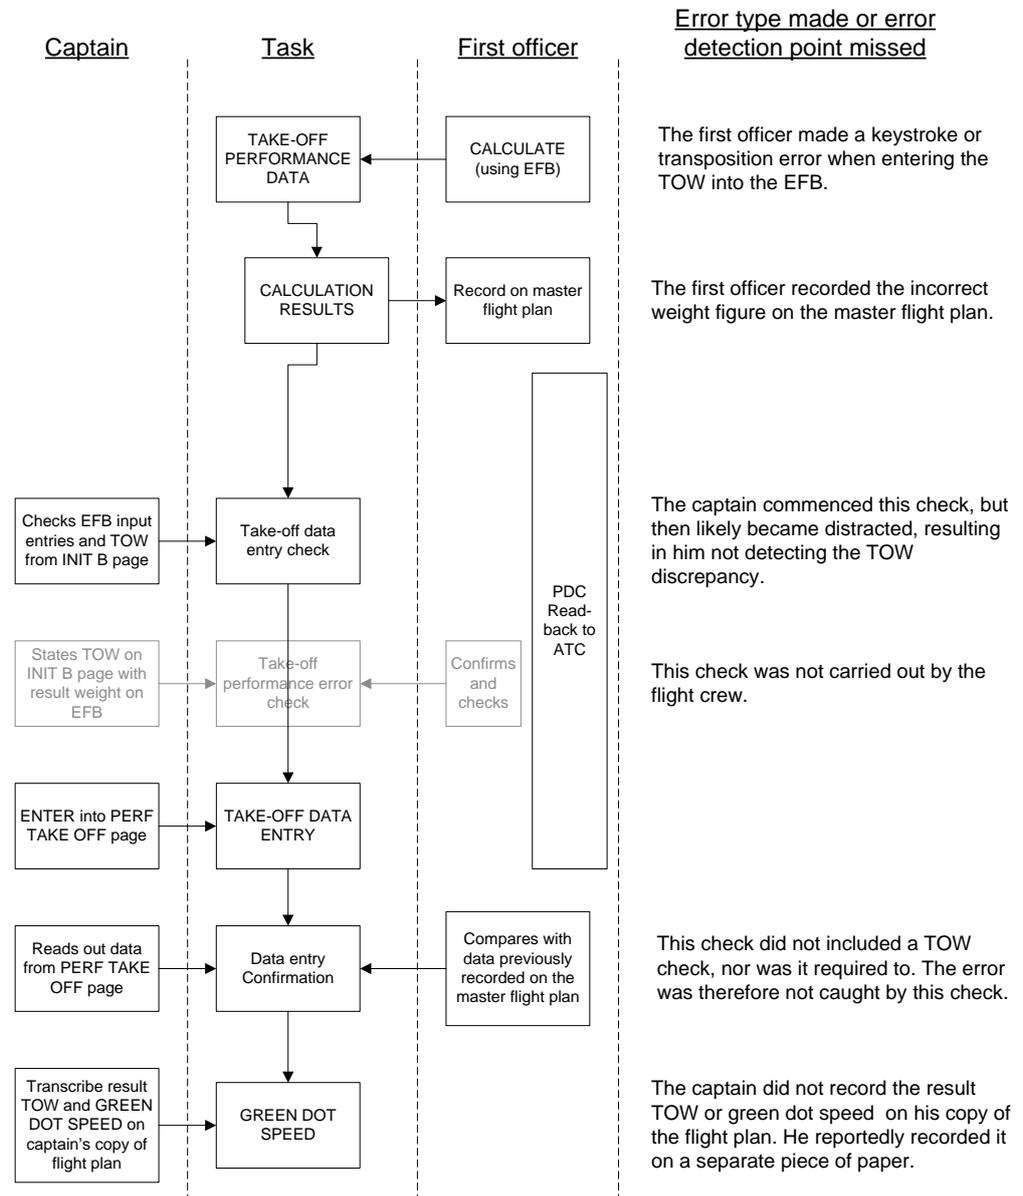
**Figure 33: Take-off performance error check**

The take-off performance error check included a check of the data input into the EFB that was performed silently by the captain, and a verbal check by the captain and first officer of the EFB 'result' take-off weight against the FMGS INIT B page take-off weight (Figure 33).

Although not required by the operator's procedures, had the augmenting captain the opportunity to perform his own check of the take-off performance calculations, he may have detected the take-off weight entry error.

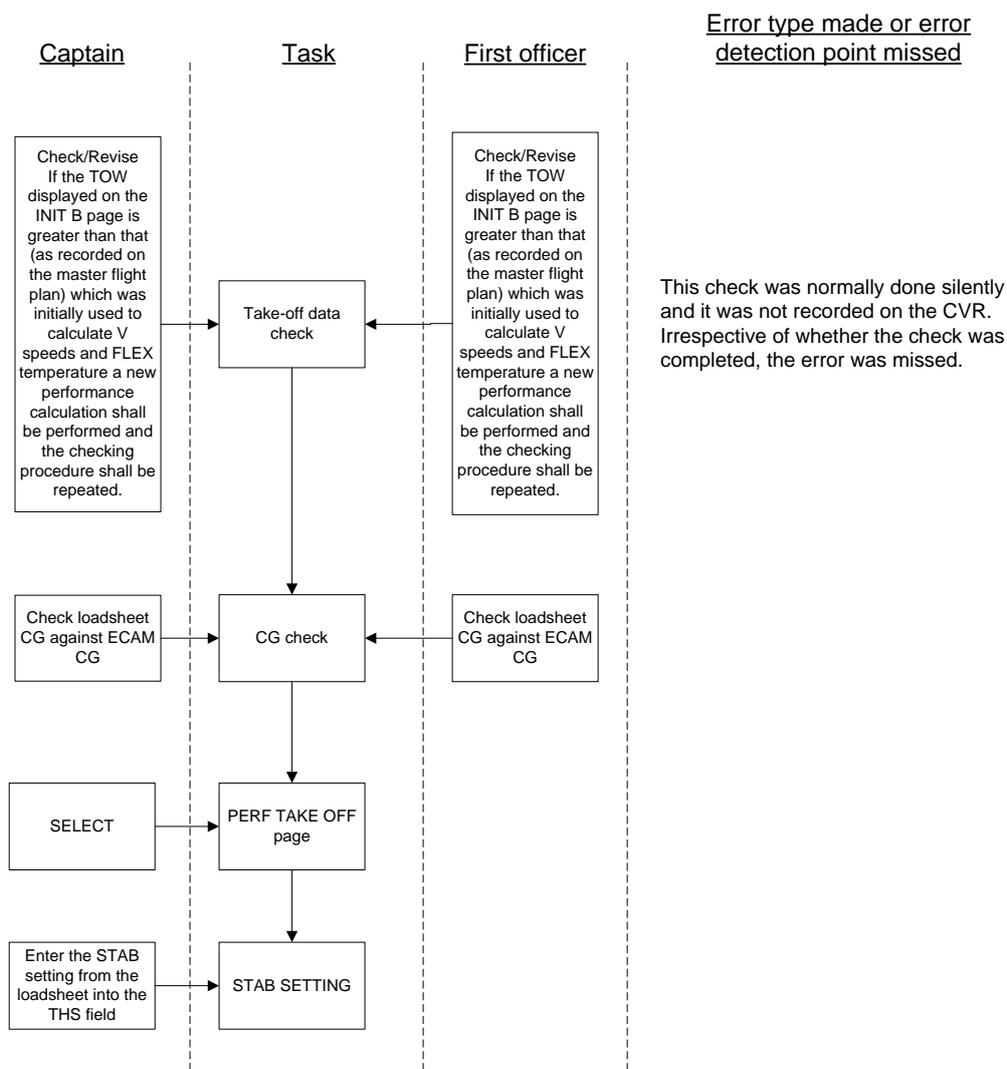
**Figure 34: Take-off data check**

The take-off data check was to be carried out following receipt of the final load sheet, and included a requirement for both crew members to silently verify that the take-off weight displayed on the INIT B page was greater than the FLEX-limiting take-off weight previously recorded by the first officer on the master copy of the flight plan (Figure 34).

The lack of a requirement to verbally verify the two take-off weights prevented the investigation from confirming whether this check was carried out by the crew. However, if it was carried out, it was ineffective and neither the captain nor the first officer detected the erroneous take-off weight.

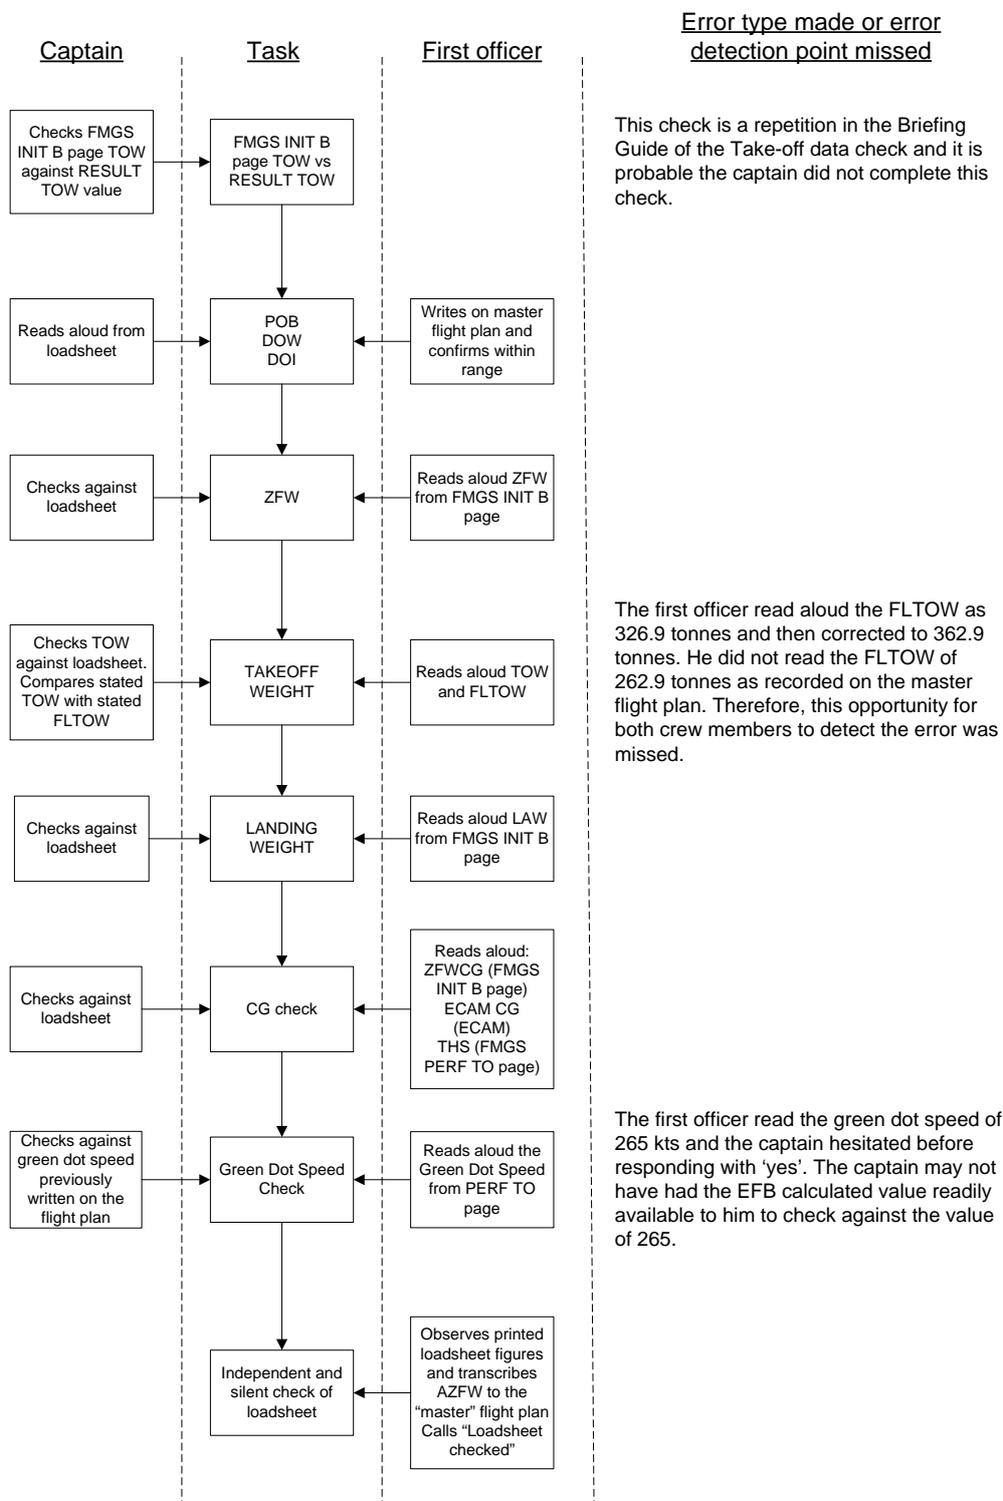
**Figure 35: Loadsheet confirmation procedure**

The loadsheet confirmation procedure provided the final two procedural defences to detect the error in the take-off weight (Figure 35). The first was when the first officer read out the take-off weight from the FMGS INIT B page and then the 'result' take-off weight from the master flight plan.

In summary, the crew's non-detection of the erroneous take-off weight entry in the EFB was multifaceted, and reduced the effectiveness of the procedural checks that could, individually, have detected the error. It is possible for errors to pass

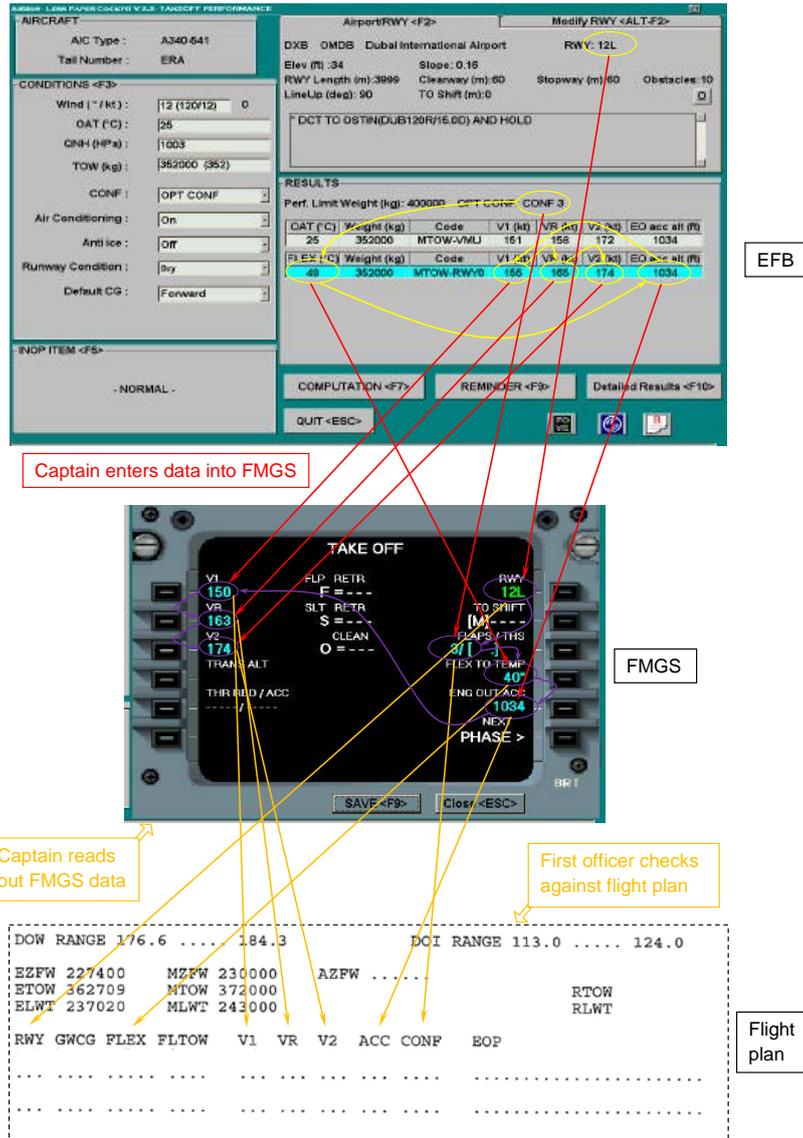
Figure 36: Link analysis on EFB

This included a review of the flow of information into the EFB, from the EFB to the flight plan, from the EFB to the FMGS, and from the FMGS to the final check against the flight plan. Figure 36 shows the link analysis for the flow of information from the EFB to the FMGS and then to the flight plan for the final check.

In addition to the flow of information, a number of other issues were highlighted. The first related to the inconsistency in the weights entered into the EFB and recorded on the flight plan, which varied between tonnes and kilograms. The possibility of transposition errors would be reduced if the units were consistent.

The second issue was related to the initial entry of data into the EFB. The EFB required the user to enter the take-off weight and not the individual ZFW and fuel load figures. The previous incidents highlighted the number of times that the zero fuel weight was entered into the EFB instead of the take-off weight. If the user was required to enter the ZFW, the fuel weight and the take-off weight, the EFB could perform an independent check of the figures to reduce the likelihood of a data entry error.

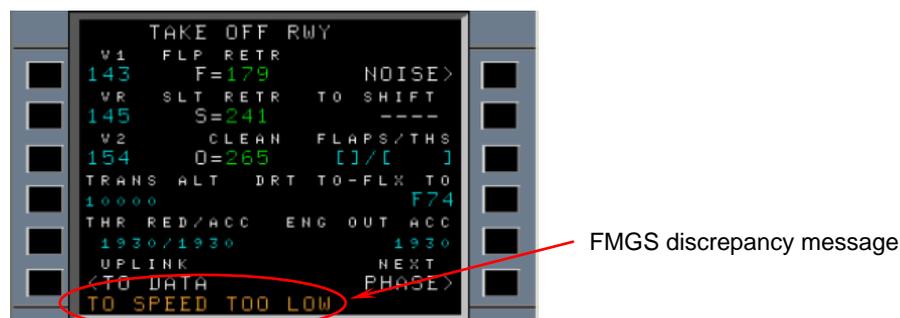
On 28 May 2010, Airbus provided the ATSB with the results of a simulation of the TOS function for the A340 using the accident flight take-off performance parameters. The result is shown below.

In July 2009, Airbus announced in their *Safety First* magazine that they were developing a software package called the 'Take-off Securing' (TOS) function. The TOS function automatically checks the data being entered into the flight management and guidance system (FMGS) for consistency between the take-off parameters. A check is carried out on the takeoff reference speeds entered into the FMGS against take-off limitation speeds calculated within the FMGS based on the aircraft weight. If the TOS function detects a discrepancy between these speeds, it alerts the flight crew by displaying a message on the FMGS display unit.

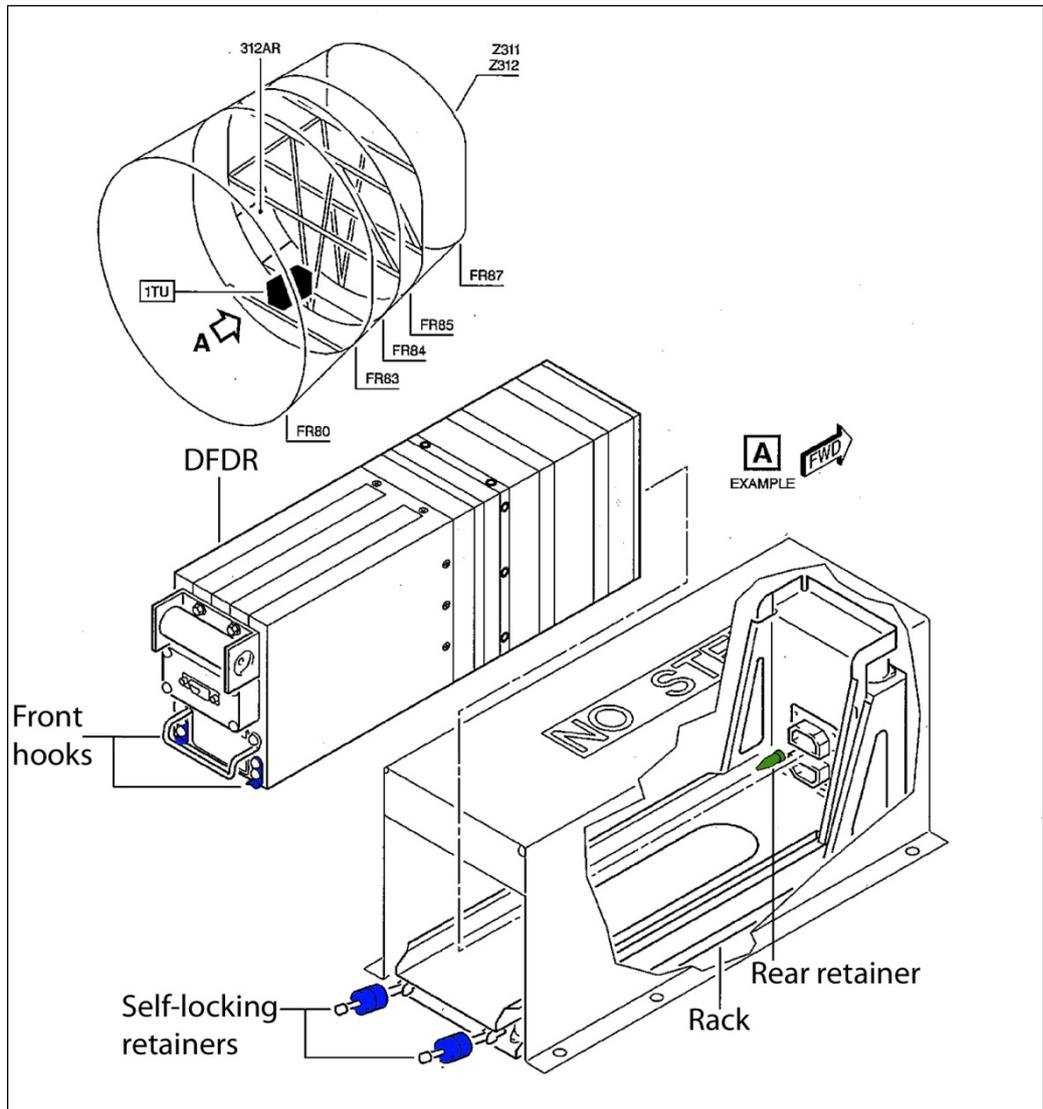
**Figure A2: Schematic diagram showing the orientation of rack/FDR in aircraft**

The FDR was normally secured in the rack with two attachment hooks on the front of the unit. The fasteners used for securing the FDR are known as positive self locking retainers, and work on a spring loaded mechanism (Figure A2). The knurled outer sections of the fastener are placed over the hooks on the front of the FDR, and then tightened via the internal nut to lock it in position. The spring forces the lower section to lock onto the top segment (closest to the rack) which cannot rotate around the rod. The fastener is loosened by pulling on one side of the outer casing, to release the locked mating faces, allowing for the threaded nut to be undone.

The upper shelf of the rack had deformed upwards, and some distortion across the width of the rack was also observed (Figure A5). The heads of the screws holding the upper tray in position had been pulled through their recesses.

The damage observed on the FDR rack was considered to be the result of the tailstrike event. The vertical forces from the impact, acting on the weight of the FDR unit, would have imparted sufficient load to the rack through the fasteners, to permanently deform the aluminium sheet of the upper tray. The upper tray exhibited permanent plastic deformation/buckling along the vertical axis, towards the fastener end, in the order of 14 millimetres.

With the upper tray deformed, the nuts would have been able to disconnect from the FDR hooks, leaving the unit unsecured. The deformation was observed to be equal on the left and right sides of the upper tray, which indicated that both fasteners were secured at the time of the occurrence.

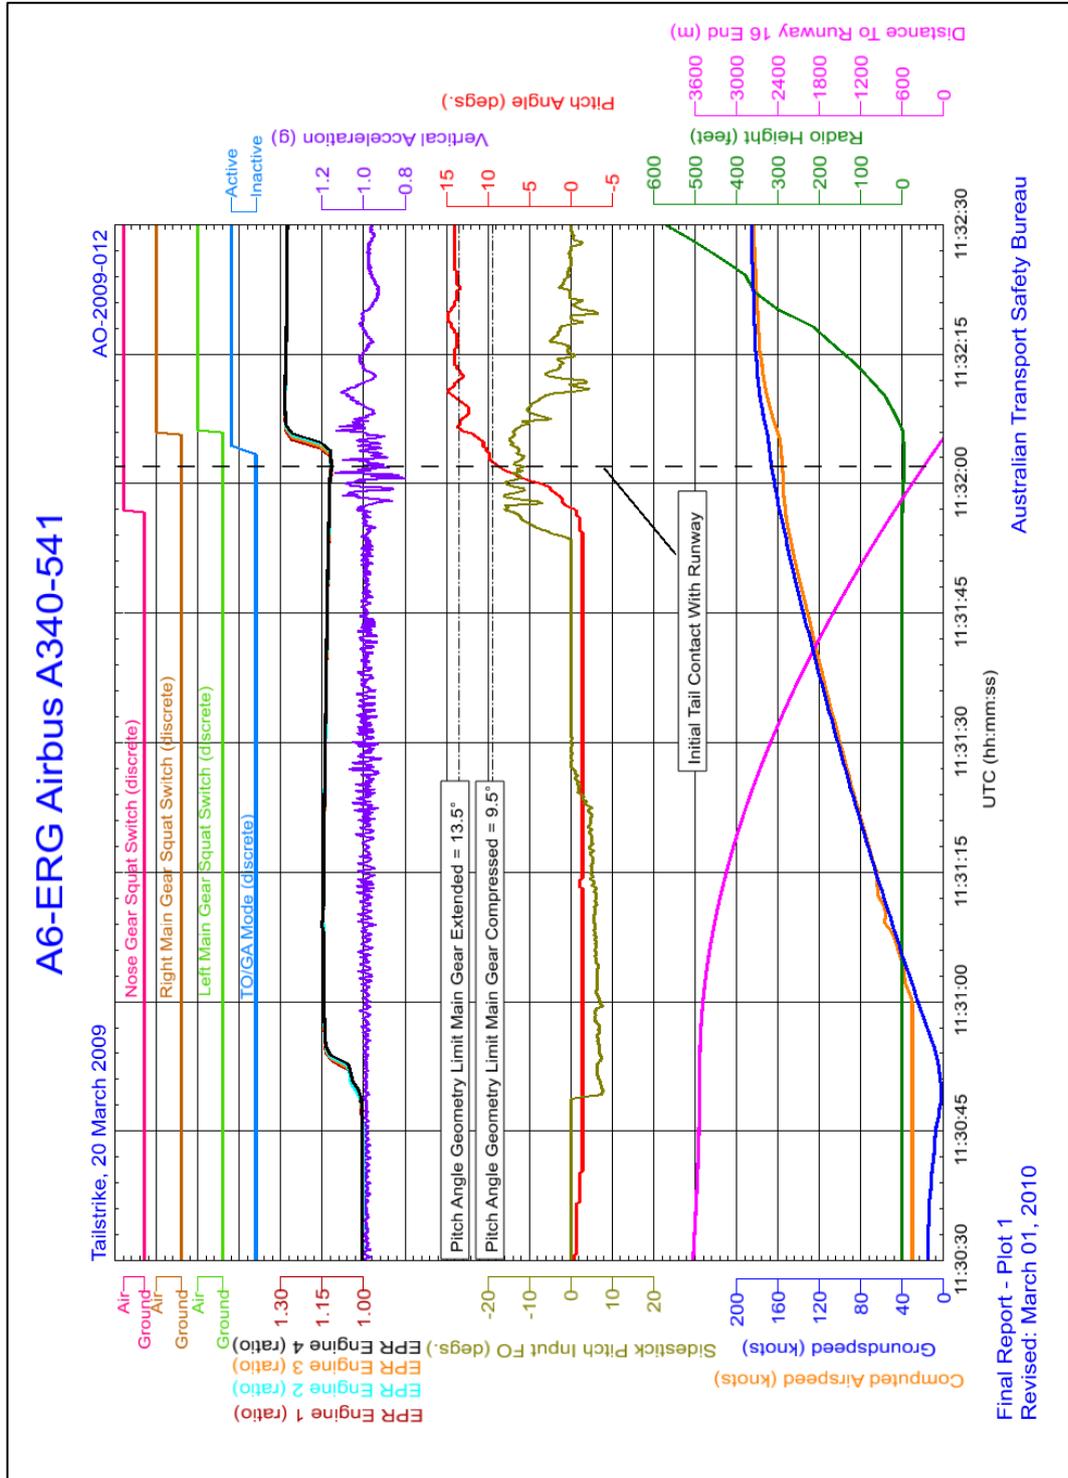
Figure C11: Selected DAR parameters for the take-off roll

Two plots of the relevant flight data from the digital aircraft condition monitoring system recorder (DAR) were prepared and are at Figure C11 and C12.
