**ATSB TRANSPORT SAFETY REPORT**  
Aviation Occurrence Investigation  
AO-2010-081  
Final

**Stickshaker activation**  
**Kalgoorlie Airport, Western Australia**  
**13 October 2010**  
**VH-NXD, Boeing 717-200**

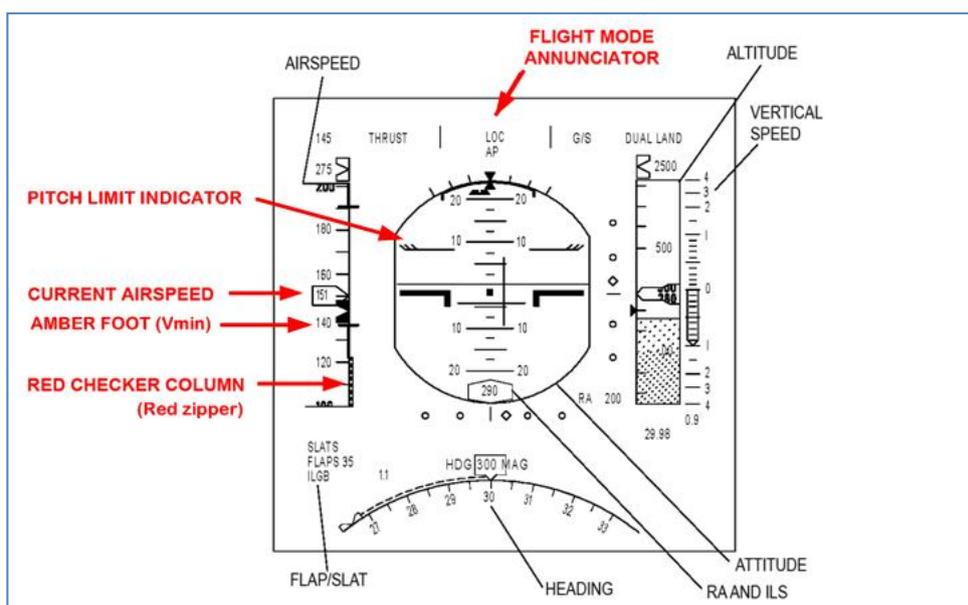
Figure 1: Primary flight display

During an approach, the pitch limit indicator (PLI) on each pilot's PFD indicated the difference between the aircraft's angle of attack and the stickshaker angle of attack. The PLI, which was normally cyan in colour, turned amber as the aircraft approached the stickshaker angle of attack and red at the stickshaker angle of attack. The PLI was for information only and was not to be used for guidance command.

Both PFDs displayed the red checker column (Red zipper) that moved vertically on the airspeed tape, graphically displaying the margin between the stickshaker activation speed and the current airspeed. The margin between the aircraft's current airspeed and the stickshaker speed was dynamic and was displayed throughout the flight. In addition, the current airspeed indication, shown at the centre of the airspeed tape, would turn amber when the airspeed was below the minimum operating speed ( $V_{min}$ )<sup>8</sup> and red when the stickshaker activated.
