**AIRCRAFT ACCIDENT INVESTIGATION COMMITTEE  
MINISTRY OF TRANSPORT, THAILAND**

**AIRCRAFT ACCIDENT FINAL REPORT**

**ONE TWO GO AIRLINES COMPANY LIMITED  
MCDONNELL DOUGLAS DC-9-82 (MD-82)  
HS-OMG**

**16 SEPTEMBER 2007**

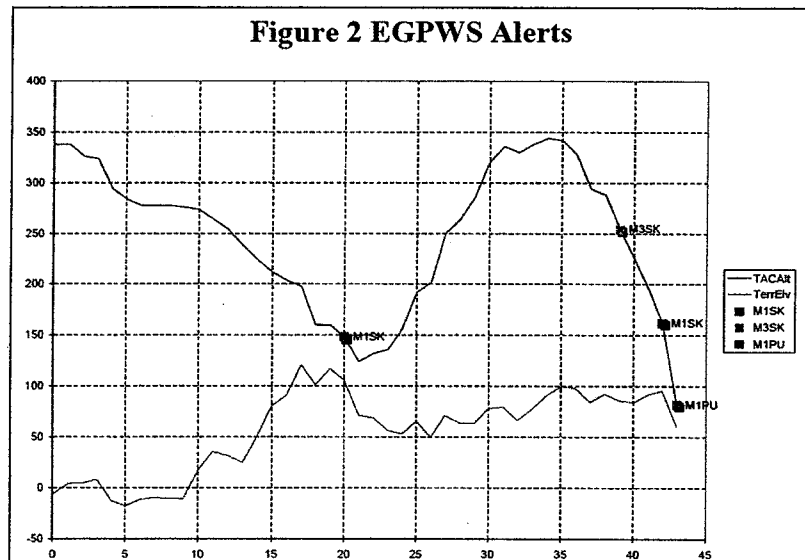
1.16.1.3 The EGPWS, Mark V EGPWS part number 965-0976-003-216-216 and serial number 18254, produced by Honeywell, was sent to Redmond, Washington, Hoeywell facility for examination. The initial examination of the unit was conducted with the presence of a representative from the NTSB and FAA. The data indicated that four alerts were recorded over an approximate 43-second span. The first alert (Sink Rate) was recorded at 20 seconds of the data. The second alert (Sink Rate) was recorded at 39 seconds of the data. The third alert (Sink Rate) was recorded at 42 seconds of the data. The fourth alert (Pull Up) was recorded at 43 seconds of the data. After the last alert, the data recording ended, presumably the time the airplane had impacted.

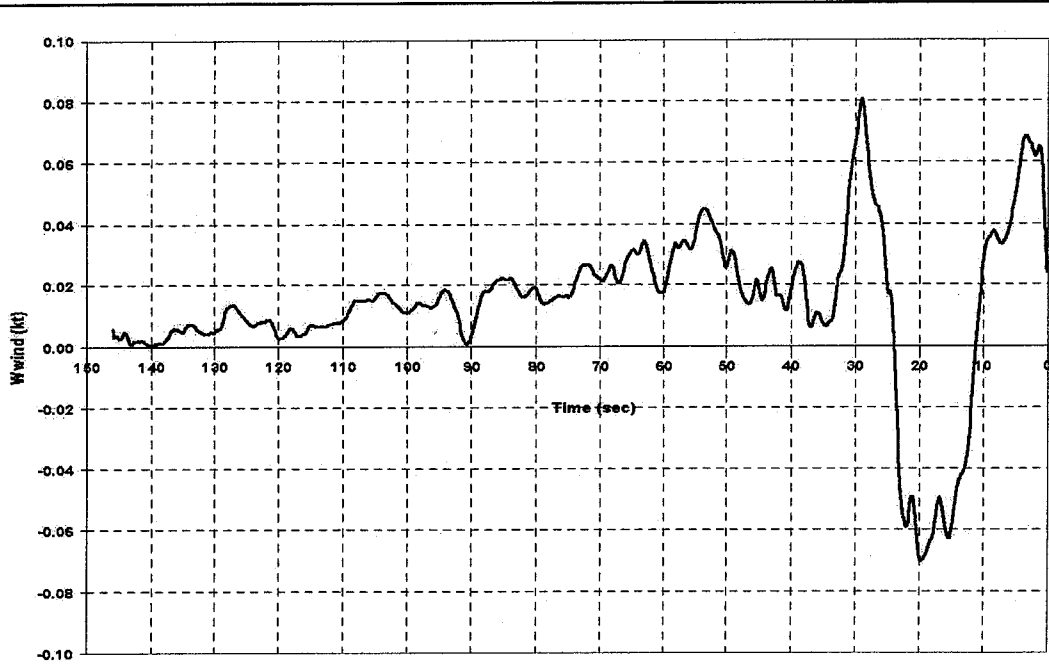
Figure 1. Vertical Wind

The wind data provided by the NTSB (Reference 3) shows that there was a relatively insignificant vertical component of wind during the landing approach (Figure 1), and it is not expected that a windshear alert should have been issued based on the vertical shear. The variable within the legacy Honeywell algorithm which is most responsive to vertical shear is the variable TVERT, and the response of this variable is shown in Figure 3.

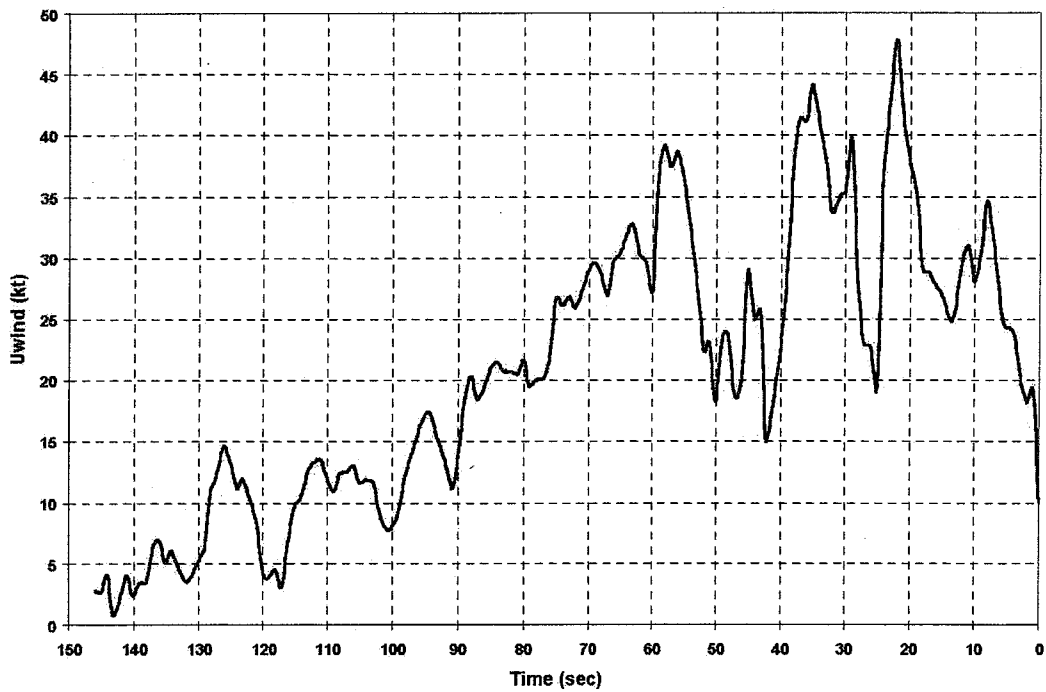
Figure 2. Horizontal Wind

The horizontal wind component (Figure 2) shows a general increase from a headwind of 3 knots to a headwind of 47 knots during the majority of the approach, and then a rapid decrease to 10 knots at the end-of-data time. During the 'increasing' phase the wind speed oscillated considerably. These oscillations were attenuated by the gust filters of the windshear algorithm, as intended.

Towards the end of the approach, the headwind component (Figure 2) decreases, and the negative shear value eventually reaches a magnitude sufficient to cause the system to issue a warning alert (Figure 5).

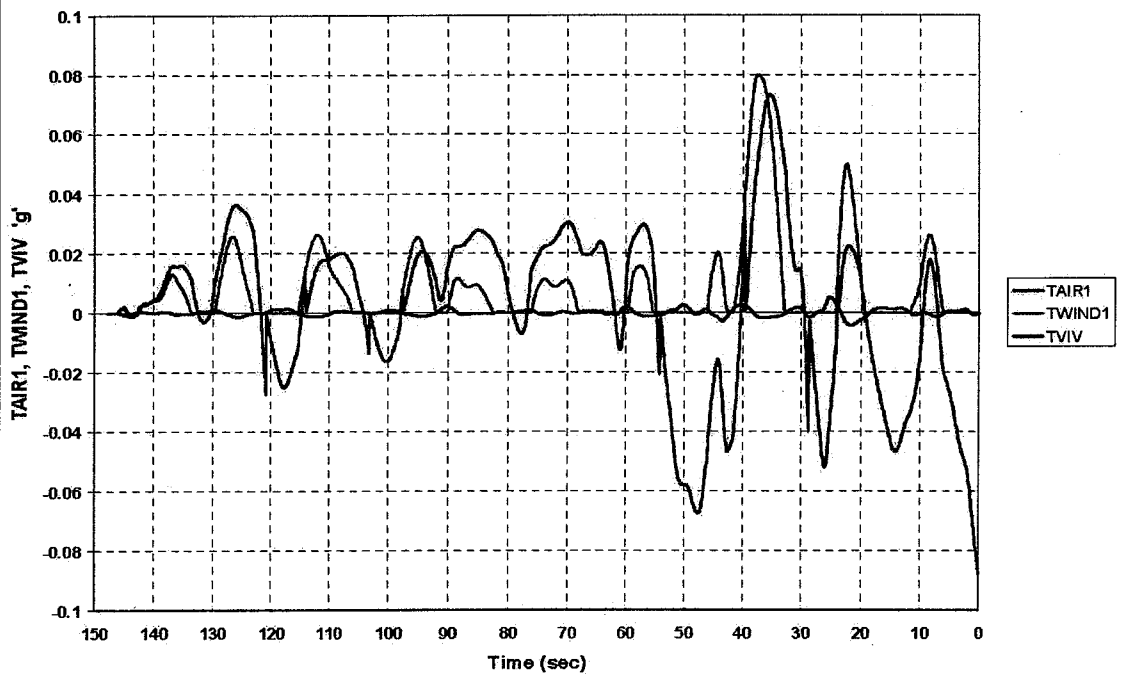
Figure 4. Simulation Time Histories of Windshear Algorithm Variables TAIR1, TWIND1 and TVIV

The variables within the legacy Honeywell algorithm which are most responsive to horizontal shear are the variables TAIR1, TWIND1 and the 'wind vector rotation' variable TVIV. Plots of these variables against time from the simulation are shown in Figure 4. It is the variable TAIR1 which finally exceeds the threshold and causes an alert, as shown in Figure 5.
