DUTCH
SAFETY BOARD

Loss of separation over Uitgeest

The Hague, May 2013

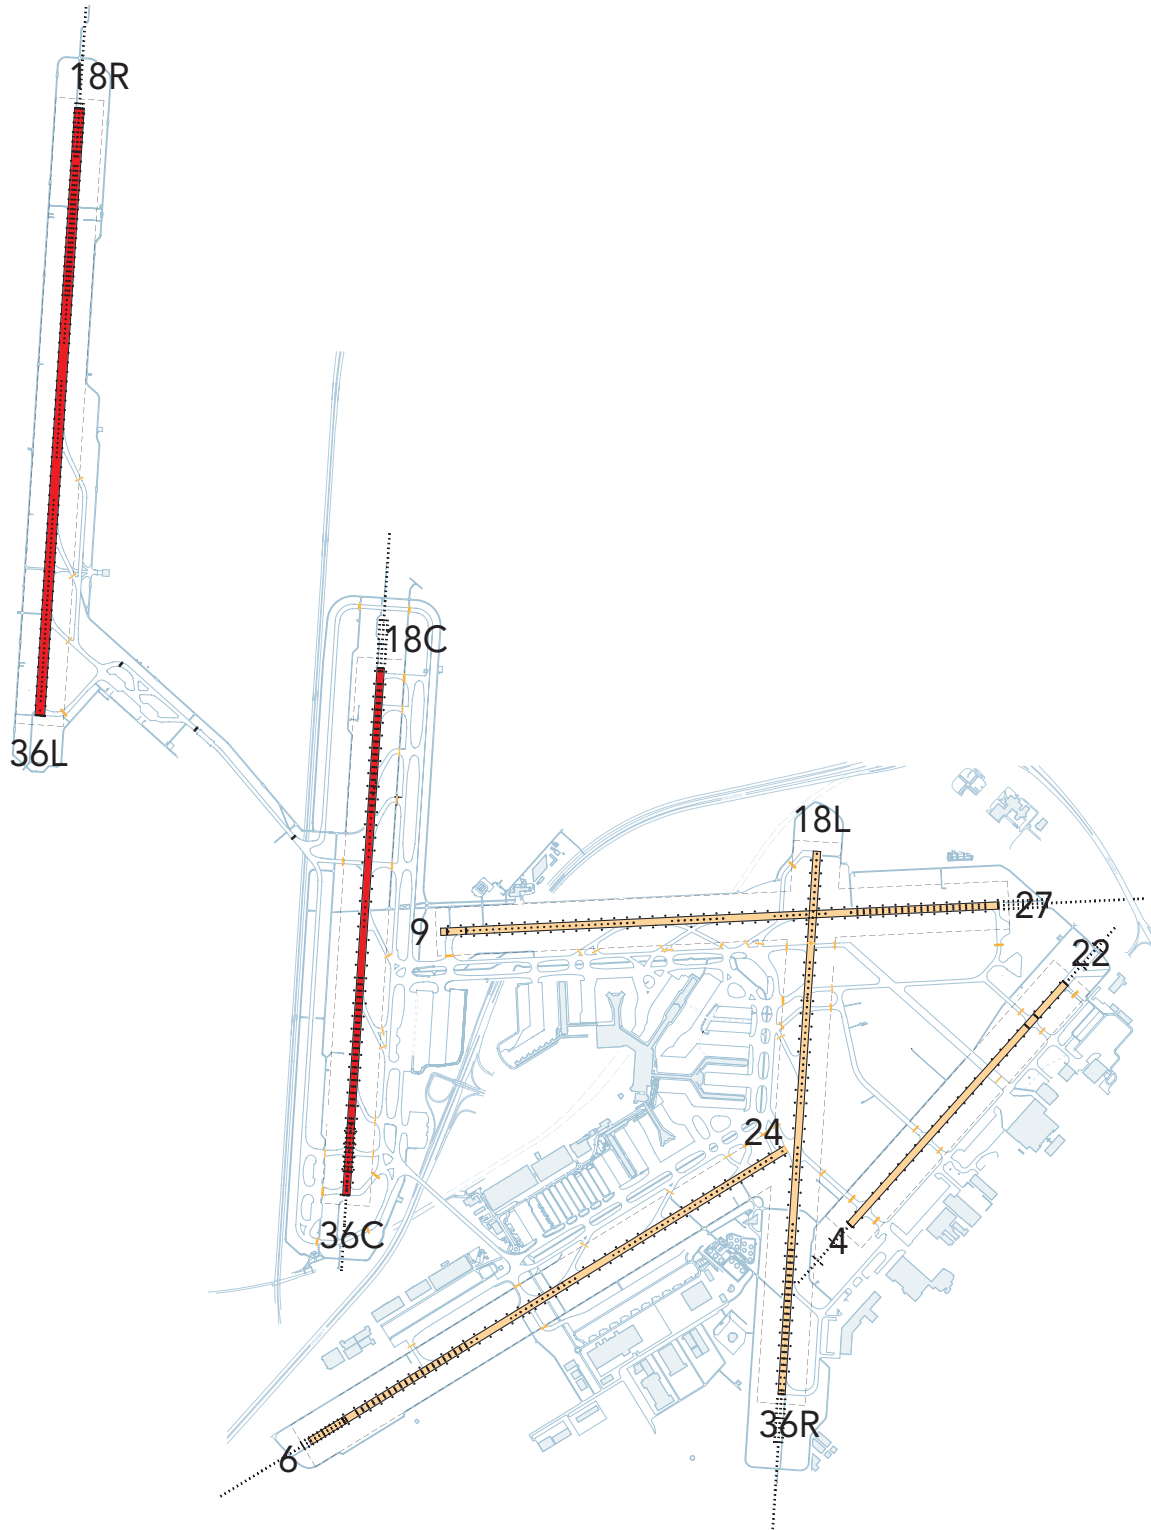
Schiphol Airport has three (3) parallel runways, positioned north-south: 18 right (18R), 18 centre (18C) and 18 left (18L, Aalsmeer, see figure 1). The two most westerly runways 18R and 18C are used simultaneously for incoming traffic, so called parallel approaches. 18L is used for departing traffic. Because of infrastructure north of the runway, and noise abatement for the nearby city of Aalsmeer, 18L is not used for landings.

Figure 1: Airfield layout of Amsterdam Airport Schiphol, runways 18 C and 18R are situated at the top left.

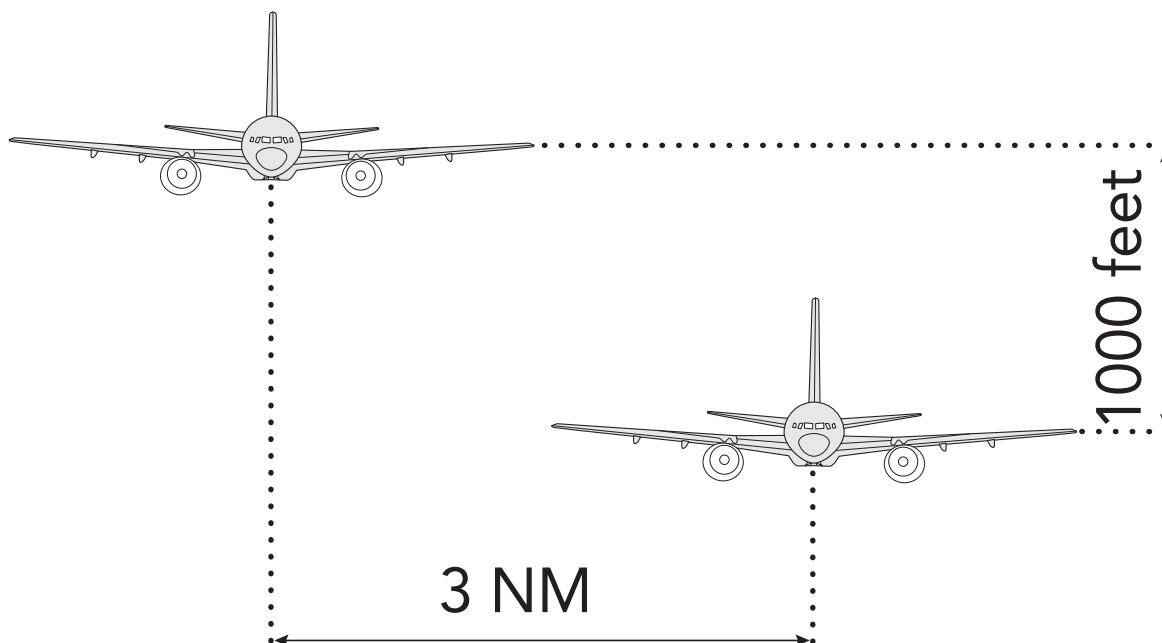
Figure 4: Minimum distance between aircraft, separation minima

When using parallel runways for landing, the minimum distance between aircraft in the approach is 3NM⁸ (circa 5,5 km) horizontally or 1000 feet⁹ (circa 305 m) vertically (figure 4).¹⁰ Minimum separation is maintained until both aircraft in the approach intercept the final radial¹¹ to the runway, guiding them to the threshold.¹² LVNL has translated ICAO Document 4444 in their own procedure, written down in "Voorschriften Dienst Verkeersleiding" (VDV).

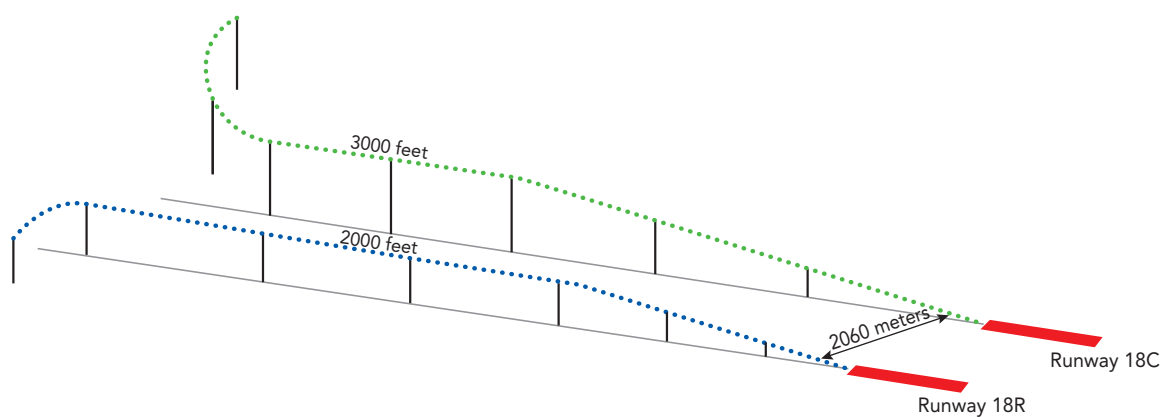
Given the fact that both runways are not precisely next to each other, and distances between the beginning of final approach and threshold vary, traffic will fly opposite with an altitude difference of 1000 feet before commencing their turn to final.

Figure 5: 3D image of approaches for both runways, note the runway offset

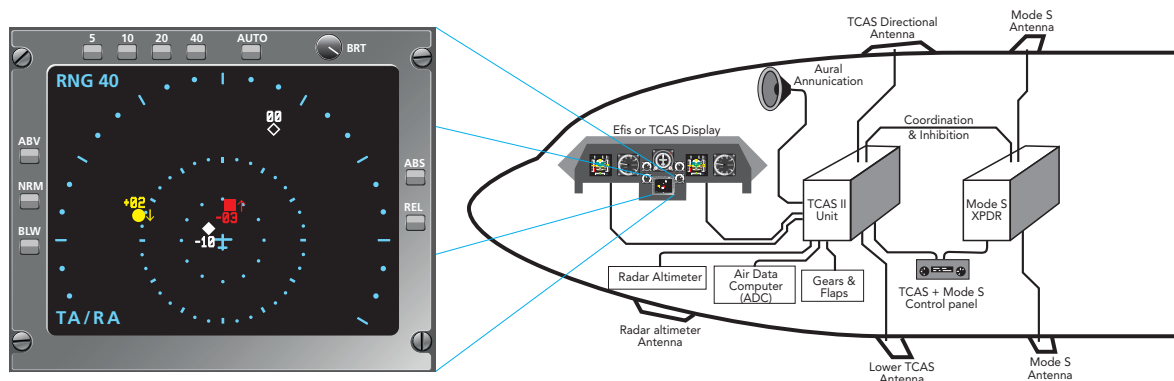
The crew of both aircraft were given two TCAS 'traffic advisory'-warnings (figure 8). Crews were prepared to take the necessary actions if needed (evasive manoeuvre in case of 'resolution advisory'). Until the moment of the first TA warning, both crews were following ATC instructions.

Figure 8: Schematic working of the system¹⁴

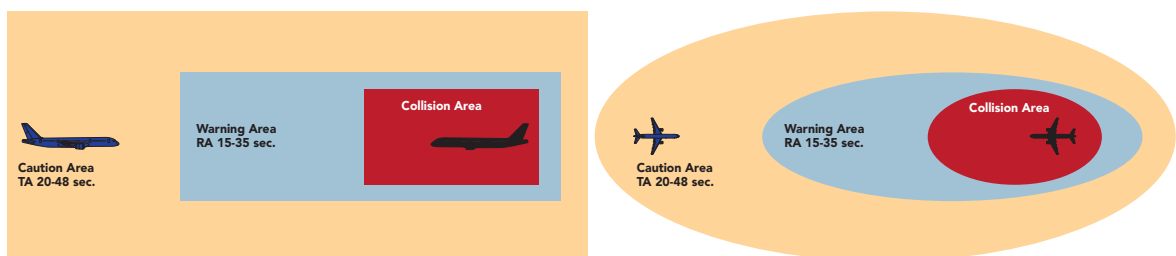
Figure 9: Schematic showing the vertical and horizontal plane, including the 'Traffic Advisory' and 'Resolution Advisory' regions¹⁵
