INTERSTATE AVIATION COMMITTEE
AIR ACCIDENT INVESTIGATION COMMISSION

FINAL REPORT
ON RESULTS OF INVESTIGATION OF ACCIDENT

Type of accident	Fatal accident
Type of aircraft	ATR72-201 aeroplane
Registration	VP-BYZ, Bermudas
Owner	BLF Limited
Operator	UTAir Aviation, JSC
Place of accident	1500 m from RWY 21 threshold; cross-track deviation about 400 m, Roschino aerodrome, Tyumen. Coordinates: N 57°09.440' E 065°16.000'
Date and time of accident	02.04.2012, 01:35 UTC (07:35 local time), day time

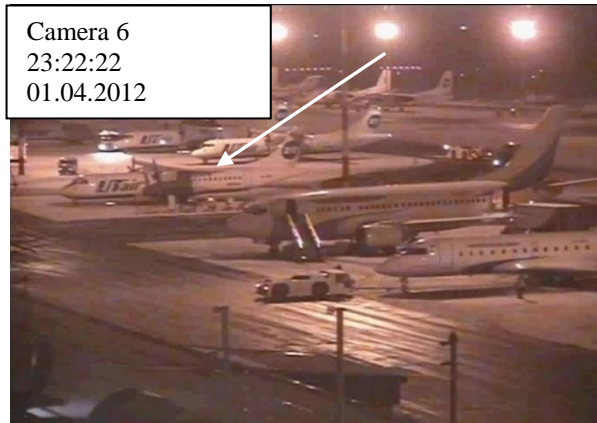
Figure 15. ATR 72 VP-BYZ A/C arrived to Roschino AD on 01.04.2012 at 17:43 and was put to stand 3

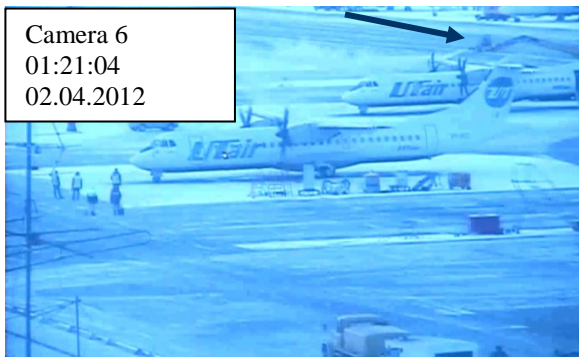
Figure 25. ATR 72 VQ-BLI anti-icing treatment at stand 2 to the right of the ATR 72 VP-BYZ A/C

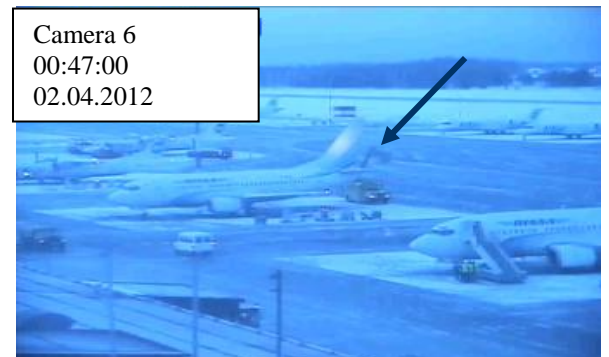
Figure 26. B-737 (Yamal) anti-icing treatment at stand 4 to the left of the ATR 2 VP-BYZ A/C

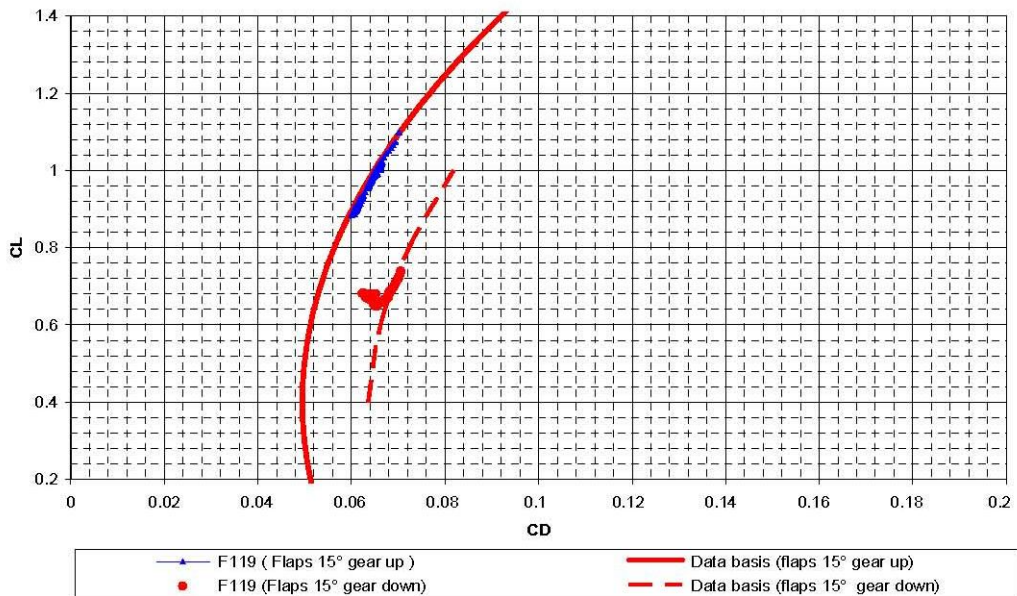
Figure 42. Takeoff simulation Flight UTA-119 (Flaps 15°)

The simulation revealed that the actual drag and lift of the aircraft (Flight UTA-119) with flaps 15° (landing gear up and down) and flaps 0° (landing gear up) are well consistent with the aerodynamic data basis (Figure 42 and Figure 43).

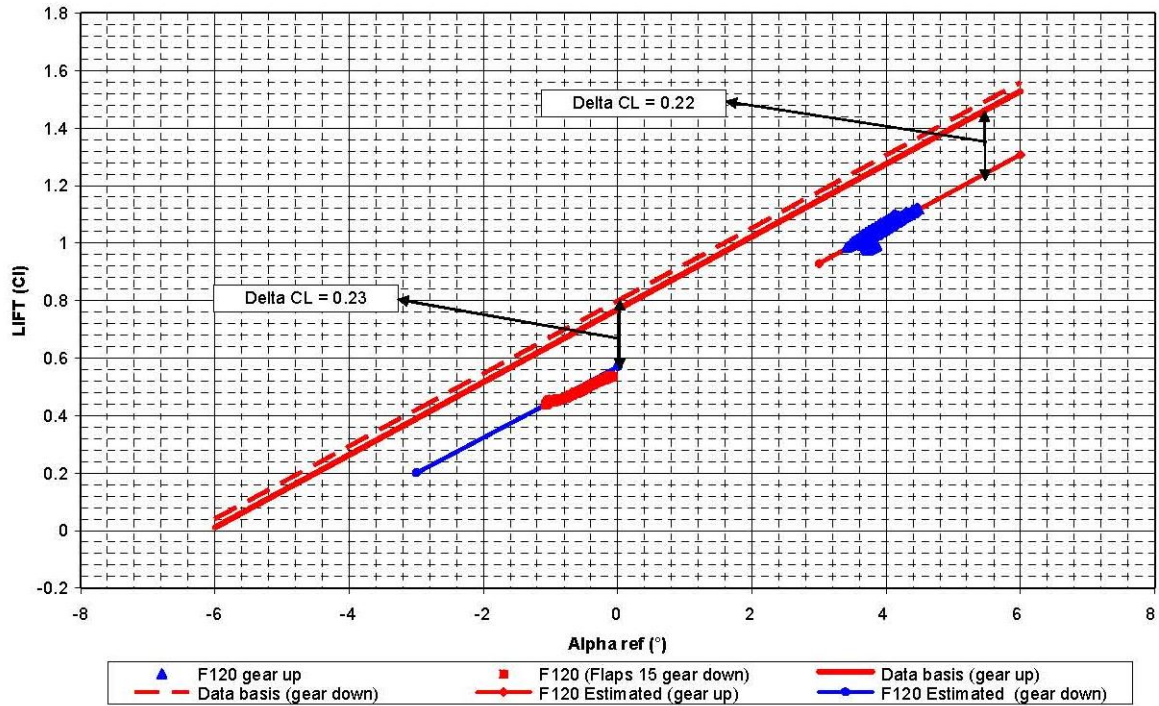
Figure 46. Takeoff simulation Flight UTA-120 (Flaps 15°)

The simulation revealed that during the takeoff run at angle of attack near 0° , a loss of lift and an increase of drag were $\Delta CL_0 = -0.23$ and $\Delta CD_0 = 0.05$ (Figure 46). The graph analysis shows that at that phase of flight CL was reduced by approximately 25%, while drag was doubled. Further after the landing gear retraction the loss of lift remained more or less constant, while the drag increased with angle of attack, providing a $\Delta CD_0 = 0.064$ (Figure 46). After the flaps retraction the loss of lift still remained almost constant, while the drag increasing was $\Delta CD_0 = 0.05$ (Figure 47).

When the aircraft has been contaminated on ground (with frost, snow or ice) the aerodynamic lift surfaces are affected and produce a loss of lift and an increase of drag. The other surfaces (fuselage, fairing, nacelles, etc.), when contaminated, produce additional drag due to modification of surface roughness and, consequently, friction. The angle of attack increase

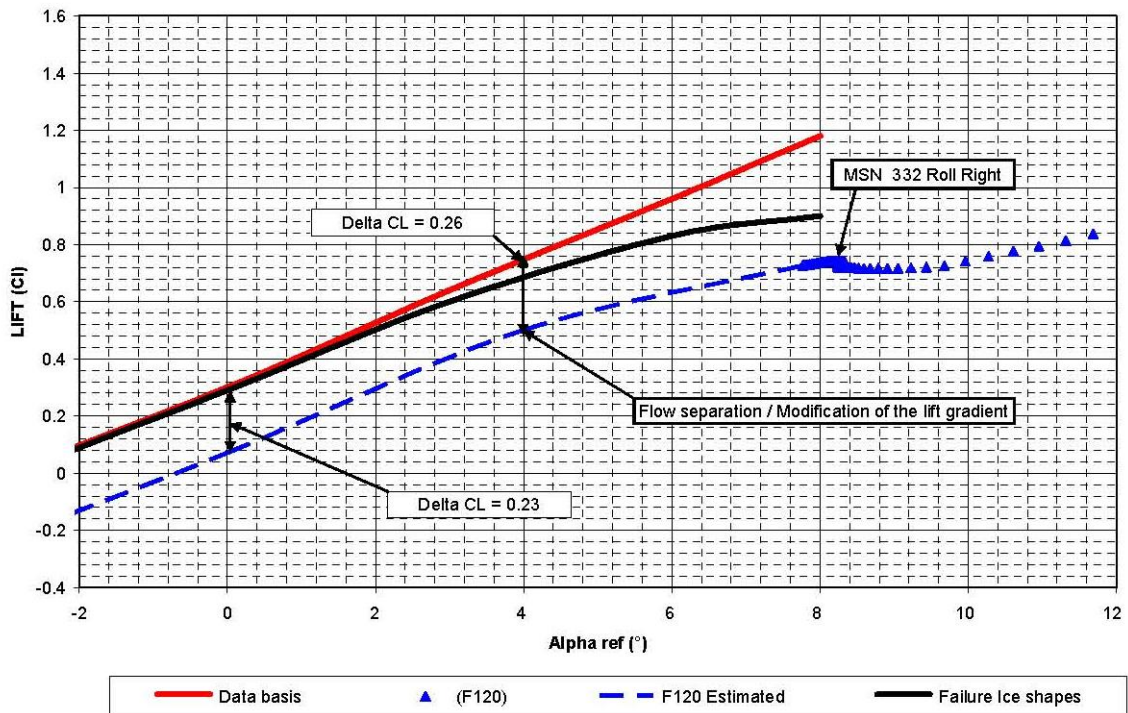
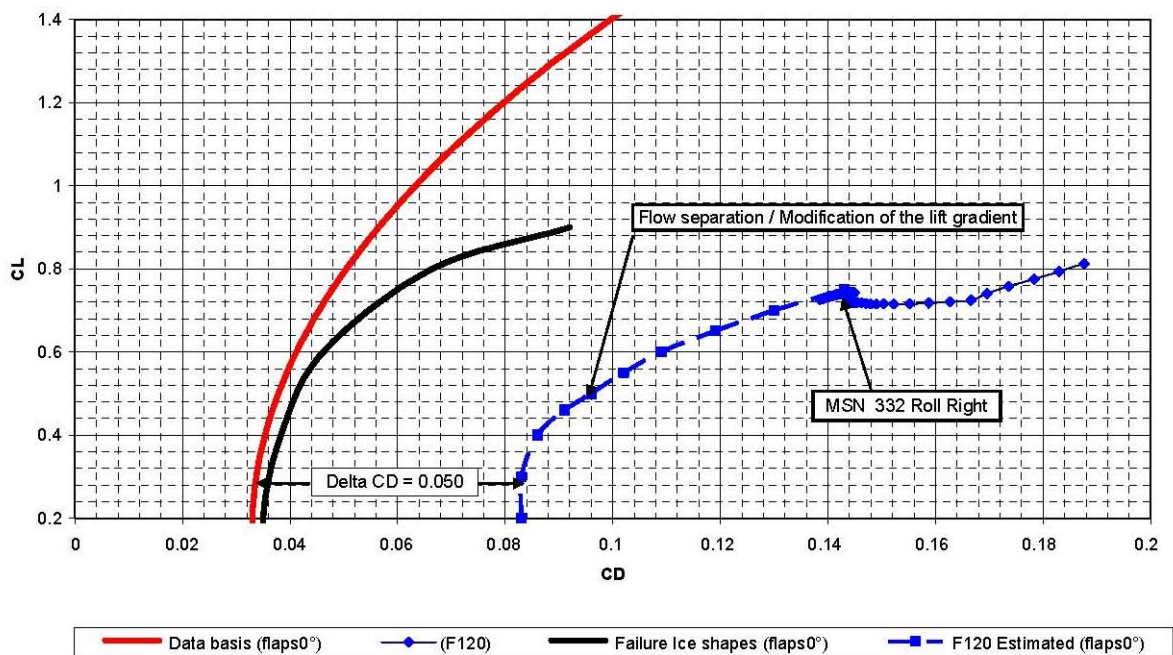
Figure 47. Takeoff simulation Flight UTA-120 (Flaps 0°)

A comparison of simulated results with ice shapes tests (“boots failures case” - ice shapes corresponding to 1.5 inch of ice on the leading edge protected with boots and 3 inches ice shapes on the leading edge unprotected areas, Figure 47) revealed that the performance degradation in the accident flight was significantly greater than in the boot failure case. Taking into account that the aircraft had stayed outside the night before, in ground icing conditions, and was not deiced before departure, its upper surfaces (wing, stabilizer and fuselage) were evidently completely contaminated, including during the takeoff run. According to the aircraft manufacturer’s estimation, the contamination level in the accident flight in term of surface roughness was about 4 mm.

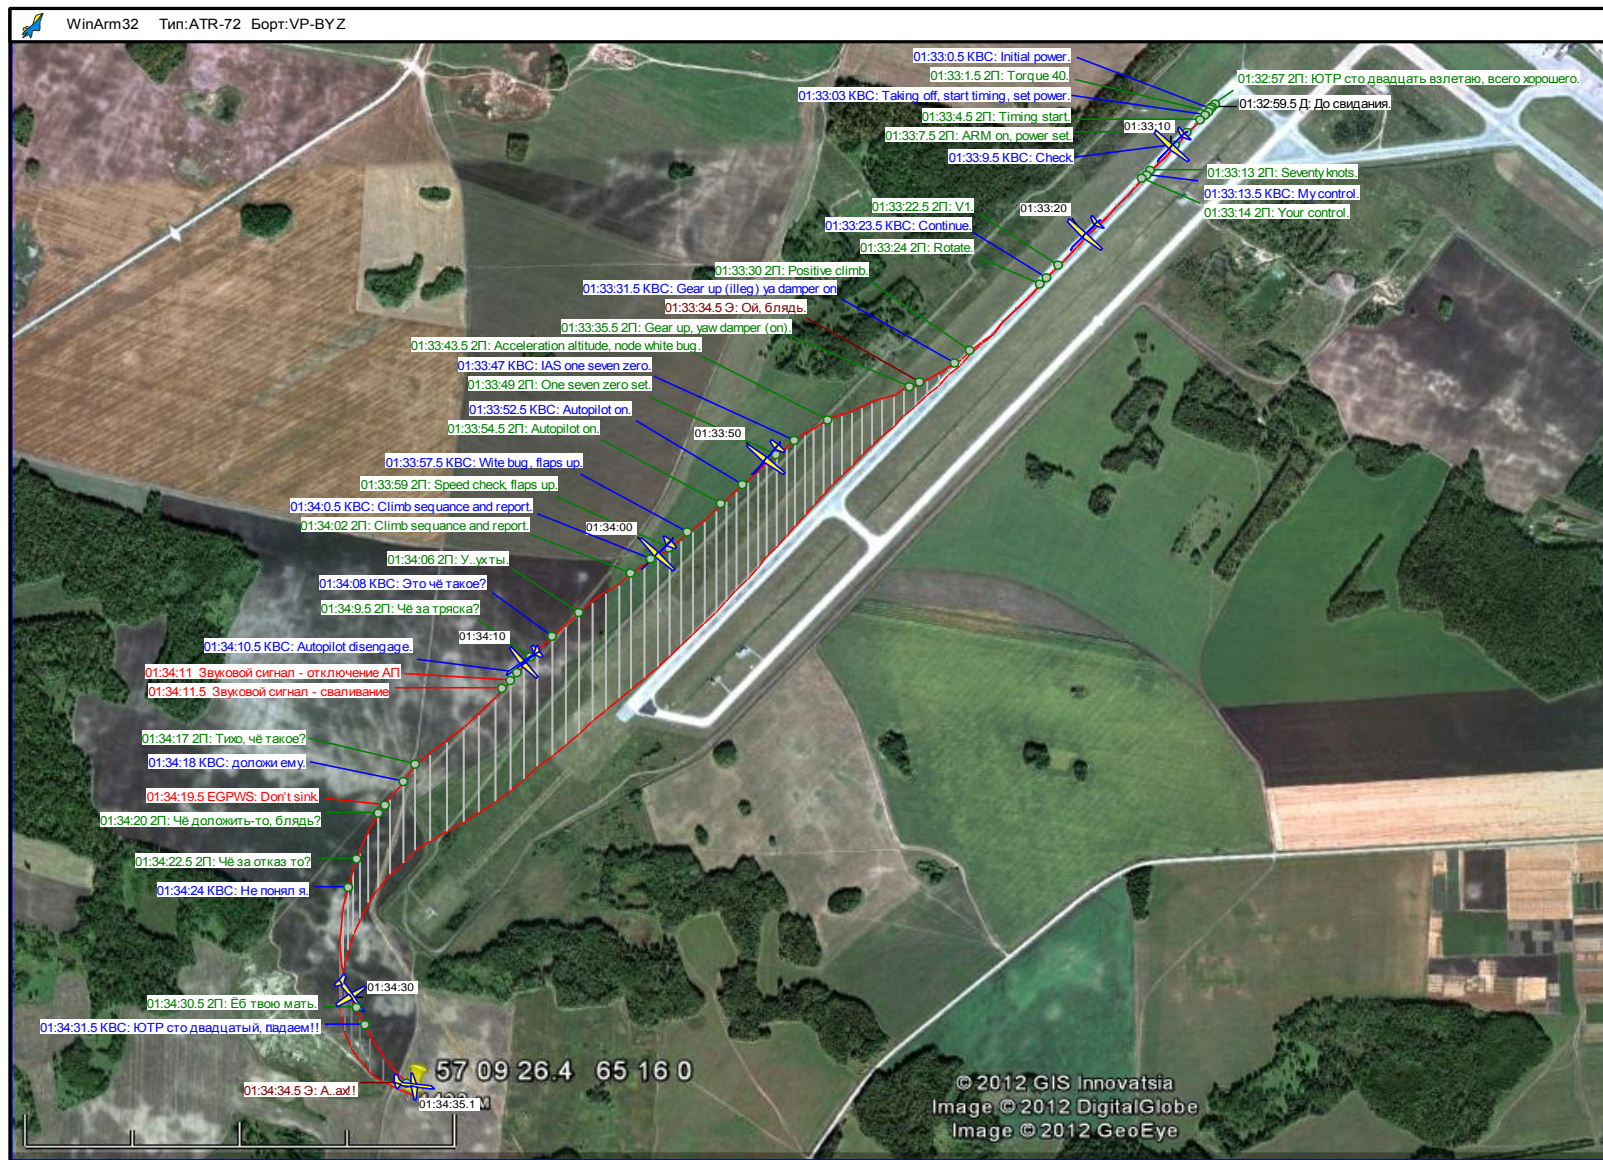
Figure 51. Flight trajectory and crew communications synchronized

The aircraft flight path was computed using the FDR and TAWS data.

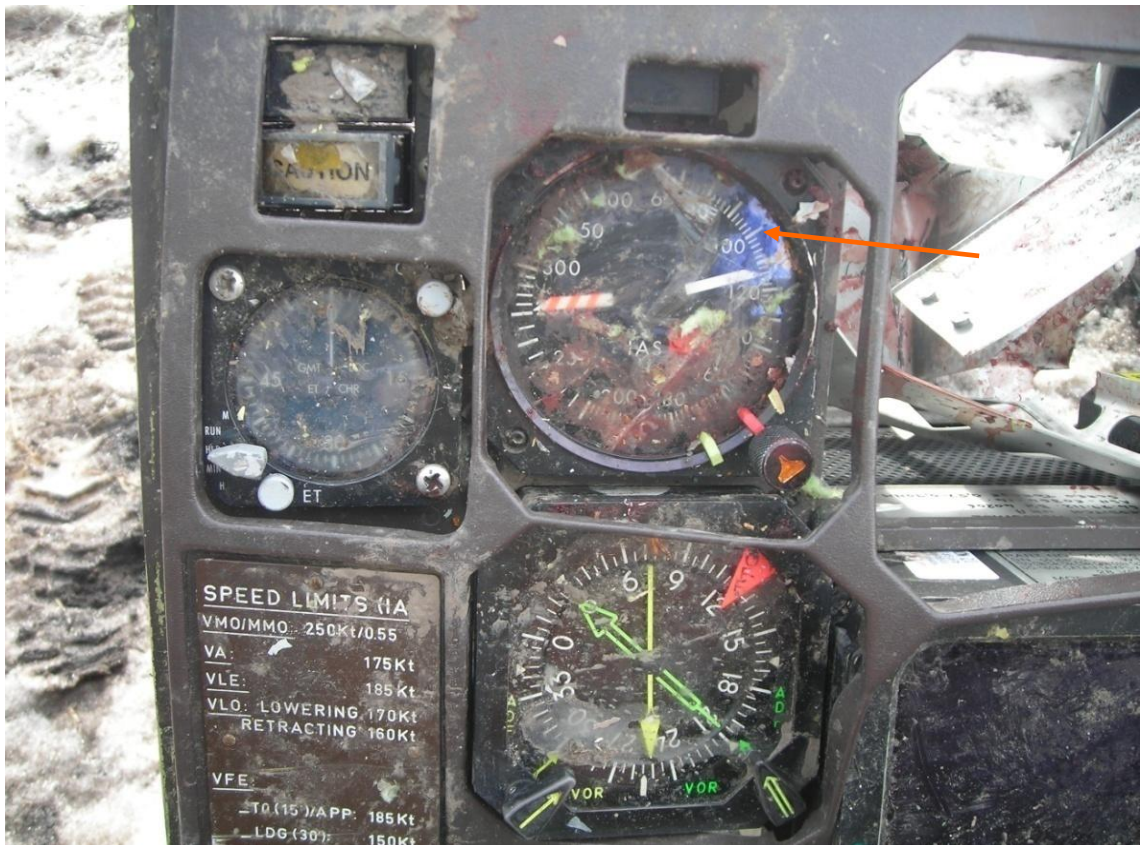
All the crew further actions also confirm that they were not aware of the danger of aircraft takeoff with non-removed ground icing. The value of takeoff safety speed (V_2) was set on the airspeed indicator for normal conditions but not for flight under the conditions of possible icing. During the inspection of the PIC's and F/O's instrument panels it was revealed that the V_2 bugs were set at 111 kt. According to FCOM this speed value corresponds to takeoff normal conditions for the actual weight. For takeoff under possible icing conditions this value would be equal to 115 kt.

After the takeoff the crew performed flaps retraction, being guided by the white bug (minimum flight speed with retracted flaps for normal conditions, 132 kt, TOW 18730 kg), but not to the red bug of minimum flight speed with retracted flaps under possible icing conditions (160 kt for TOW 18730 kg).
