Unstabilised approach, hard landing

Aircraft	Embraer ERJ 145 MP registration F-GUBF
Time and date	1.07 p.m. ⁽¹⁾ on Monday 24 May 2010
Operator	Regional CAE
Location	Ljubljana aerodrome (Slovenia), runway 31
Nature of the flight	Scheduled public transport of passengers
(Flight) crew	Pilot-in-command, co-pilot
Consequences	Damage to landing gear and structural components

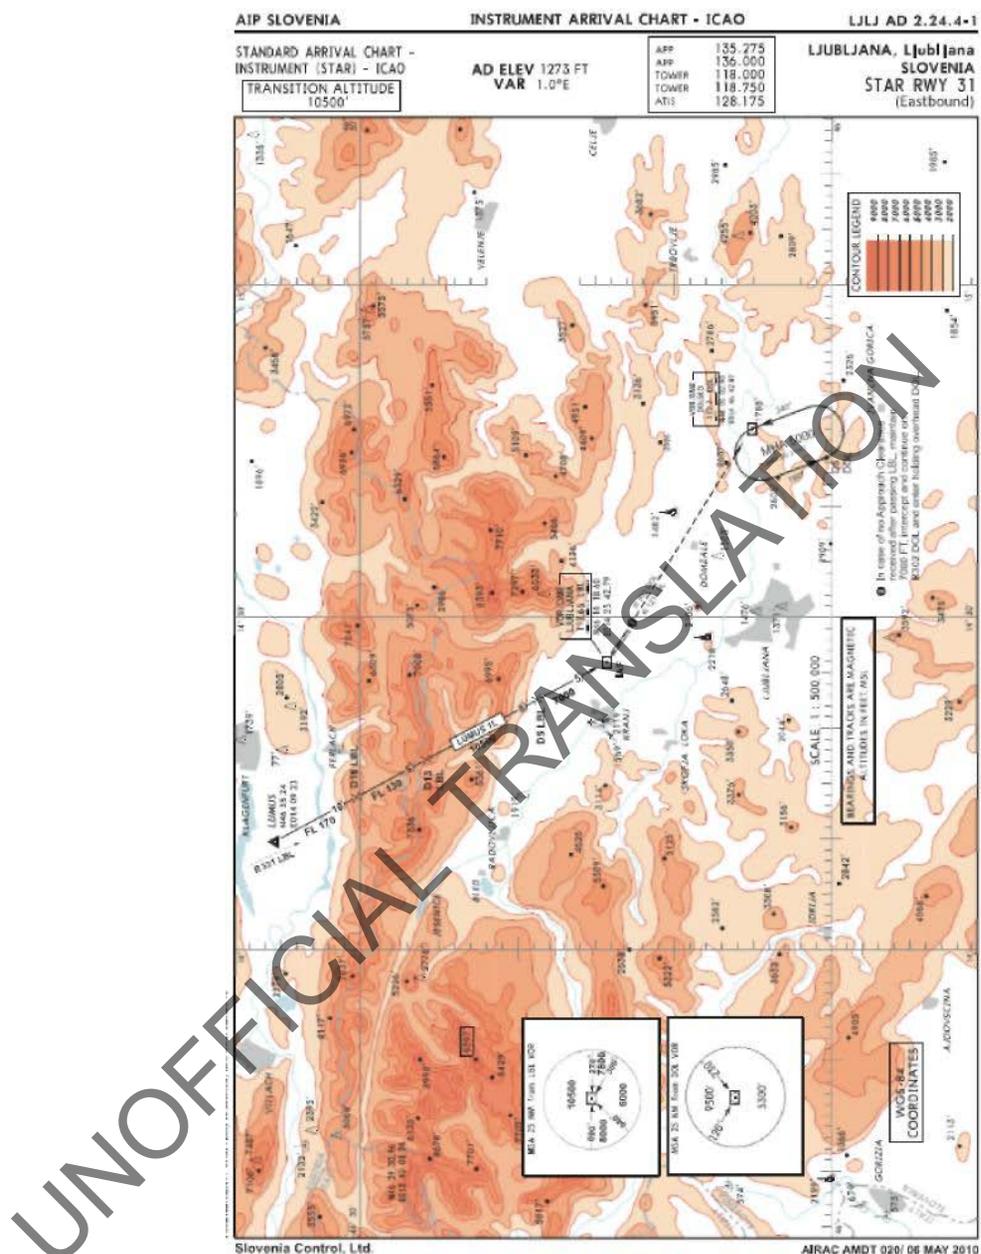
Aerodrome information

Ljubljana aerodrome is located at the foot of the Julian Alps, at the entrance to a valley which runs north-west/south-east. This valley, closed to the north and west by a mountain chain, the highest summits of which reach almost 7,000 ft, is open to the south-east towards the plain and the town of Ljubljana.

Owing to the topographical environment of Ljubljana aerodrome, Regional's Operations Manual states that all members of flight crew must conform that they have familiarised themselves with the instructions set out in Part C of the Manual. In particular, these instructions draw the crews' attention to the prevailing winds at altitude to the west and to the immediate proximity of terrain which could lead to turbulence during the approach phase when the wind has a northerly component.

The final descent of the ILS approach to runway 31 is performed with an angle of descent of 3 degrees and begins at 4,000 ft, at a FAP (BASTA) which is located at 8.9 NM on the ILS DME. Runway 31 is equipped with a PAPI.

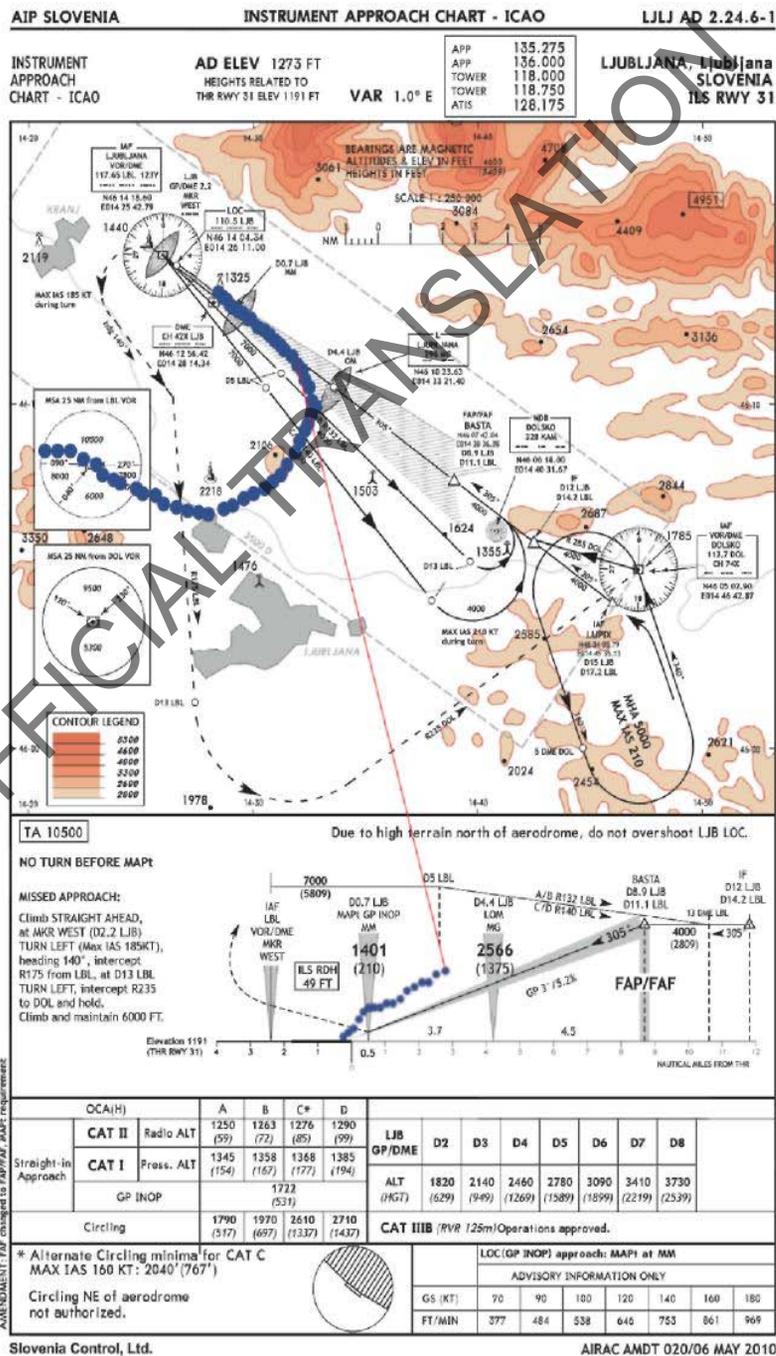
The approach carried out by the crew was not stabilised at any point. At a height of 1,337 ft, the angle of descent being followed was 4°, the configuration was flaps 22° with the landing gear down with the speed 170 kt compared to a Vapp calculated for this configuration of 134 kt. At a height of 800 ft, the pilot-in-command levelled off the aircraft to set the flaps at 45°.
