**INVESTIGATION REPORT OF ACCIDENT
INVOLVING GEORGIAN AIRWAYS AIRCRAFT
CRJ-100ER (4L-GAE)
AT KINSHASA'S N'DJILI AIRPORT
DEMOCRATIC REPUBLIC OF CONGO (DRC)
ON 04 APRIL 2011**

<p style="text-align: center;">Permanent office of investigations of aviation Accidents/Incidents</p>	<p style="text-align: center;">FINAL REPORT OF TECHNICAL INVESTIGATION ON THE ACCIDENT OF THE CRJ-100 PLANE, REGISTER 4L-GAE</p>	<p style="text-align: center;">Page 2</p>
-----------------------------------------------------------------------------------------------------------------------------------------------------------------------------------------------------------------------------------------------------------------------------------------------------------------------------------------------	---------------------------------------------------------------------------------------------------------------------------------------------------------	---------------------------------------------

Investigation report of accident involving Georgian Airways CRJ-100ER (4L-GAE), which occurred at Kinshasa's N'DJILI Airport, Democratic Republic of Congo (DRC) on 04 April 2011.

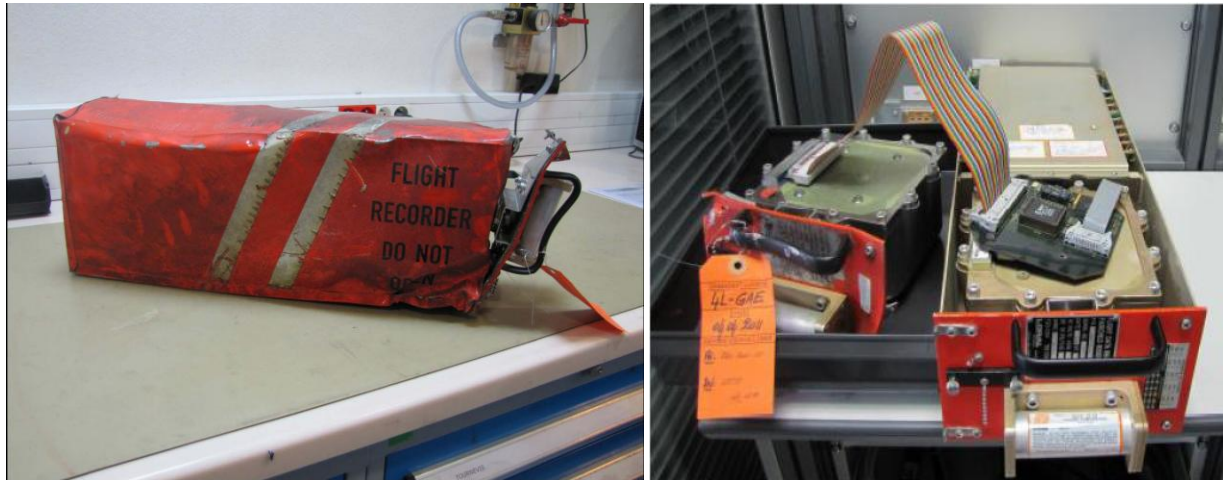
Fairchild F1000 Flight Data Recorder

The FDR was able to provide good information about the sequence of events leading up to the accident. Downloaded Data indicated that all aircraft systems were functioning normally and no technical failures were recorded during the flight.

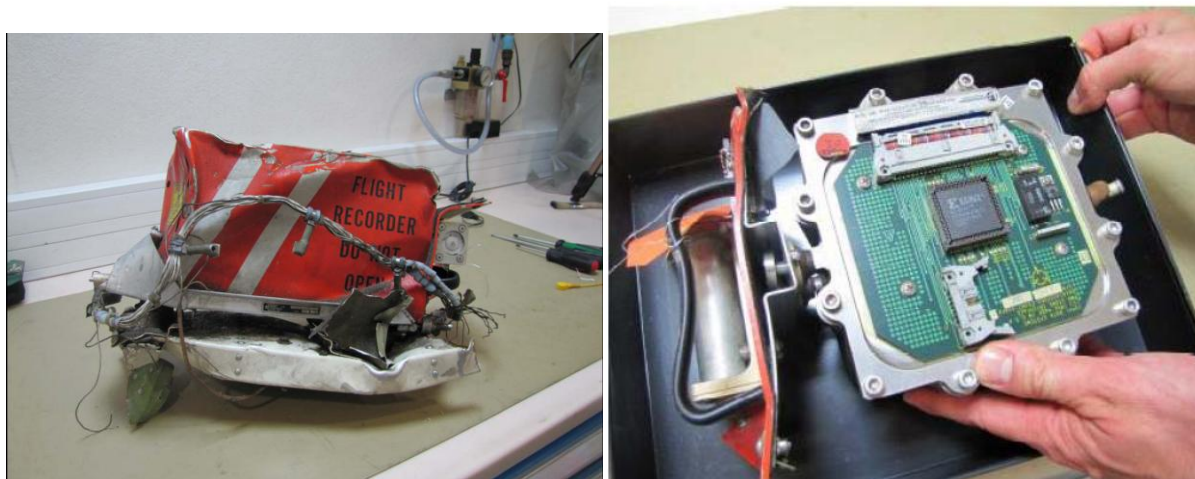
L3 Com A200S Cockpit Voice Recorder.

FDR readouts and CVR transcript confirm that aircraft systems were functioning normally; there were no technical failures on the aircraft.
