Ref. No. CZ -12 - 514

**FINAL REPORT**  
**Investigation into the serious incident of aircraft type ATR 42-500,**  
**registration mark OK-JFJ, at LKPR aerodrome**  
**on October 31, 2012**

Prague  
May 2014

Owner/Operator : Czech Airlines J.S.C.  
Manufacturer and aircraft model: Avions de Transport Régional, ATR 42 – 500  
Registration mark: OK-JFJ  
Site: LKPR, TRA70, FIR Prague  
Date and time: October 31, 2012, 10:40 UTC (all times are UTC)

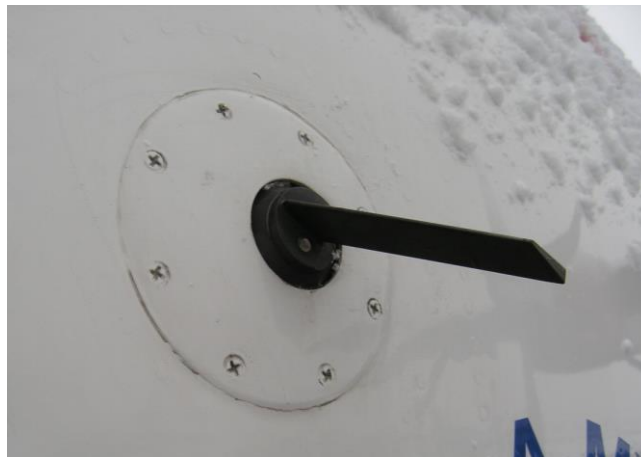
Fig. 1 AOA sensor

In the above mentioned technical specifications, there is an emphasis on the complete and thorough covering of all parts not to be painted, including the AOA sensor blades in order to avoid damage to the system.

Both AOA sensors p/n C16363AAA (s/n 788 and s/n 2246) were dismantled from the aircraft and handed over to the manufacturer and repair organisation Thales Avionics S.A. in a standard manner. Thales Avionics S.A. was required to put forward a deliverance regarding the found conditions of the sensors and issued the "Teardown report". The report states that the sensors were completely disassembled and no defect in sensor sealing was observed during dismantling. Corrosion was discovered inside the ball bearing of the sensor vane axis. Occurrence of corrosion is attributable to the detected presence of water inside the AOA sensors. Corrosion caused an increase in the force necessary for rotation of sensors' vanes. The measured force value was 0.12 N instead of the permitted value of 0.03 N. The measured value of ohmic resistance of the sensor de-icing heating system was beyond the limit values.

The aircraft manufacturer was notified of the arisen issue by means of the airworthiness report. The manufacturer has analysed the DFDR data over three flights preceding the event of which two assessed flights (October 6 and October 21, 2012) were carried out before aircraft repainting. The manufacturer has found out that during the first flight after repainting of the aircraft (October 28, 2012) both AOA sensors were blocked likewise in the case of AOA sensors blockage during the event test flight (October 31, 2012). The manufacturer in its report, the Technical Directorate Technical Note, Identification: DT/F-522/13, has stated that the AOA sensors were contaminated with water particles sprayed during cleaning of the aircraft before or after repainting.

No damage to the aircraft was caused during the incident flight. Both MFCs, both AOA sensors, and FIN 29GB relay were replaced as a precautionary measure after the performed flight.
