Final Report no. 2211 of the Swiss Accident Investigation Board SAIB

concerning the serious incident (Airprox)

involving the Boeing B737-800 aircraft, EI-ENK
operated by Ryanair
under flight number RYR 3595

and the Airbus A319-111 aircraft, CS-TT
operated by Air Portugal
under flight number TAP 706

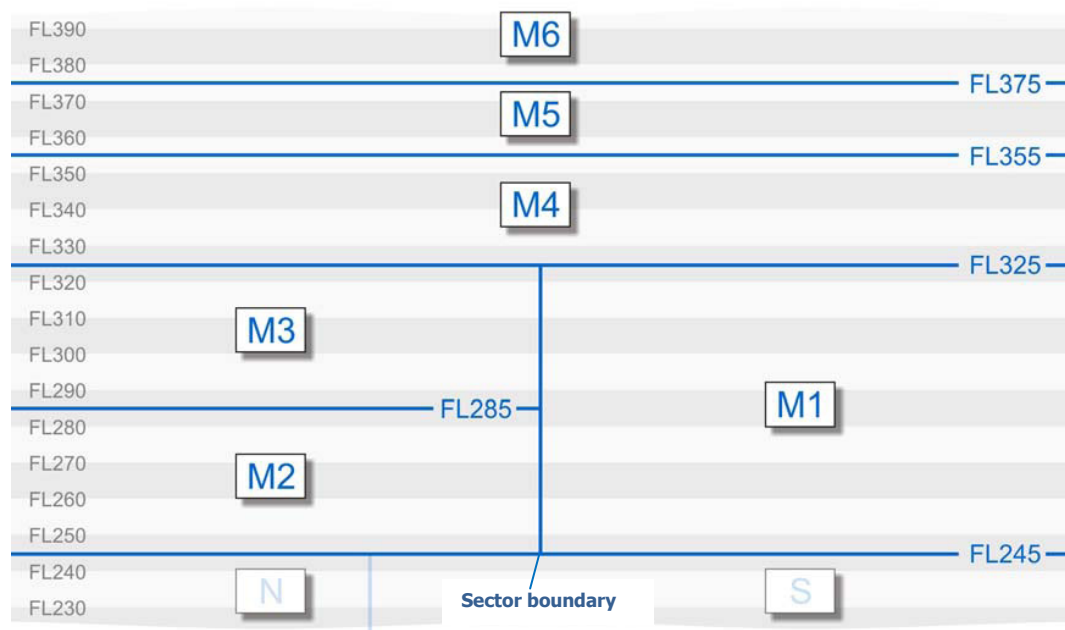
Figure 1: Division of the upper airspace of the Zurich ACC in terms of altitude

According to the statements of the two duty supervisors, the low volume of traffic at the time of the serious incident meant that the Zurich ACC Control Sectors M4, M5 and M6 had been combined into one sector (M4) (cf. Section 1.1.2, Figure 1). The serious incident took place in Class C airspace in the Control Sector M5 altitude band.

According to the statements of the two duty supervisors, the low volume of traffic meant that the Zurich ACC Control Sectors M4, M5 and M6 had been combined into one sector (M4) at the time of the serious incident (cf. Section 1.1.2, Figure 1).
