## AIRCRAFT ACCIDENT REPORT AND EXECUTIVE SUMMARY

Reference:	CA18/2/3/9257	
<b>Aircraft Registration</b>	<b>G-BNLL</b>	<b>Date of Accident</b>	22 December 2013		<b>Time of Accident</b>	20:43Z
<b>Type of Aircraft</b>	Boeing 747- 400		<b>Type of Operation</b>		Air Transportation	
<b>Pilot-in-command Licence Type</b>		ATPL	<b>Age</b>	57	<b>Licence Valid</b>	Yes
<b>Co-pilot Licence Type</b>		ATPL	<b>Age</b>	51	<b>Licence Valid</b>	Yes
<b>Pilot-in-command Flying Experience</b>		Total Flying Hours	±20 050,00		Hours on Type	±12 500.00
<b>Co-pilot Flying Experience</b>		Total Flying Hours	± 5700,00		Hours on Type	± 1400,00
<b>Last point of departure</b>		OR Tambo International Airport (FAOR) at Gauteng in Republic of South Africa.				
<b>Next point of intended landing</b>		Heathrow International Airport (EGLL) at London in United Kingdom.				
<b>Location of the accident site with reference to easily defined geographical points (GPS readings if possible)</b>

## AIRCRAFT ACCIDENT INTERIM REPORT

**Name of Owner** : British Airways PLC  
**Name of Operator** : British Airways  
**Manufacturer** : Boeing Company  
**Model** : B747- 400  
**Nationality** : United Kingdom  
**Registration Mark

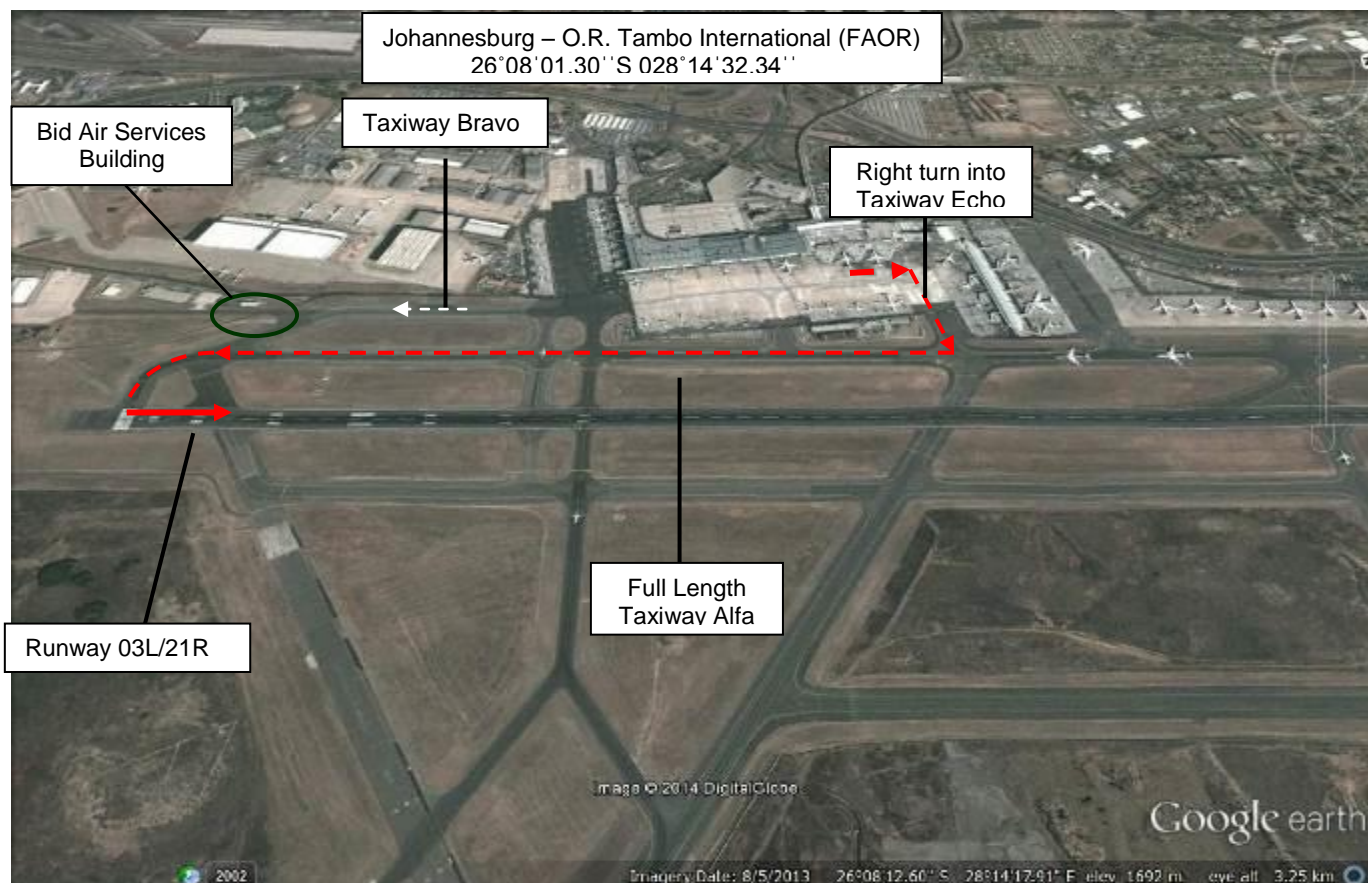
Figure 1 The expected taxi route which the flight crew discussed during the taxi and take-off briefing session

- 1.1.5 It appears that the crew was using the Navtech Aerodrome Overview Chart at the time. According to the CVR, at 20.16:00 UTC (22.16:00 local time), during a period of  $\pm 7$  minutes, the crew completed the taxi and take-off briefing. The crew's briefed (expected) route is shown below.

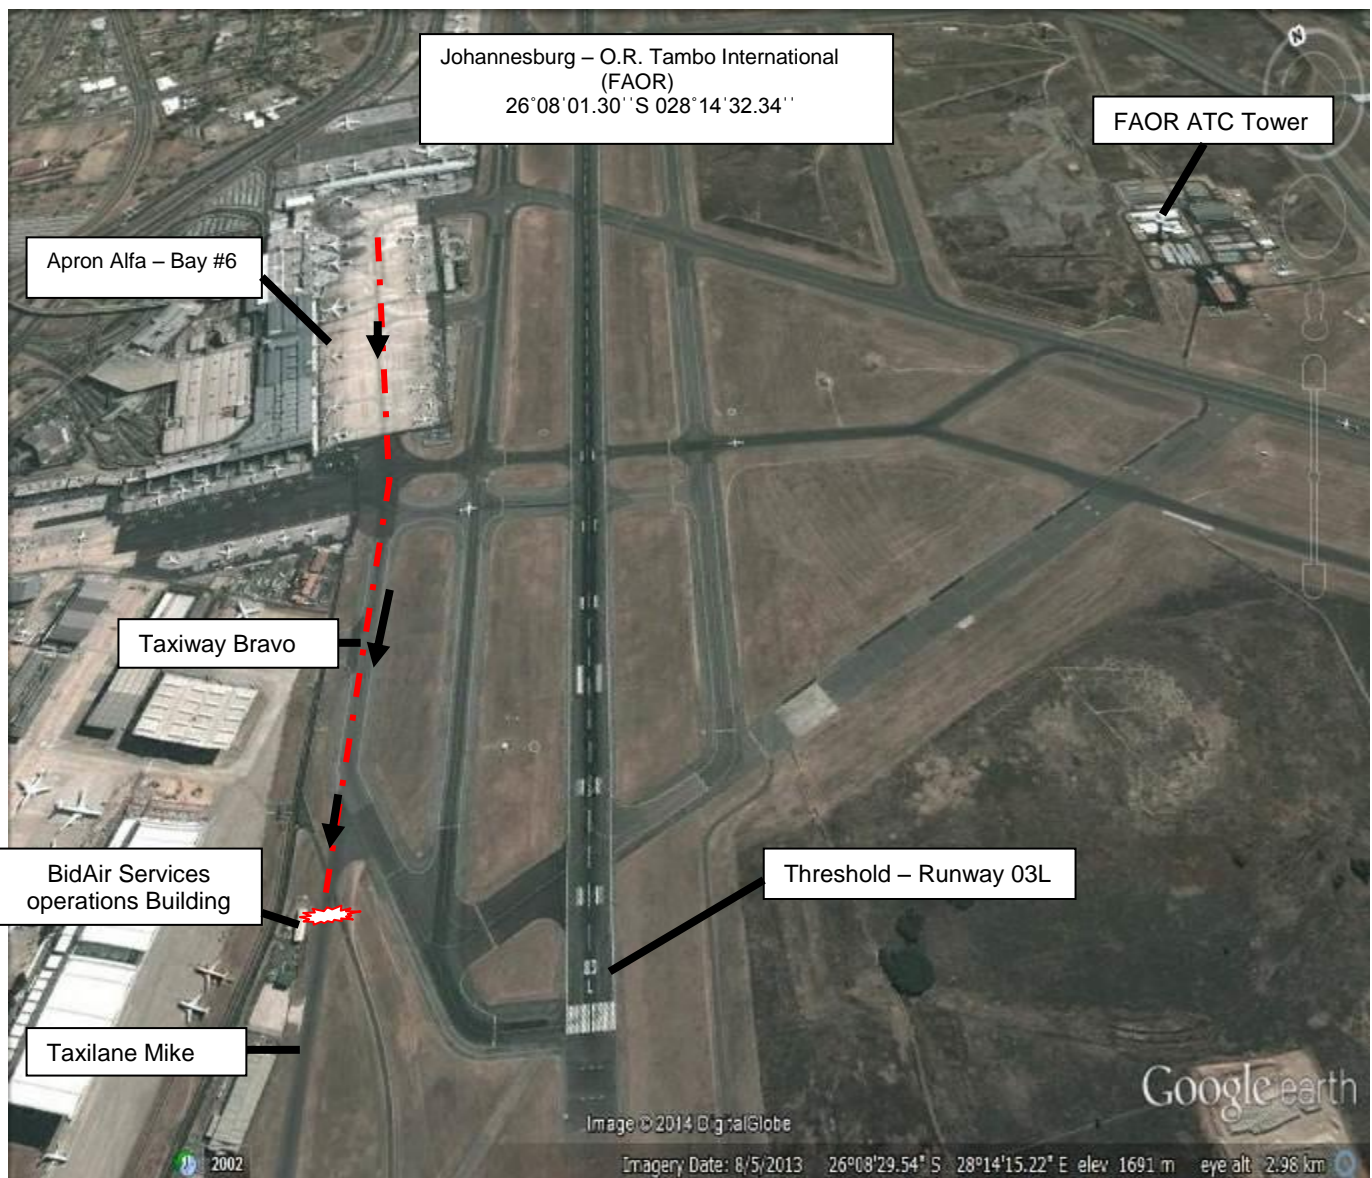
Figure 2 Actual taxi route which the pilots followed before the collision with the Bid Air Services Building

1.1.21 The actual route followed by the crew after it had been confirmed, but not followed as instructed by ATC, is shown below:

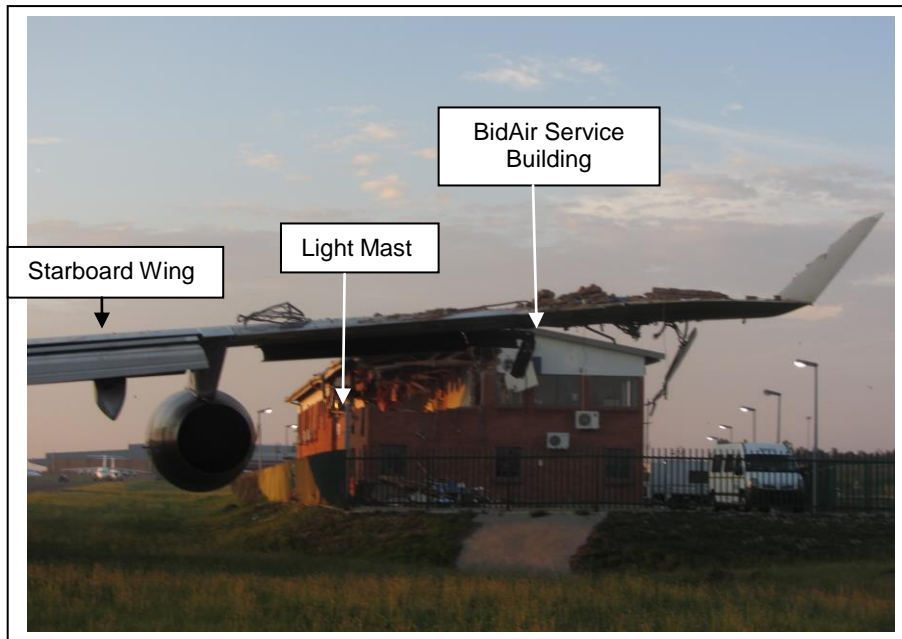
1.4.1.2 The investigation determined that the aircraft taxied facing south using taxiway Bravo and crossed the intersection straight onto Mike. The aircraft then taxied on Mike, where the starboard wing of the aircraft impacted the eastern side of the second floor of the BidAir Services building. The magnitude of the impact caused substantial damage to the building and facilities, as follows:

1.4.1.2.1 The first point of impact was determined to be a light mast installed next to the eastern side perimeter fence of the building. The light mast was cut at the same height as where the wing sliced through the hall. The remaining piece of the light mast was found standing at a distance of  $\pm 5$  to 10 meters from the building.

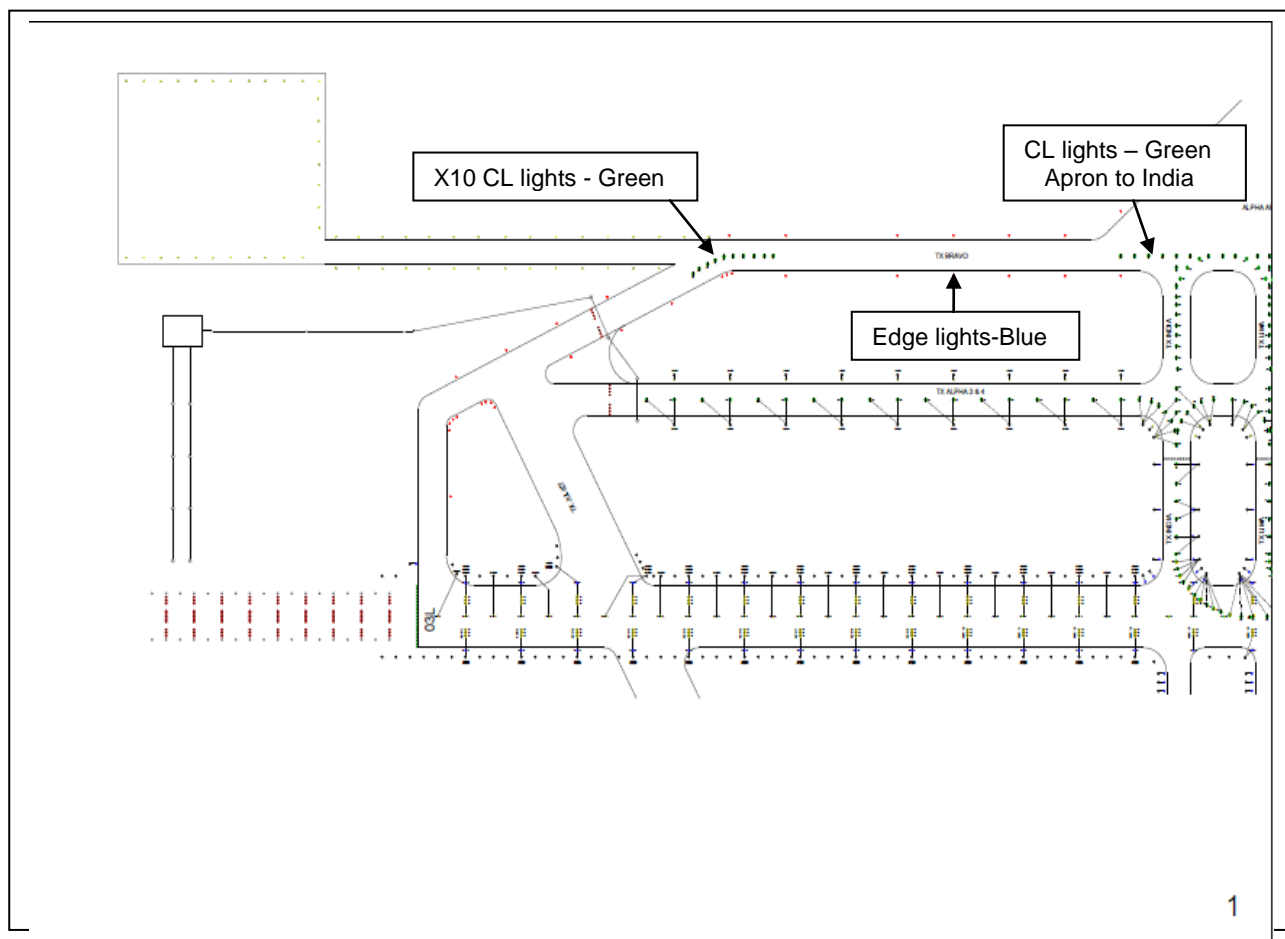
Figure 15 Centreline lights installed on Bravo in the area of the intersection/junction

- The evidence of the above information from ACSA supports what the crew observed:
  - The taxiway edge lights illuminated in a continuous straight line, with no signage indicating the change of the taxiway Bravo and Mike.
  - Also, that some of the green centre line lights on taxiway Bravo were not illuminated in sequence.

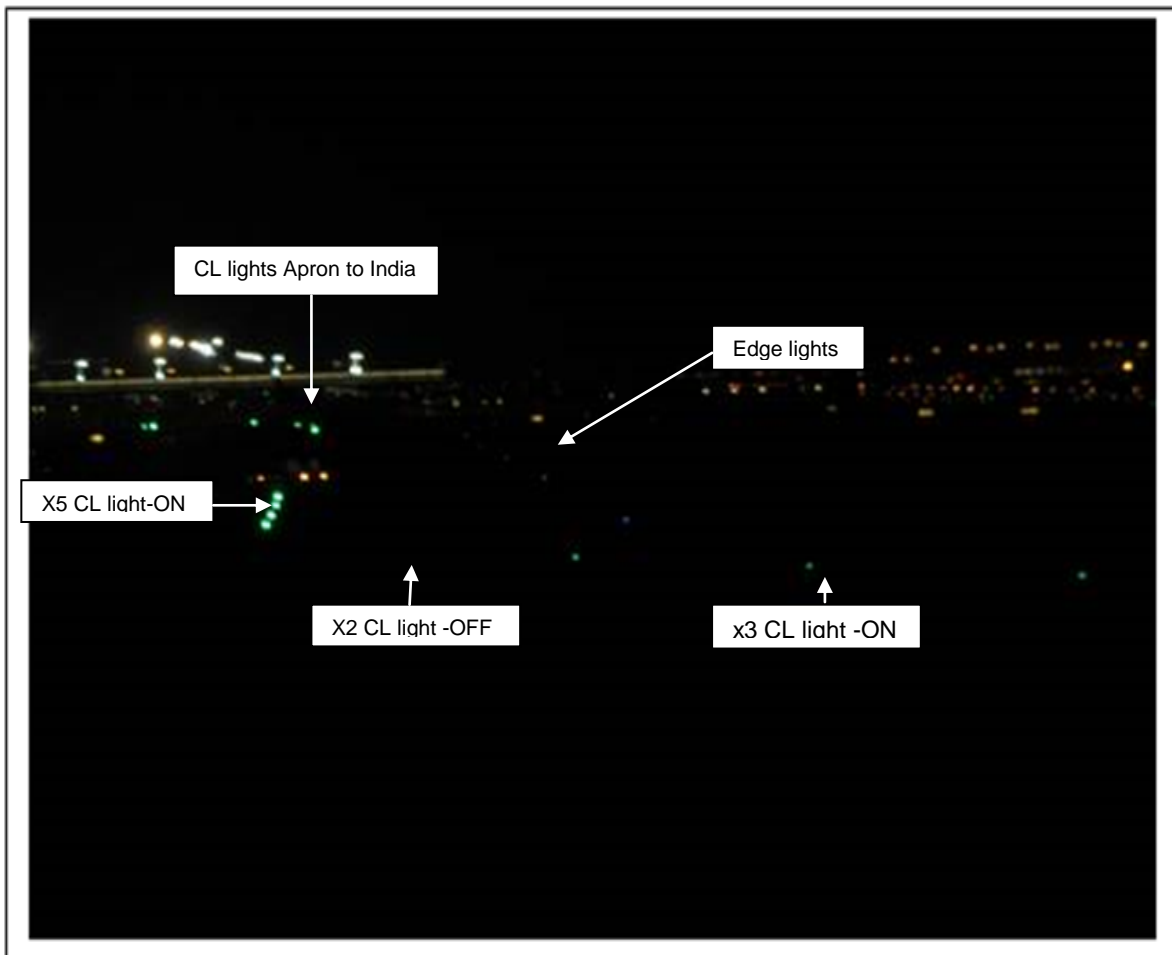
Figure 17 Green centreline and blue edge lights illuminating on taxiway Bravo

- The investigation determined the taxiway centreline lighting situation as follows:
  - The investigation did find centreline lights installed on taxiway Bravo.
  - A total of 15 centreline lights were counted and switched on (serviceable). Below is a picture taken on the night in question.
  - The picture was taken from the intersection area of Bravo and Mike showing the 15 green centreline lights installed on Bravo.

- Below are short descriptions of the condition of centreline lights installed:
  - There were 3 centreline lights switched on when leaving the apron;
  - There were 4 centreline lights switched on at the intersections of Bravo, Lima and India;
  - There were 5 lights centreline lights switched on in the straight line prior to the split between Bravo and Mike;
  - There were 3 centreline lights switched on in the straight line leading to the Category 2 holding point.

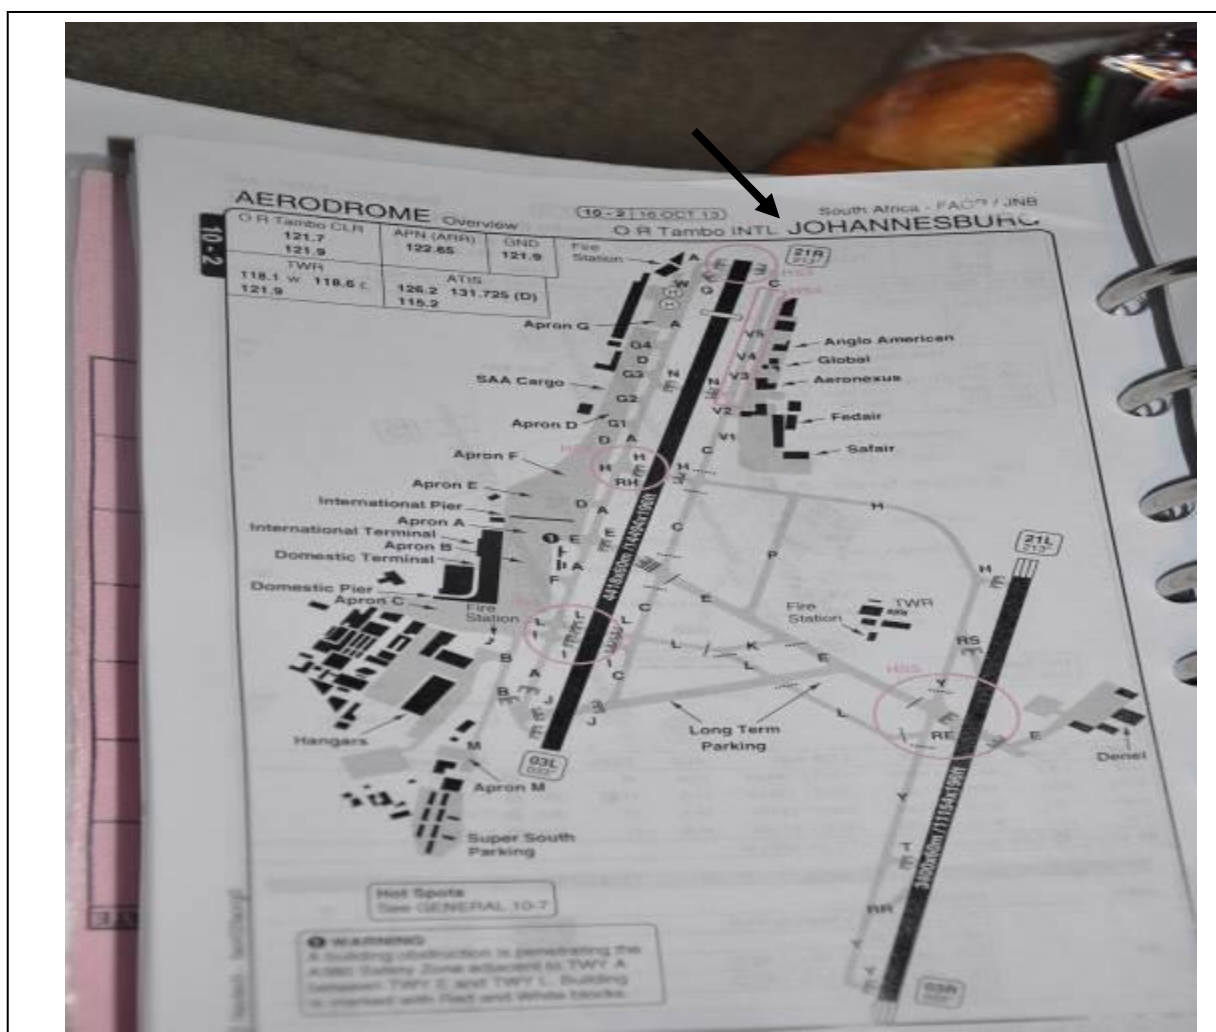
Figure 20 Navtech Aerodrome Overview Chart 10-2

1.10.4.3 Given the above information, the crew was expected to be in possession of the latest revision/update of aeronautical information which complies with that published in the South African AIP. The evidence found was that the crew carried the Operator’s Aerodrome Booklet which had the Navtech Aerodrome Overview Chart with description on it: “South Africa – FAOR/JNB 10-2, dated 16 October 2013”. The crew indicated that they used the identified chart to plan the taxi route during the briefing. A copy of the Navtech chart is shown below:

1.10.4.4 The Navtech Chart 10-2 information was reviewed against that published in the South African AIP (e.g. Chart AD-02 eff. 12 DEC 13). The evidence was that the wording of the Navtech Chart had not been revised/updated to the latest revision of the South African AIP.

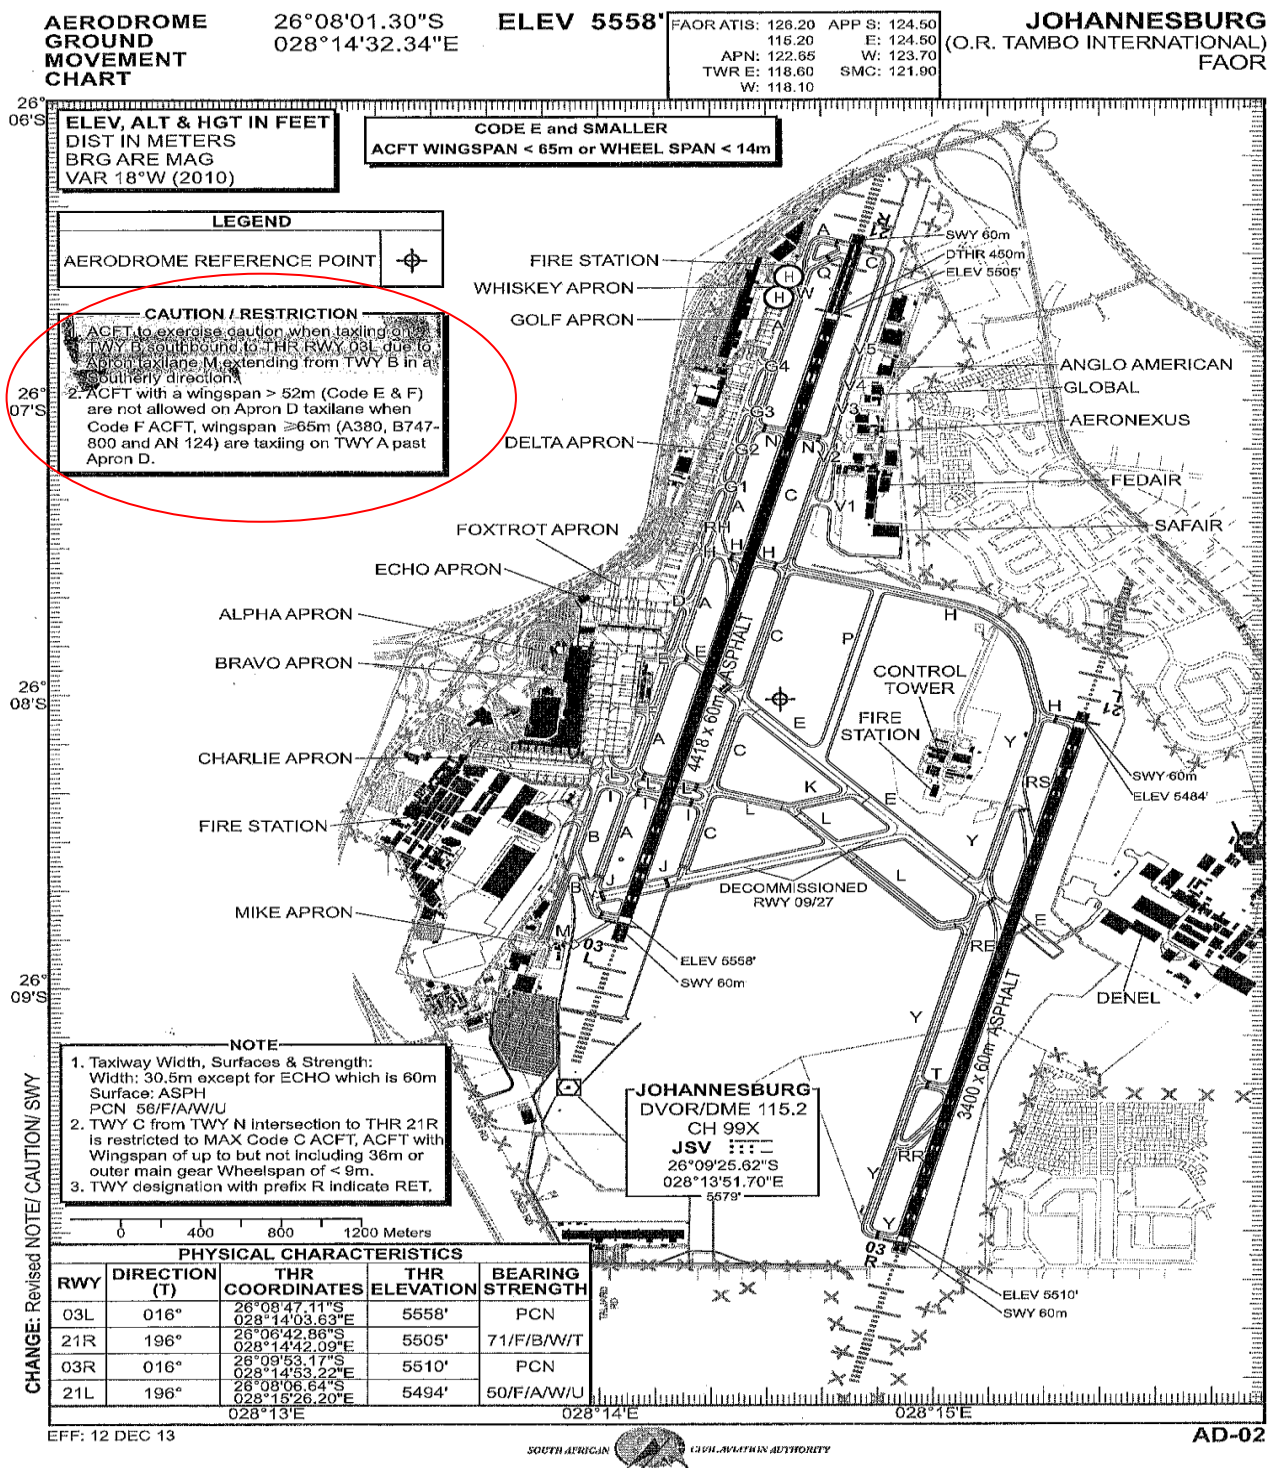
Figure 21 Aerodrome ground movement chart AD-02

- The State aviation regulating authority (SACAA) was requested to clarify the aeronautical information revision relevant to the Bravo and Mike intersection in relation to the British Airways/Navtech Aerodrome Overview Chart (South Africa – FAOR/JNB 10-2, dated 16 October 2013).
- In response, the SACAA submitted an aerodrome ground movement chart (AD-02 eff. date 12 Dec 2013) of Johannesburg/OR Tambo International Airport (FAOR), which was the latest version published.
- The publication of AD-02 meant that they complied with applicable civil aviation regulations (CAR), aeronautical information circular (AIC) and relevant procedures requirements in that they made a submission, validation, approval and publication of the aeronautical information as required by the originator (ACSA).
- See below copy of chart (AD-02, eff. date 12 Dec 2013):

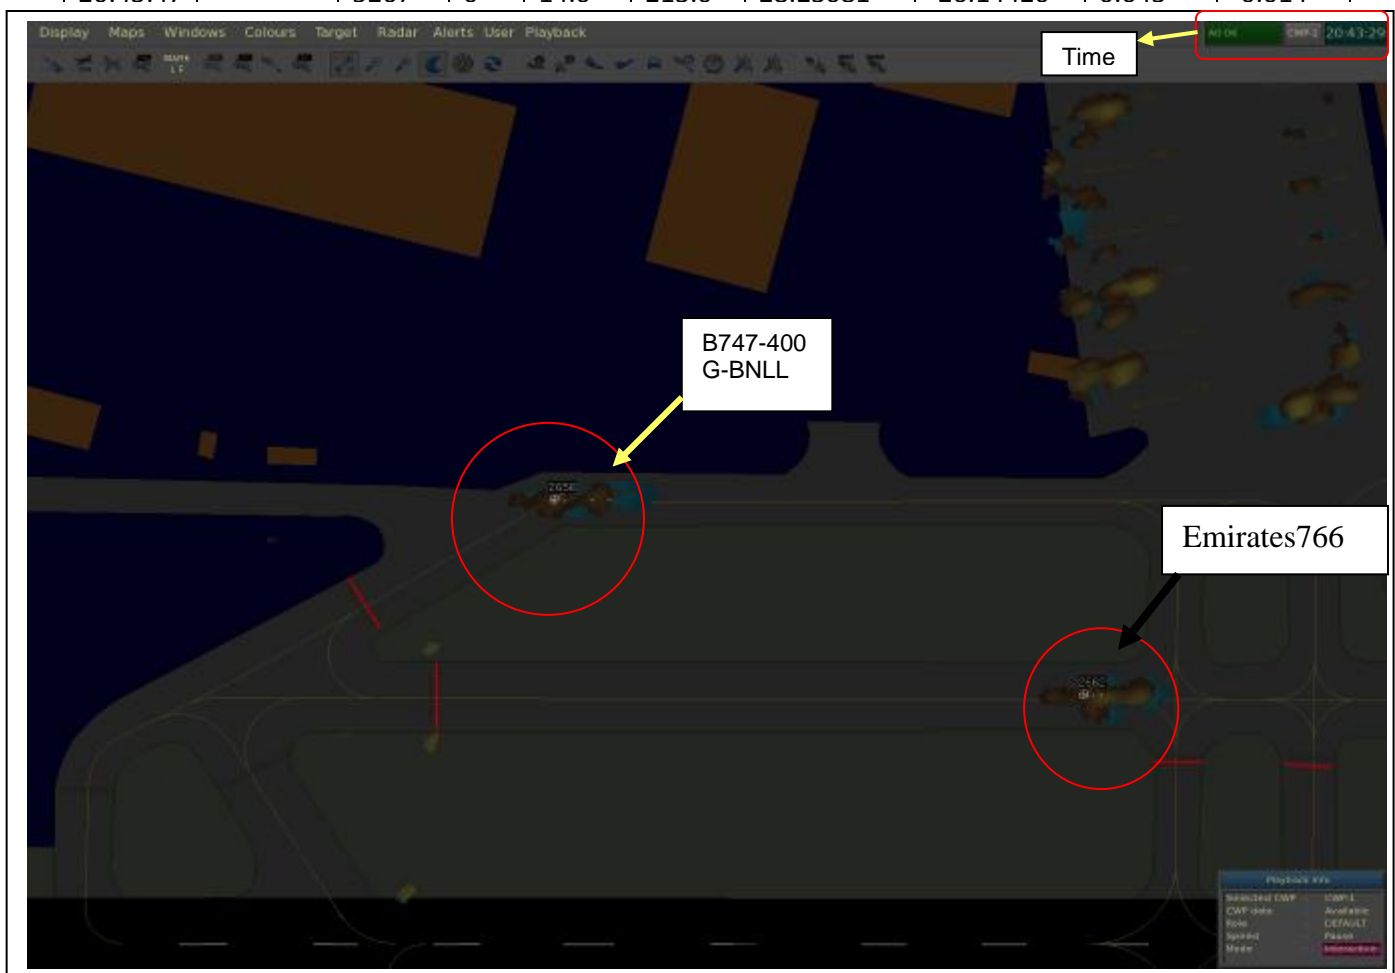
Figure 29 A-SMGCS image of BA034 at intersection of Bravo and Mike

- 1.11.4.7 The FDR and A-SMGCS show that at 20.43:29 UTC (22.43:29 local time), BA034 was taxiing (GSPD: 14.3 kts), reaching the intersection of Bravo and Mike (GPS reading: E28.23149 S26.14289), southbound (heading 213.3 degrees). At this time, there was no report of any defect, malfunction or anomaly and the situation was still uneventful.
- 1.11.4.8 On taxiway Alfa, the Emirates766 aircraft was also taxiing southbound toward Cat 1 holding point en route to Runway 03L/21R.
- 1.11.4.9 There is no evidence of any communication on between BA034 and Tower (ATC), communication was among the crew (pilots). Nothing was said that is considered relevant to the accident at this time.

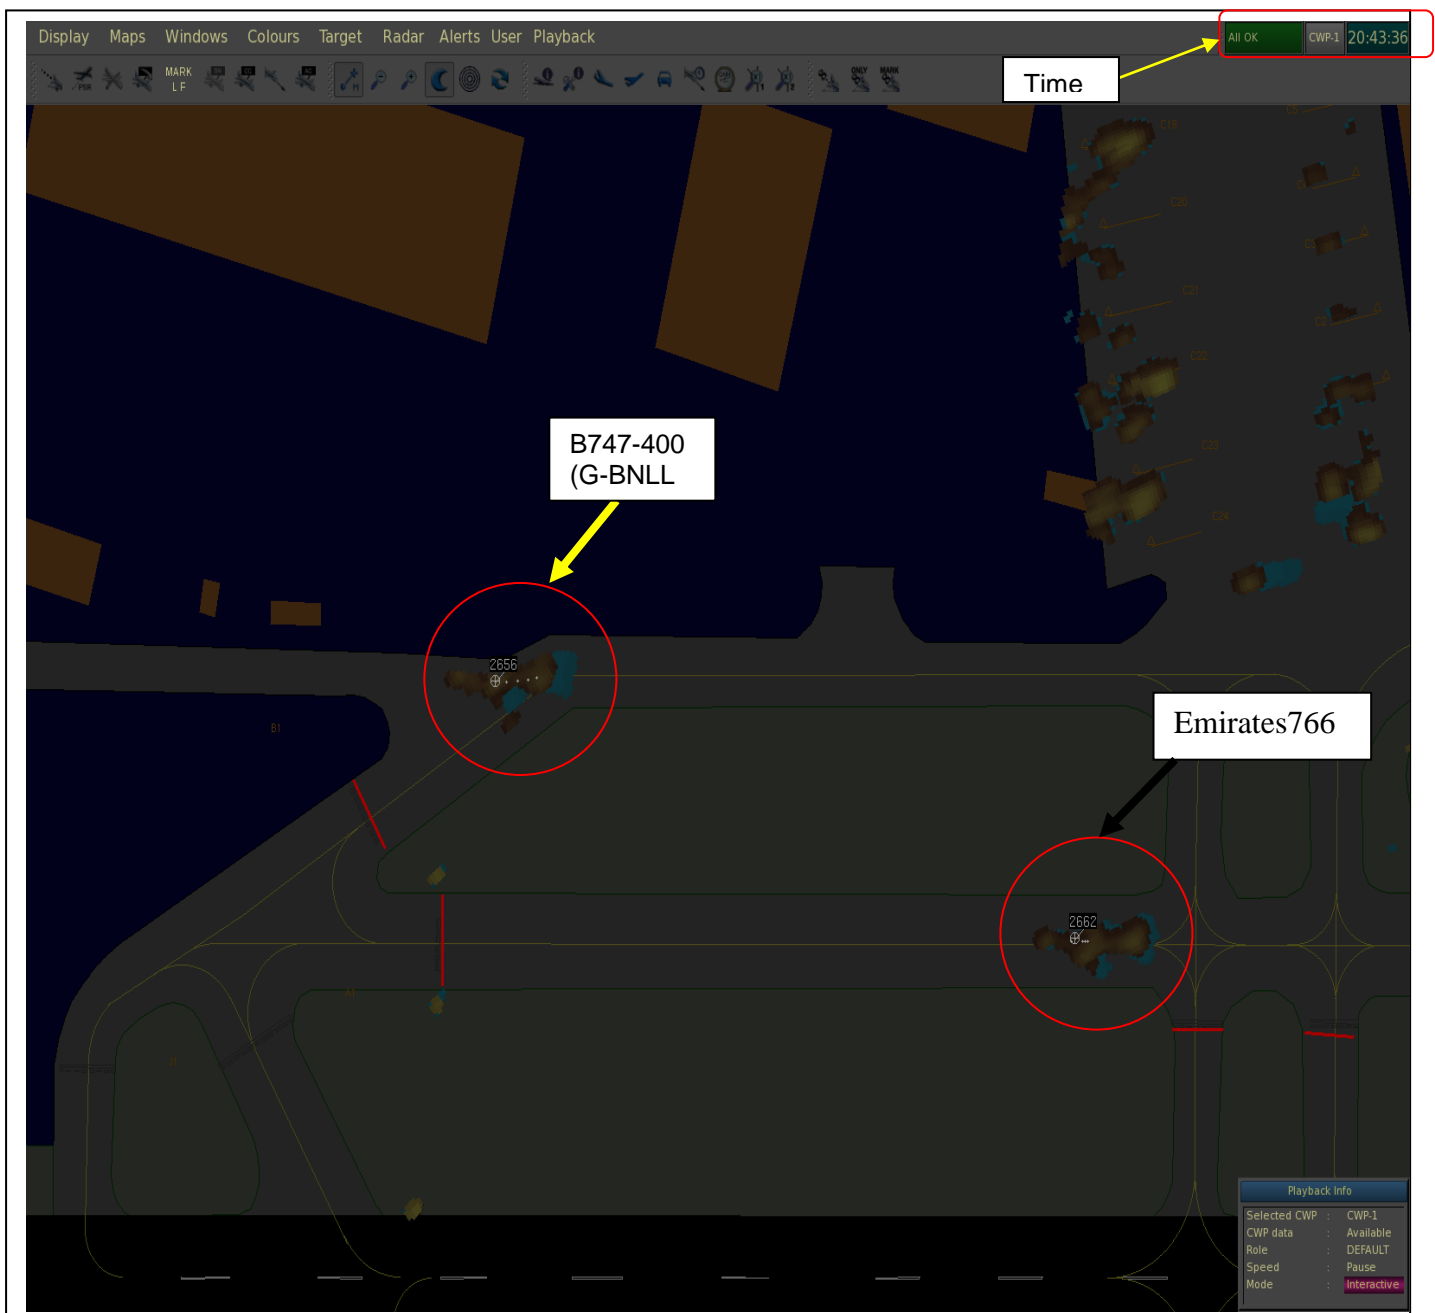
Figure 30 A-SMGCS image of BA034 proceeding onto Mike

1.11.4.10 The FDR and A-SMGCS show that at 20.43:36 UTC (22.43:36 local time), the BA034 aircraft was taxiing (ground speed 14.3 kts), turning slightly to the left ( $\pm 0.5$  degrees).

**Note:** At this point (GPS reading E28.23149 S26.14426) the aircraft heading was 213.8 degrees and it was entering the intersection/junction area of taxiway Bravo and aircraft stand taxilane Mike. The width of Bravo is 30 metres and Mike is 18 metres. The observation here is that the centreline continues straight ahead, but the right-hand edge line is not continuing straight; it decreases at an angle.

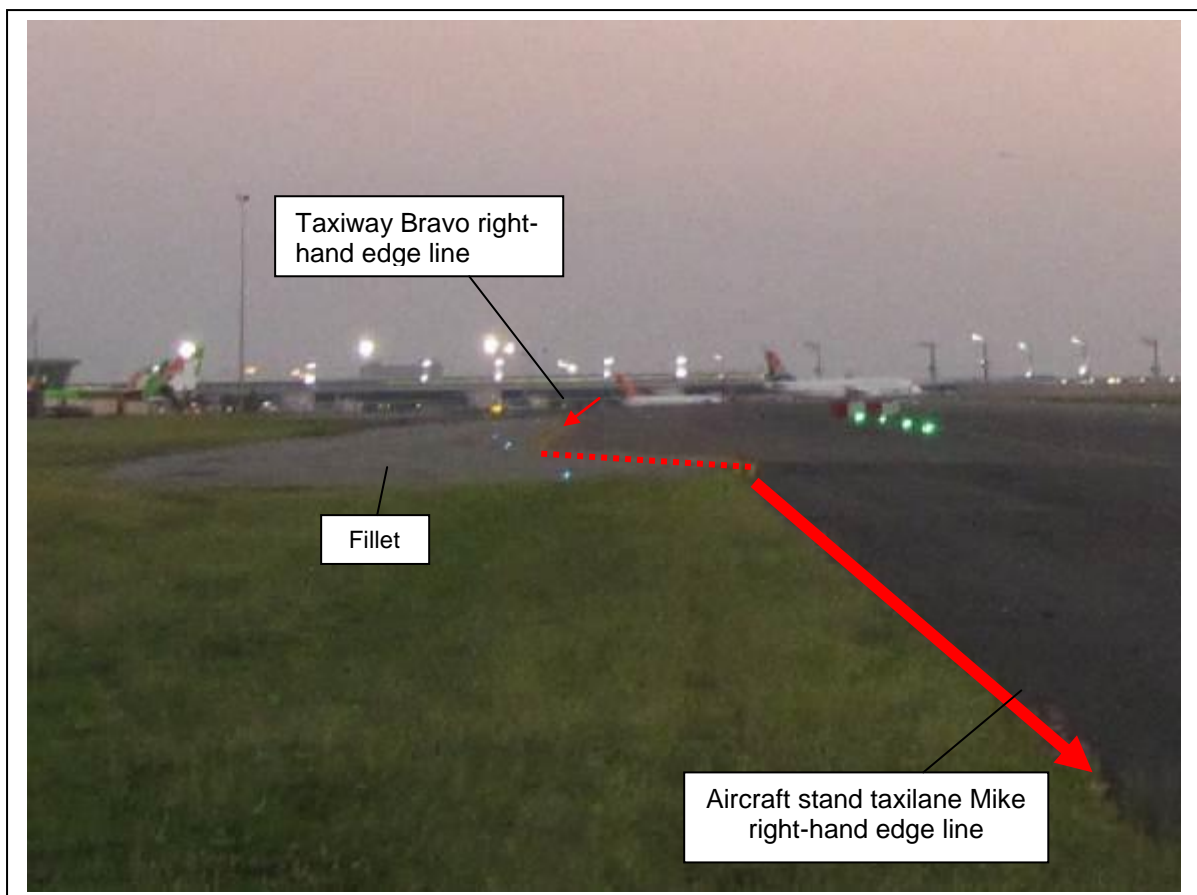
Figure 31 Right-hand edge lines of Bravo and Mike

- The picture below was taken during the morning on the day after the accident. It shows the right-hand edge lines of Bravo and Mike at the intersection/junction.

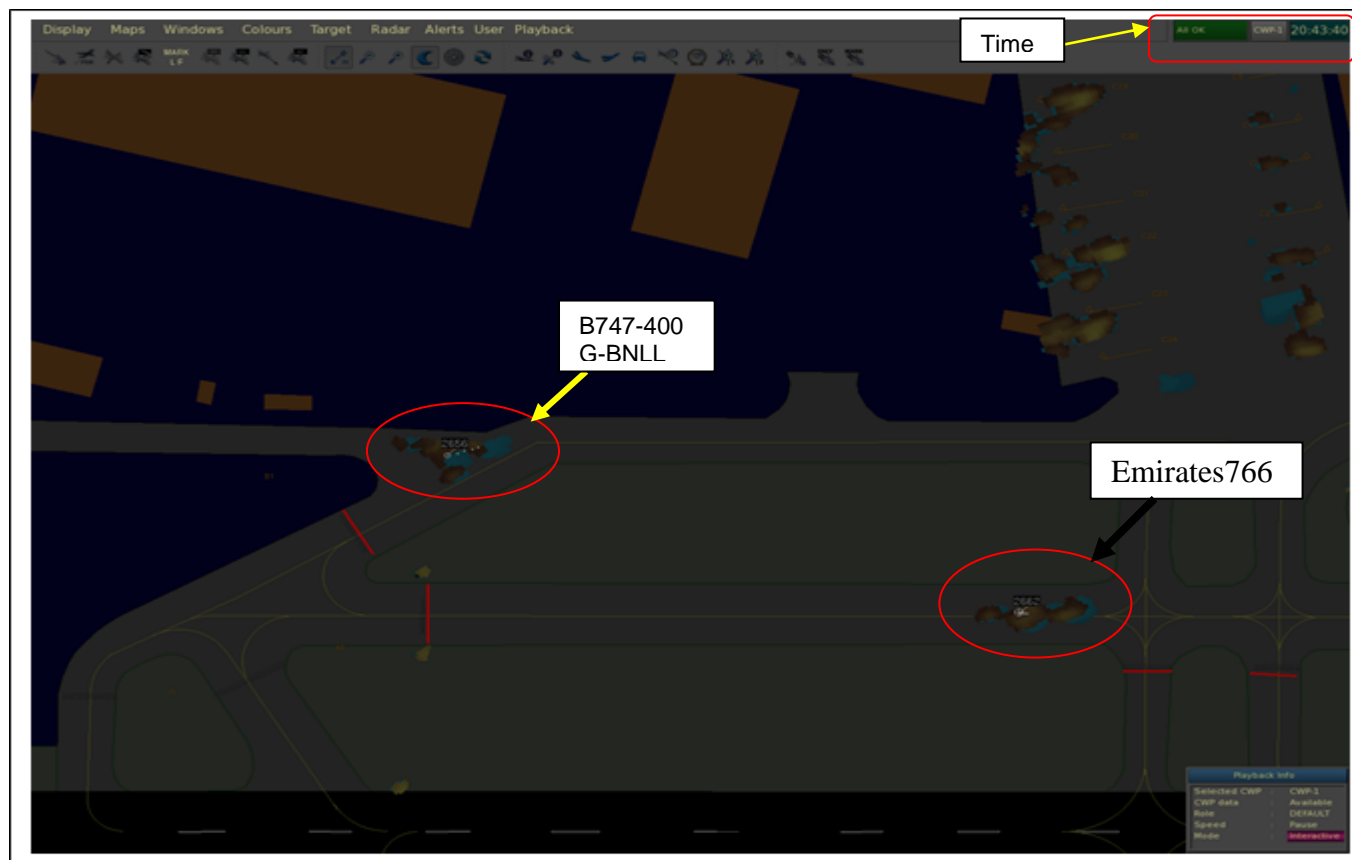
1.11.4.11 The A-SMGCS images below show the sequence of events that followed when the B747-400 aircraft crossed the intersection/junction of Bravo and Mike, intending to go straight ahead.

Figure 32 A-SMGCS image of BA034 proceeding to Mike

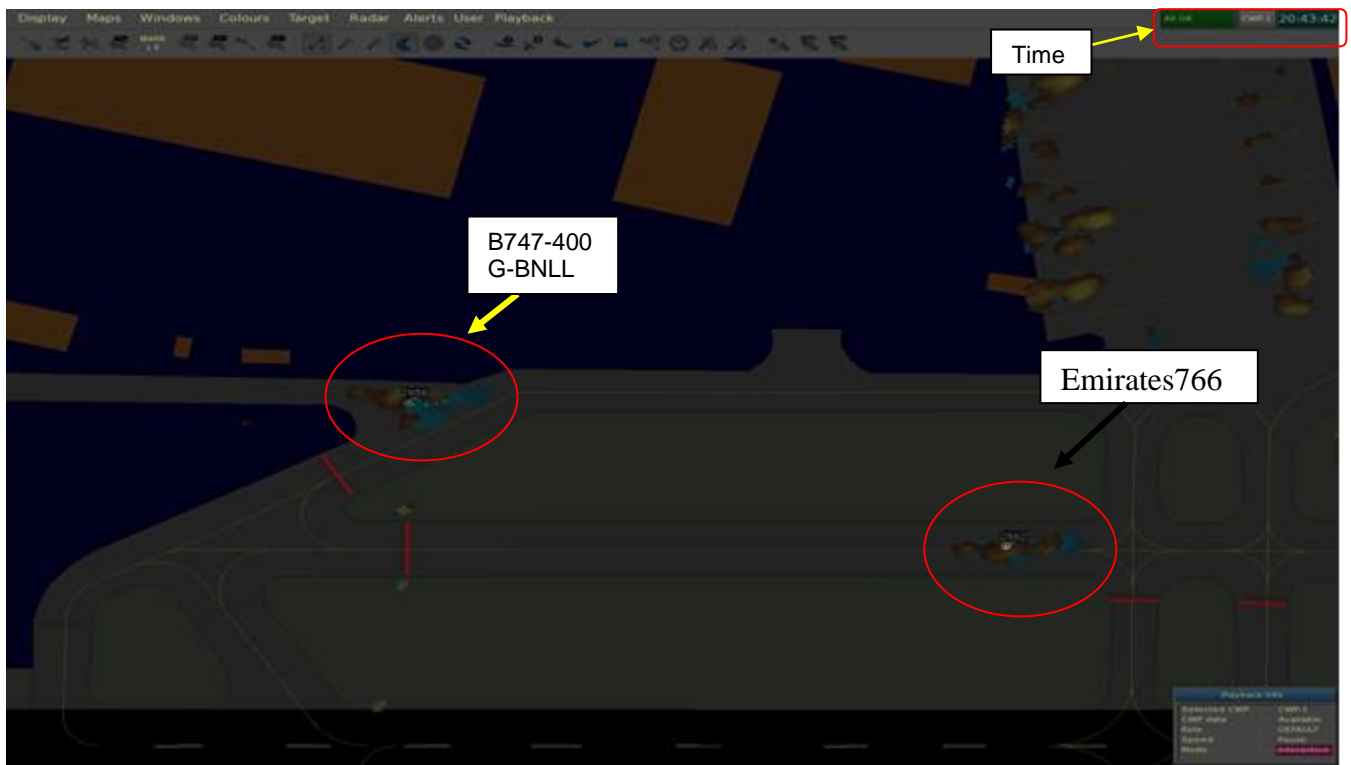
Figure 33 A-SMGCS image of BA034 proceeding to Mike

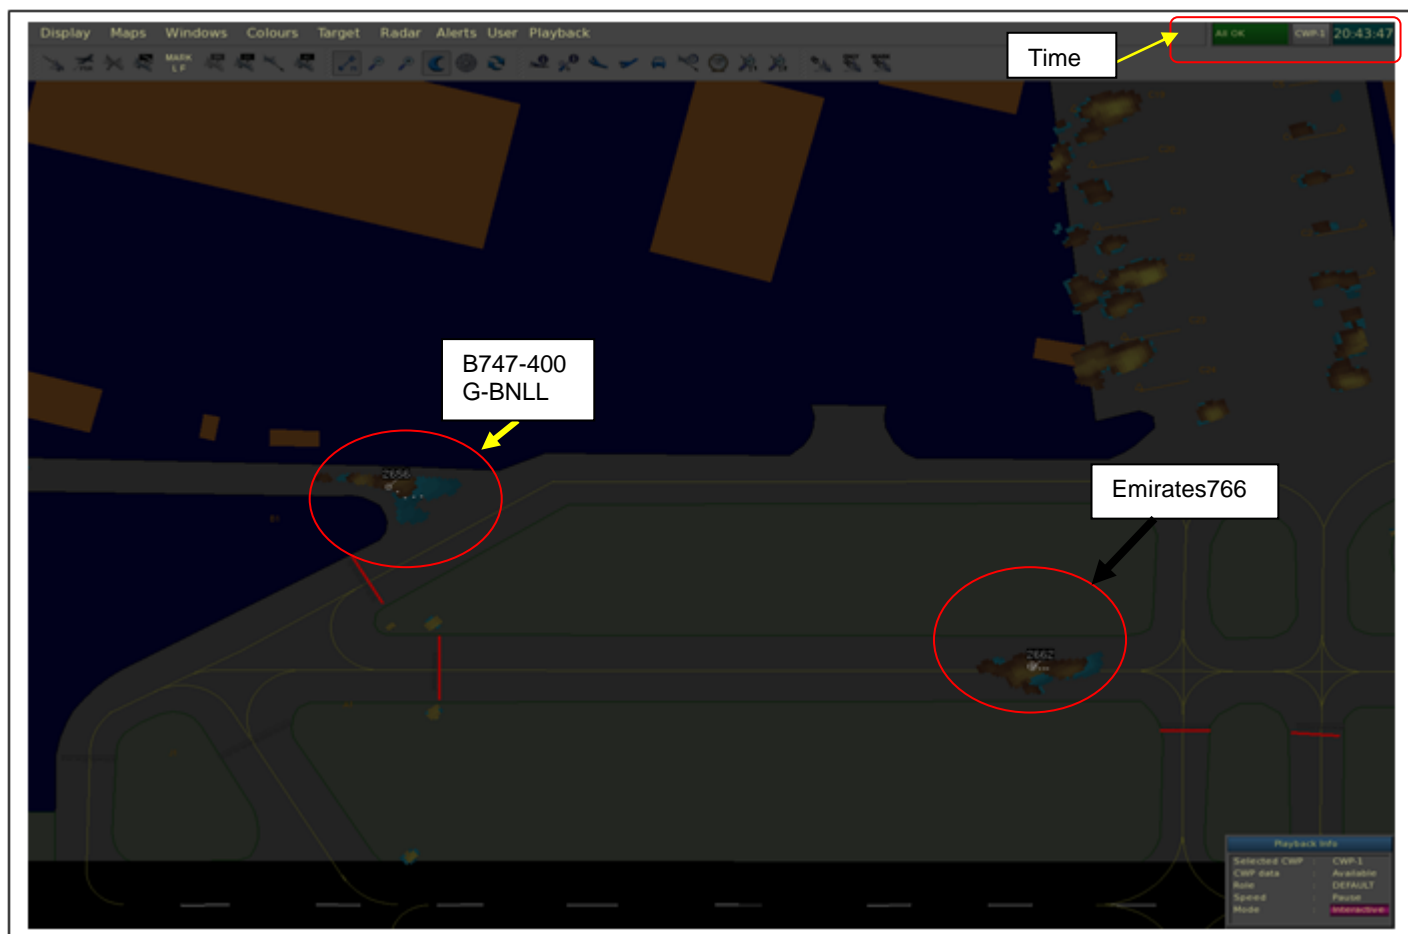
Figure 34 A-SMGCS image of BA034 proceeding to Mike

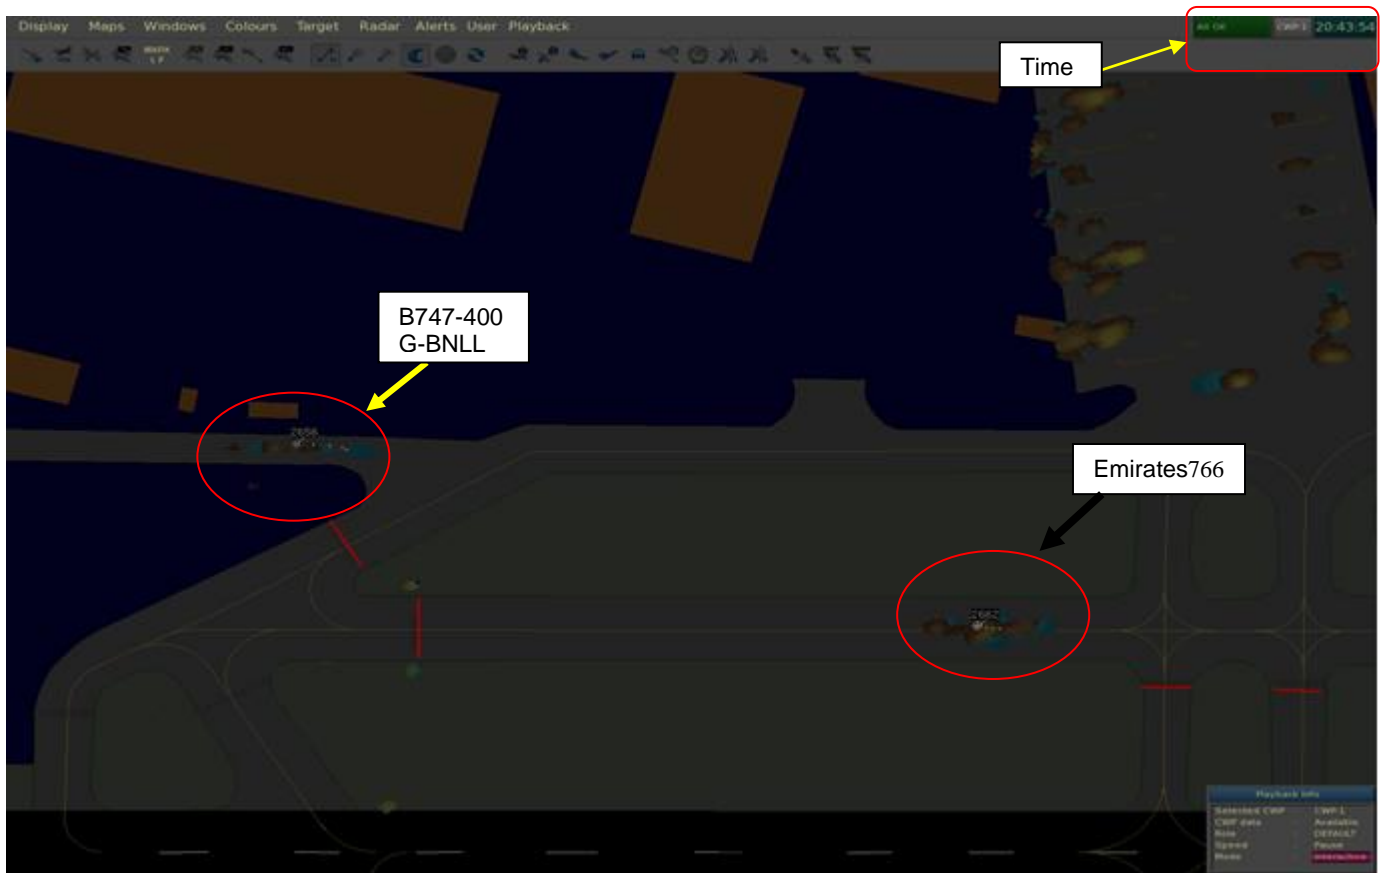
Figure 35 A-SMGCS image of BA034 on Mike

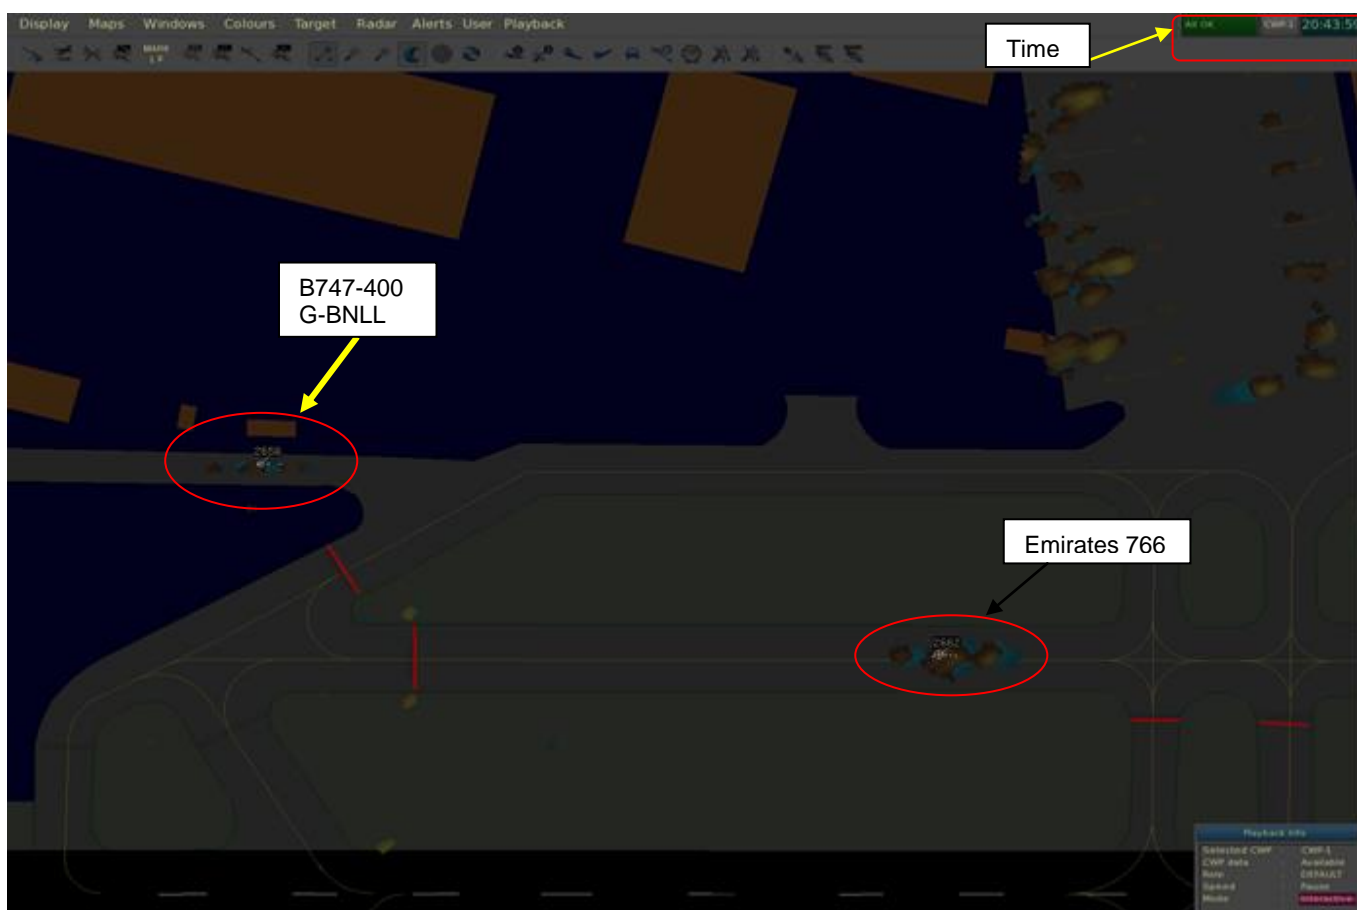
Figure 37 A-SMGCS image of BA034 involved in accident

- 1.11.4.14 The FDR and A-SMGCS show that at 20:43:59 UTC (22:43:59 local time), BA034 was taxiing on taxiway Mike. The aircraft was then involved in a collision with Bid Air Services Building (GPS reading: E28.23081 S26.14426). The heading was 214.4 degrees. At this point in time, as a result of the impact the aircraft ground speed dropped to 1.3 kts.

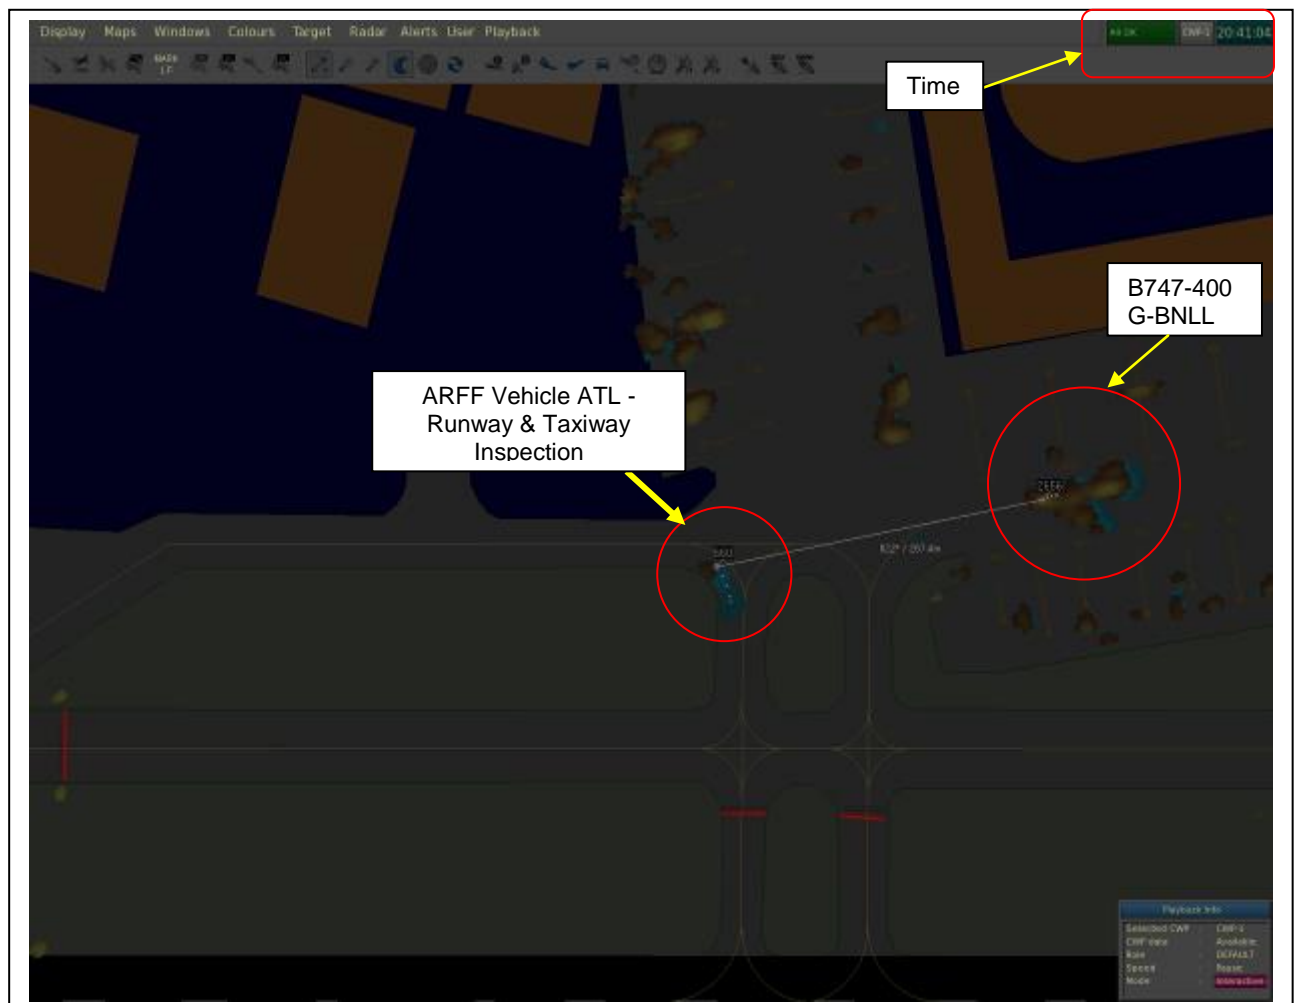
1.11.5.1 Below the A-SMGCS shows, at 22:41:04 UTC (20:41:04 local time), the ARFF vehicle (FTL) entering taxiway Bravo. The vehicle then continued to drive in front of BA034, heading south in the direction of intersection/junction of Bravo and Mike. The separation was 022°/2674 m between the vehicle and BA034. The evidence is that the ARFF person inside the vehicle completed the runways and taxiways inspection. They were heading back to the station.

Figure 37 A-SMGCS image of ARFF vehicle (FTL) heading to Bravo
