## AIRCRAFT ACCIDENT REPORT AND EXECUTIVE SUMMARY

Reference:	CA18/2/3/9257	
<b>Aircraft Registration</b>	<b>G-BNLL</b>	<b>Date of Accident</b>	22 December 2013		<b>Time of Accident</b>	20:43Z
<b>Type of Aircraft</b>	Boeing 747- 400		<b>Type of Operation</b>		Air Transportation	
<b>Pilot-in-command Licence Type</b>		ATPL	<b>Age</b>	57	<b>Licence Valid</b>	Yes
<b>Co-pilot Licence Type</b>		ATPL	<b>Age</b>	51	<b>Licence Valid</b>	Yes
<b>Pilot-in-command Flying Experience</b>		Total Flying Hours	±20 050,00		Hours on Type	±12 500.00
<b>Co-pilot Flying Experience</b>		Total Flying Hours	± 5700,00		Hours on Type	± 1400,00
<b>Last point of departure</b>		OR Tambo International Airport (FAOR) at Gauteng in Republic of South Africa.				
<b>Next point of intended landing</b>		Heathrow International Airport (EGLL) at London in United Kingdom.				
<b>Location of the accident site with reference to easily defined geographical points (GPS readings if possible)</b>

## AIRCRAFT ACCIDENT INTERIM REPORT

**Name of Owner** : British Airways PLC  
**Name of Operator** : British Airways  
**Manufacturer** : Boeing Company  
**Model** : B747- 400  
**Nationality** : United Kingdom  
**Registration Mark

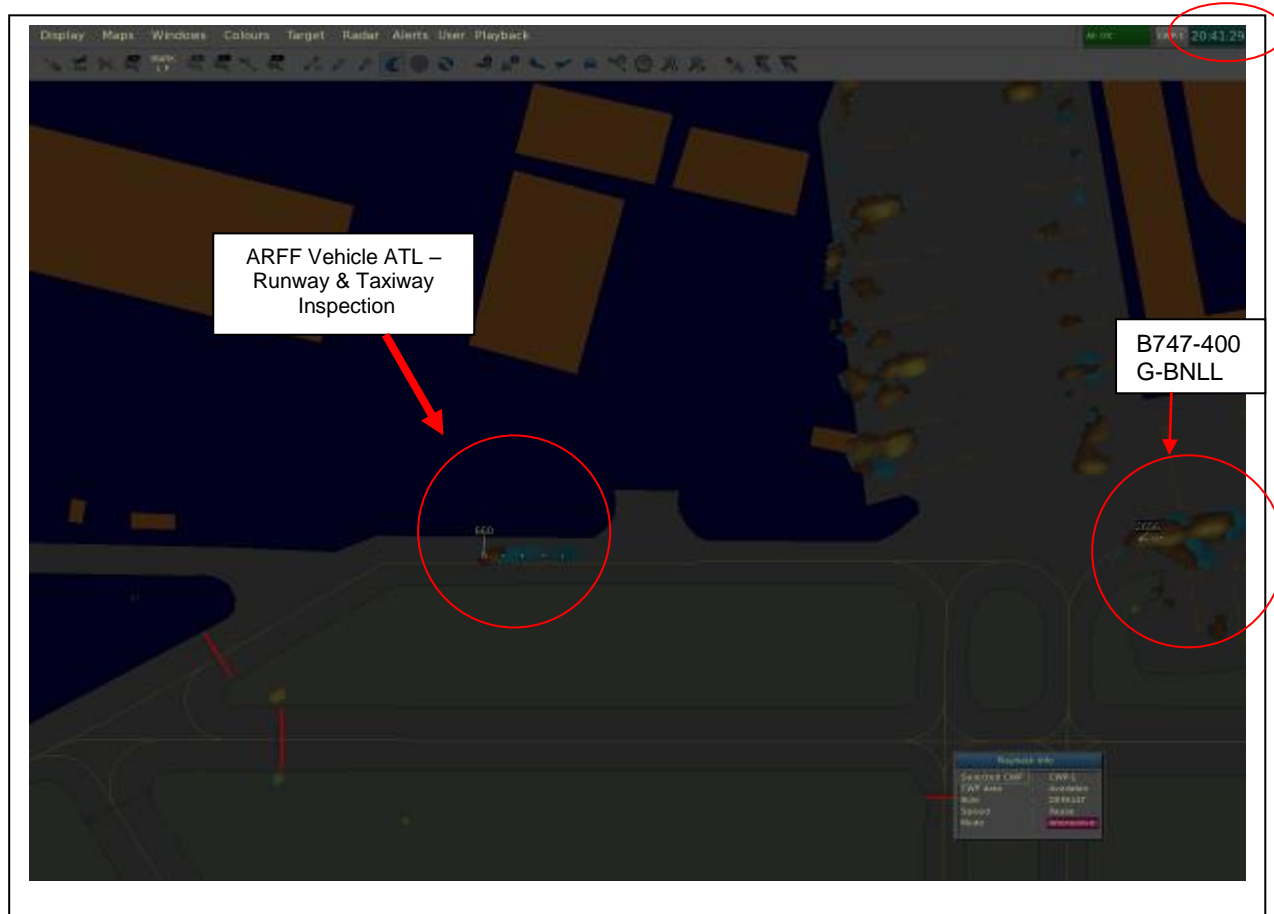
1.11.5.2 Below the A-SMGCS shows the ARFF vehicle (FTL) heading toward the intersection/junction of Bravo and Mike, which is where the two green centreline lights were found not illuminating and not reported.

Figure 38 A-SMGCS image of ARFF vehicle (FTL) near intersection of Bravo and Mike

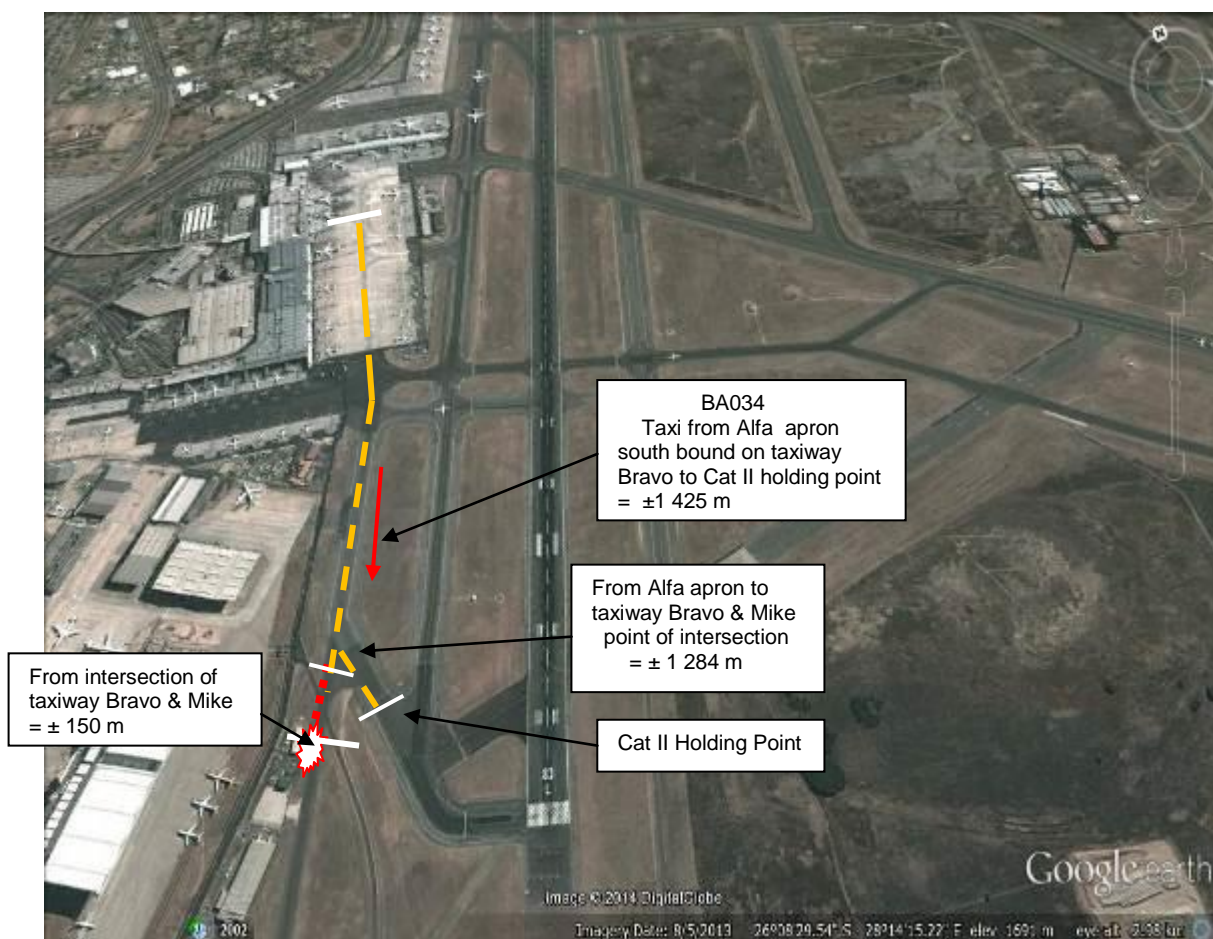
1.12.1.2 The aircraft was expected to turn to the left following taxiway Bravo at intersection with Mike. The distance from Alfa apron to the intersection of Bravo and Mike was measured as approximately 1284 metres.

1.12.1.3 The aircraft proceeded straight onto taxiway Mike heading into the direction of Mike apron. On taxiway Mike, at a distance of approximately 150 metres from the intersection, the aircraft right wing collided with the BidAir Services Operations Office building.

Figure 39 Google Earth ground map of taxi route

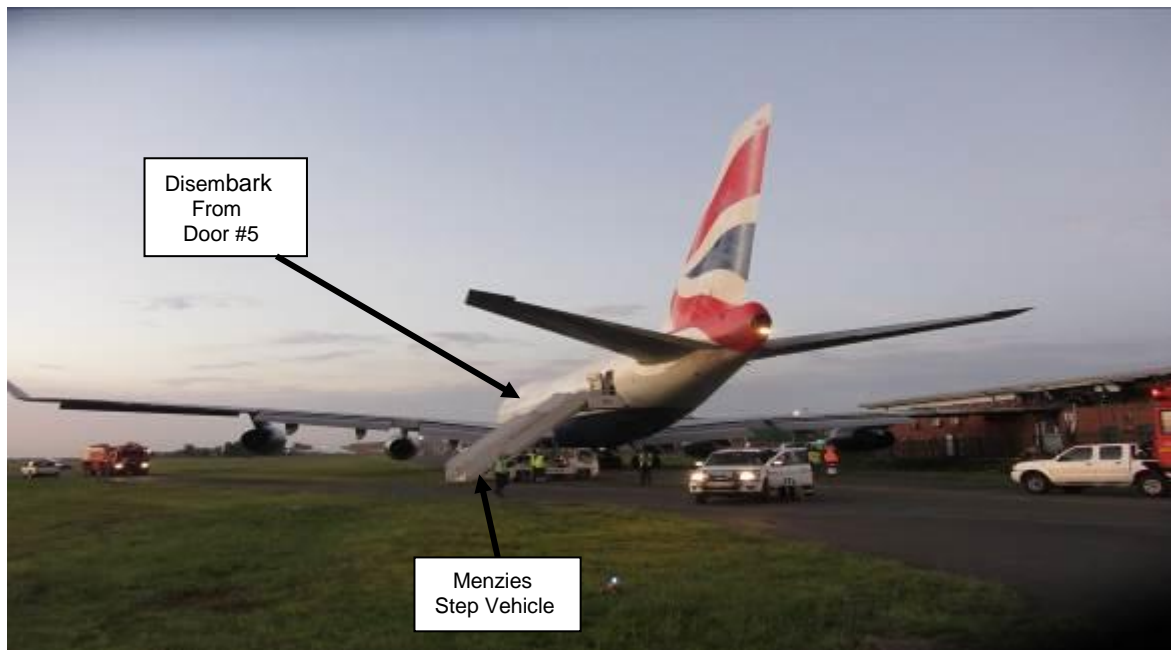
- (i) At 21.15:00 UTC (23.15:00 local time), a step vehicle and two buses from Menzies Handling Company arrived at BA034. The step vehicle first drove to Door #1 (left side) of the aircraft, as the initial decision was to do the evacuation from Door #1. However, the step vehicle had to drive off Mike into grass and got stuck in the soft grass. The step vehicle could not reach Door #1 and decided to use Door #5 (left side) instead. Eventually, at 21.20:00 UTC (23.20:00 local time, which was 5 minutes later), the step vehicle was properly positioned at Door #5 and the passengers started to disembark from the aircraft.

Figure 42 Door #5 and step vehicle used to disembark

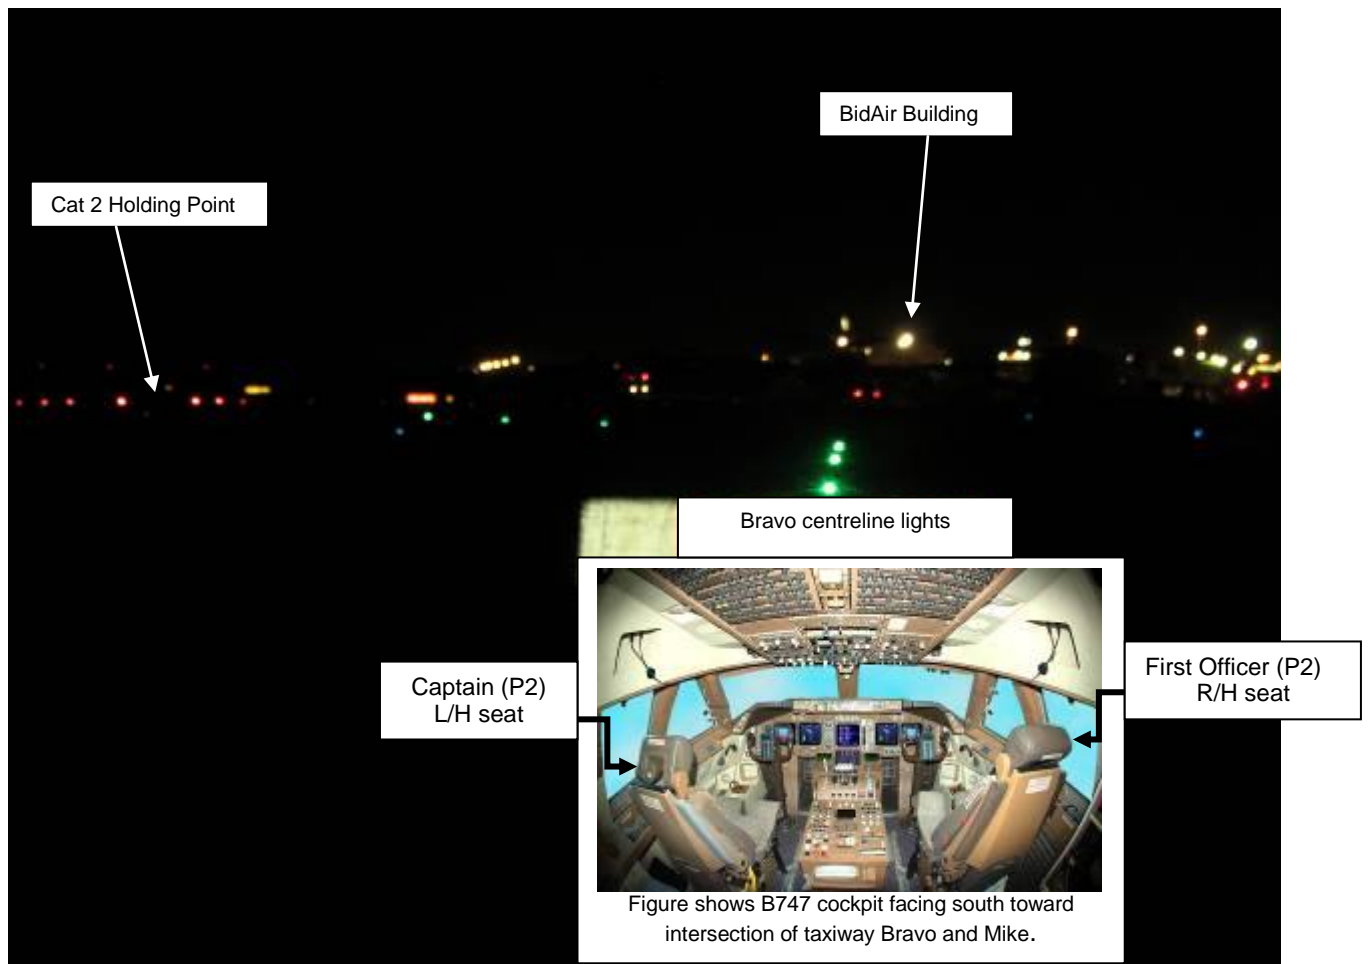
Figure 44 Cockpit with reference to airside surrounding on the night
