Final report RL 2015:10e

**Serious incident on 31 January 2014
involving the aircraft ES-PJR of the model
Bae Jetstream 3200, operated by AS Avies
at Torsby airport, Värmland county.**

File number L-0018/14

22/06/2015

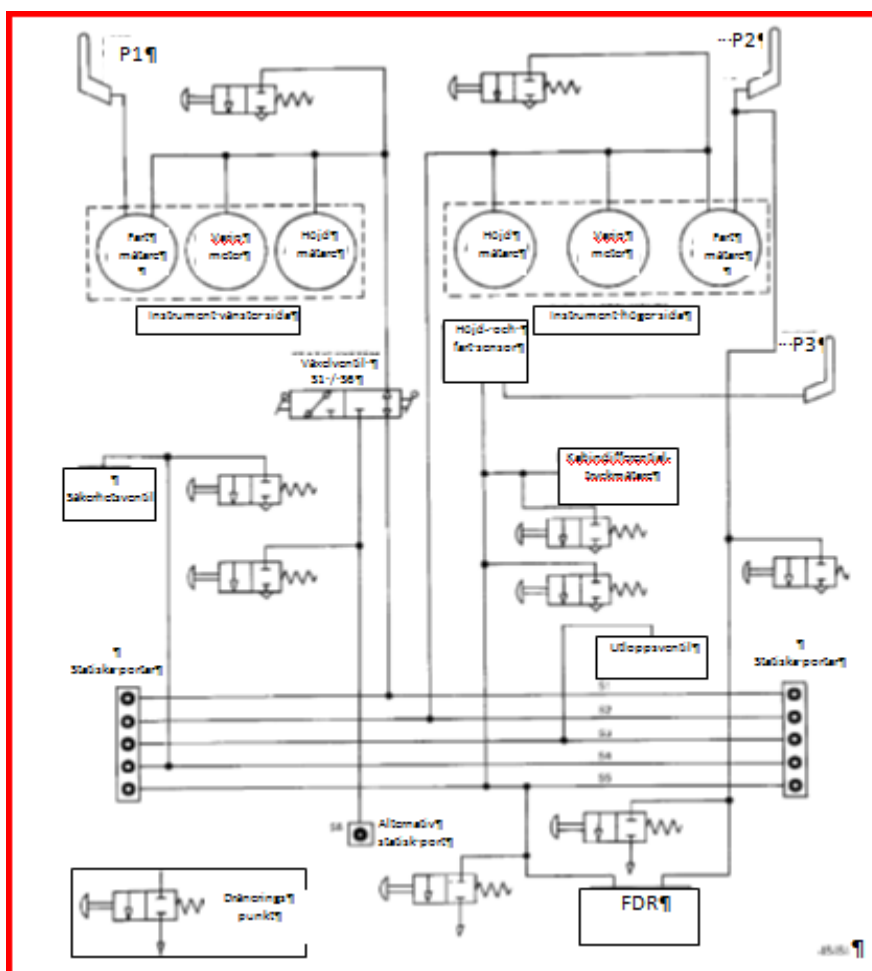
Figure 4. Schematic view of the pressure system.

Since the forward speed recorded by the FDR is based on the pressures S5 and P2, and the altitude recorded by the FDR is based on the pressure S5, an assessment of the source of error can be made. The minor erroneous display on the right side's airspeed indicator that had been noted by the co-pilot indicates that a partial explanation for the FDR fault can be found in the P2 system. If the fault had been found in the S5 system, the recorded altitudes from the FDR and transponder would have differed, which it has not been possible to establish (see Figure 4).
