Final Report

BOEING B777-300ER, REGISTRATION 9V-SWD EGPWS INCIDENT

2 SEPTEMBER 2019

TIB/AAI/CAS.190

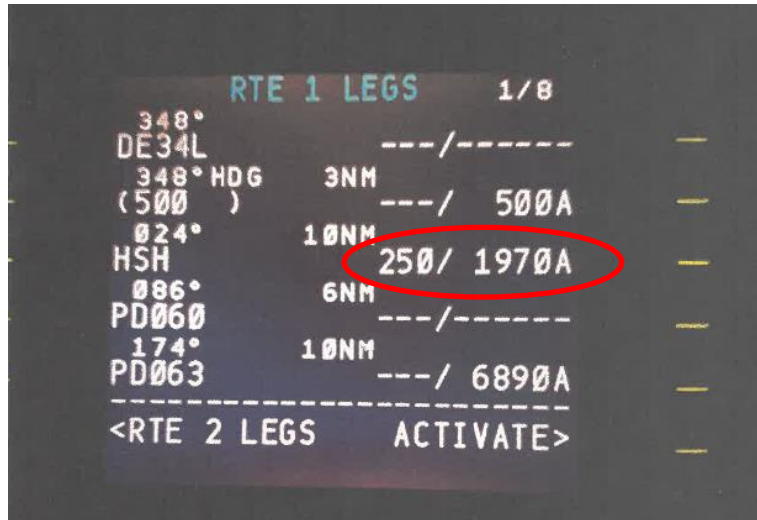
Figure 1. Picture reconstruction (for illustration purpose) showing the programmed speed/altitude constraint of “250/1970A” on SID HSN 22X

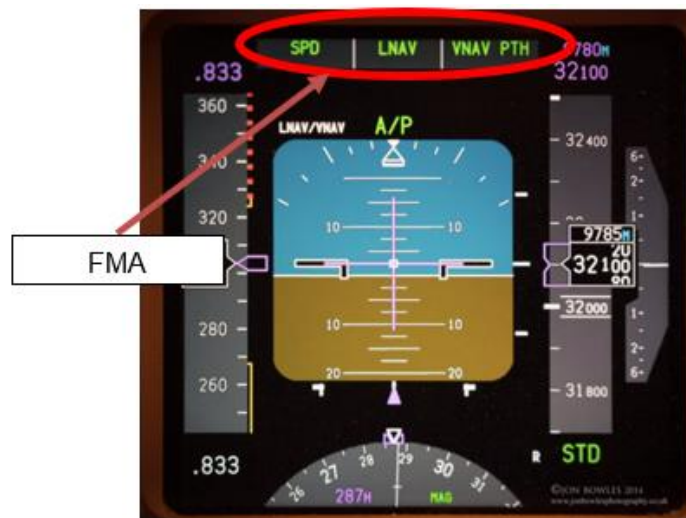
- 1.1.6 According to the FO, when the aircraft was climbing past 400 feet above ground level (AGL), the Flight Mode Annunciation (FMA) on the Primary Flight Display (PFD) changed from “HOLD / LNAV / TO/GA” to “SPEED / LNAV / VNAV PTH¹⁶” (see **Figure 3**). The FO called out “SPEED, VNAV PTH¹⁷”. He made the callout twice. However, according to the PIC, he did not hear the FO’s callouts. The FO did not pursue in seeking a response from the PIC.

Figure 3. Picture (for illustration purpose) showing FMA

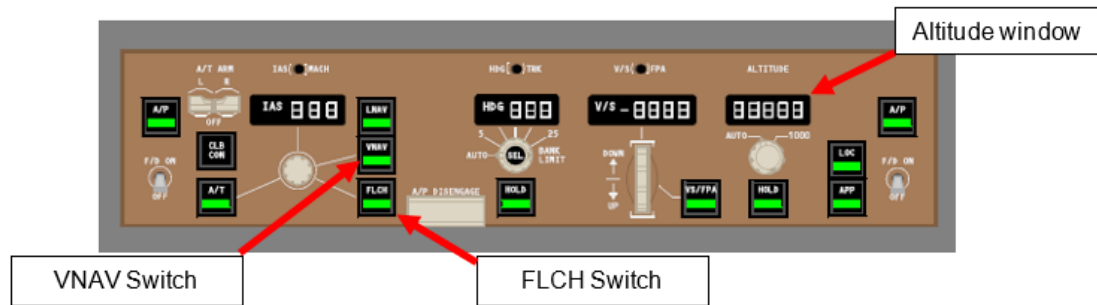
- 1.1.11 The PIC engaged the Flight Level Change (FLCH) on the Mode Control Panel (MCP) (see **Figure 4**)²². However, two seconds later, he re-engaged the VNAV mode²³ by engaging the VNAV switch, which removed the FLCH mode. The PIC thought that he had resolved the issue as the “DON’T SINK” caution alert had ceased. However, according to the QAR data, the short FLCH engagement resulted in no appreciable change in altitude as the aircraft was oscillating between 480 to 500 feet AGL.

Figure 4. Picture (for illustration purpose) of MCP

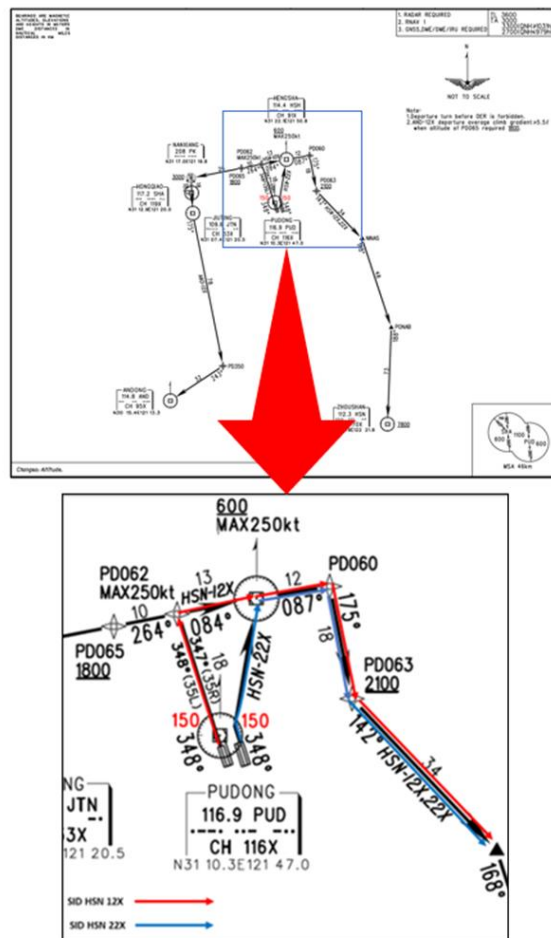
1.4.1 **Figure 5** shows SID HSN 22X and HSN 12X.

Figure 5. Chart for Pudong Radio Navigation Departure extracted from the Aeronautical Information Publication. Note: Altitudes in meters as published
