**SERIOUS INCIDENT**

<b>Aircraft Type and Registration:</b>	Sikorsky S-92A, G-LAWX	
<b>No &amp; Type of Engines:</b>	2 General Electric CO CT7-8A turboshaft engines	
<b>Year of Manufacture:</b>	2004 (Serial no: 920007)	
<b>Date &amp; Time (UTC):</b>	14 October 2019 at 1742 hrs	
<b>Location:</b>	Near Shipston-on-Stour, Warwickshire	
<b>Type of Flight:</b>	Private	
<b>Persons on Board:</b>	Crew - 2	Passengers - 9
<b>Injuries:</b>	Crew - None	Passengers - None
<b>Nature of Damage:</b>	None reported	
<b>Commander's Licence:</b>	Airline Transport Pilot's Licence (Helicopters)	
<b>Commander's Age:</b>	54 years	
<b>Commander's Flying Experience:</b>	6,200 hours (441 of which were on type) Last 90 days - 25 hours (25 hours on type) Last 28 days - 15 hours (15 hours on type)	
<b>Information Source:</b>	AAIB Field Investigation

**Synopsis**

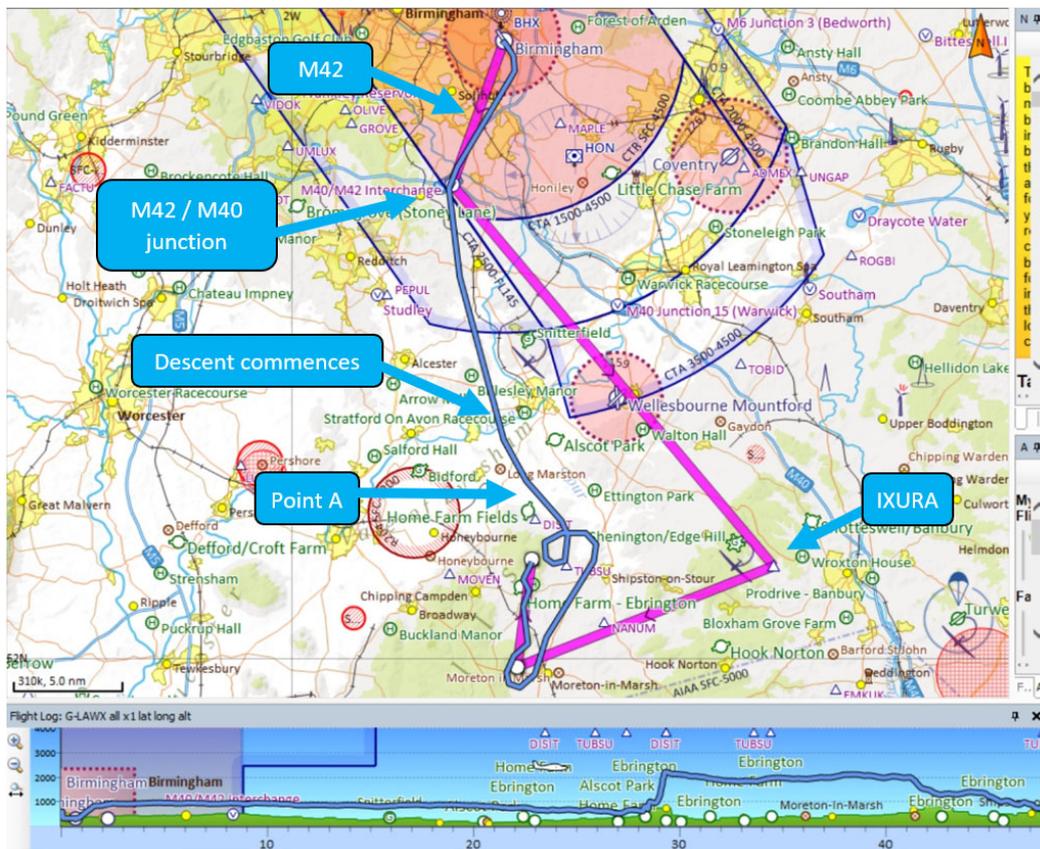
**Figure 1**

G-LAWX planned flight path (pink line) and actual flight path (blue line)  
Chart used with permission of SkyDemon. Not to be used for navigation.

The actual flight path flown (Figure 1) was more direct, following low ground, but then approached the LS from the east along the valley of a small stream. The routing was not explicitly discussed by the pilots before the helicopter departed Birmingham.

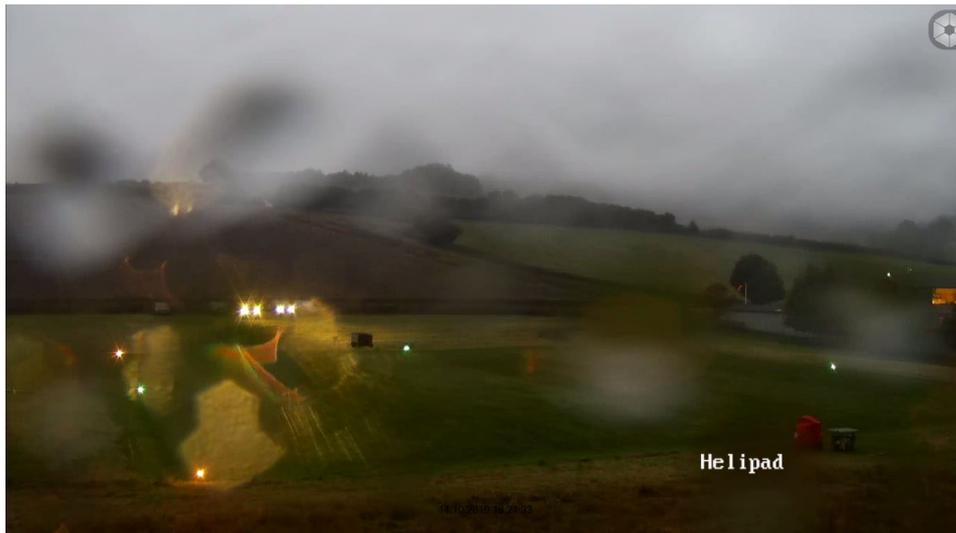
**Figure 6**

The LS had no weather reporting equipment and the estate manager had no formal meteorological observation qualifications. When the co-pilot spoke to him at around 1710 hrs, the estate manager reported that the weather was "closing in" and that the aerials to the north could not be seen, but that the poor weather was probably confined to that direction because the helipad camera indicated the LS was clearer. The conditions at the LS 10 minutes later are shown in CCTV picture (Figure 6.)

View of LS to the West at 1720 hrs, 10 minutes before departure from Birmingham (used with permission)

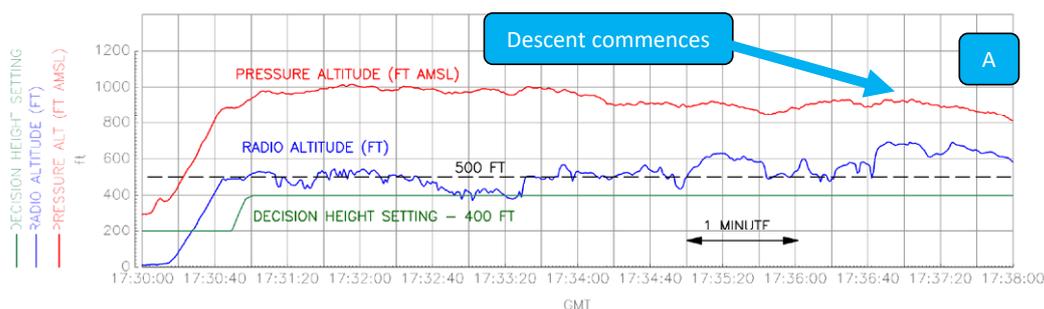
**Figure 9**

The altitude profile for the flight from takeoff to Point A in Figure 1 is shown in Figure 9. Parts of this flight were performed at a height of less than 500 ft agl. As the helicopter crossed the M40/M42 junction VRP, the CVR recorded a radalt alert “ALTITUDE, ALTITUDE” on five occasions in quick succession, which the commander acknowledged. At 1733:34 hrs, after one of the alerts, the commander stated, “CHECKED, CAN YOU BUG THAT DOWN.” The FDR recorded that the radalt alert value was not altered in response. Further radalt alerts were recorded on the CVR until at 1739:29 hrs, the pilot stated, ‘LET’S GO, BUG IT DOWN TO ONE FIFTY PLEASE.’ Ten seconds later, the FDR recorded the radalt alert value reducing to 150 ft. At 1737:36 hrs, the helicopter commenced a descent from an altitude of 890 ft (689 ft agl).

G-LAWX recorded pressure and radio altitude. Point A refers to location in Figure 1

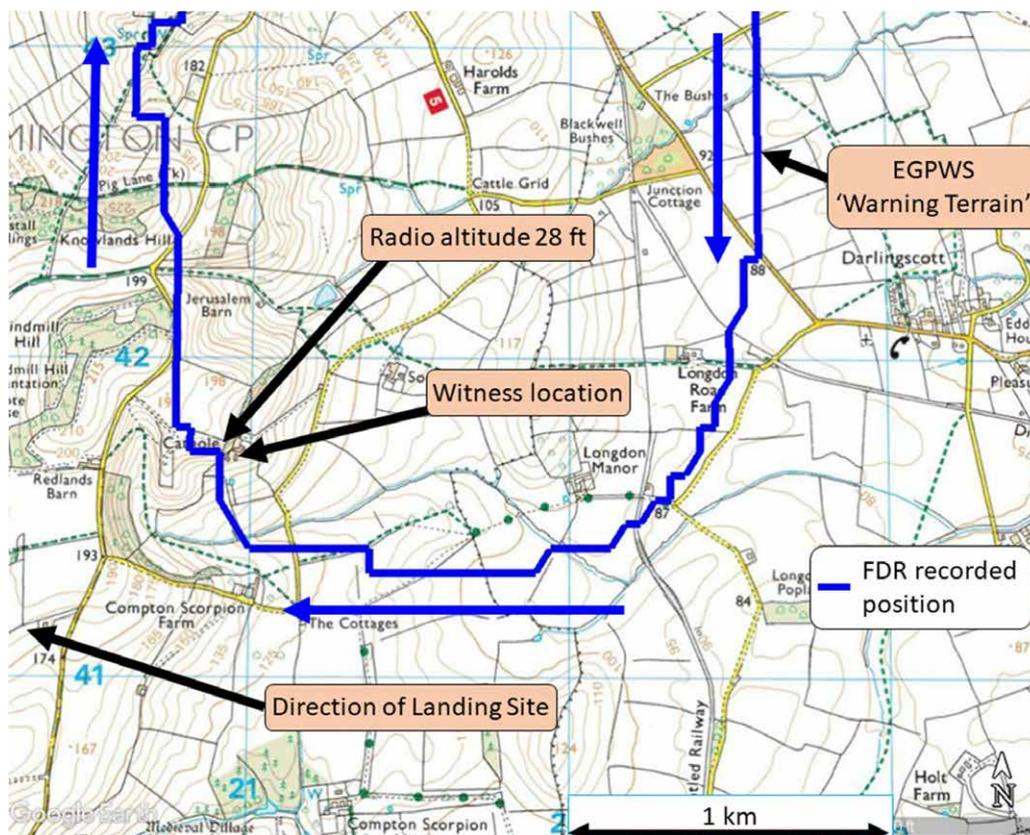
**Figure 11**

After the first EGPWS alert, the helicopter started a slow turn to the right. Just after the second EGPWS alert, it began tracking towards the LS (Figure 11)

G-LAWX incident flight track (terrain heights are in metres)
