AIRCRAFT ACCIDENT REPORT

ARIK/2018/03/06/F

**Report on the Serious Incident involving a Bombardier
DHC-8-Q400 aircraft owned and operated by Arik Air
Nigeria Ltd with nationality and registration marks
5N-BKX which occurred en route Kotoka International
Airport, Accra, Ghana
On 6th March, 2018**

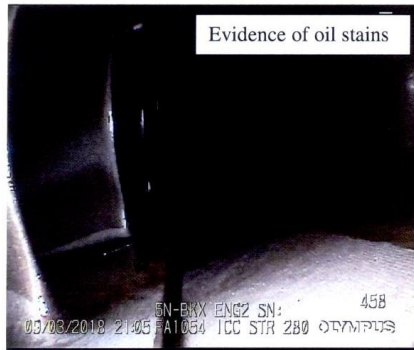
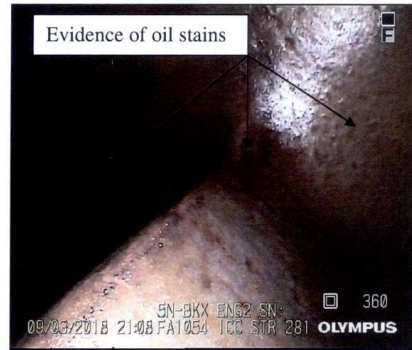
Visual inspection carried out on engine No. 2 by the Arik Maintenance Engineer shows traces of oil in the Air conditioning compartment (tail section). The engine No. 2, P2.2 inter-stage valve exhaust was full of oil and also, there were signs of wetness and oil contamination in the Generator case, low and high pressure compressors, Air intake ducts and P2.2 and P2.7 bleed air ducts.

Due to the above observations, and in accordance with Aircraft Maintenance Manual 72-00-00-290-809, a Borescope inspection of the compressor inner support (CIS) and inter-compressor case strut was requested and carried out by Aero Contractors Nigeria Ltd, which revealed evidence of oil stains on the strut and its vicinity, oil stains within the vicinity of LPC stage 1 blade, evidence of oil stains on LPC stage 3 blade, signs of wetness on the impeller and its vicinity. **See Appendix A.**

| Location | Ea | Findings: |
|---|---|--|
| | | Evidence of oil stains found on struts and vicinity. |
