# Air Accident Investigation Unit Ireland

**FORMAL REPORT**

**Sikorsky S-92A, EI-ICR  
Black Rock, Co. Mayo, Ireland**

**14 March 2017**

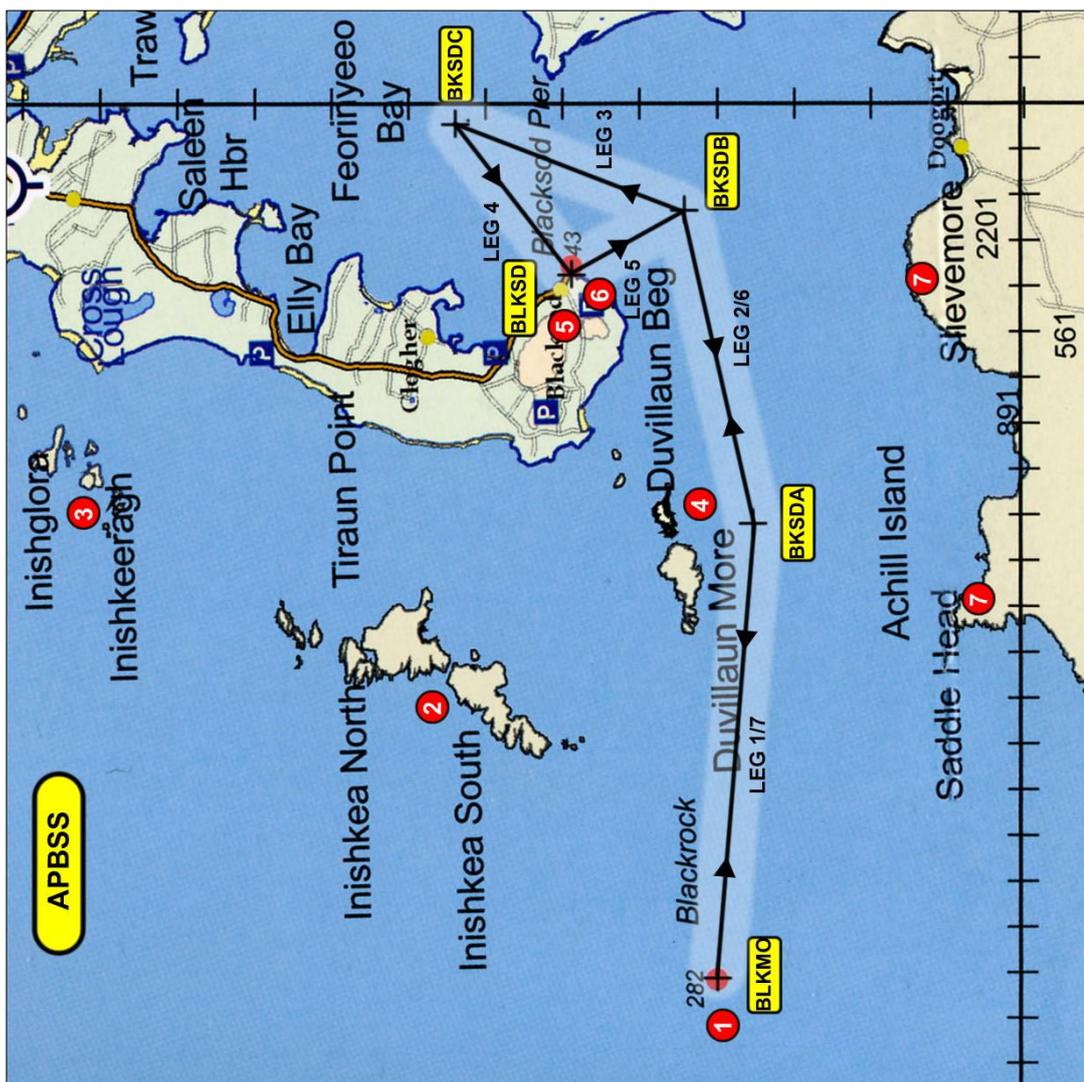
Figure No. 5: 'APBSS' Route Guide chart information (orientation as per Route Guide)

- No vertical profile guidance or minimum heights/altitudes were provided for route legs.
- Legs 1 and 7 are reciprocal legs, i.e. they have same endpoints but were flown in opposite directions. However, the distance quoted for Leg 1 was six miles, but the distance quoted for leg 7 was three miles.

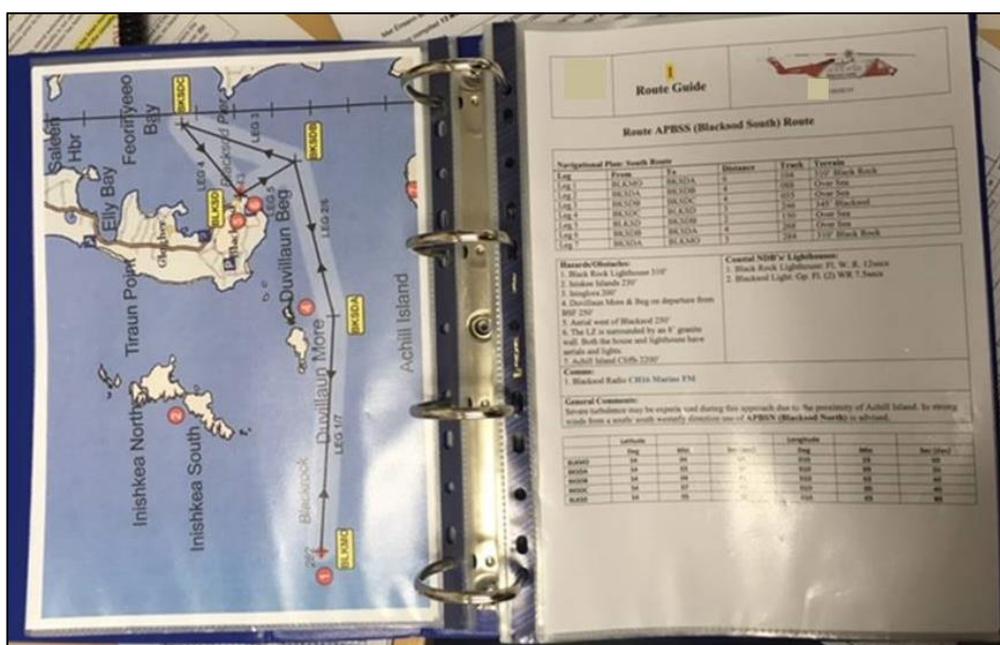
**Photo No. 7:** Route Guide (APBSS Pages) taken at Dublin Base at 03.30 hrs on 14 March 2017

The Investigation notes that the route imagery in this photograph is not the same as that contained in the Route Guide provided by the Operator (**Figure No. 5**). In particular, it is noted the terrain at Achill Island, Obstacle 3 and one of the Obstacle 7 designators are not shown. In addition, the Investigation is of the opinion that this image could invoke a greater sense of 'open-water' than the version provided by the Operator. This led the Investigation to question which version of APBSS was available to the Crew of R116.

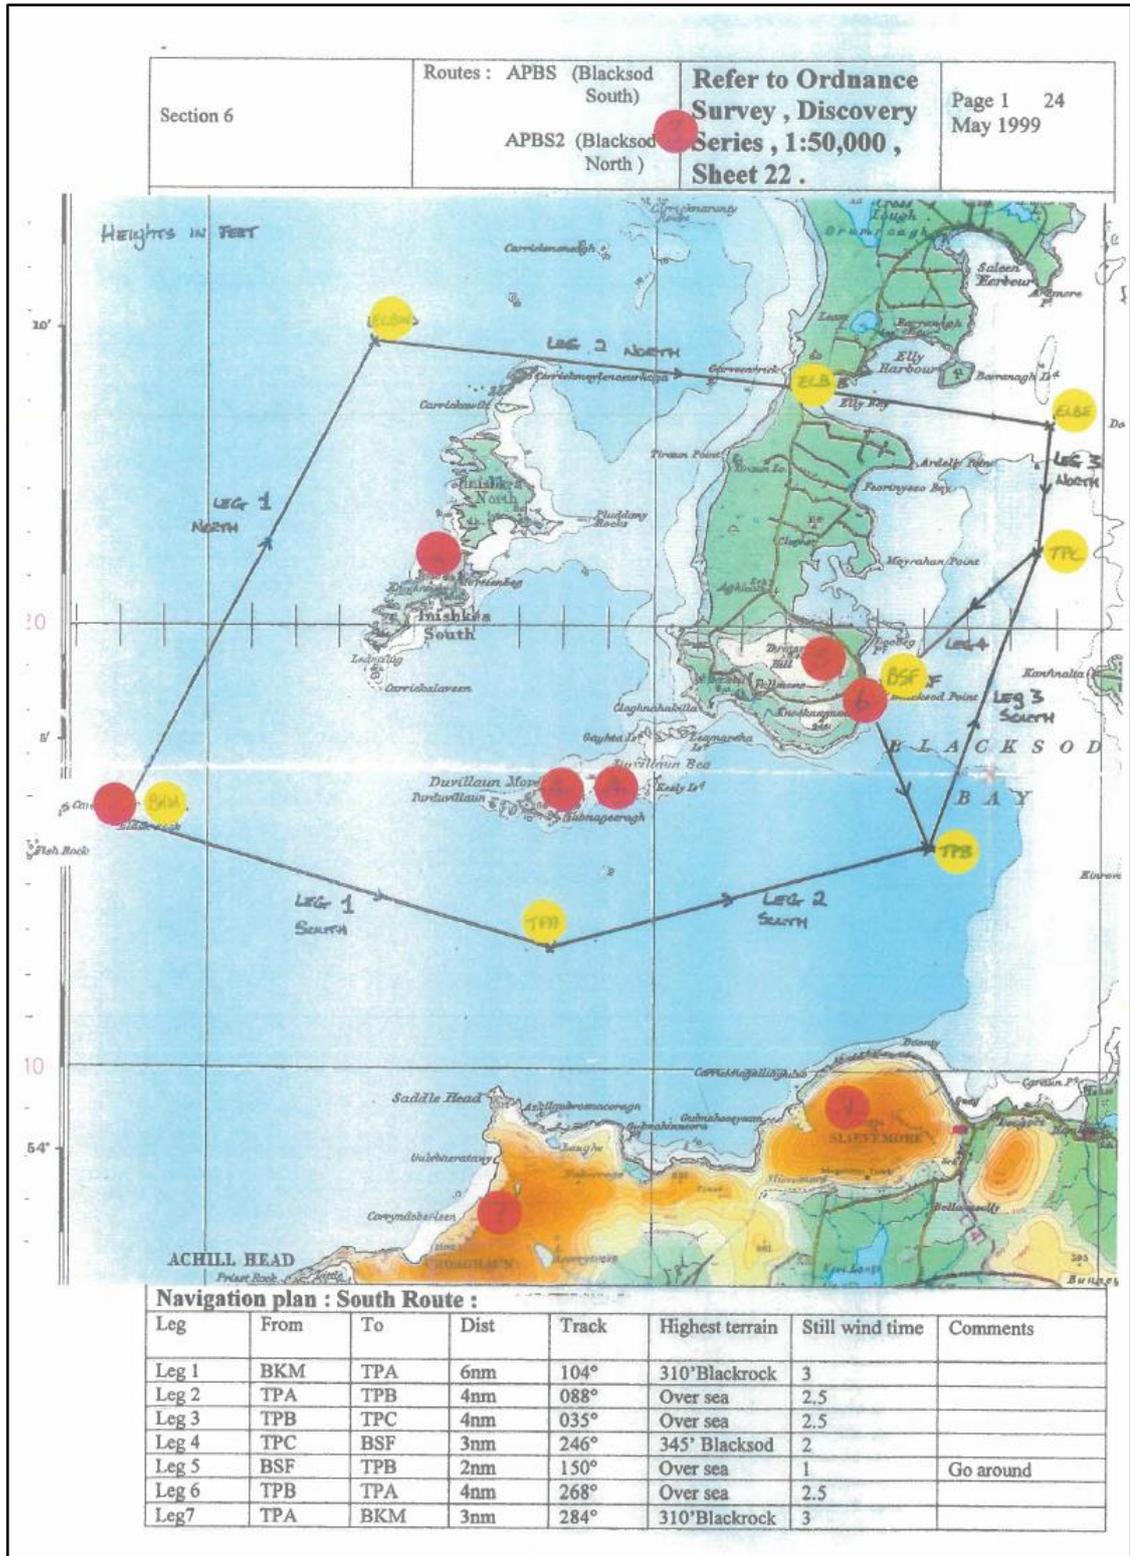
Figure No. 6: Copy of Blacksod South route from May 1999

The Investigation compared this version with the route images in use at the time of the accident. The following points were noted:

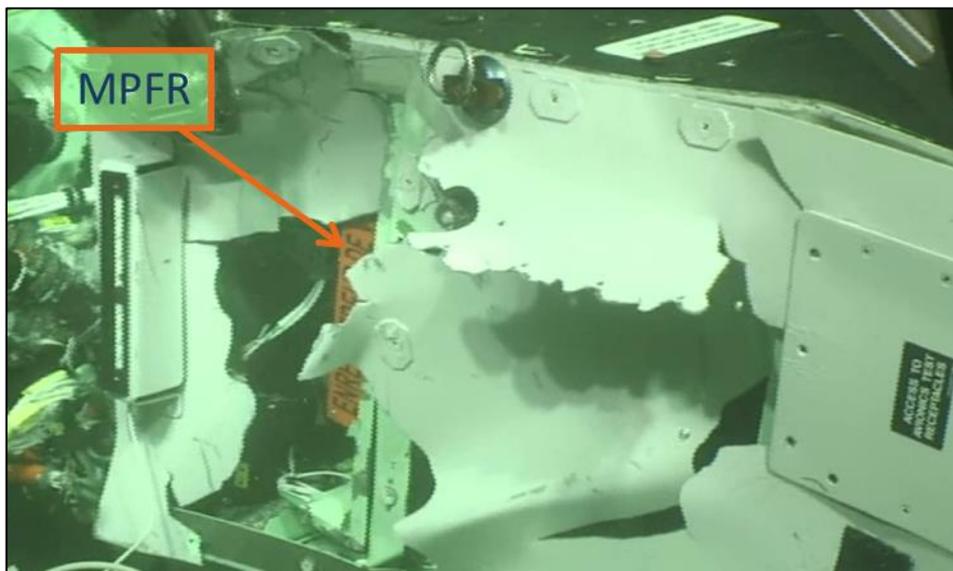
**Photo No. 9:** The MPFR in the left-hand Avionics Rack on the seabed (MI)

The MPFR was observed by ROV, attached to its original mounting points in the forward, left-hand avionics rack (**Photo No. 9**), and recovered by Irish Naval Service divers on 24 March 2017, 10 days after its immersion.

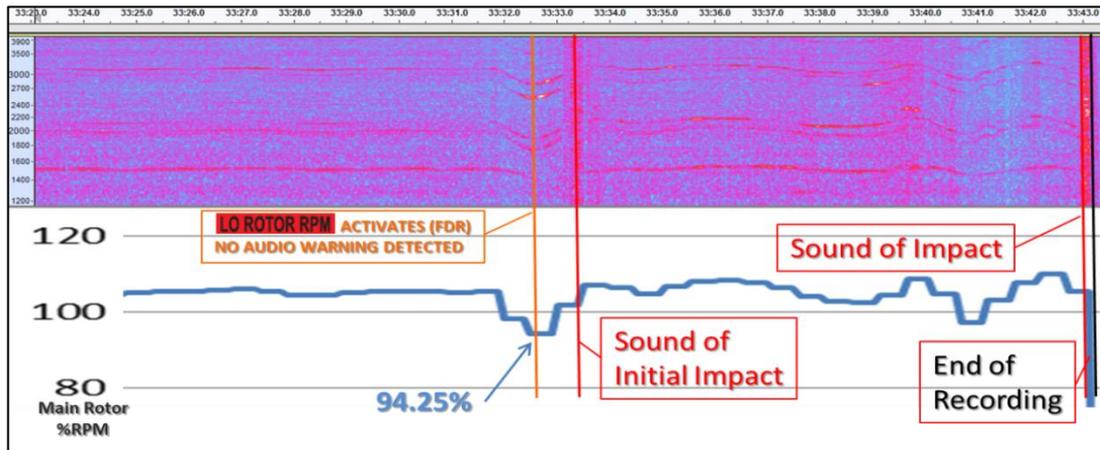
**Figure No. 14:** Spectrogram of final 20 seconds of 'HQC' CAM recording with FDR Main Rotor RPM data

The Investigation examined a spectrogram<sup>55</sup> of the CAM recordings (**Figure No. 14**) with the assistance of the UK AAIB Recorder Laboratory and noted that the audio frequency of the recording was consistent with the Helicopter's main rotor RPM as recorded on the FDR. In particular, the Investigation observed that there was a drop in the audio frequency of the CAM recording in the moments leading up to the initial sound of impact at 00.46:08 hrs.

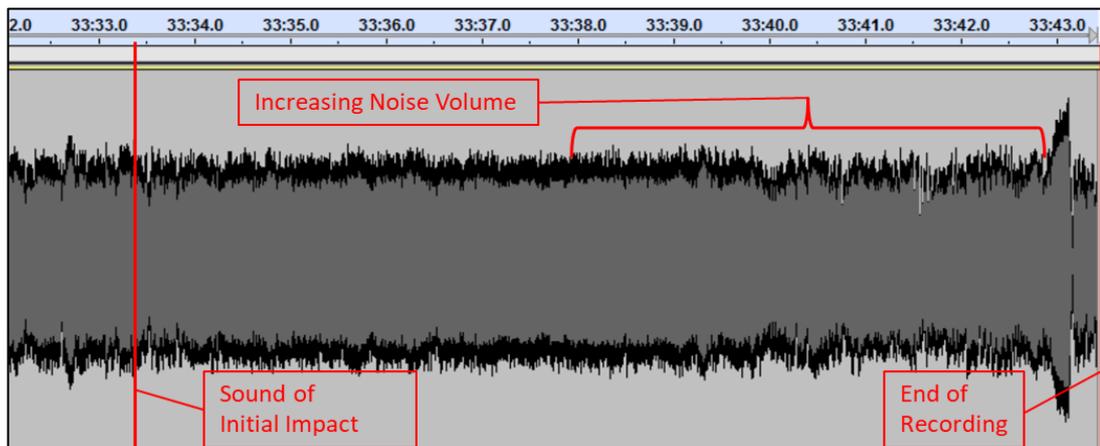
**Figure No. 15:** Waveform of Final 10 seconds of R116 'HQC' Cockpit Area Microphone

The CAM audio recording indicated that there was an increase in a sound that may have been due to wind noise. While the noise was of a similar frequency to the rotor RPM noise shown in the Spectrogram, an examination of the waveform<sup>56</sup> of the final 10 seconds of the flight (**Figure No. 15**) indicated a gradual but considerable change in amplitude during the final five seconds of the recording.

The CAM channel did not record any sounds that would indicate the separation of any parts of the cabin structure, doors or windows prior to the end of the recording.

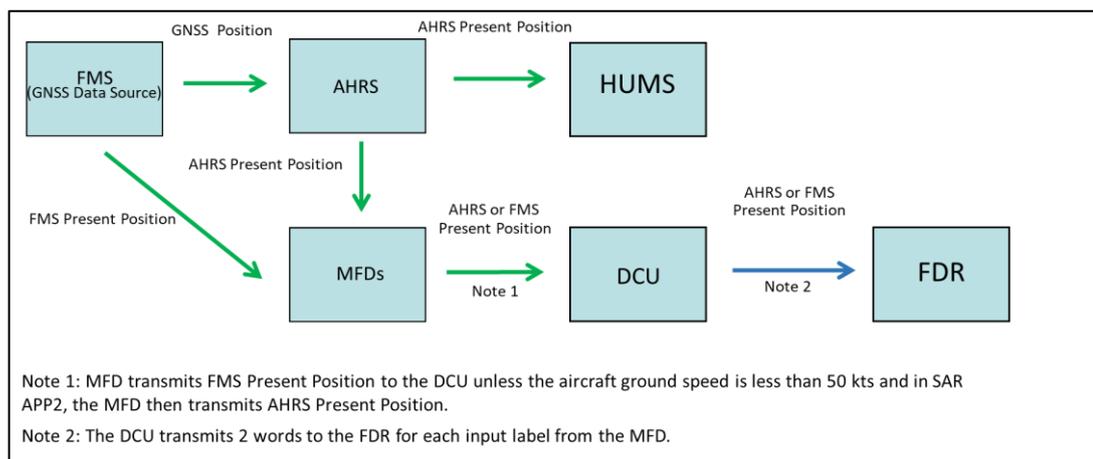
**Figure No. 18:** Positional Data Flow from FMS to FDR and HUMS (*Helicopter Manufacturer*)

Thereafter, the position data is provided to the various recording systems on board the helicopter, such as the FDR and HUMS. This architecture is shown in **Figure No. 18**. The Helicopter Manufacturer informed the Investigation that the position data being supplied from the AHRS, to the MFD and HUMS is formatted in four parts; a *coarse* position for latitude, a *coarse* position for longitude, a *fine* position for latitude and a *fine* position for longitude. The *coarse* position is accurate to within approximately 61 ft, and the addition of *fine* position increases the accuracy of the overall position to within approximately 2 ft. It was noted by the Investigation that the MFD did not supply the four components of the position data to the FDR at all times.

The Helicopter Manufacturer informed the Investigation that the MFD logic was designed to provide both *coarse* and *fine* position data to the FDR if the helicopter was travelling at a groundspeed of less than 50 kts and/or in SAR APP2 (SAR Approach Mode 2). At all other times, only *coarse* data was to be provided to the FDR, which reduced the accuracy from within 2 ft to within 61 ft approximately.

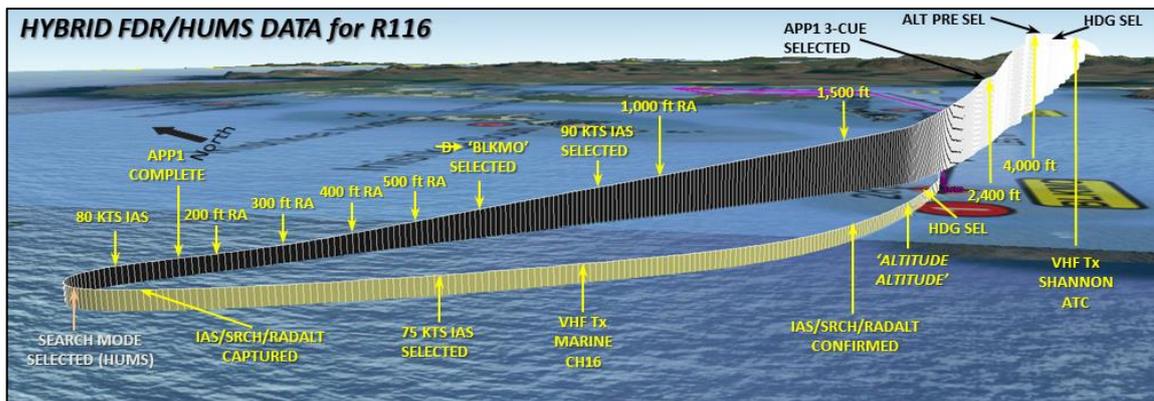
**Figure No. 20:** FDR/HUMS Significant Events, 00.34 hrs - 00.46 hrs

Once the Helicopter had levelled at 200 ft on the Rad Alt, the selected heading bug was turned to the left over a period of fourteen seconds from its heading of 291 degrees onto a heading of 137 degrees. This was the course required to fly direct to BLKMO when, at 00.40 hrs, the Commander had previously requested (as recorded on the CVR) 'Direct to BLKMO'. The Helicopter began to turn to the left in 'heading' mode. A roll angle of 12 degrees was recorded by the FDR. The turn rate shown in **Figure No. 20** appears higher than this roll angle would suggest. This was due to the effect of the prevailing wind at the time.

The FDR recorded the wind as coming from 230 degrees magnetic with a speed of 33 kts; the Helicopter's groundspeed was recorded as 50 kts during the turn. As the Helicopter passed through a heading of 230 degrees, the crosswind component caused the Helicopter to drift further eastwards in the turn. The Helicopter continued turning left and as it passed through 203 degrees, the FDR recorded that the FD No. 1 'Heading Select' mode was de-activated and the roll angle reduced to 3 degrees to the left. This reduction in roll angle coincided (00.42 hrs) with a recording on the CVR of the Co-pilot announcing 'Search selected'. The HUMS data recorded the activation of the AFCS SAR SRCH navigation mode at this time. The Commander was heard to confirm 'Indicated Airspeed, Search and Rad Alt captured' on the CVR.

At 00.43 hrs, the FDR recorded a change in roll angle to the right, which caused a three degree turn to the right. The Helicopter then returned to a roll angle of 1-2 degrees to the left. Although the FDR or HUMS recorded no change in lateral mode selection, this sequence of manoeuvres would be indicative of the Helicopter AFCS Flight Director transitioning from a navigation ARM mode to navigation CAPTURE mode; the NAV mode in this instance being SRCH. At 00.44 hrs, the IAS was further reduced to 75 kts, and remained at this selection until the final accident sequence.

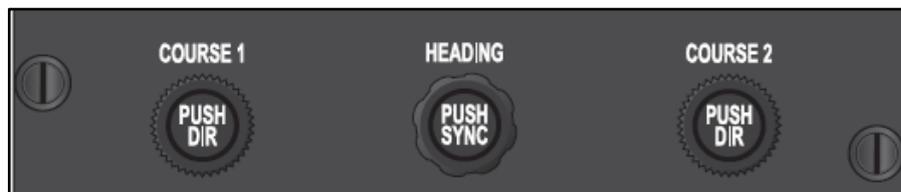
**Figure No. 21:** Remote Instrument Controller with Heading Synchronisation button

A graphical representation of the FDR parameters for the final minutes of the accident flight is included in **Appendix N**. At 00.45:48 hrs, the 'selected heading' parameter on the FDR changed instantly from 137 degrees to the Helicopter's actual heading of 120 degrees, indicating that the 'PUSH SYNC' button was pressed on the heading knob on the Remote Instrument Controller (**Figure No. 21**) located on the right-hand side of the cockpit central console. For clarity, the 'PUSH DIR' buttons on the controller do not function when FMS navigation mode is selected; they cause the respective left or right course indicator bar ('the split bar') to point at the selected navigation source. This action will not cause the Helicopter to route direct to the source unless an appropriate lateral navigation mode is selected on the AFCS. It will not change the navigation mode or waypoint selection in the FMS Flight Plan.

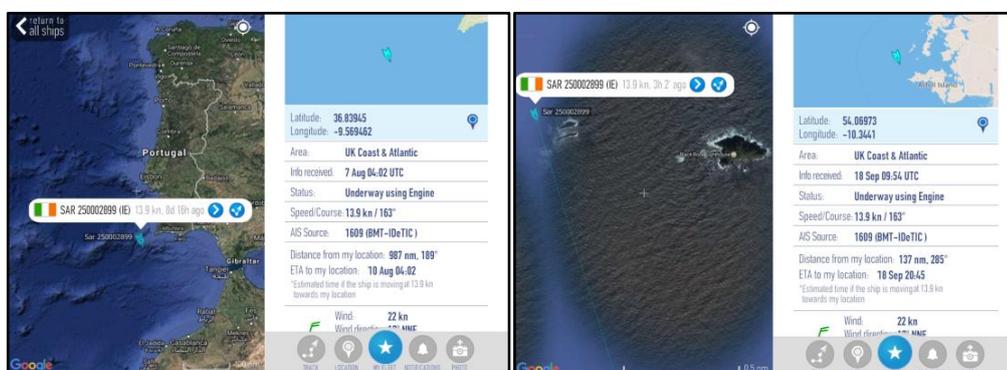
**Figure No. 26:** Examples of AIS displaying different Locations of EI-ICR

The Investigation was notified that an AIS signal apparently associated with EI-ICR had appeared on a number of occasions after the accident. In each instance, the MMSI<sup>61</sup> number associated with EI-ICR would appear on commercially available AIS software systems. The MMSI would appear in several different locations, including: near Black Rock, Co. Mayo; south-west of Portugal (**Figure No. 26**); and South America. However, the vessel status, speed, course, AIS source, wind speed and wind direction would remain identical regardless of the current date or place, and would be more suggestive of a surface vessel than a helicopter.

The Investigation requested the assistance of the UK MAIB to contact industry sources regarding the reliability of commercially available, open-source, AIS-based products. The Investigation was informed that the AIS data in question was most likely caused by an internal error in the database of received AIS transmissions, rather than due to an erroneously programmed AIS transmitter on a vessel, or a signal from EI-ICR's AIS. Accordingly, the Investigation does not consider that these were valid signals from EI-ICR.

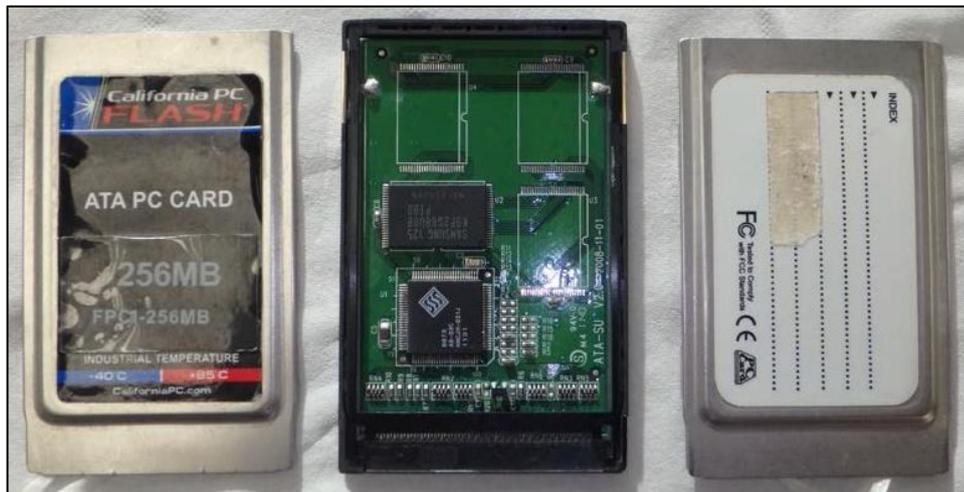
**Photo No. 15:** HUMS PCMCIA card with top and bottom covers (UK AAIB)

The DTMU from EI-ICR was located on 23 March 2018 by ROV. It was still attached to its original mounting point in the front right avionics rack. The DTMU was recovered by Irish Naval Service divers on 24 March 2017, 10 days after its immersion. The DTMU was transported under AAIU escort to the UK AAIB Recorders Laboratory in the UK. Although the HUMS is not designed or constructed to be crash-protected, the DTMU was in good condition and the data was recovered from the card (**Photo No. 15**).

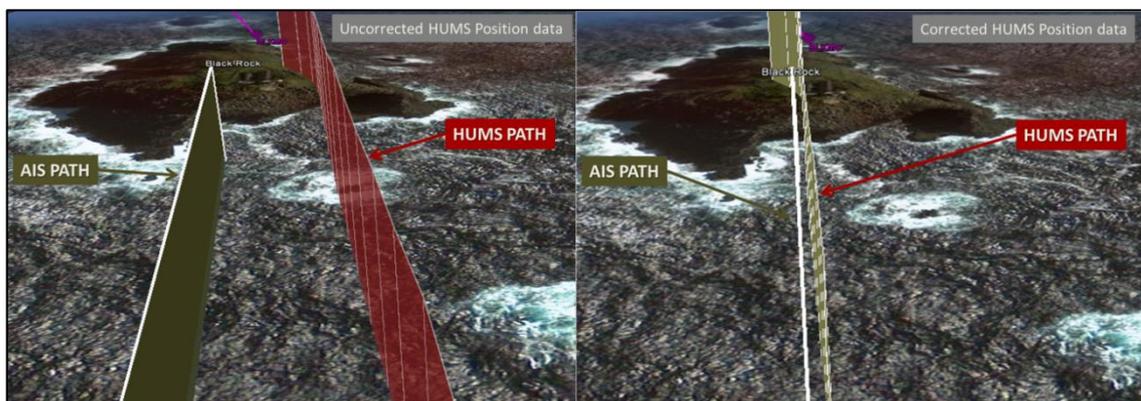
**Figure No. 28:** AIS Path data with uncorrected and corrected HUMS Path Data - R116

The difference between the AIS position data and the HUMS position data (uncorrected and corrected) is shown in **Figure No. 28**. The discrepancy noted in the Investigation's First Interim Statement was examined by the Helicopter Manufacturer. This included the completion of a test flight at the Manufacturer's facility to confirm the findings of the examination. Following the flight, the Manufacturer noted that the HUMS software supplier did not have the correct significance (in degrees) assigned to bits in the latitude and longitude labels recorded to the DTMU. Bit significance has been rounded down, therefore shifting the recorded position. The corrected helicopter flight path was 159 ft to the north and 18 ft to the west of the original HUMS recorded data.

Following the completion of the Manufacturer's internal examination and identification of the error in the HUMS software, the Helicopter Manufacturer updated software version -112 with a new -114 software version which corrected the discrepancy. The corrected position data is estimated by the Manufacturer to be within a margin of error of 2 ft approximately.

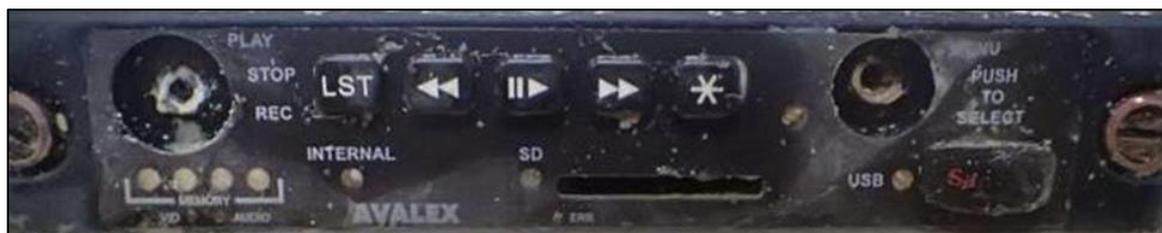
**Photo No. 17:** Avalex AVR-8240-XM DVR from EI-ICR (with Flash Drive)

Following ROV operations in March and April 2017, a further sea bed search commenced on 23 July 2017 (**Section 1.12.5**), when the DVR (**Photo No. 17**) was recovered. The unit was damaged and both the *Menu* button and *Mode Control* knob were missing from the panel. It was not possible to determine by visual inspection of the panel which position the Mode Control knob was set to at the time of the accident. It was also not possible to determine which media (USB, SD Card, internal) was selected as the storage location for recorded data.

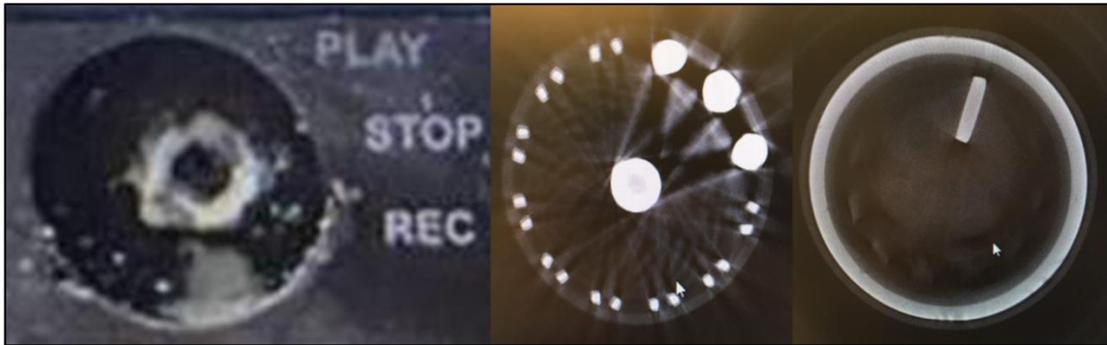
**Photo No. 18:** CT Scan of *Mode Control* knob showing '*PLAY*' mode selected (NTSB)

The unit was brought to the NTSB Vehicle Recorder Section in Washington D.C. for analysis. The DVR was analysed by the use of both X-ray and Computer Tomography (CT) scans. In particular, the remaining parts of the *Mode Control* knob were examined to determine the position of the selector knob. These scans (**Photo No. 18**) showed that the knob was set to the 'PLAY' mode, and not to 'RECORD'. There was no video data found on the DVR internal storage.

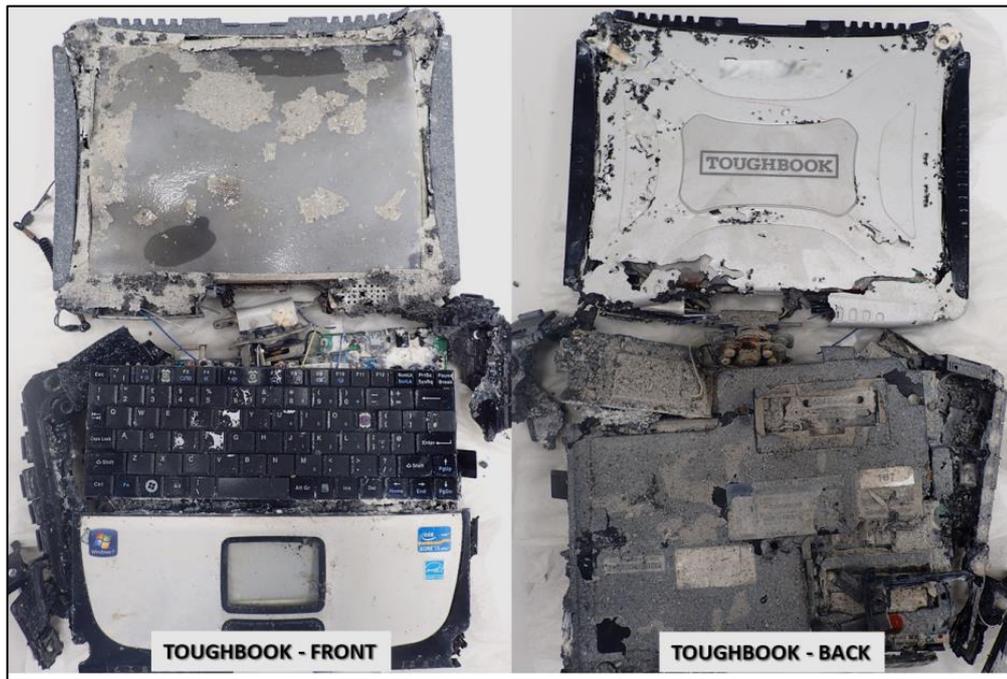
**Photo No. 19:** Photo of front and back of R116 Toughbook

The Toughbook was recovered from the seabed on 23 March 2017. It had been immersed in salt water for nine days. The device was extensively damaged during the accident sequence, and significant salt corrosion was evident on many of the components upon recovery (**Photo No. 19**). Due to the extent and nature of the damage to the Toughbook, it was not possible to extract any data from the device.

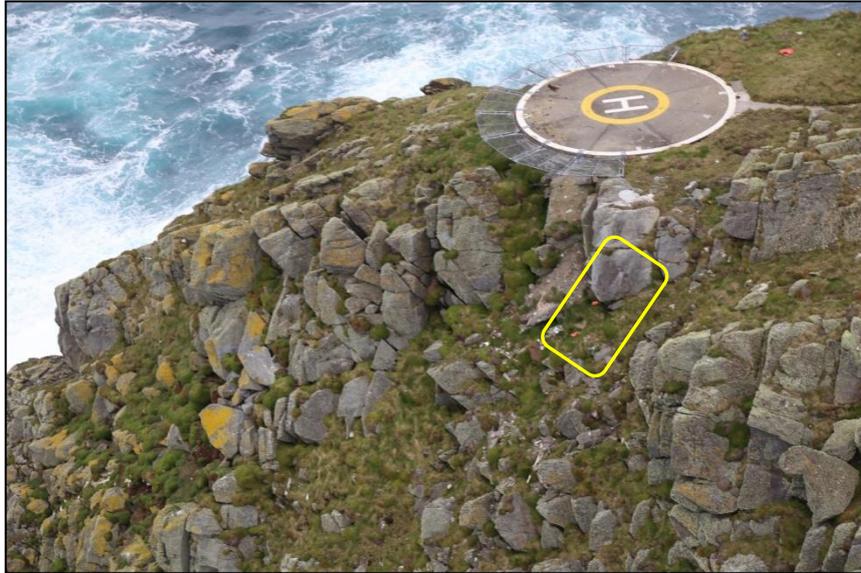
**Photo No. 21:** Location where a high concentration of debris was found

In an attempt to locate a point of impact, further visits were made to Black Rock on 20 March 2017, and again on 21 March 2017. With the assistance of Defence Forces personnel, who provided mountaineering expertise, members of the AAIU examined large areas of Black Rock not accessible by foot. No obvious point of impact was found. A high concentration of debris was found in the area below the helipad on its southern side (**Photo No. 21**).

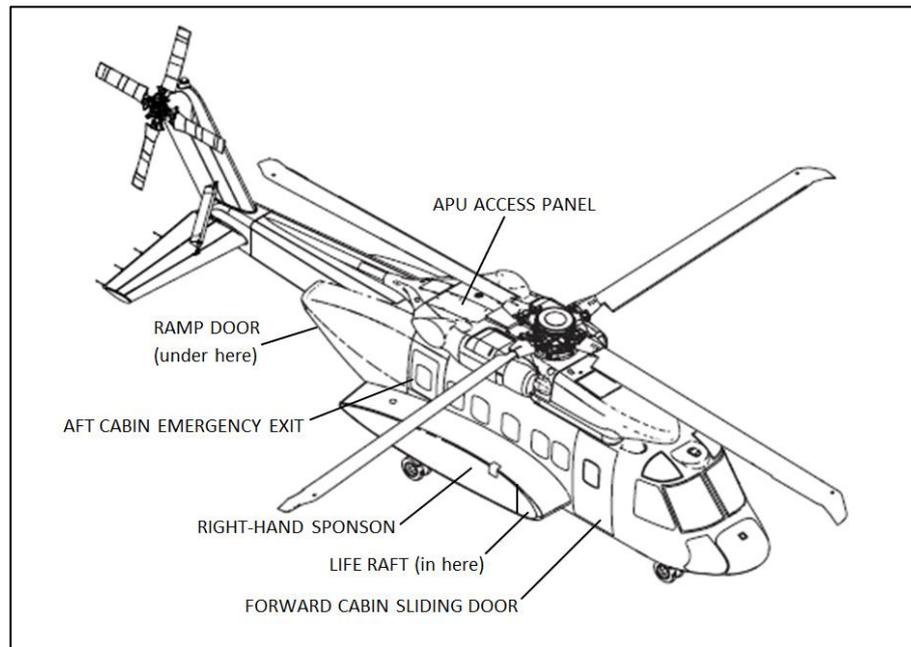
**Figure No. 36:** Pieces found on the sea surface

The centre (main) portion of the right-hand sponson (containing the right-hand fuel tank) was found floating intact on the sea surface. The fuel tank was found to contain a substantial quantity of fuel. Various pieces of the left-hand sponson, which had shattered, were recovered from the surface. Both life rafts were found floating on the sea surface. The forward cabin sliding door was recovered floating in the water. The top sliders were still attached to the structure. The door latch and pin exhibited bending. The upper ramp door (cargo hatch) was recovered in the water, separated from the structure. The locking handle was broken and the exposed honeycomb structure was visible over the entire length of the left-hand side. The main ramp itself was also recovered from the sea. The left-hand and right-hand ramp pistons had separated from the ramp. Approximately 150 mm of the ramp on the left-hand side fractured and separated. The right-hand wooden skid plate was intact; the left-hand skid plate was fractured and separated from the ramp. The APU access panel, aft upper fuselage section (*'whale tail'*) separated from the structure. The left-hand and right-hand emergency exit panels from the aft cabin were recovered. The left-hand emergency exit panel was distorted and had fractured on the upper forward corner. A diagram of the helicopter type, with some of the pieces found on the sea surface is shown in **Figure No. 36**.

The overall pattern of damage indicated that the Helicopter suffered more impact damage to its left-hand side.

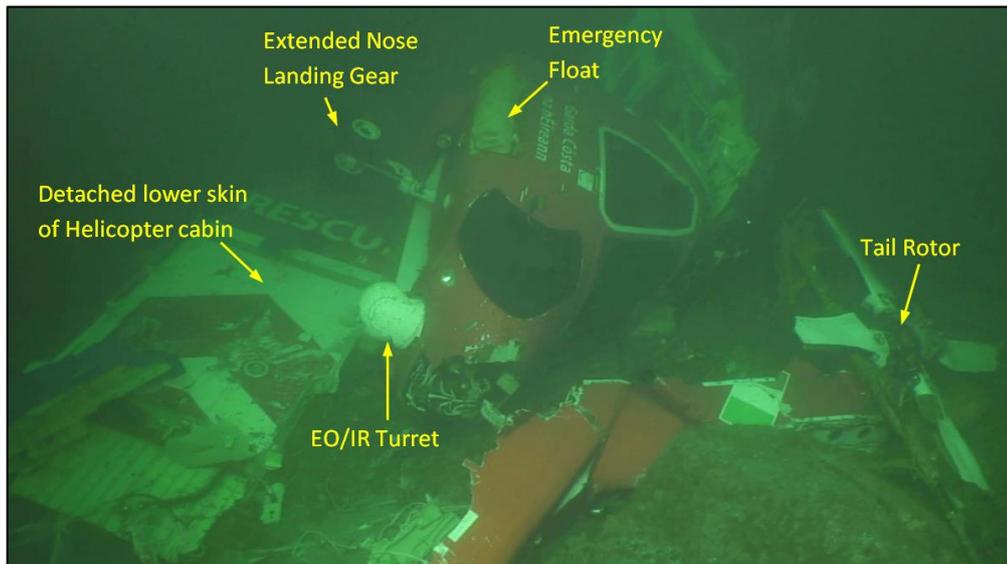
**Photo No. 24:** Disposition of the main wreckage on the sea bed

Within a short time of the ROV launch, the main wreckage was located on the seabed to the south-east of Black Rock at a depth of approximately 40 m (**Photo No. 23**). The main section of wreckage, comprising of the cockpit and cabin ceiling/upper fuselage was found lying on its left-hand side approximately  $135^{\circ}$  from vertical, and on a heading of approximately  $140^{\circ}$  magnetic (**Photo No. 24**).

The right-hand side of the cockpit area was relatively undamaged. It was not possible to view the left-hand side as this side was in contact with the seabed. The deceased Co-pilot was located within the cockpit wreckage, in his seat, with his harness fastened. On 24 March 2017, divers from the Irish Naval Service attempted to remove the Co-pilot, but this was not immediately possible due to the disposition of the wreckage. Following extensive preparatory work using the ROV, the Co-pilot was recovered by Irish Naval Service divers on 26 March 2017. Extensive surface and ROV searches were carried out in attempts to locate the two Rear Crew members. Despite these efforts, the Rear Crew members were not located and remain lost at sea.

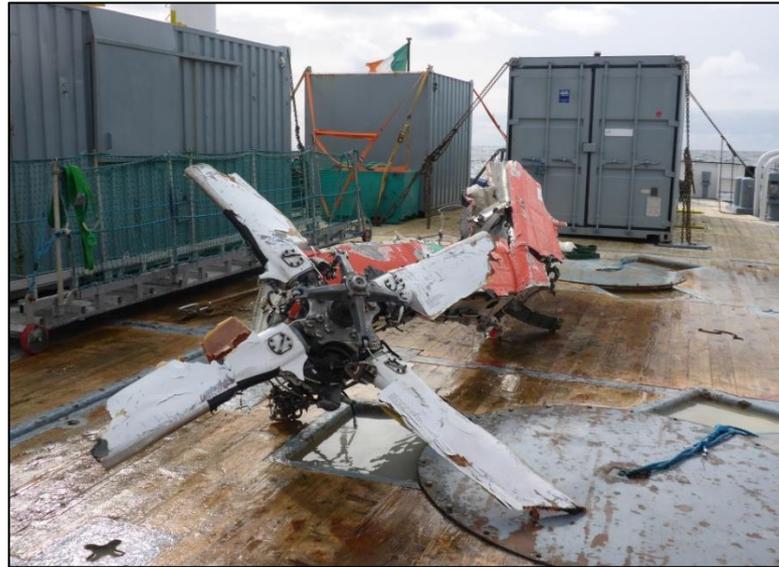
**Photo No. 25:** Recovered tail pylon section (on board ILV 'Granuaile')

On 10 April 2017, the tail pylon from EI-ICR, which included the tail rotor assembly, was recovered from the seabed by the ILV '*Granuaile*' after the ROV had attached lifting harnesses (**Photo No. 25**).

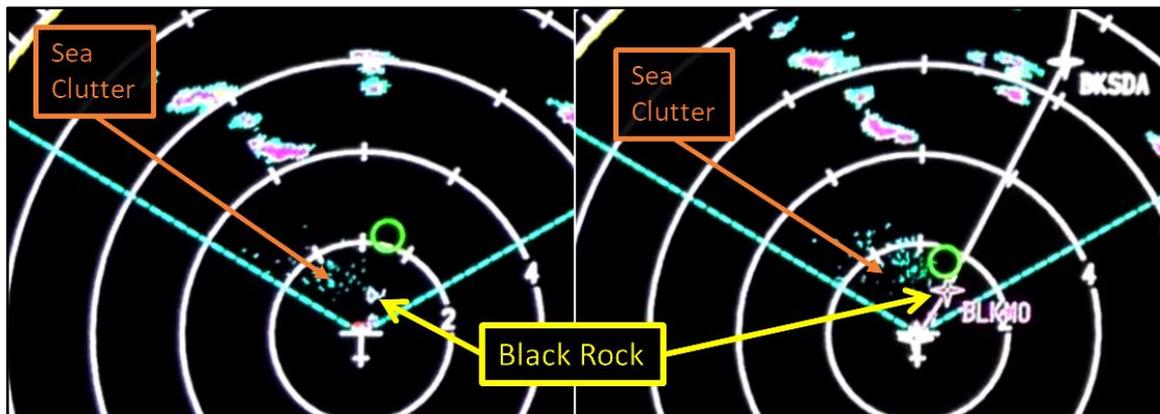
**Photo No. 31 and Photo No. 32:** Radar returns from Black Rock on 10 NM range, without and with, APBSS route overlay.

The magenta coloured, star-shaped waypoint marker (**Photo No. 32**) indicates the location of the BLKMO waypoint, and the magenta coloured track line indicates the helicopter's track to that waypoint. Comparison of **Photo No. 31** and **Photo No. 32** shows that the waypoint marker for BLKMO overlaid and obscured the radar imagery for Black Rock based on the radar returns. The radar image also shows an area of multiple smaller returns known as 'sea clutter'<sup>81</sup>. These are returns from the sea surface due to wave action caused by local wind conditions, and cannot be filtered when operating the radar in GMAP2 mode.

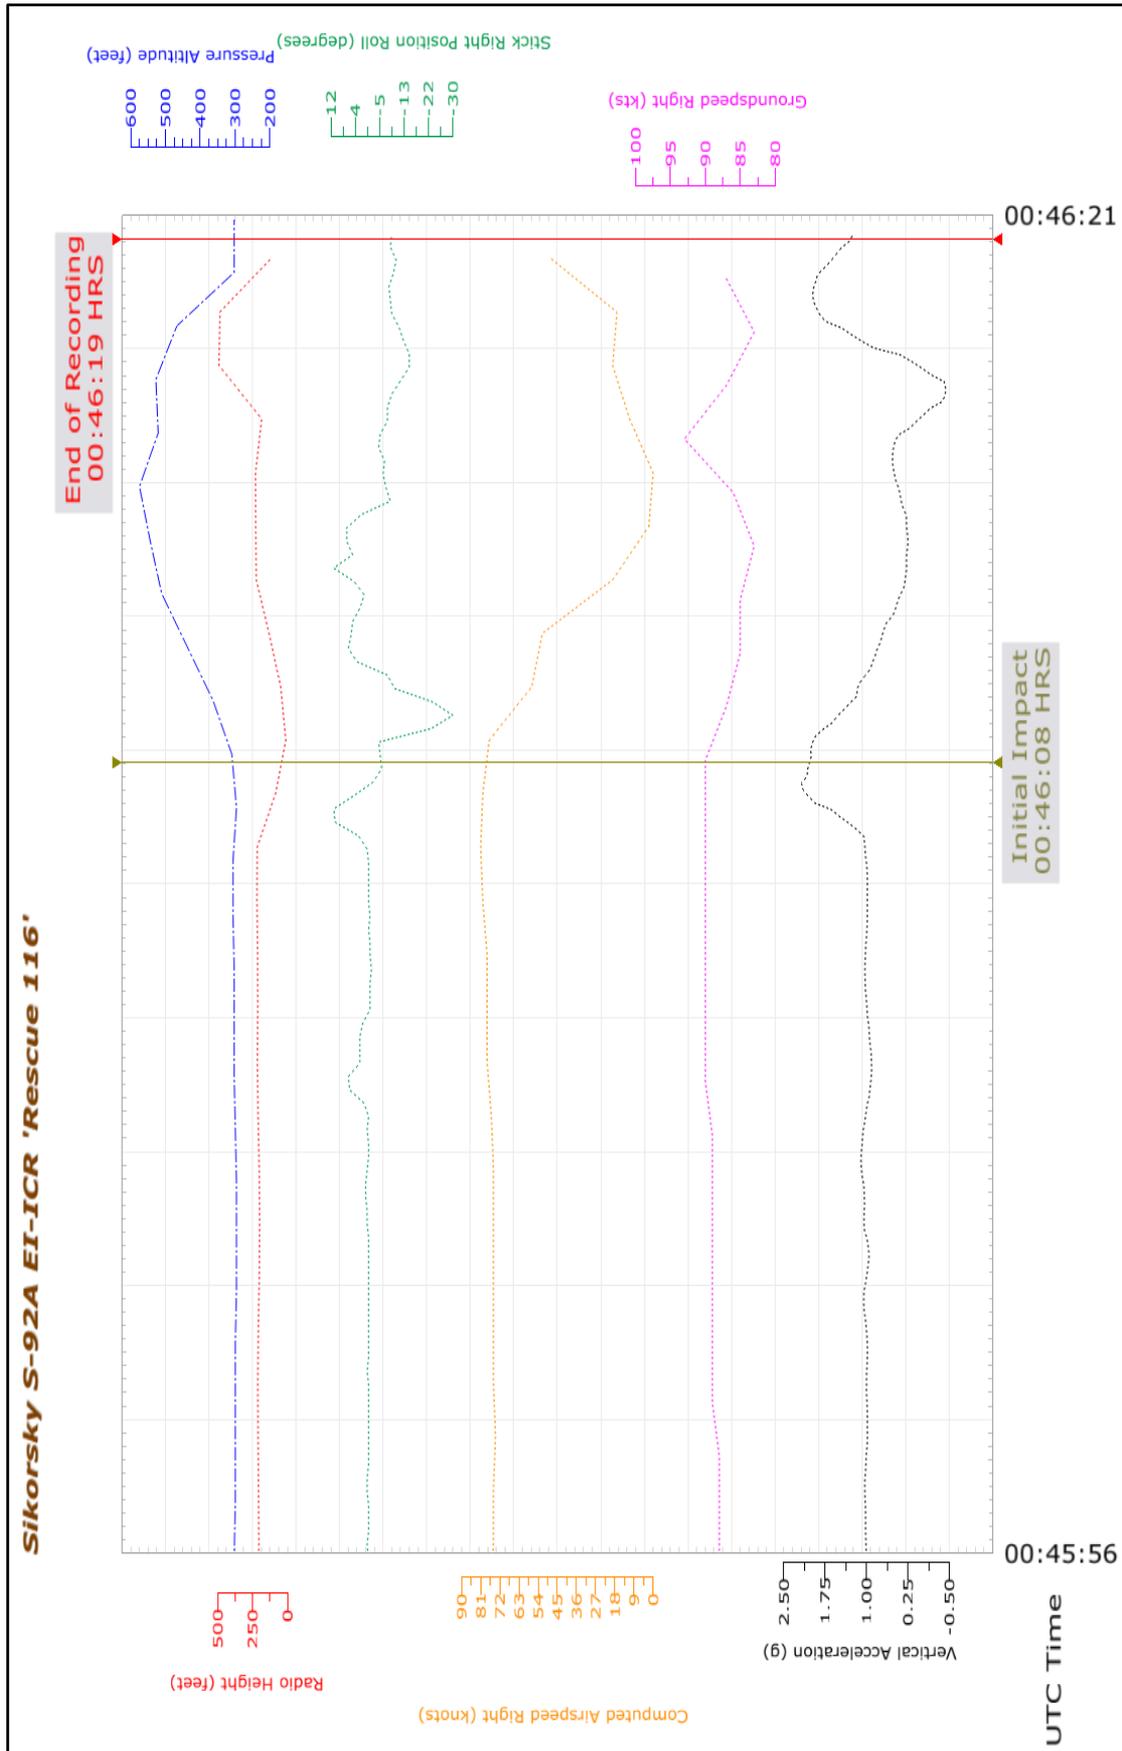
Graphic No.N2: Flight Data Recorder Parameters

A number of additional binary parameters were recorded on the FDR between 00.46:09 hrs and the end of the recording at 00.46:19 hrs. These parameters indicated the functional state of particular systems. The term 'binary' refers to a system that was recorded as either ON or OFF, ACTIVATED or DEACTIVATED, FUNCTIONAL or FAILED. They were, in chronological order;

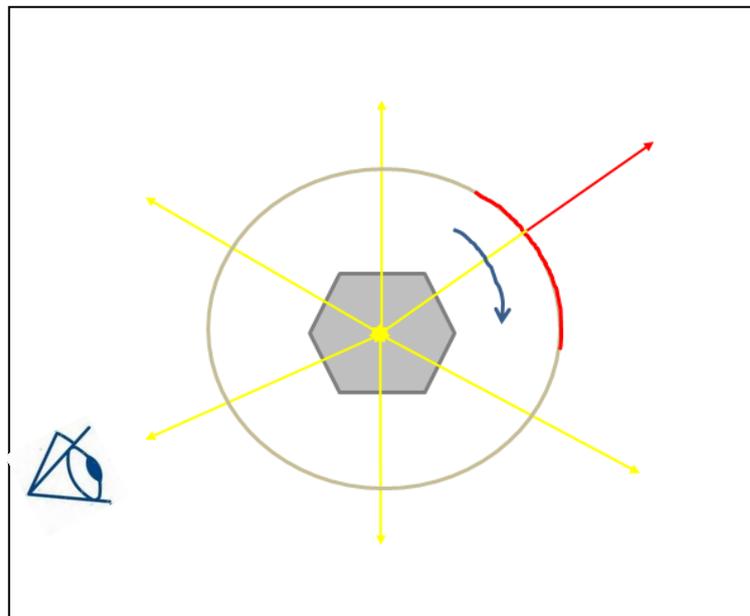
**Figure No. V1:** Illustration of white and red 'pencil beam' rotating through observer position (not to scale)

Each of the 6 lens panel focuses the light coming from the lamp into a 'pencil beam' such that there are 6 'pencil beams' rotating at night. The passing of the 'pencil beam' across the observer creates the flash of light. The red flash (in the red sector) is created by the beam passing through red filter material installed at the lantern room glazing. This is illustrated below in **Figure No. V1**.

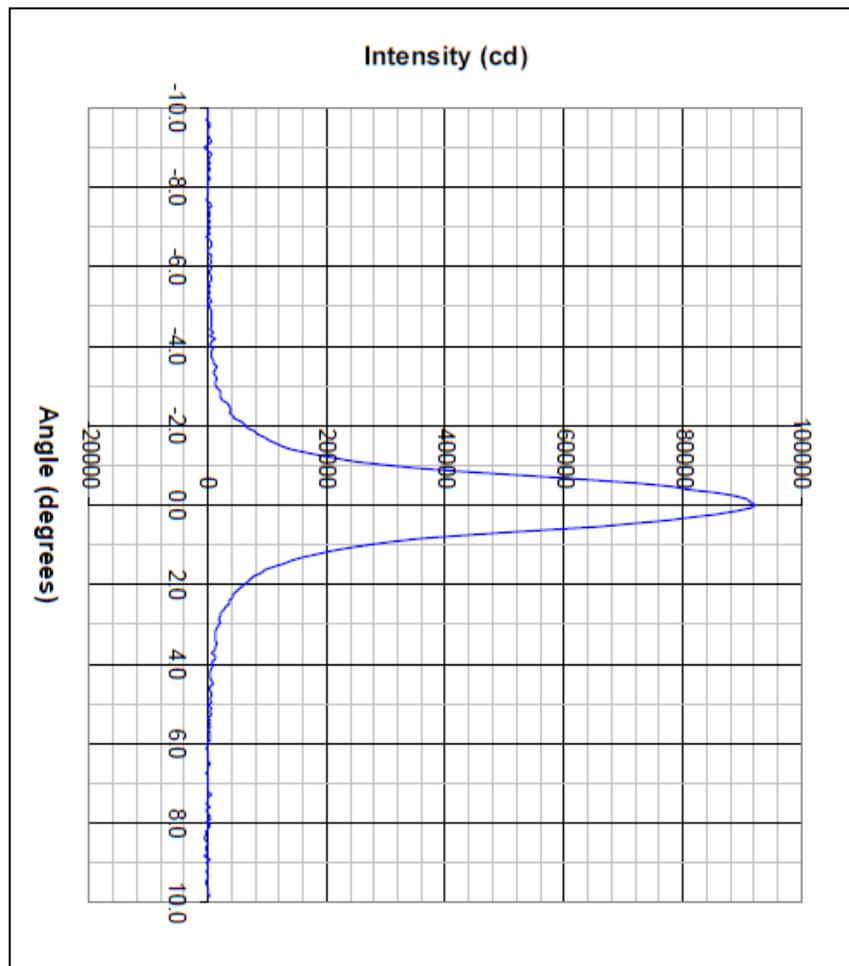
**Figure No. V2:** Vertical Beam Profile

Tests on the Vertical Beam Profile of a 35W lamp in the TRB-220 is shown in **Figure No. V2** below. The peak intensity of 92,000cd (candelas) calculates to an 'Effective Intensity' of 55,200cd at a flash length of 0.3 seconds, which is an 18 NM light according to IALA figures (49,000cd – 73,000cd = 18 NM range).

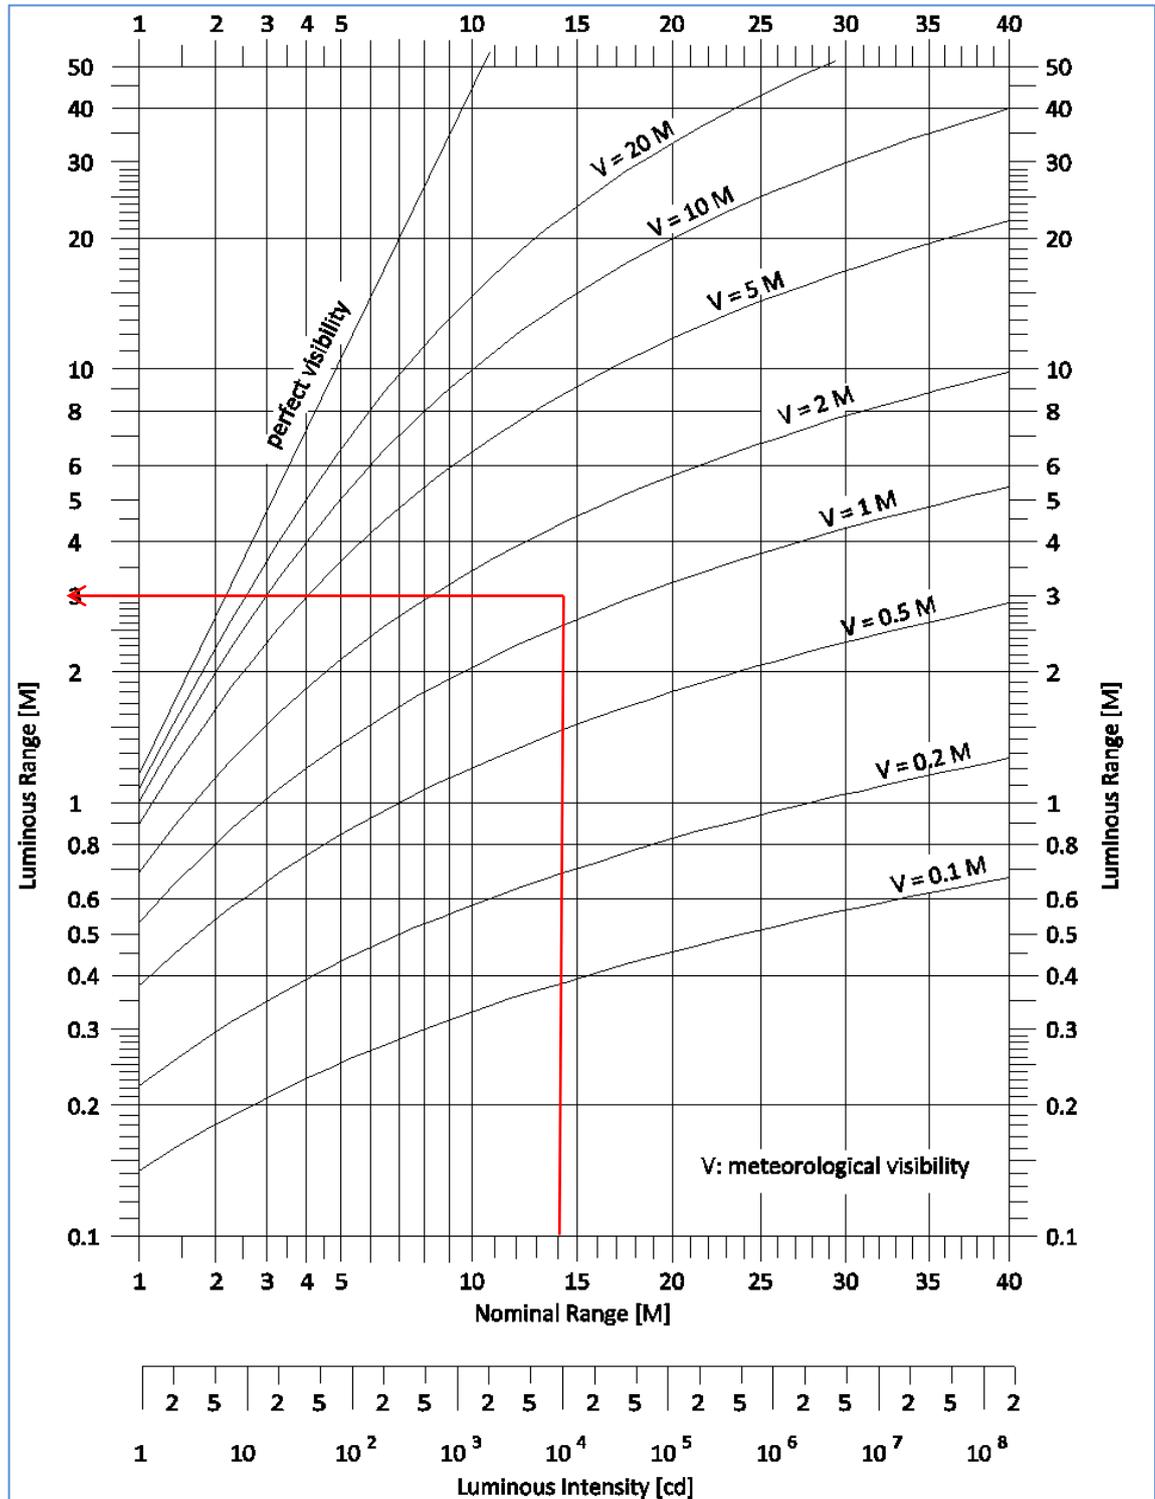
Figure No. V3: Luminous Range Diagram

IALA publishes a Luminous Range Diagram (**Figure No. V3**), which shows how the Luminous Range of a light varies in different meteorological visibility. This shows for example that for a nominal range of 18 NM, in meteorological visibility of 1,000 m, the luminous range of the light is 3,000 m.

The local visibility on 14 March 2017 @ 00.45 UTC is noted as being 2-3 km (1 – 1.6 NM) with mist and drizzle. **Figure No. V3:** shows that a light of 18 NM *nominal range* will only have *luminous range* of approximately 3 NM when the meteorological visibility is 1 NM (poor visibility).
