Air Accident Investigation Unit Ireland

SYNOPTIC REPORT

SERIOUS INCIDENT

**Boeing 767-33A, N378AX
Shannon Airport, Co. Clare**

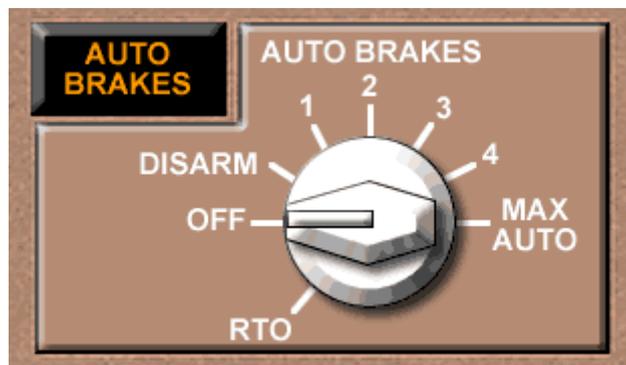
Figure No. 2: Auto Brake Selector

An auto brakes system was installed on the aircraft. **Figure No. 2** shows a schematic of the cockpit auto brake selector.
