## Serious Incident –Final Report–

AAIS Case N°: AIFN/0010/2018

# Runway Confusion Takeoff from Wrong Runway

Operator:	Air Arabia
Make and Model:	Airbus A320-214
Nationality and Registration:	The United Arab Emirates, A6-ANV
Place of Occurrence:	Sharjah International Airport
State of Occurrence:	The United Arab Emirates
Date of Occurrence:	18 September 2018

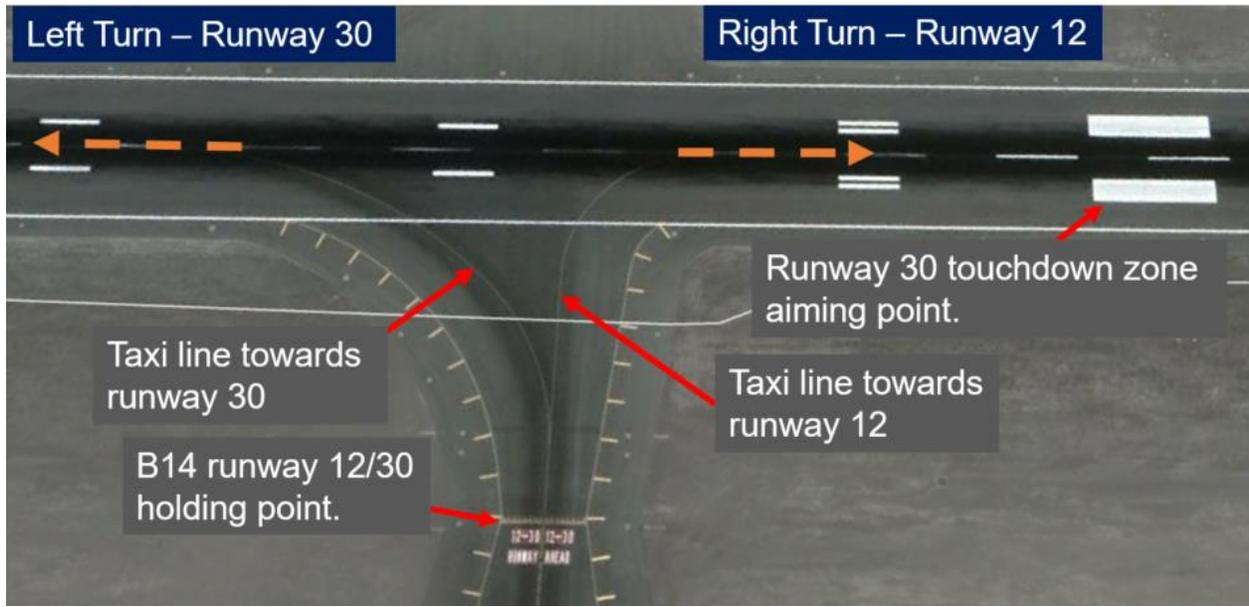
Figure 6. Taxiway Bravo 14 to runway 12/30 taxi lines

Figure 7 illustrates that when runway 30 is used for intersection takeoff at Bravo 14, a left turn is required, with a take-off distance available of 3052 meters. The taxiway centerline that leads to runway 12 and runway 30 is marked with a continuous 150 millimeter wide yellow line in accordance with the requirements of the Civil Aviation Regulations *CAR Part IX - Aerodromes*. In case a right turn is made, the aircraft will be on runway 12 with the runway available of 1006 meters,

and immediately in sight will be runway 30 touchdown zone white bar markings as well as the aiming point with start of runway 30 threshold white markings approximately 650 meters from Bravo 14 runway intersection.
