# Final Report

## IN-038/2019

Incident involving an Airbus A321 operated by British Airways PLC, registration G-MEDN, on 05 August 2019 at Valencia Airport (Valencia, Spain)

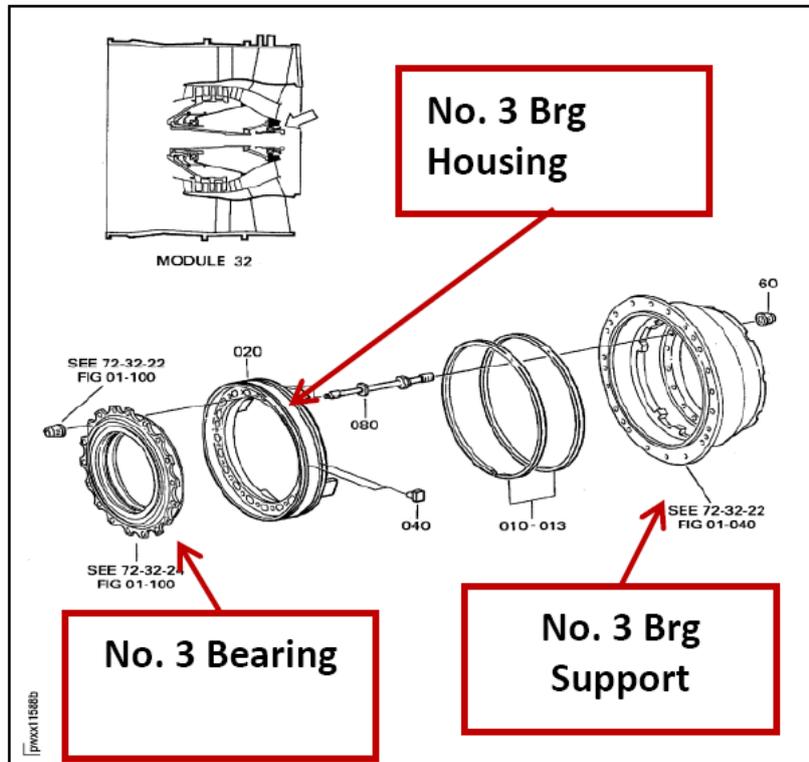
Fig. 3: Bearing no. 3. Position and parts

Bearing number 3 is a thrust bearing located in the Front Bearing Compartment (FBC).

- A metallurgical examination determined that the failure of bearing number 3 was the primary cause of the right engine problem during the incident flight. The starting point of the bearing's deterioration could not be conclusively determined from the evidence available.
- The primary damage was chipping or spalling due to rolling contact fatigue, which led to further secondary damage. The bearing's operating time/cycles, material, manufacture or assembly, do not appear to have contributed to the failure.

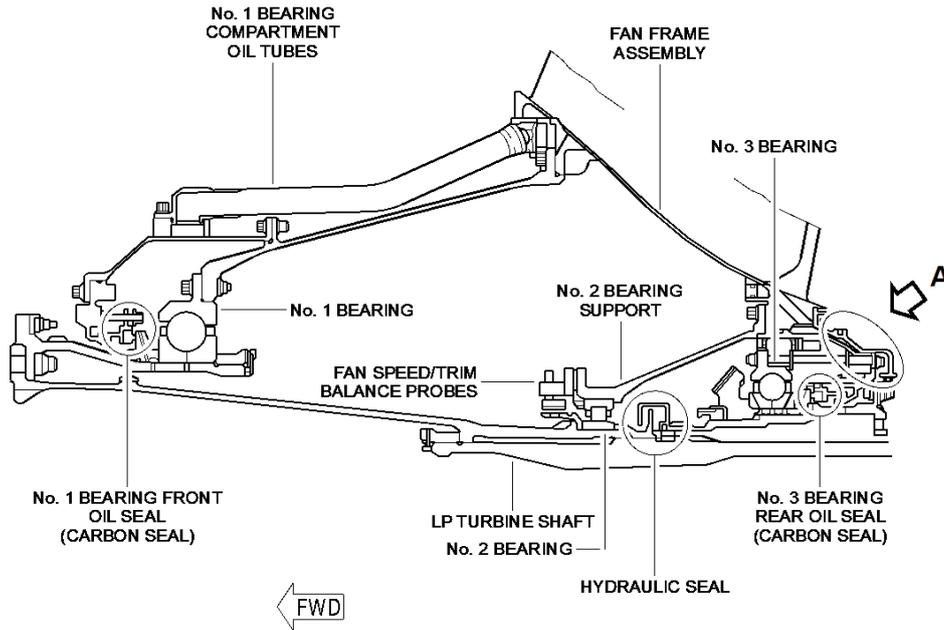
Fig. 4: Location of the seals in the front bearing compartment

The investigation has identified the cause of the incident as the misalignment and breakage of bearing number 3 (and its hydraulic seal) in engine number 2. This resulted in the bleed air from engine number 2 becoming contaminated with engine oil, which, in turn, caused smoke to enter the passenger cabin and the presence of oil in the anti-ice system.

The compartment is sealed to prevent oil leakage with carbon seals supported by pressurised air from stage 2.5 of the low-pressure compressor and a hydraulic seal supported by air from the 8th stage of the high-pressure compressor.

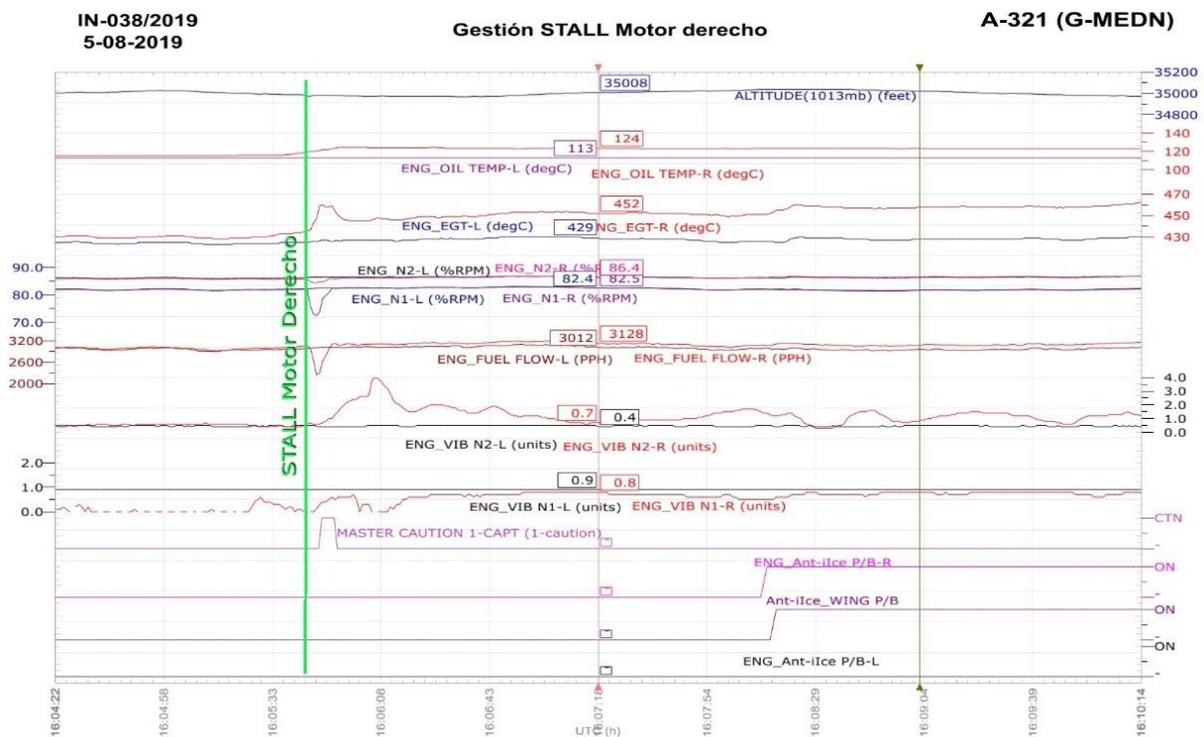
Fig. 11: Relevant parameters during the cruise phase in which the STALL occurred

The following parameters were registered during the cruise phase when the right engine STALL occurred.
