Hydraulic system malfunction, return and evacuation, involving Airbus A330, VH-EBC

94 km west-north-west of Sydney Airport, New South Wales, on 15 December 2019

ATSB Transport Safety Report
Aviation Occurrence Investigation (Defined)
AO-2019-073
Final – 21 June 2022

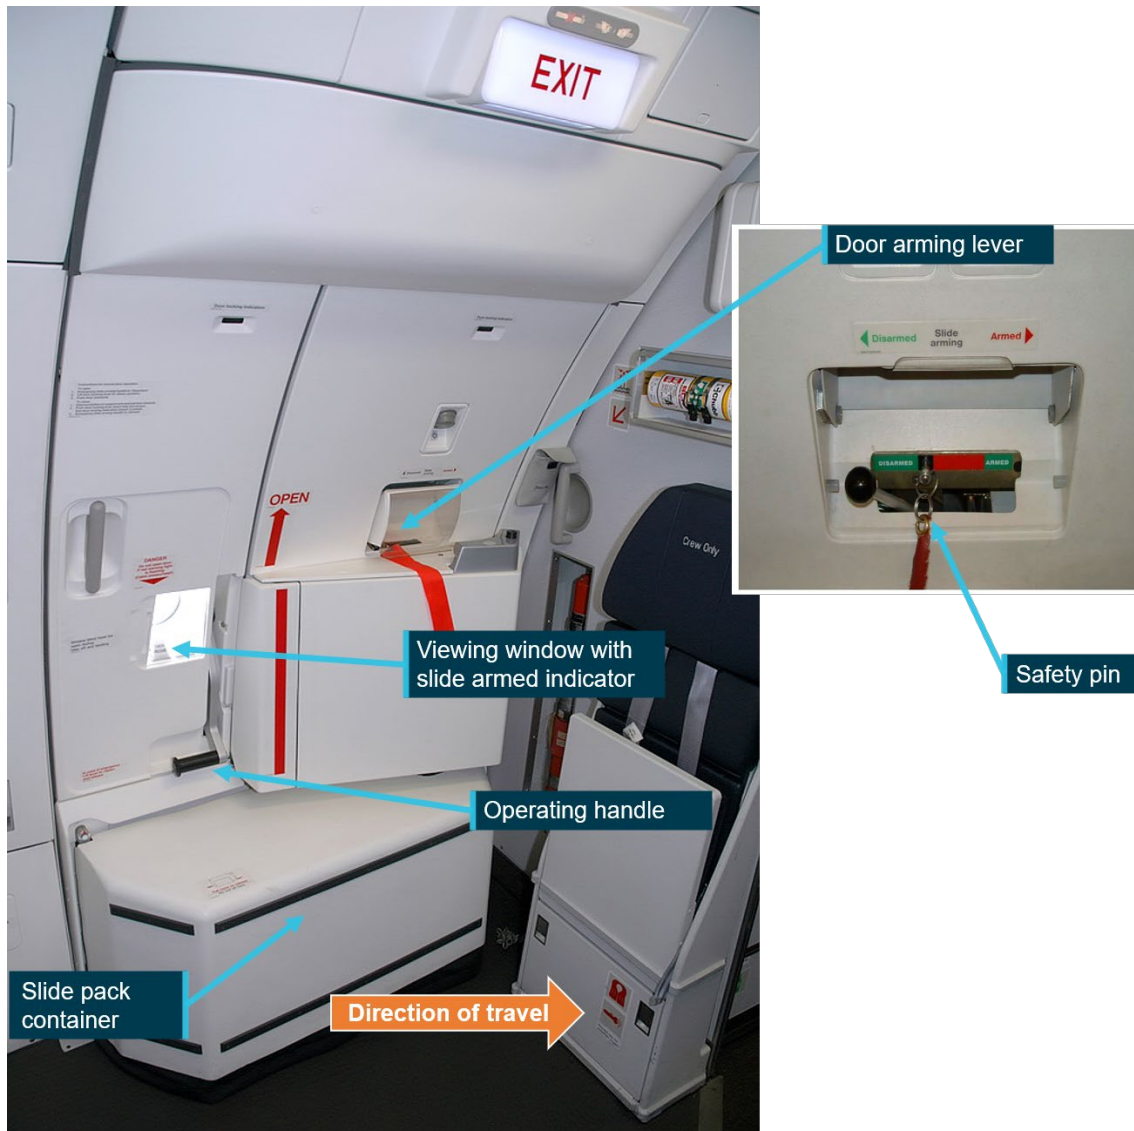
Figure 9: Type A door arming lever location and related features

After the door was armed, the cabin crew member removed the safety pin (shown with the red tag in Figure 9), moved the arming lever into the armed position and placed the safety pin in a pouch located at the door. Therefore, when the door was armed there was no red tag visible to the cabin crew.

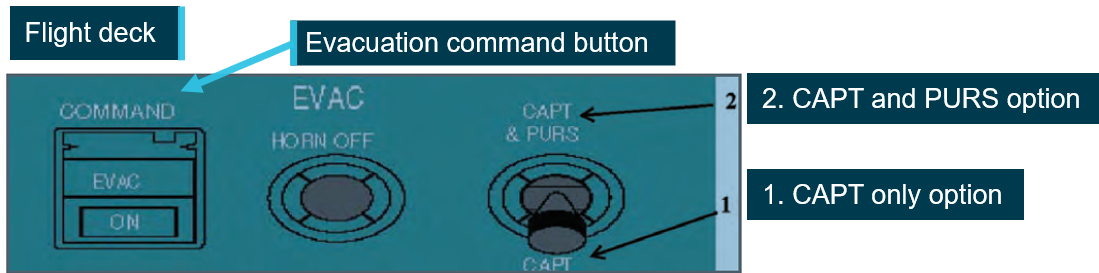
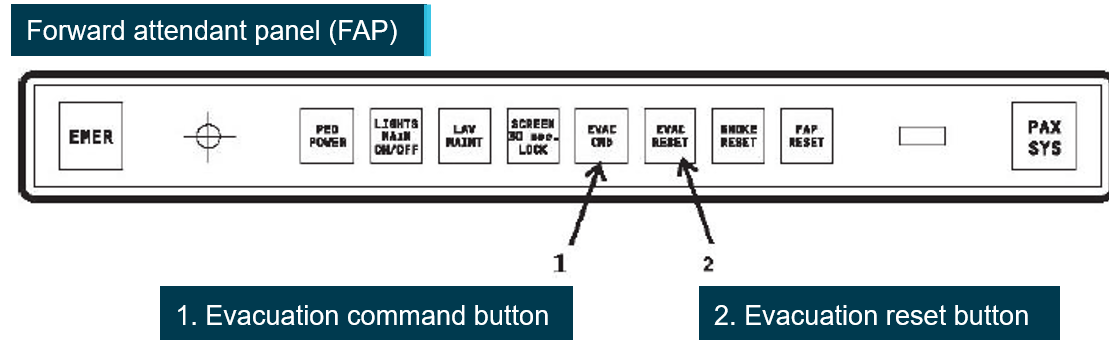
Figure 10: Evacuation signal controls

Figure 10 shows a switch in the flight deck that could be set to either CAPT, or CAPT & PURS. This selection would determine whether or not the aural alert for the cabin could be activated in the flight deck only (set to CAPT) or also by the button at the forward attendant panel (CAPT & PURS). It was the operator’s normal practice to have the switch set to CAPT & PURS.

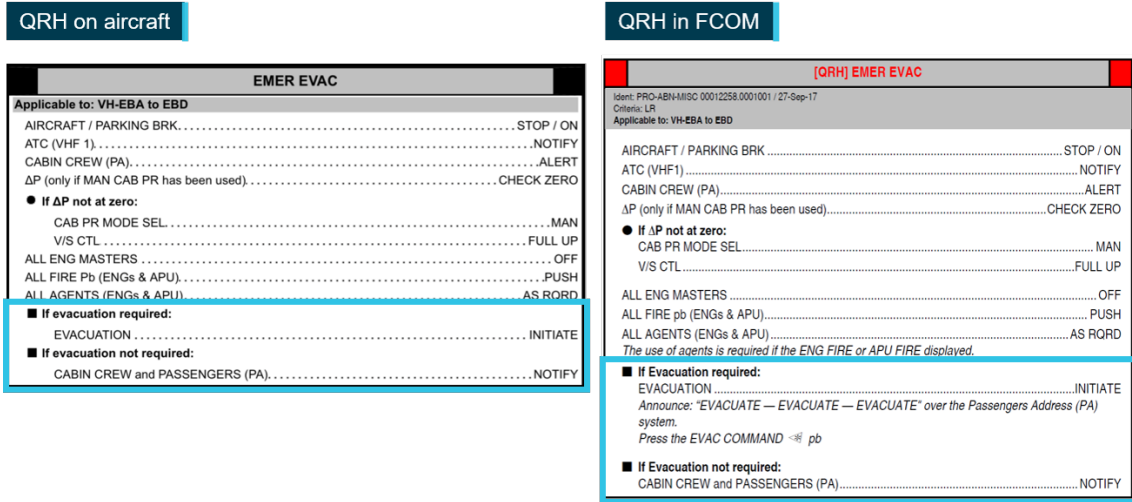
Figure 11: Flight crew evacuation checklists

The evacuation checklist was also documented in other flight crew manuals within the operator’s suite. Following this evacuation, the operator found that the QRH checklist in the *Flight Crew Operating Manual* (FCOM) had been expanded to include ‘Press the EVAC COMMAND’ for the initiation of the evacuation (Figure 11). This additional action was not included in the actual QRH on the aircraft.

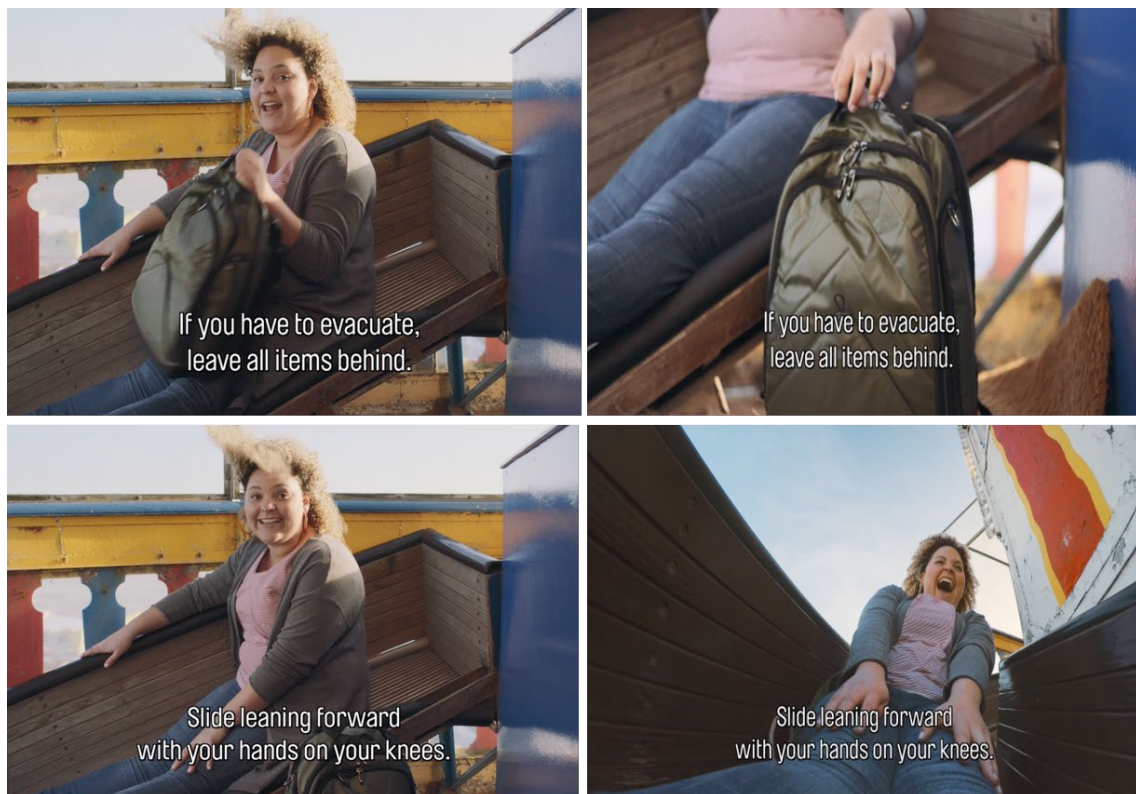
Figure 14: Still images from the operator’s passenger safety video

Figure 14 shows still images from the video where information was provided about cabin baggage in an emergency, and the use of emergency escape slides. There was no information provided to passengers about the use of the escape slide with infants.
