# REPORT AVIATION 2022/02

***Air accident in the Skoddevarre mountains, Alta municipality, Troms og Finnmark county, Norway on 31 August 2019 with Airbus Helicopters AS350 B3, LN-OFU, operated by Helitrans AS***

# Report on air accident

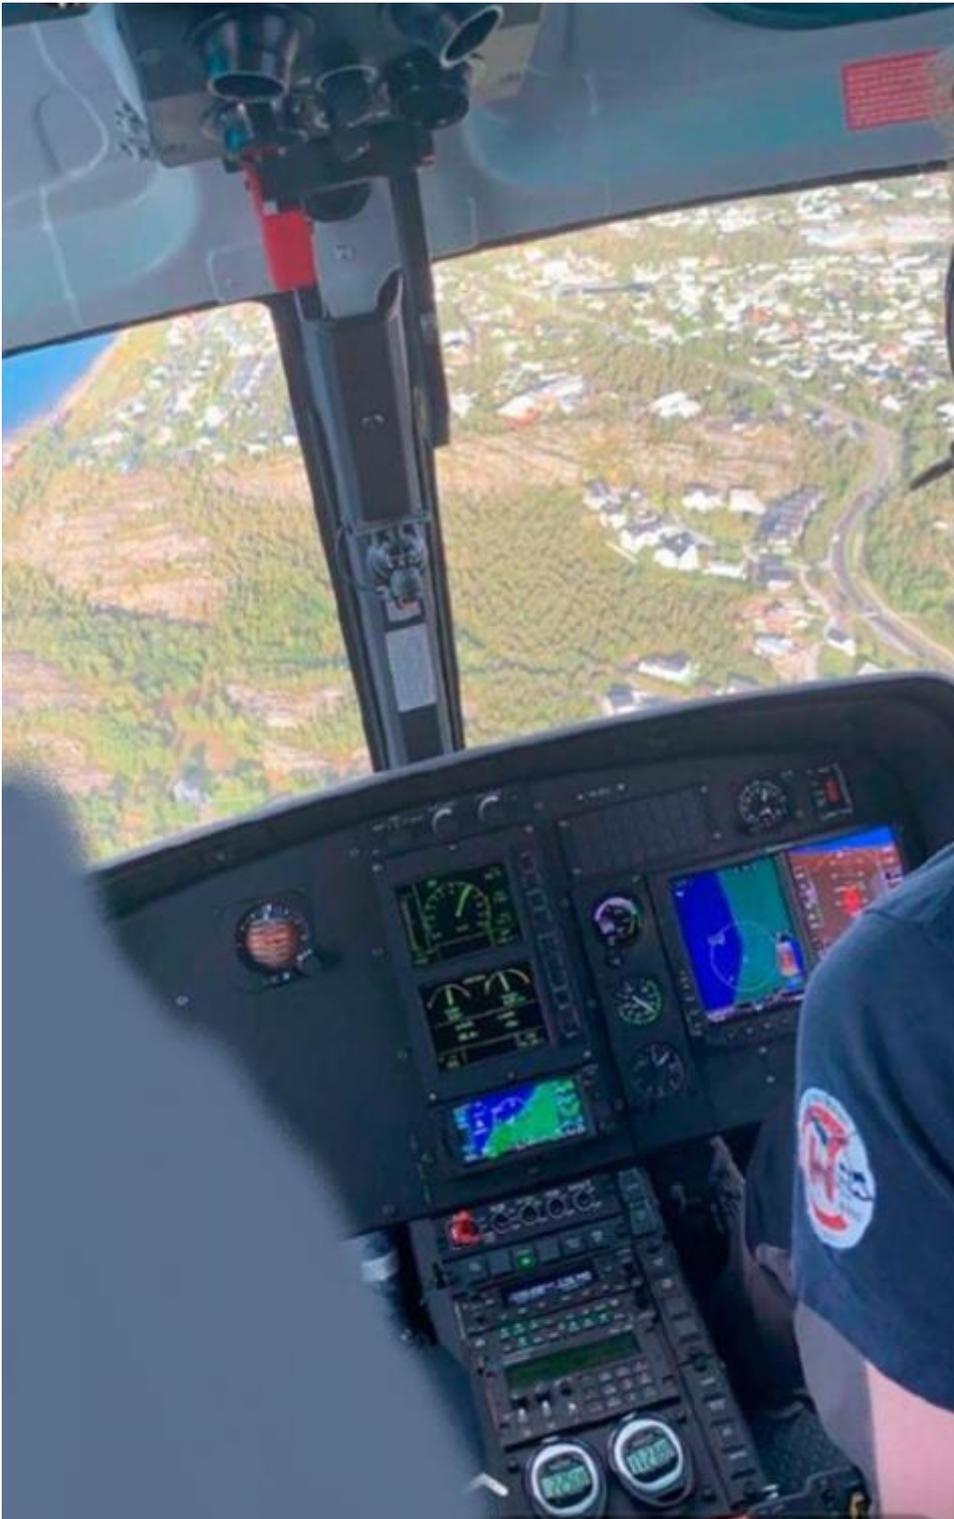
It is estimated that the photo was taken some time between 17:02:05 and 17:02:15. The photo shows that, at that moment, the indicated helicopter speed was approx. 90 kt and the fuel tank was 80% full. The photo also shows a leftward roll (rotation around the longitudinal axis) of approximately 10° and a downward nose angle (pitch) of approximately 30°, between 77% and 79% on the first limit indicator (FLI)<sup>7</sup> and that the bleed valve<sup>8</sup> was open (see Figure 3).

Figure 3: Descent above Hjemmeluftbukta. Photo: Passenger on board/NSIA

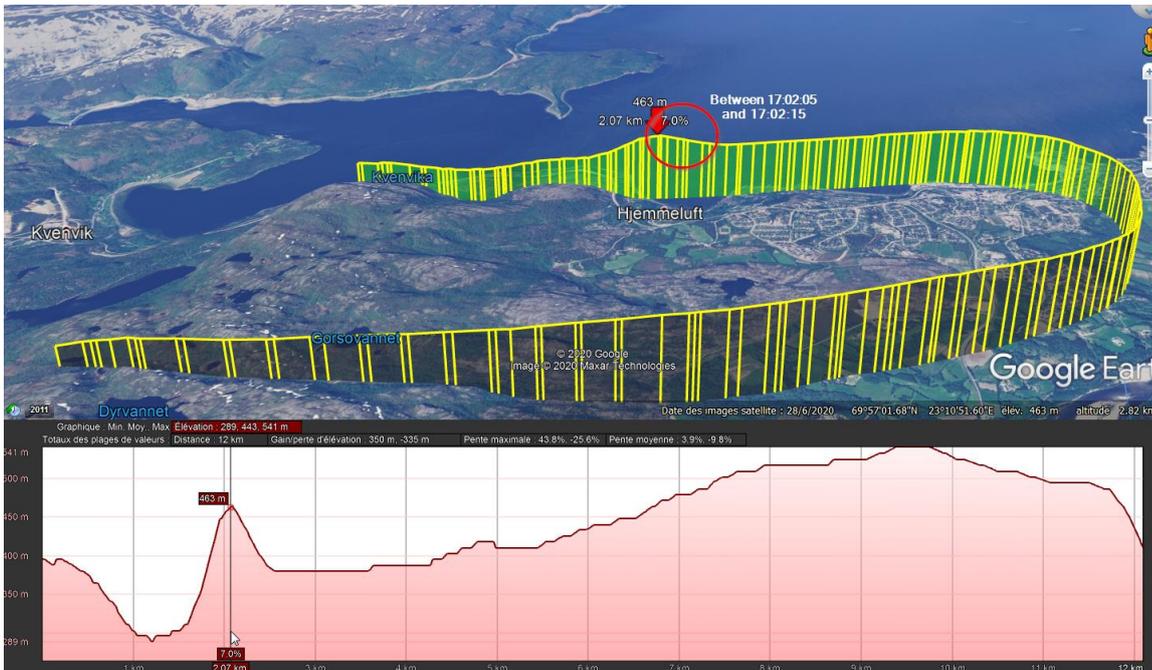
Information from Flightradar24 shows that the descent started at 1,525 ft<sup>9</sup> and lasted for 12 seconds. The ground speed increased from 70 to 110 kt, the highest sink rate was 2,432 ft/min.<sup>10</sup>, and the helicopter levelled out at 1,250 ft after a total descent of 275 ft (see Figure 4).

Figure 4: Vertical profile of flight path at the time when the photo above Hjemmeluftbukta was taken. The graph shows the helicopter's altitude above ground level. Illustration: Flightradar24/BEA/NSIA

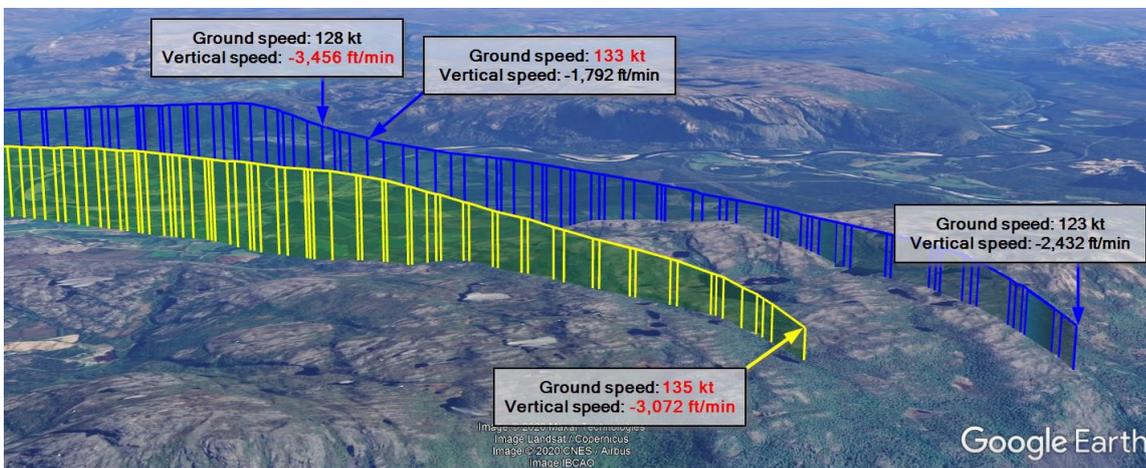
Figure 5: Comparison between the final part of the first flight and the final part of the accident flight. The first flight is indicated in blue while the accident flight is indicated in yellow. The values highlighted in red are the highest values. Source: Google Earth/BEA/NSIA

Flightradar24 shows that the helicopter's sink rate was increasing and had reached 1,728 ft/min. when the horizontal distance to the accident site was 400 m. At that time, the helicopter's altitude above ground level was 485 ft. The sink rate increased towards the end, and the last recorded sink rate was 3,072 ft/min. At the same time, the helicopter made a slight right turn from 247 to 251 degrees, and its ground speed increased from 125 to 135 kt.

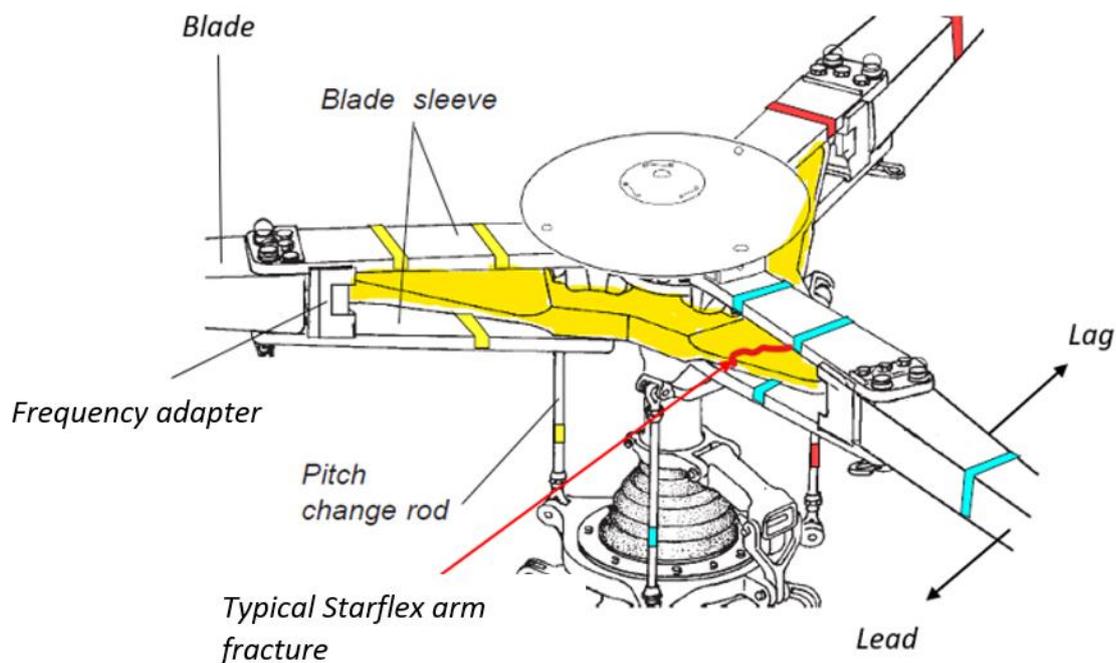
Figure 16: The Starflex hub with Starflex arms are marked in yellow. The arms will typically fracture as indicated in red. The fracture can also go in the opposite direction. Illustration: Airbus Helicopters/NSIA

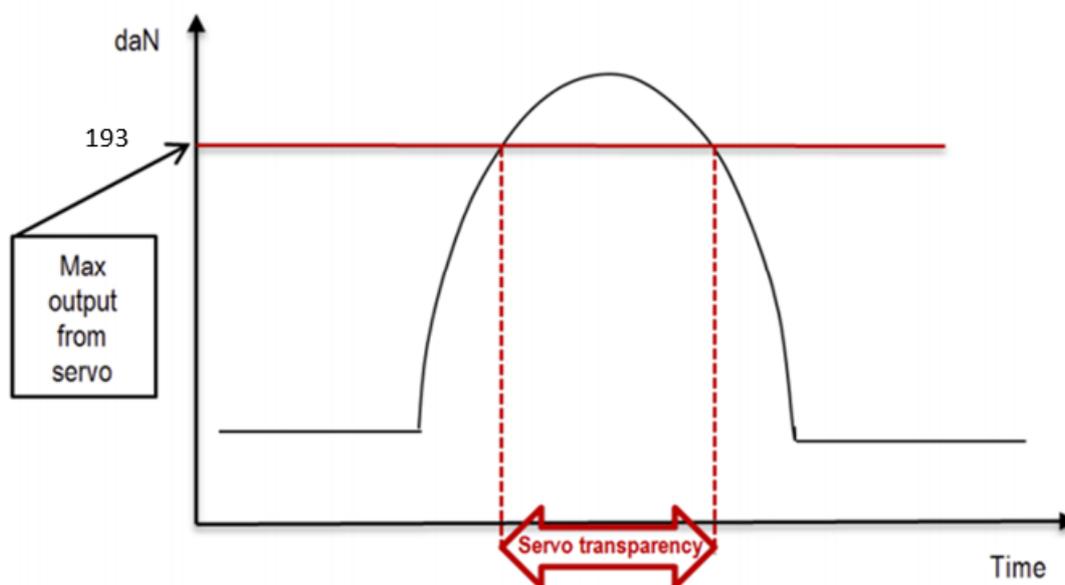
Figure 18: Illustration of servo transparency. The output needed exceeds the capacity of the servo actuators for the period between the red dashed lines. Illustration: NSIA

The aerodynamic forces required to achieve the correct pitch on the main rotor blades under the prevailing conditions may amount to, for example, 203 daN. In such cases, the pilot will have to overcome the exceeding forces manually. The pilot will experience an increase of 10 daN in stick output. This may startle the pilot and the flight controls can appear to be moving of their own accord or to be locked in position.

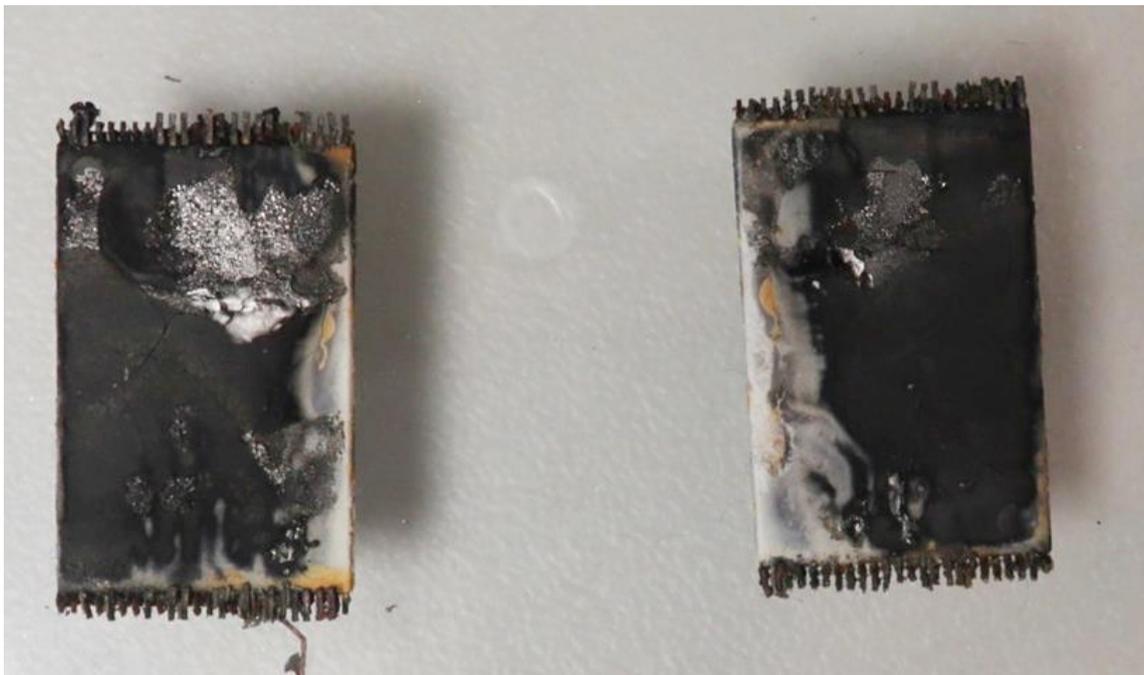
The SD card in the Appareo Vision 1000 unit was not found. The memory module was taken to BEA's laboratory, where the metal casing was removed. The severely fire damaged memory units inside the module were removed and X-rayed to ascertain their condition and the possibility of downloading their content. Several connections between the silicon dies and the pins proved to have melted away, however, rendering it impossible to download any data; see Figure 22. The units were then examined by Thales in France, with a view to possibly retrieving data directly from the silicon chips. That proved impossible.

Figure 22: The memory units from the Appareo unit examined by Thales. Photo: BEA

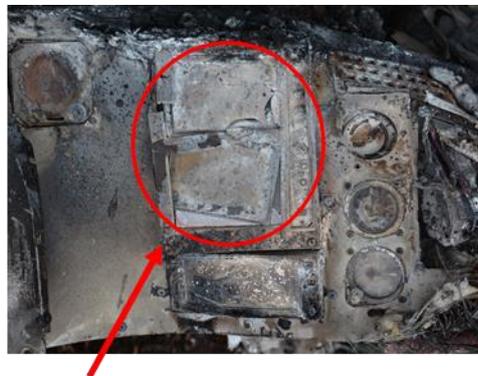
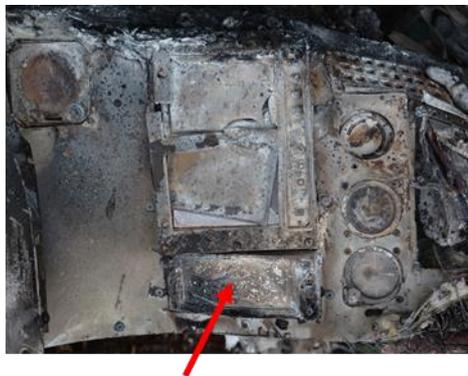
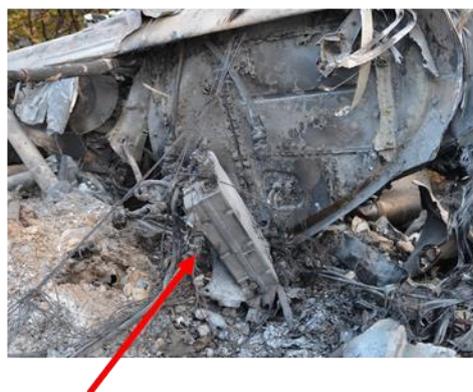
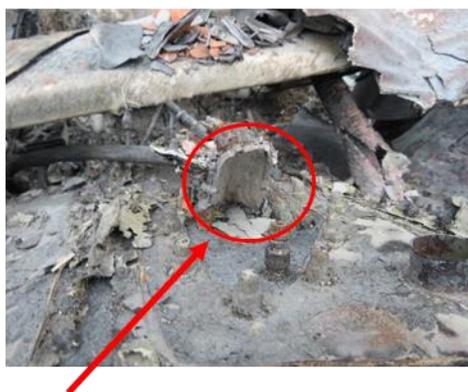
All the helicopter's electronic units for storing audio, image and video records and data were found to have been so damaged by the intense heat that it was impossible to retrieve information from any of them; see Figure 23. A photo of the instrument panel before the accident can be seen in Figure 3.

Figure 23: Burnt out electronic units with storage capability. Photo: NSIA/BEA

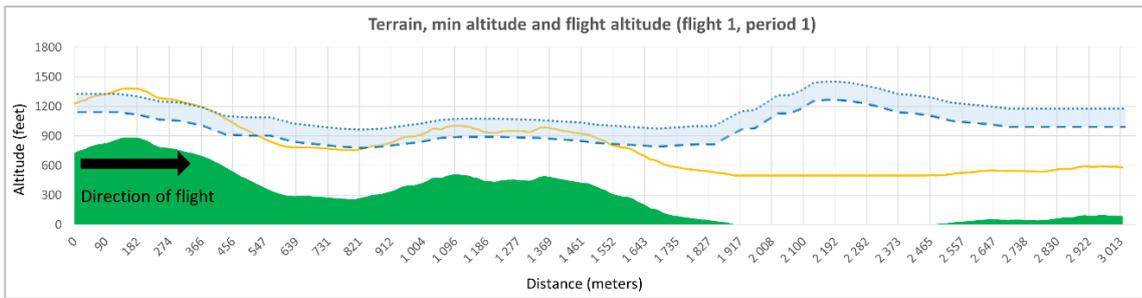
Figure 39: Altitude above the terrain during the first period of the first sightseeing flight. The green represents the terrain, the amber line shows the minimum altitude of 500 ft above the terrain, while altitude of the flight path is indicated in blue. The upper blue dotted line represents altitude data from Flightradar24, and the lower dotted line is the altitude of the flight path adjusted with data from CelloTrack. Note that the direction of flight is from right to left. Source: NSIA

The figure shows two flight path altitudes. The upper dotted line illustrates the flight path based on data from the transponder in the helicopter registered by Flightradar24. The lower dotted line is the flight path adjusted with the difference between the transponder altitude and altitude data from CelloTrack and represents the probable altitude. Data from CelloTrack contains fewer data points but corresponds with the elevations of the festival area and the accident site. The comparisons are expressed in more detail in Appendix B.

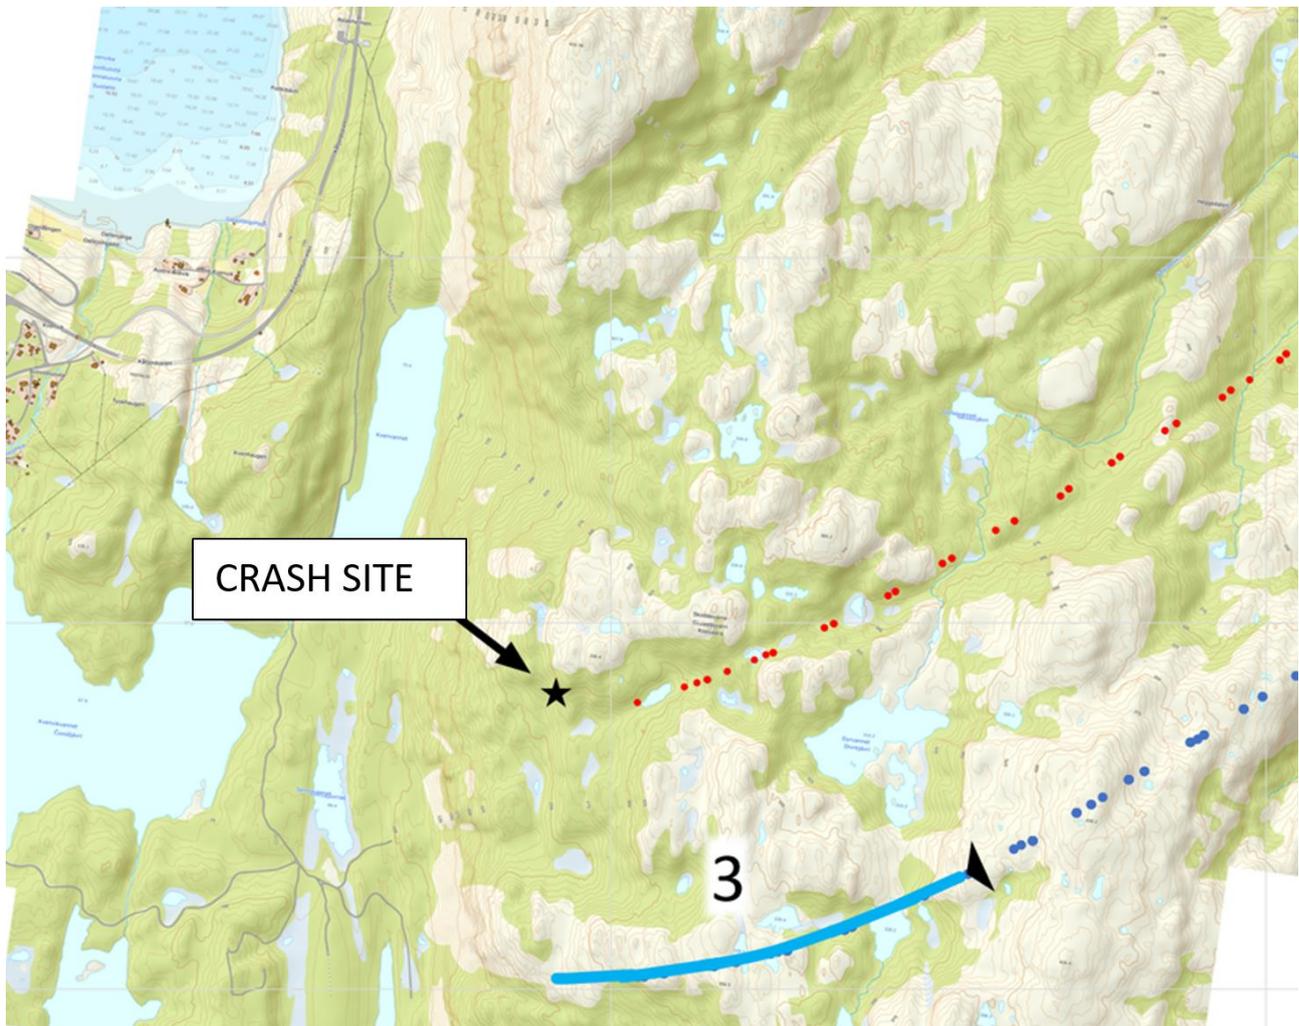
Figure 40: The final period of the first sightseeing flight is marked with a blue line. The last registered part of the accident flight is marked in red. Map: © The Norwegian Mapping Authority. Markings: NSIA

The last registered data point on the first sightseeing flight shows an altitude of 1,400 ft and a vertical speed of -2,432 ft/min. One of the passengers on the sightseeing flight stated that, after that, the flight descended along the mountainside in the direction of the festival area. The terrain profile and the flight path for the last period of the first flight are illustrated in Figure 41.

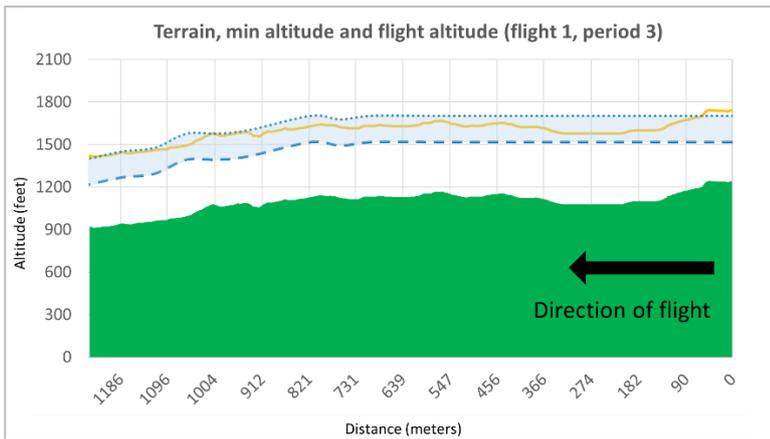
Figure 41: Altitude above the terrain during the last period of the first sightseeing flight. The green represents the terrain, the amber line shows the minimum altitude of 500 ft above the terrain, while altitude of the flight path is indicated in blue. The upper blue dotted line represents altitude data from Flightradar24, and the lower dotted line is the altitude of the flight path adjusted with data from CelloTrack. Source: NSIA

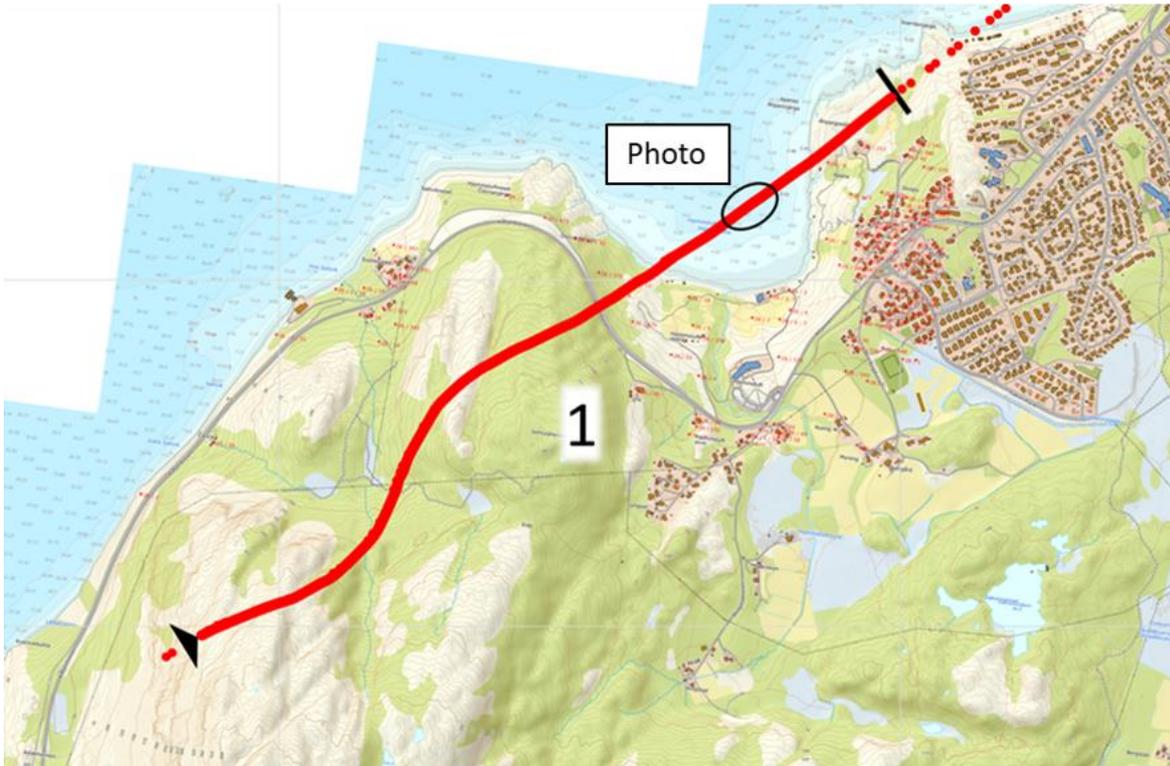
Figure 43: The first period of the accident flight. The area where the photo in Figure 3 was taken is marked. Map: © The Norwegian Mapping Authority. Markings: NSIA

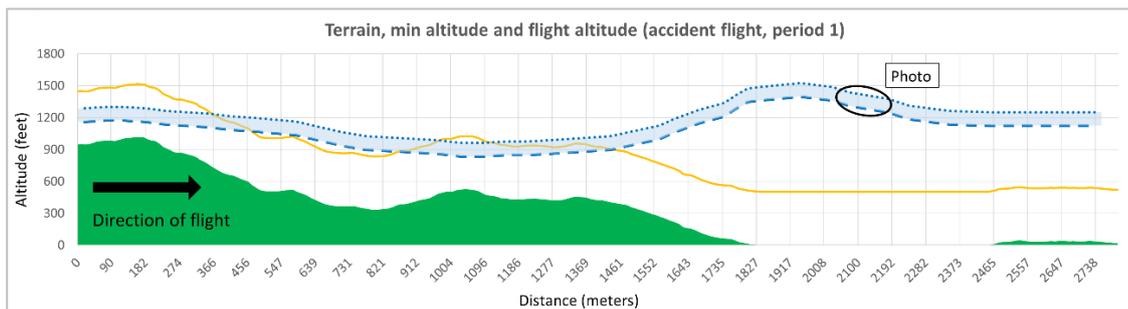
Figure 44: Altitude above the terrain during the first period of the accident flight. The green represents the terrain, the amber line shows the minimum altitude of 500 ft above the terrain, while altitude of the flight path is indicated in blue. The upper blue dotted line represents altitude data from Flightradar24, and the lower dotted line is the altitude of the flight path adjusted with data from CelloTrack. The area where the photo in Figure 3 was taken is also marked. Note that the direction of flight is from left to right. Source: NSIA

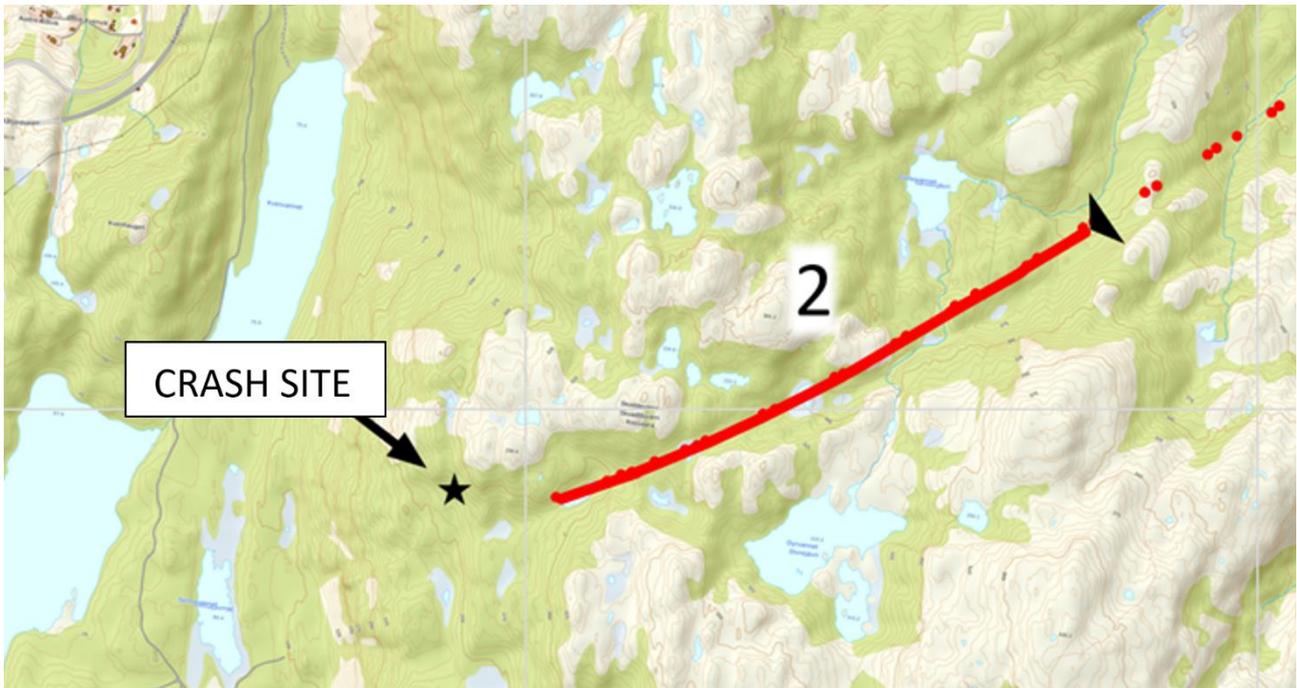
The flight path followed during the final period of the accident flight, which had variations in altitudes and speeds, is shown in Figure 45. The terrain profile and flight path for the last period of the accident flight are illustrated in Figure 46.

Figure 45: The final period of the accident flight. Map: © The Norwegian Mapping Authority. Markings: NSIA

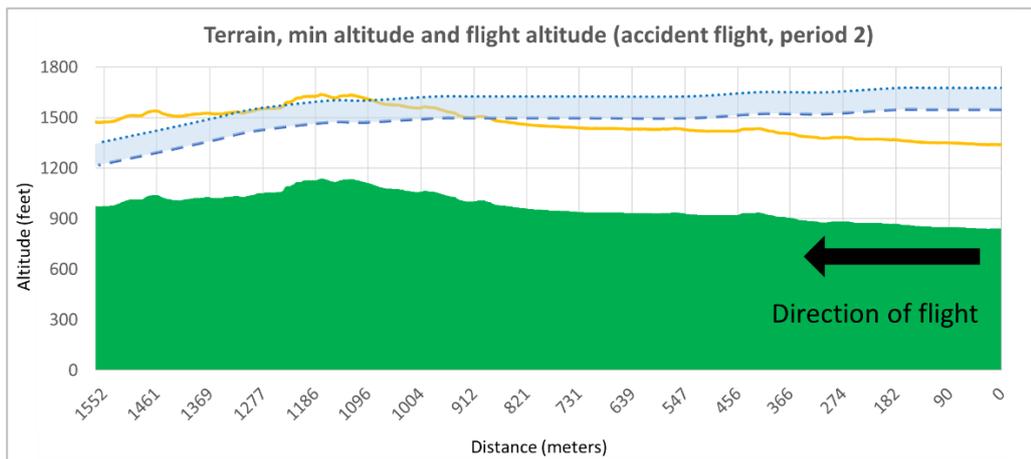
Figure 46: Altitude above the terrain during the final period of the flight leading up to the time of the accident. The green represents the terrain, the amber line shows the minimum altitude of 500 ft above the terrain, while altitude of the flight path is indicated in blue. The upper blue dotted line represents altitude data from Flightradar24, and the lower dotted line is the altitude of the flight path adjusted with data from CelloTrack. Note that the direction of flight is from right to left. Source: NSIA

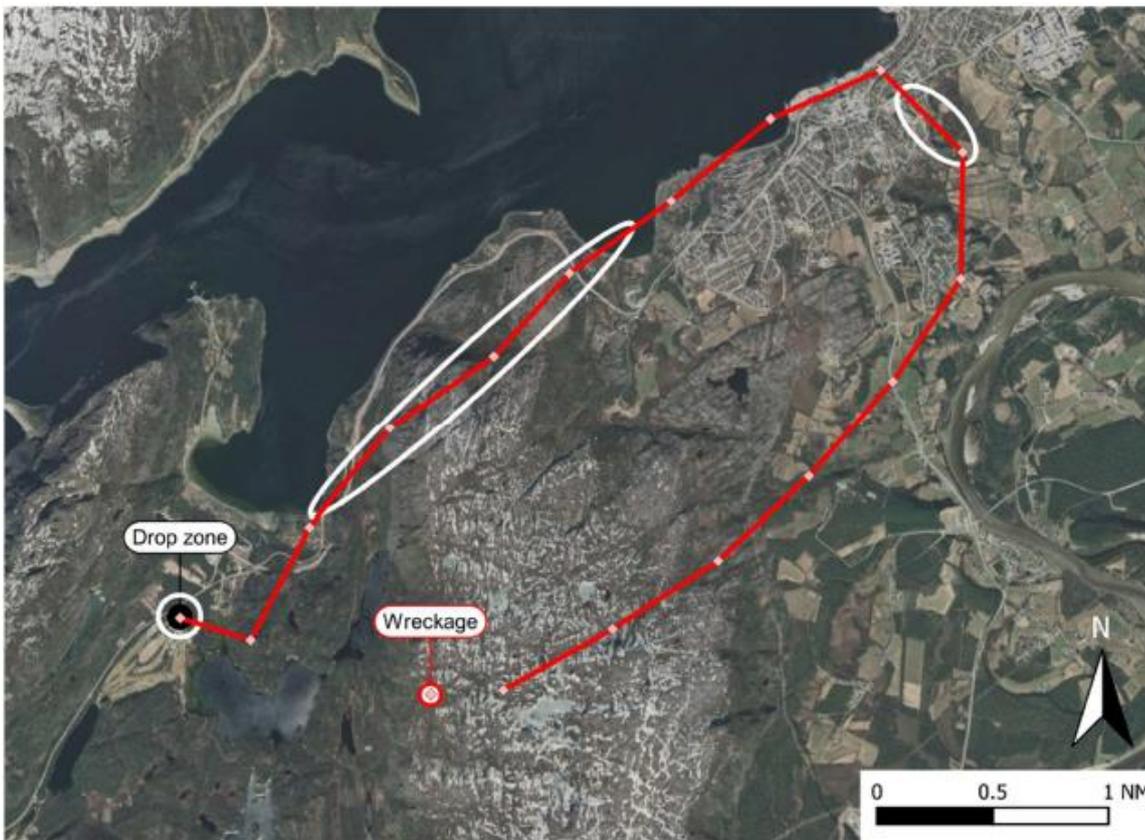
Several of the passengers on both sightseeing flights made brief video recordings and sent them to friends and acquaintances during the flight. The video recordings have been analysed for the purpose of extracting both operational and technical information. The time of the recordings could be determined by comparing the surroundings with information about the flight path (see Figure 47).

Figure 47: The flight track is marked in red and based on information from CelloTrack. The NSIA has received several videos that were taken during the flight. The white circles show where during the flight these were filmed. Source: Google Maps/BEA/NSIA

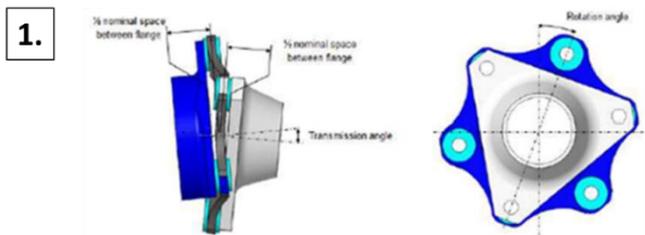
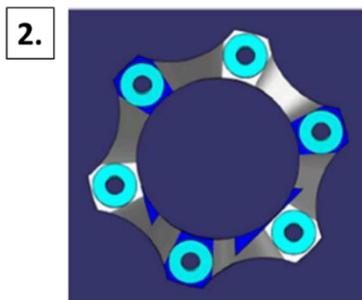
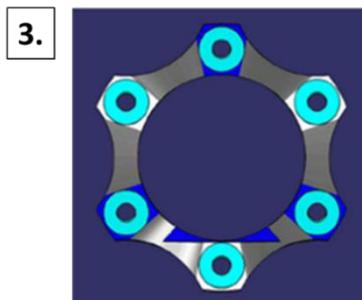
To understand the damages to the disc segments of the flexible coupling Airbus Helicopters made an animation. The animation showed the load at different angles of misalignment and rotation between the drive shaft and the main gear box. Still pictures from the animation is shown in Figure 54 and Figure 55. The animation shows that there must be a significant angle of misalignment to explain the damages. A disc from LN-OFU is shown for comparison in Figure 55.

Figure 54: The illustration from the animation shows how the damages to the flexible coupling discs can be created after contact with the drive shaft due to misalignment between engine and main gear box. Source: Airbus Helicopters/NSIA

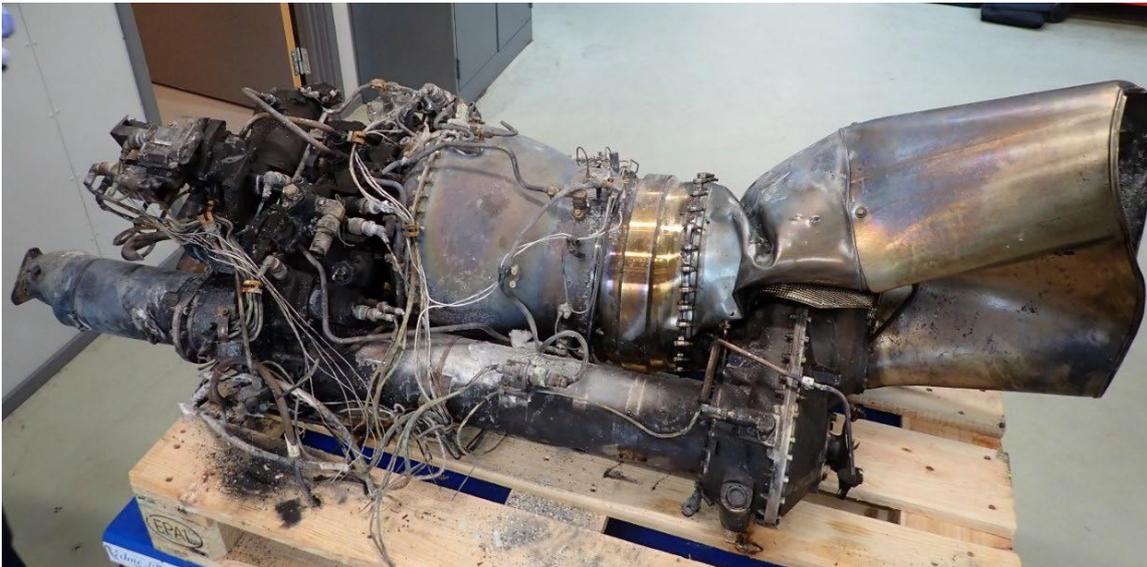
The engine and external components were relatively undamaged; see Figure 56. The engine was examined by the NSIA and Safran Helicopter Engines. The plugs for the wiring to the EBCAU and torque sensor were broken. Large parts of the wiring for the DECU had burnt up completely (see section 1.6.3 for a description of the engine and relating systems).

Figure 56: The engine before it was disassembled in the NSIA's premises. Photo: Safran Helicopter Engines/NSIA

Rotation marks on the conical surface at the centre of the compressor and notches in the compressor blades are indications that foreign bodies had entered the air inlet while the gas generator was in highspeed rotation. Molten aluminium had run down the engine at different angles, which indicates that the engine had changed position while the fire was in progress.

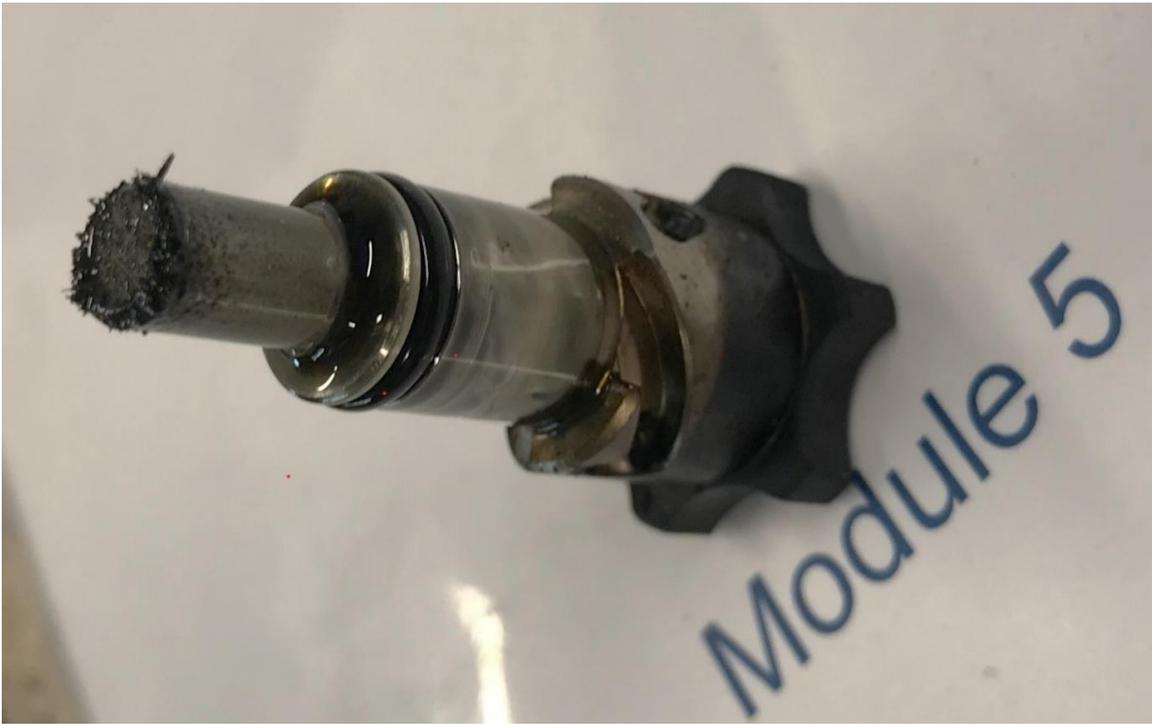
- Fuel filter: visually inspected and found to be uncontaminated.
- Engine oil filter: visually inspected and found to be uncontaminated.
- Magnetic oil plug, Module M01: no particles worth mentioning were found.
- Magnetic oil plug, Module M05: some minor particles found; see Figure 57. Safran Helicopter Engines considered the particles to have come from the gearbox in connection with the increase in rotational speed and the damage to the power turbine.
- Magnetic plug for return oil: visually inspected and found to be uncontaminated.

*Figure 57: Magnetic oil plug in Module M05. Photo: NSIA*

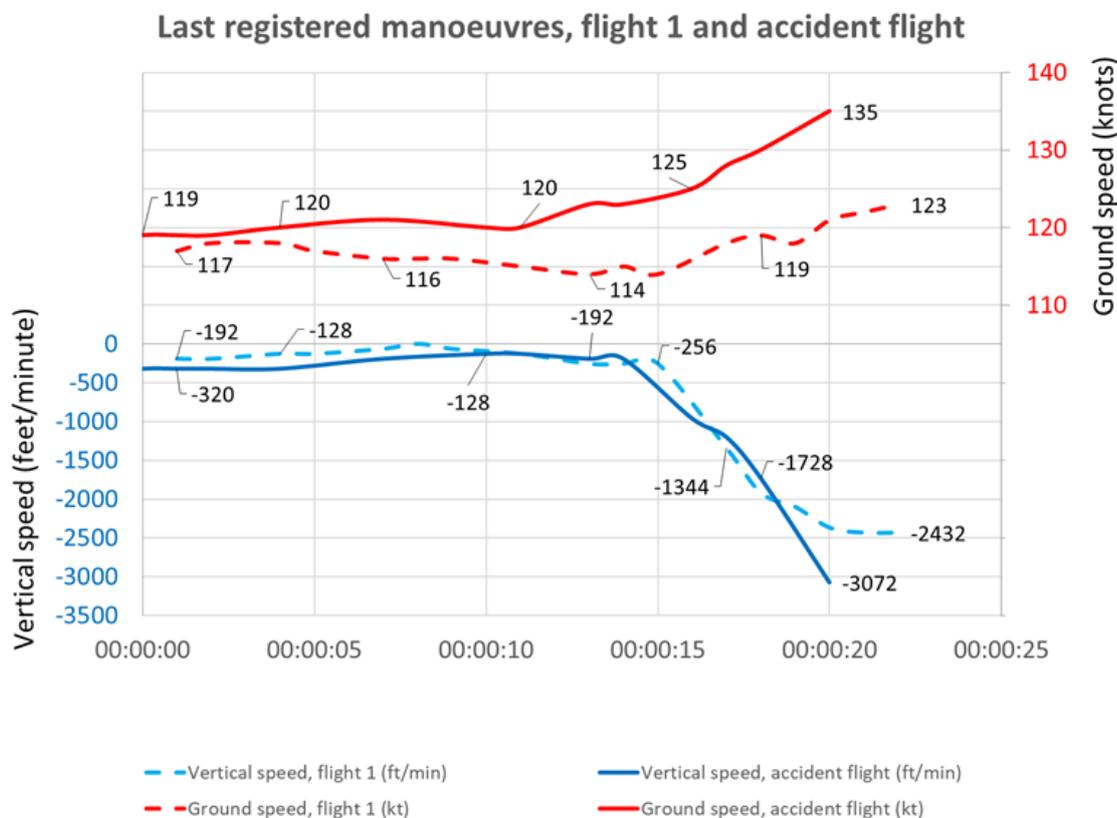
Figure 71: Last helicopter movements registered by FlightRadar24. Comparison between the last recorded manoeuvre (approx. 20 seconds) on the first sightseeing flight and the accident flight. Source: NSIA

Figure 71 shows the similarities between the manoeuvres during the last registered seconds of the first sightseeing flight and the accident flight, both of which were terminated by a slight right-hand turn. On the accident flight, the concurrent increase in sink rate and ground speed was greater than on the first sightseeing flight. During the final seconds, the first sightseeing flight kept an altitude of around 500 ft above ground level, while the altitude was somewhat lower on the accident flight.
