AIRCRAFT ACCIDENT REPORT

AASL/2019/01/03/F

**Final Report on the serious incident involving
Boeing 737-500 Aircraft with nationality and
registration marks 5N-AIS, operated by Azman Air
Services Limited, which occurred at Port-Harcourt;
Nigeria on 3rd January, 2019**

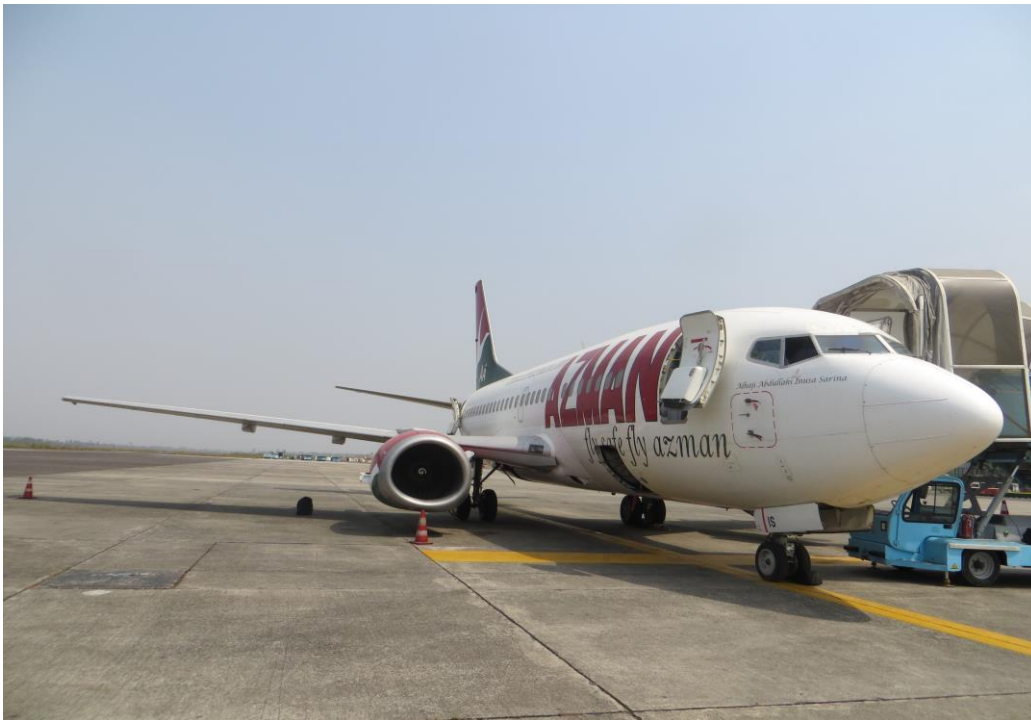
Figure 12: The aircraft after the incident

The aircraft landed safely on runway 21 and taxied to the apron with no physical damage.
