Aviation Accident and Incident Investigation Directorate

**Report on the investigation of the runway excursion incident
to Boeing B727 with registration EY-724, at Kigali
International Airport on November 13th, 2020.**

Ref AAID 2021-02

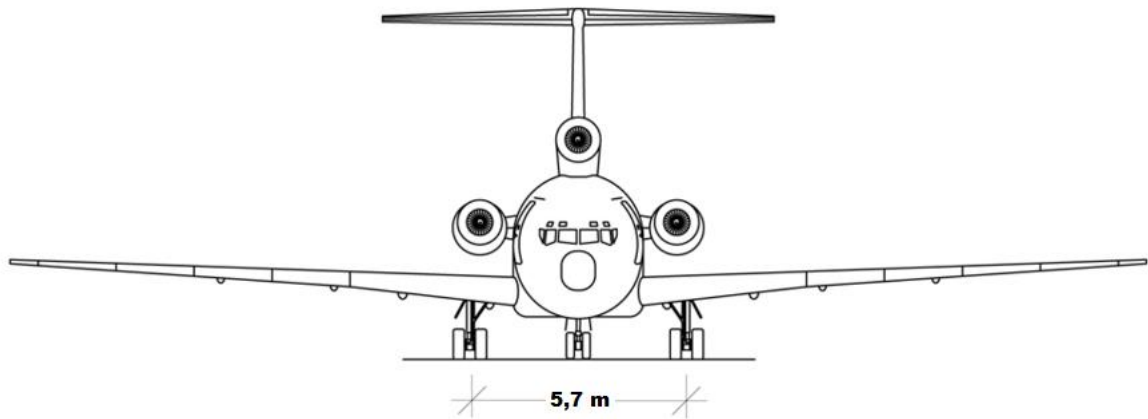
Figure 1: Lateral distance between main gears of B727-100

The Boeing B727-100 is equipped with a nose gear and two main gears. Each gear has an axle with two wheel assemblies. The lateral distance between the main gears is 5.7 m, see figure 1 below.

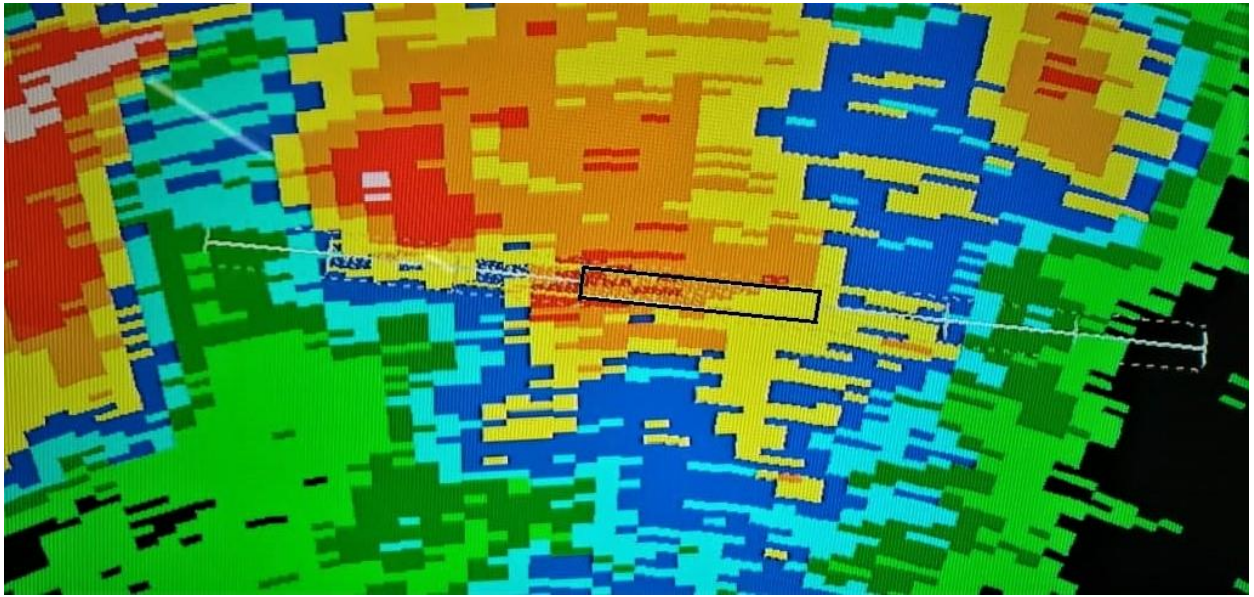
Figure 8: Weather radar display at 10:00 UTC.

Figure 8 shows moderate rain in the touchdown zone of RWY 28 (depicted by the yellow colour in the left-hand part of the rectangle indicating the runway) and heavy rain on the remaining part of the runway (indicated by the orange and red colour).

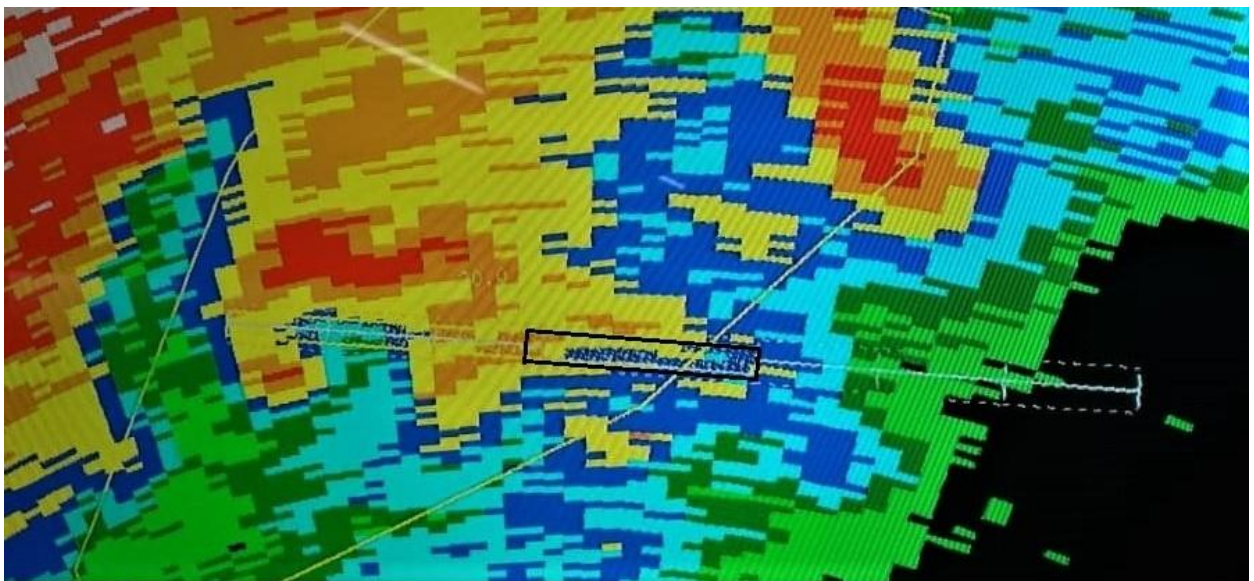
Figure 9: Weather radar display at 10:05 UTC.

Figure 9 shows light rain in the touchdown zone of RWY 28 (depicted by the blue colour in the left-hand part of the rectangle indicating the runway) and moderate to heavy rain on the last part of the runway (indicated by the yellow and orange colour).

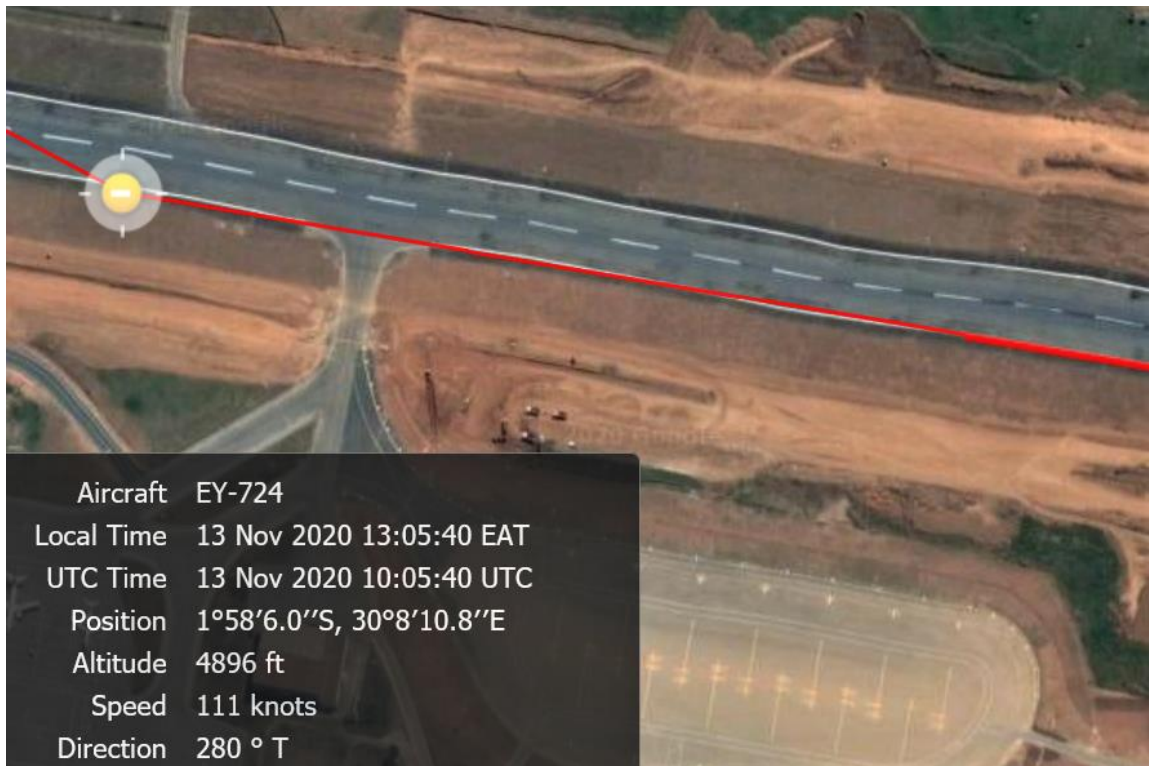
Figure 12: Speed of Flight TAK 270 300 m after passing taxiway Charlie.

- The entire touchdown zone of runway 28 was covered by a substantial layer of rubber deposits (also see figure 10 in paragraph 1.10). In combination with a wet runway this forms a well-recognised circumstance for a lack of runway friction.
- The main gear tires of the EY-724 aircraft were all worn to the minimum acceptable limit.
- Deceleration during the landing roll of flight TAK 270 was unusually slow, which is an indication of reduced wheel brake effectiveness. GPS data indicate that the aircraft was still travelling at a groundspeed of 111 knots (205 km/hour) at a position 300 m West of taxiway Charlie, see Figure 12 below:

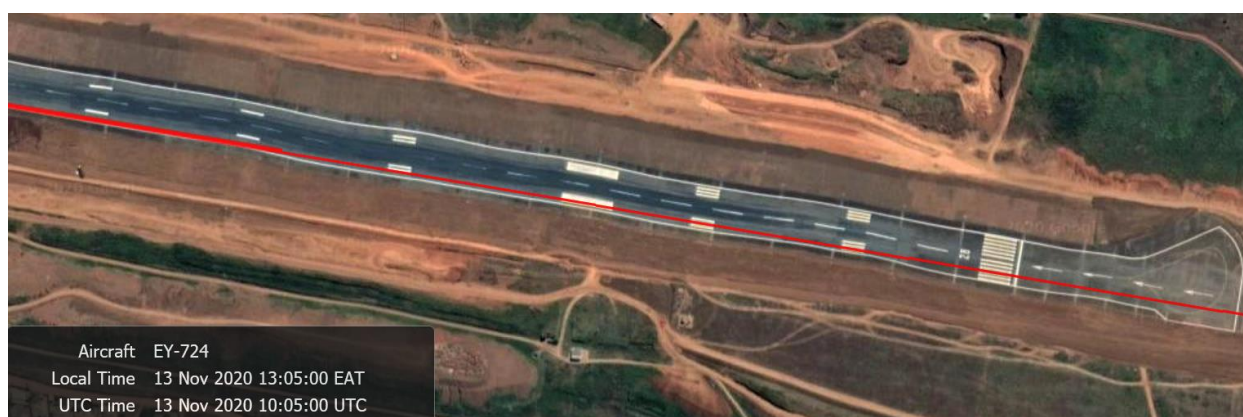
Figure 13: Satellite picture showing the track of flight TAK 270 on short final approach.

After weighing all factors from paragraph 2.2.1 through 2.2.7 it can be concluded that the excursion was caused by lack of proficiency of the crew, foremost by not conducting a go-around when the aircraft had drifted to the left on short final approach. The satellite picture 13 below clearly illustrates the significant flight path deviation that should have been reason for initiating a go-around.

After the decision to continue for landing the runway excursion became unavoidable because of an incorrect crosswind landing technique and subsequent skidding due to viscous aquaplaning once the aircraft was on the ground.

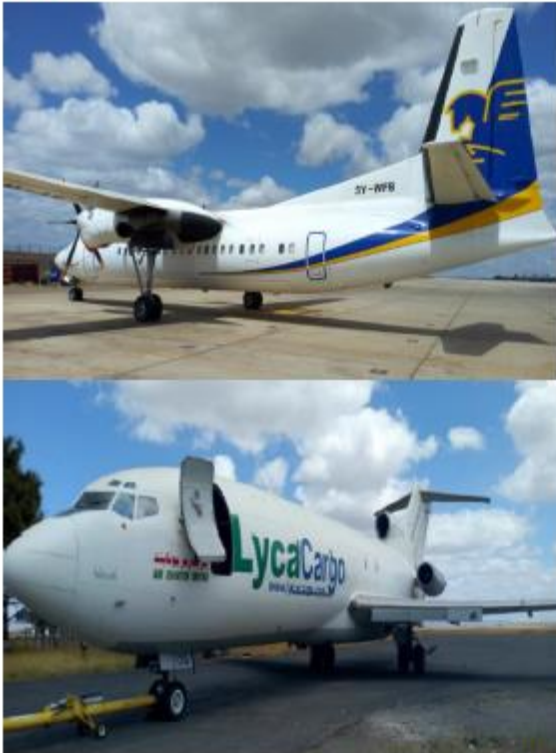
The two aircraft that were involved in the incident.

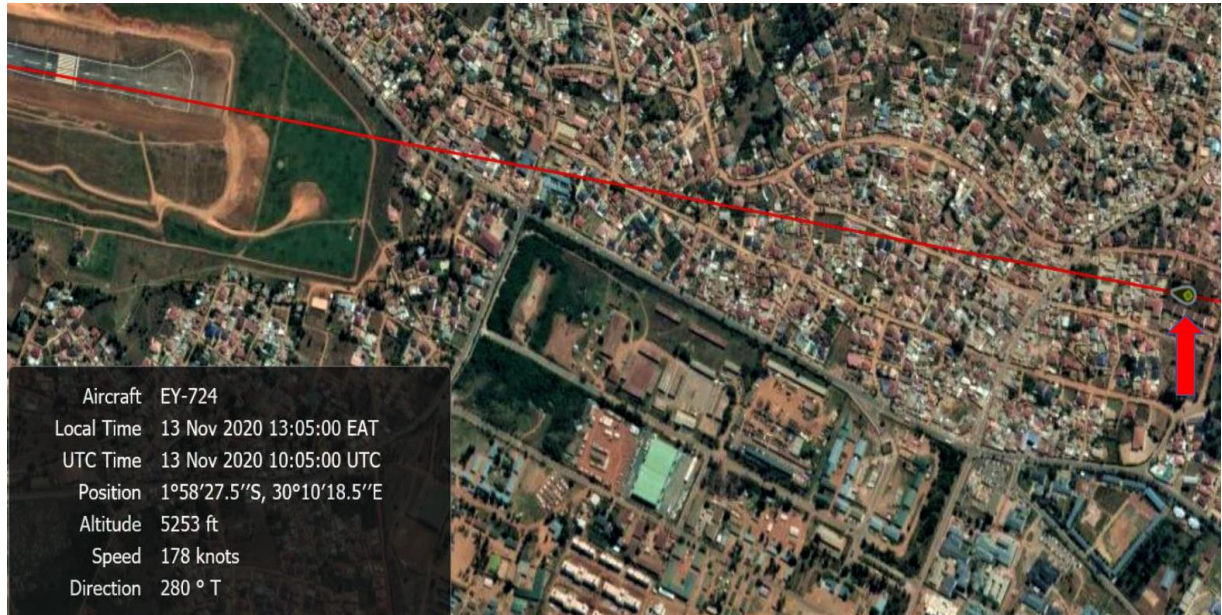
Figure A

The GPS plots received from Zone Four International include this position on short final, see figure A:

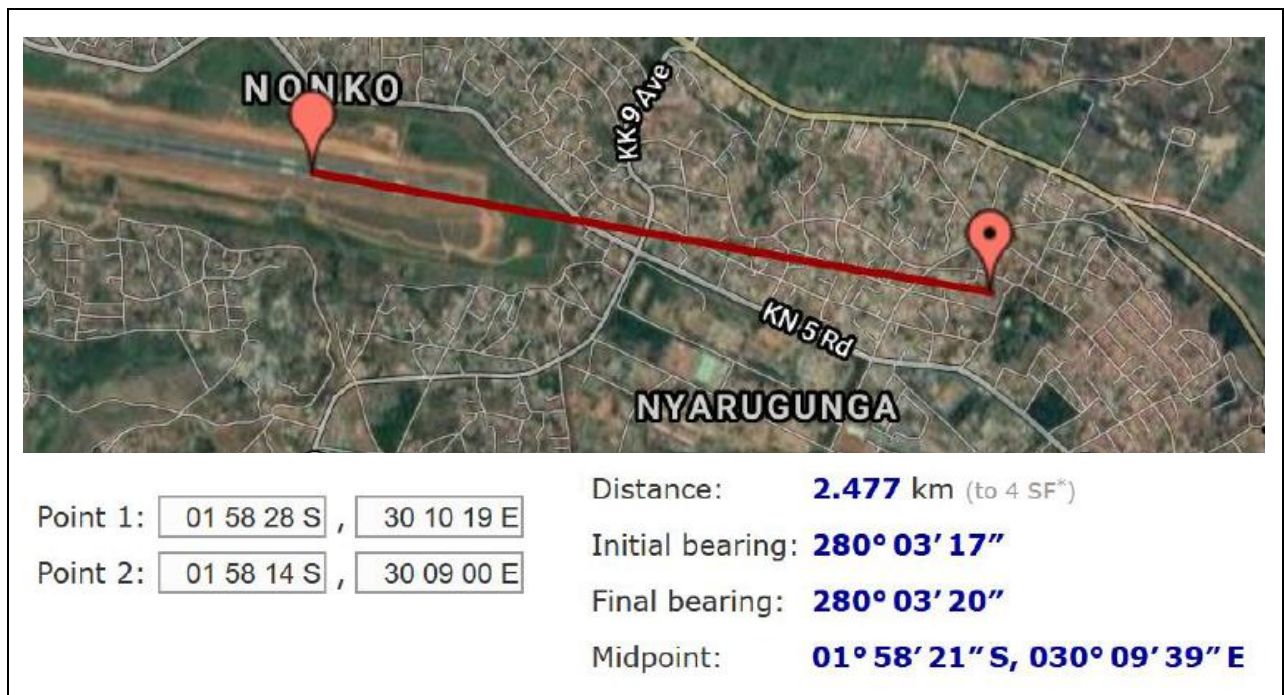
Figure B

When calculating the distance between this position and the touchdown point for the ILS of runway 28 KGL, we find a distance of 2.477 m, see figure B below:

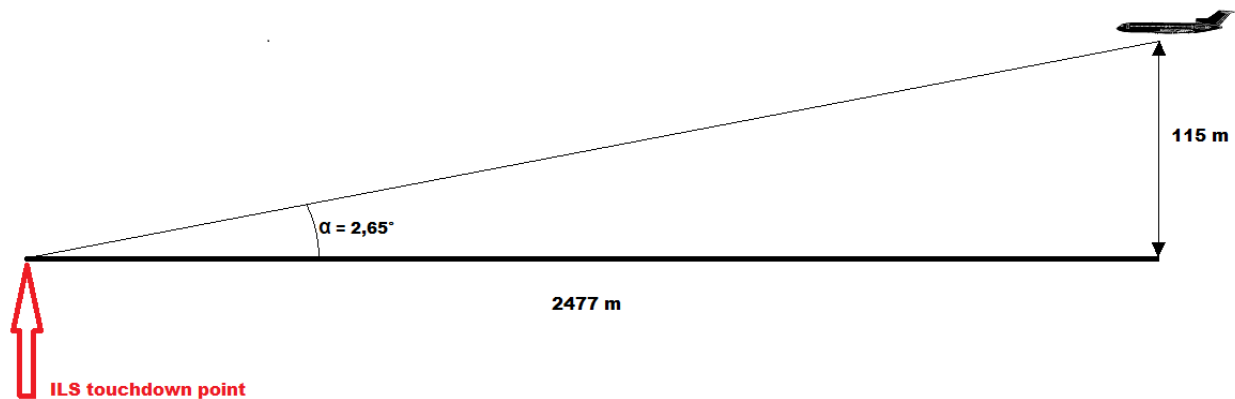
Figure C

The GPS altitude of the aircraft when at the position listed in figure 1 was 5.253 ft. The elevation of the touchdown zone of runway 28 KGL is 4.875 ft. When at the position of figure A, flight TAK 270 therefore was 378 ft or 115 m above the touchdown zone as illustrated in figure C:

As illustrated above, the resulting glide path angle is 2,65°, which is lower than the standard ILS glide slope angle of 3°.
