# Air Accident Investigation Sector

### - Final Report -

AAIS Case N°: AIFN/0016/2012

## Engine Hot Gas Leak

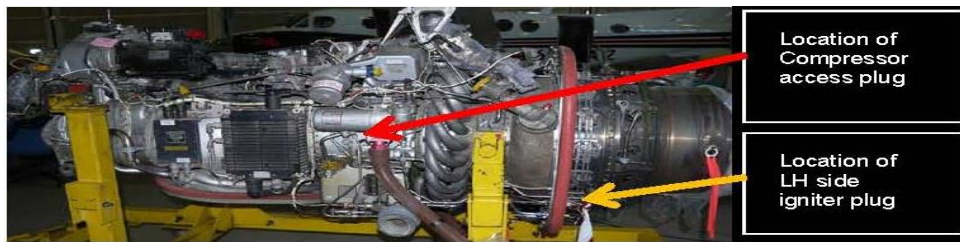
**Figure 5.** Location of engine compressor wash plug

These two mechanics had been made aware, verbally, that the Aircraft had a new requirement for engine washing. During the Investigation, it was revealed that there was a misunderstanding as they were unsure if the requirement was for a compressor only, turbine only or compressor and turbine wash combined. As stated by the mechanics, the previous washes they had performed on this Aircraft's engines was that of compressor desalination washes only. Therefore, the mechanics prepared both engines for compressor water washes by removing the single access plug<sup>14</sup> ([figure 5](#)) on the external engine compressor casing. The compressor wash does not require engine nacelle panels 415AL and 425AL to be opened, but does require another two adjacent panels, 413AL for the LH engine and 423AL for the RH engine to be opened in order to access these plugs.

The mechanics removed panels 413AL for the LH engine and 423AL for the RH engine, in order to access the compressor plugs. The single access plug (figure 5) on the external engine compressor casing was then removed.

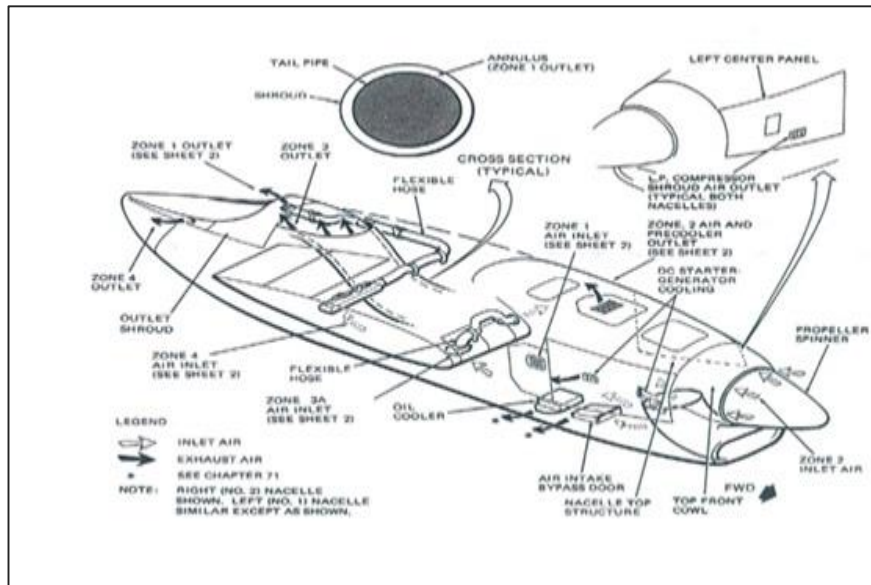
Figure 7. Engine zones and cooling airflow.

Zone 1 is cooled by ambient air, which enters the area via the forward facing louvers located on the nacelle access panels 415AL and 416AR for the LH engine and 425AL and 426AR for the RH engine. The ambient air is circulated within the zone to cool and ventilate the compartment. The air then exits from the annulus formed between the engine tail pipe and the compartment shroud.

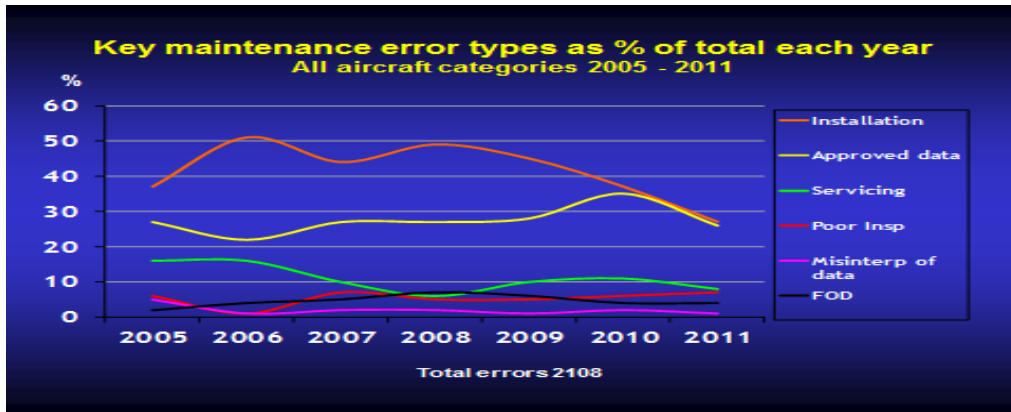
Figure 8. MEMS statistics on maintenance error types

Industry with the objective of reducing the risk of incidents reoccurring as well as reduce the costs associated with maintenance errors. (Figure 8)<sup>33</sup>.

Even though the Operator had MEMS in place, no data or reports were provided to the Investigation. It was noted by that MEMS fell under the responsibility of Quality department.
