Propulsion System Fire (SCF–PP–PSF)

Investigation Report

**Serious Incident to
Boeing 747-8F, N624UP
Hong Kong International Airport**

20 July 2021

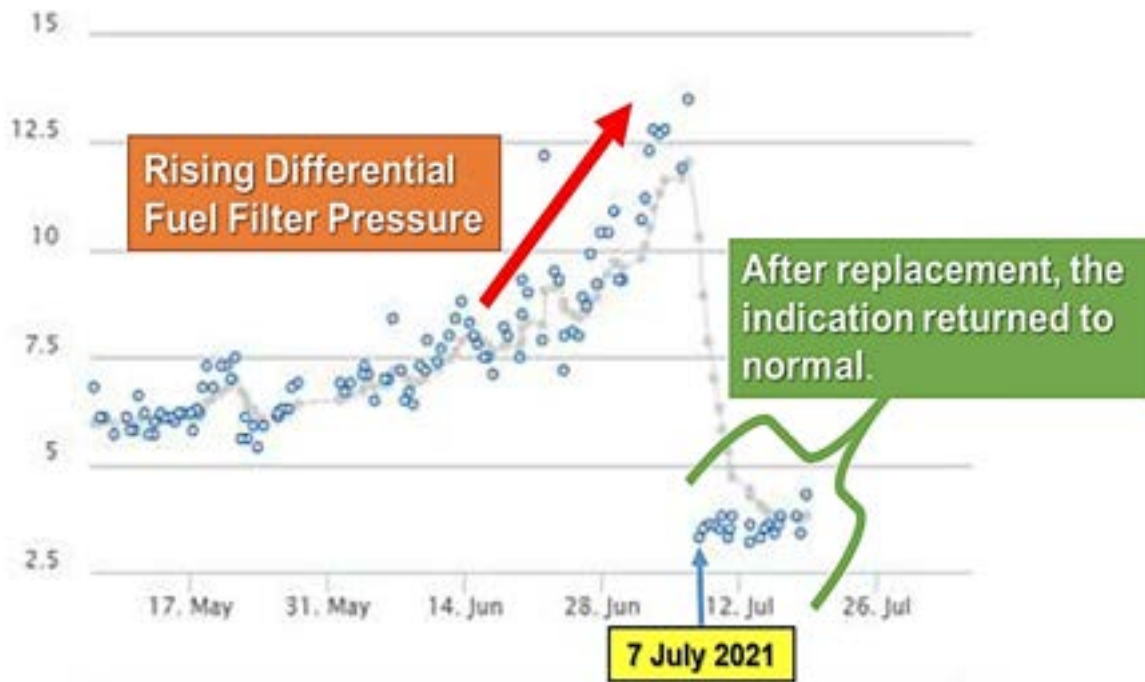
Figure 7: Trend of Fuel Filter Delta Pressure

- (1) According to the operator, the engine was installed as new. The only engine maintenance was the replacement of the fuel filter, main fuel pump strainer and lube flow screen on 7 July 2021 as the engine condition monitoring had alerted of a rising differential fuel pressure indication on the No. 1 engine.
- (2) After the replacement, the pressure indication returned to normal and remained stable until the date of occurrence.

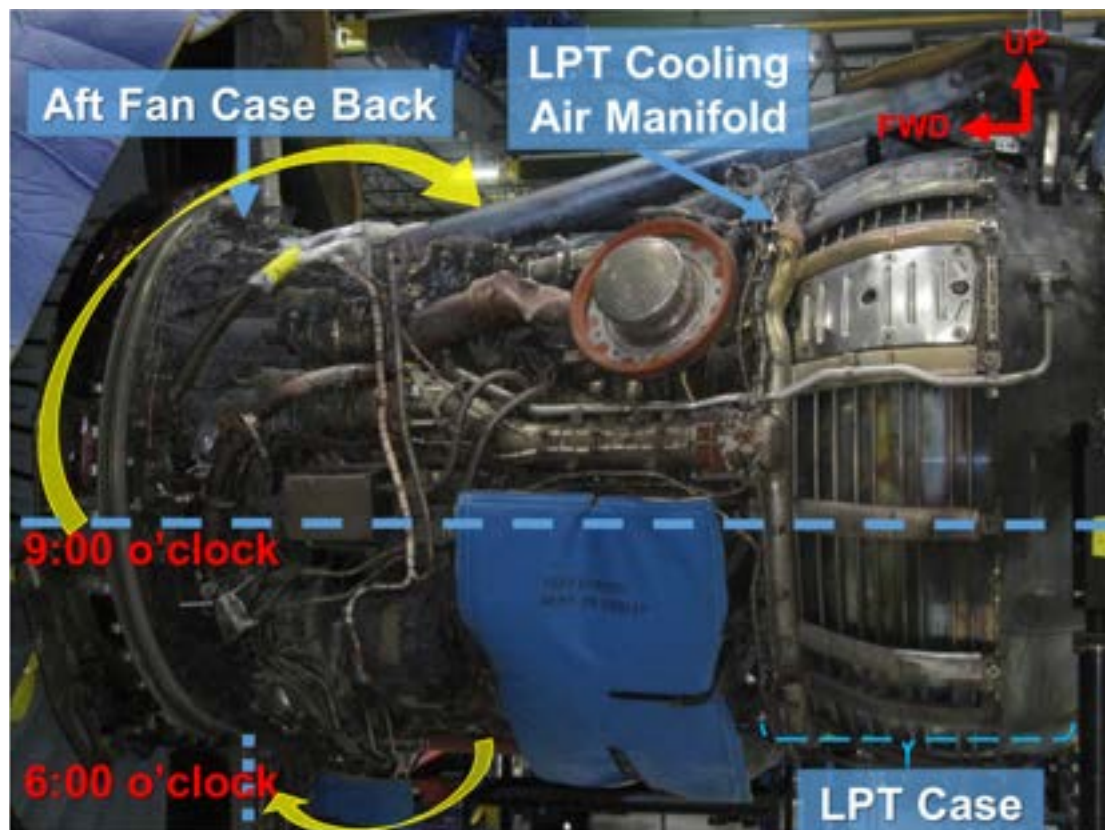
Figure 13: Left Side of Engine

- (1) Prior to the leak check, an external examination of the engine was performed to document the fire damage and a swab sample was taken of yellowish powder residue at about the one o'clock position on the environmental cooling manifold.
- (2) From the aft fan case back to the LPT cooling air manifold on the LPT case, the thermal and fire damage was most pronounced from about the nine o'clock to six o'clock position (aft looking forward).

- (3) The thermal and fire damage consisted of sooting and melted or consumed c-clamp/p-clamps cushions, fire loop rubber isolators, electrical cable outer sheathing, and fire sleeves.

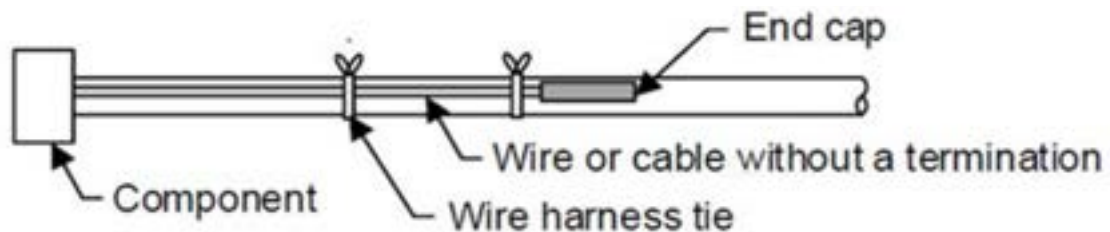
Figure 19: Standard Practice for Capping the Unused Electrical Wires

- (6) The Boeing performed a continuity check of the FMU and engine harness connectors. The results were normal.
- (7) After checking with the wiring diagram, it was confirmed that the exposed electrical wires were unused wires with an end cap on the end, as shown in the graphic below.

- (8) The end caps of the electrical wires likely melted as a result of thermal damage. Thus, the electrical wires became exposed.
- (9) The top of the engine, from about 9 o'clock to 3 o'clock position, was covered in a bluish powder residue, and yellowish powder residue at about the 1 o'clock position on the environmental cooling manifold.

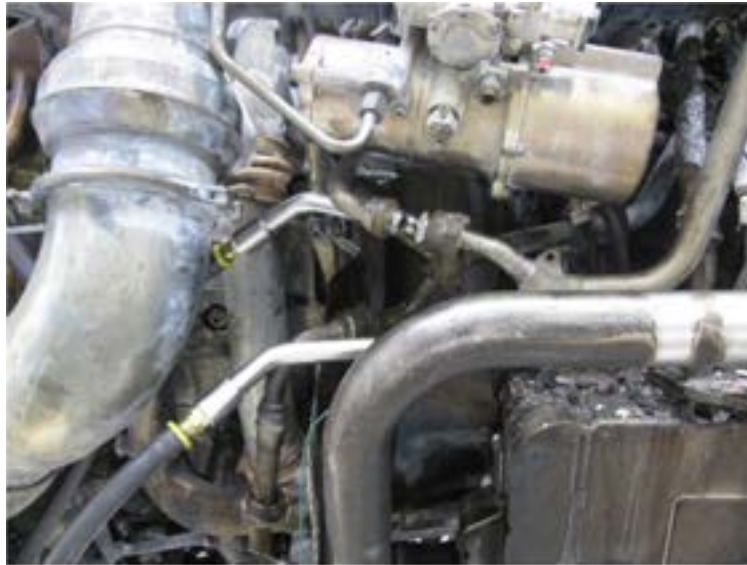
Figure 25: Fitting On Fuel Split Valve-To-Fuel Manifold Secondary Pilot Fuel Supply Line

- (8) With the manifold port covers installed, nitrogen was slowly introduced again into the MFP drain port up to 40 psi and several additional leaks were noted when Leak-Tec fluid was applied to the pressure tap ports on the inboard side of the FMU.
- (9) Examination of the main fuel filter (MFF), main fuel pump (MFP), the IDG fuel/oil cooler and main fuel oil heat exchanger (MFO HEx) exhibited no leaks.
- (10) Fittings were then connected to each branch of the fuel split valve-to-fuel manifold secondary pilot fuel supply line and nitrogen was introduced at 10 psi.

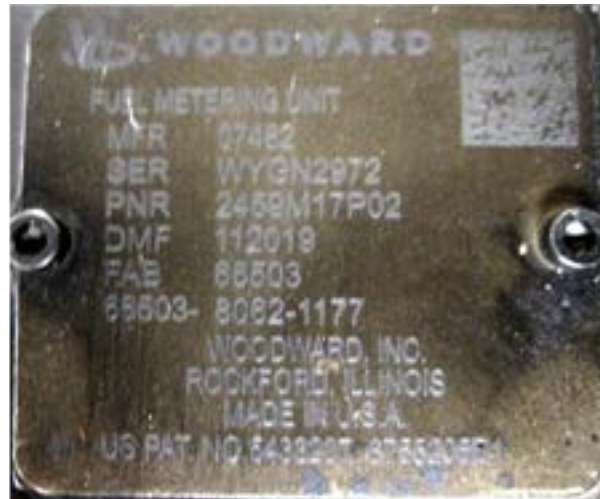
Figure 27: Data Plate of FMU

- (1) The FMU was of GE part number (PN) 2459M17P02, Woodward PN 8062-1177, serial number (SN) WYGN2972, which was manufactured in November 2019.

- (2) The FMU was completely sooted, but there were no signs of thermal distress to the housing.
- (3) Visual inspection of the FMU revealed that the safety wire from one of the drain plugs was found broken; it appeared to be a clean cut.
- (4) According to GE Field Support, the FMU was drained in Hong Kong for engine shipment; thus, the safety wire was cut to drain the unit. This was confirmed and photographed at the engine.

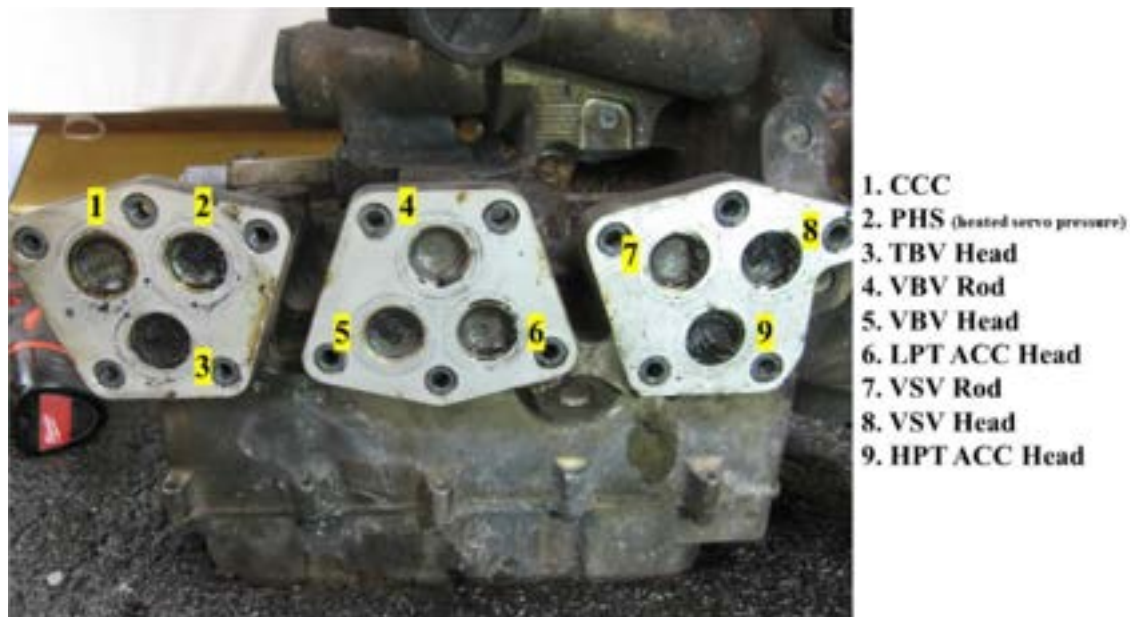
Figure 30: Covers Removed and Ports Exposed

- (6) Each fuel port has a primary black packing (O-ring) with a whitish flat backup split ring on either side of the primary packing. The O-rings and the backup split rings were all intact, in good condition, and did not exhibit thermal or heat distress.

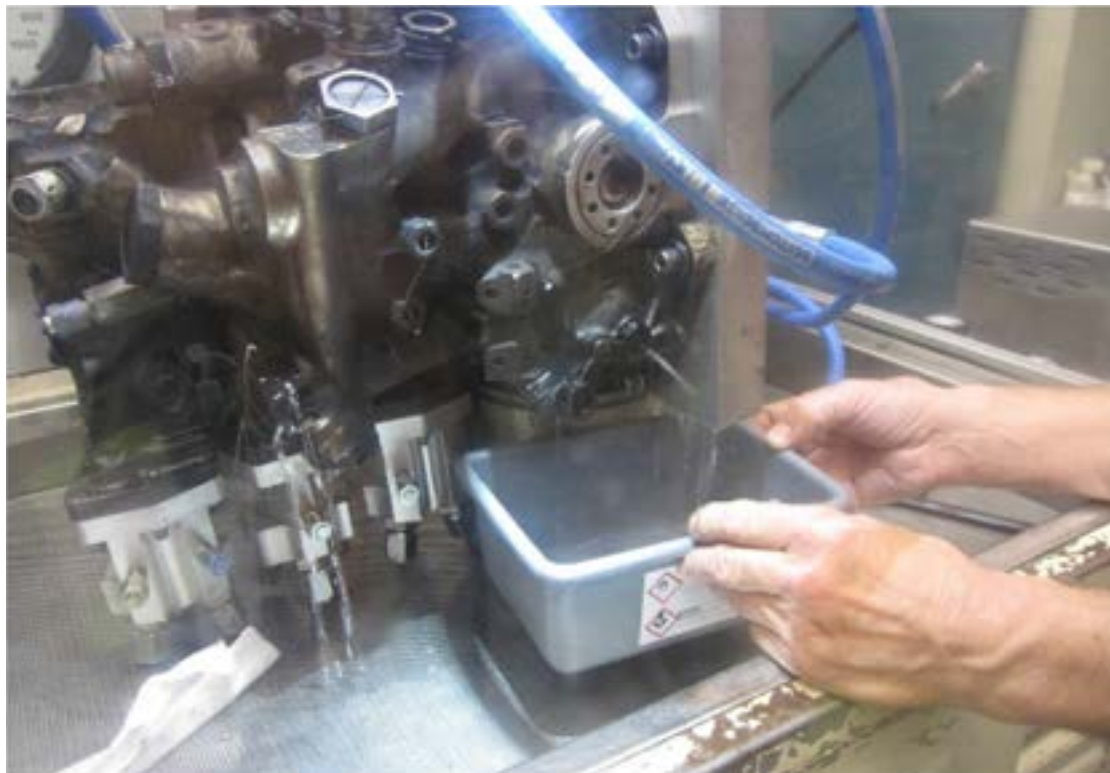
Figure 39: Calibration Fluid Collected From P1 Bypass Valve Port Fitting

- (4) The FMU was tilted in such a manner so that the P1 bypass valve port fitting leak could be isolated from the other two leak locations. The objective was to capture the calibration fluid in order to determine the leak rate from the P1 bypass valve port fitting only.
- (5) Again, at about 12 psi, calibration fluid was collected for 1 minute and 445 cubic centimetres (cc) of fuel (0.740 pounds) was collected. The leak observed from the P1 bypass valve port fitting was isolated to a single general location.
- (6) The leak rate of 445 cc per minute at 12 psi corresponded to a 0.038" external leak orifice. This external leak size was compared to a later analysis investigating how this leak had caused N1 to reach the overspeed limit in Section 1.16.3.

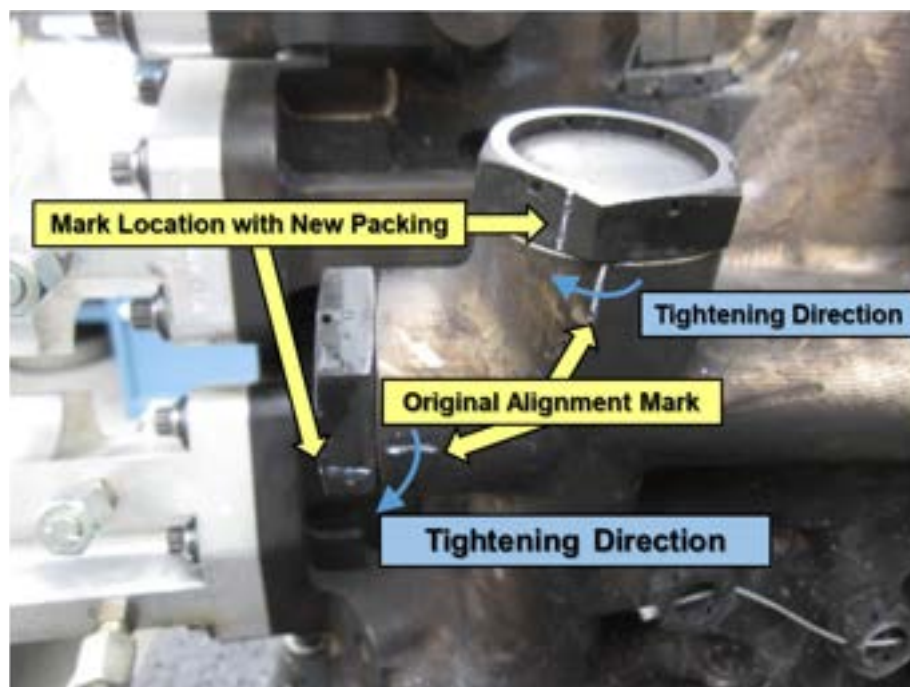
Figure 44: PB2 Bypass Fitting Alignment Marks With New Packings Installed

- (5) New packings were installed on the PB2 bypass and P1 bypass valve port fittings and the fittings were reinstalled to the specified torque.
- (6) The alignment marks for the PB2 bypass fittings went past the original "tight" marks in the tightening direction; they appeared to be about a $\frac{1}{4}$ of a flat past the original "tight" mark.

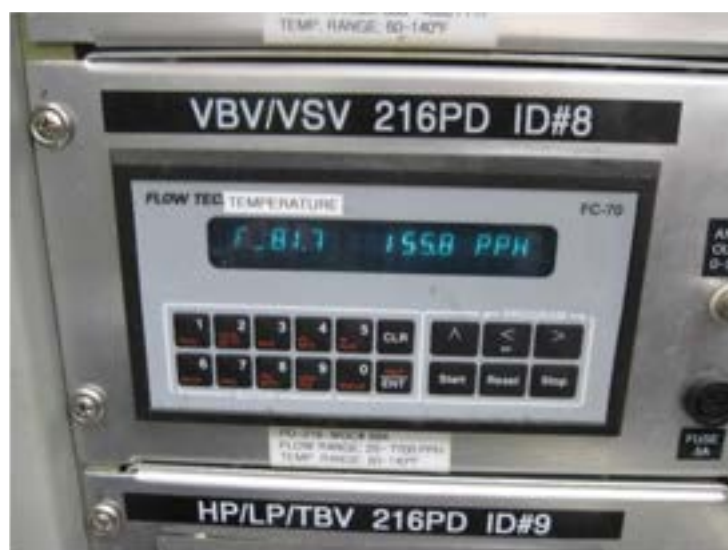
Figure 50: Leak Rate from P1 Bypass Valve Port Fitting

- (6) The needle valve was slowly opened to vary the pressure across the metering valve ($\Delta P = P1-P2$) from its normal operating ΔP pressure of about 50 psi to the event ΔP pressure of about 95.5 psi. The 95.5 psi was a calculated value based on FDR data and not an actually recorded parameter.
- (7) The opening of the needle valve allowed fuel to leak thus increasing the ΔP . The fuel flow rate (the simulated leak rate from the P1 bypass valve port fitting) was recorded as 155.8 PPH.
- (8) The leak rate at approximately idle conditions corresponded to a 0.033" external leak orifice. This external leak size was compared to a later analysis investigating how this leak caused N1 to reach the overspeed limit in Section 1.16.3.

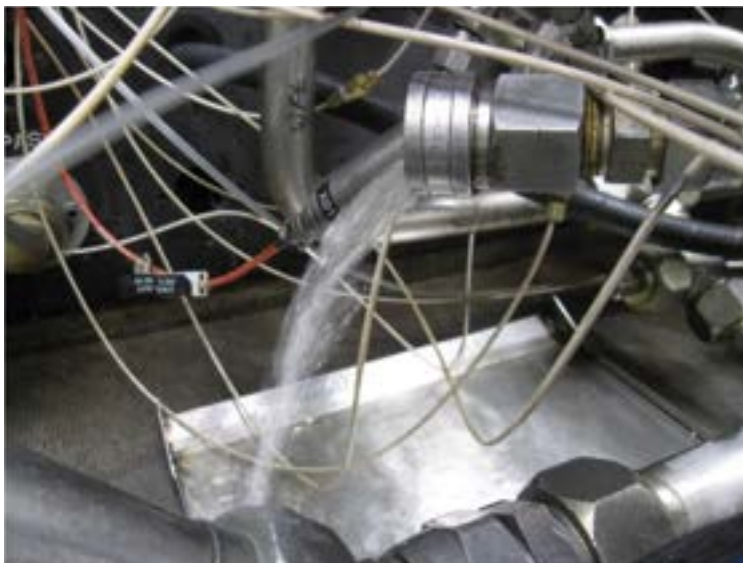
Figure 51: Fluid Leak from P1 Bypass Valve Port Fitting

- (9) The amount of flow from the discharge tube was recorded by the flowmeter.

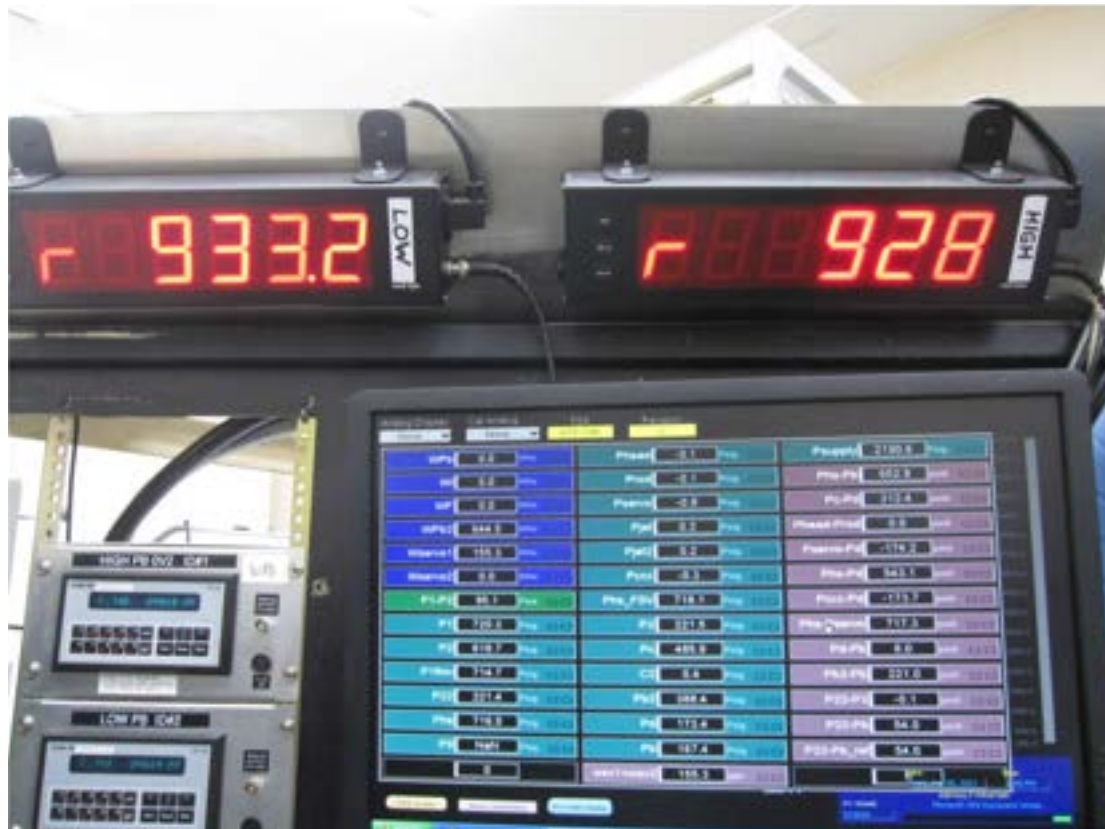
Figure 52: Meter Flow Rate With Leak

- (10) After the needle valve was opened to simulate the leak, the metered flow (Wf) value changed to 933.2 PPH.

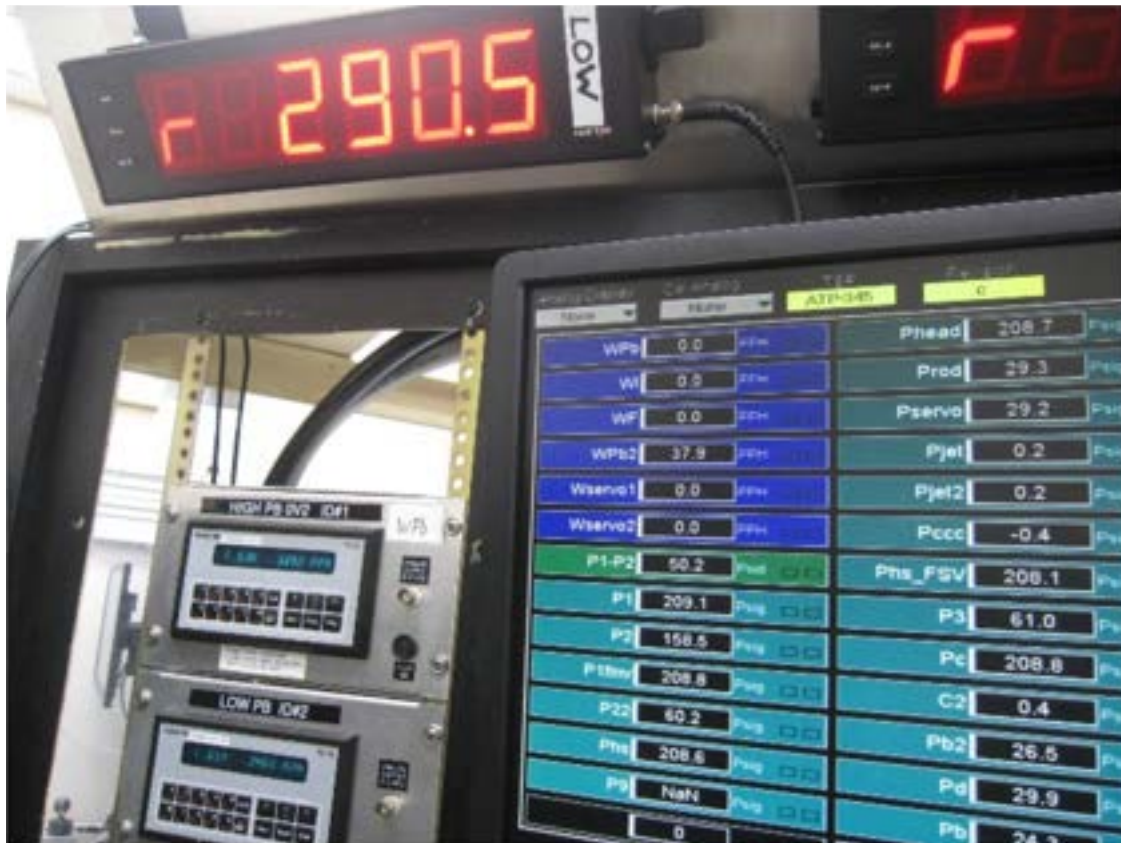
Figure 54: Near Sub-Idle Test

- 1) W_i – Inlet flow - 2254-2346 PPH
 - 2) WPB – Bypass flow - 250-350 PPH
 - 3) PB – Bypass Pressure – 20-70 pounds per square inch gauge (psig)
 - 4) P22-PB – Discharge Bypass Pressure – 50-70 psid
 - 5) LVDT – +0.1897 volt/volt
- (4) With these input values, the metered fuel flow rate from the FMU (WF) was recorded as 291 PPH (limit is 293-313 PPH) and the ΔP (P1-P2) was 50.2 psid (limit 40-60 psid).

- (5) When Woodward shipped the event FMU, the as-shipped value for WF was 293 PPH and for ΔP was 50.5 psid. So for this test point, WF and ΔP valves correlated well with the as-shipped values. It was concluded that the event FMU worked normally near sub-idle conditions.
- (6) The second test was representative of operating conditions at cruise. The input pressures and flow rates were as follows:

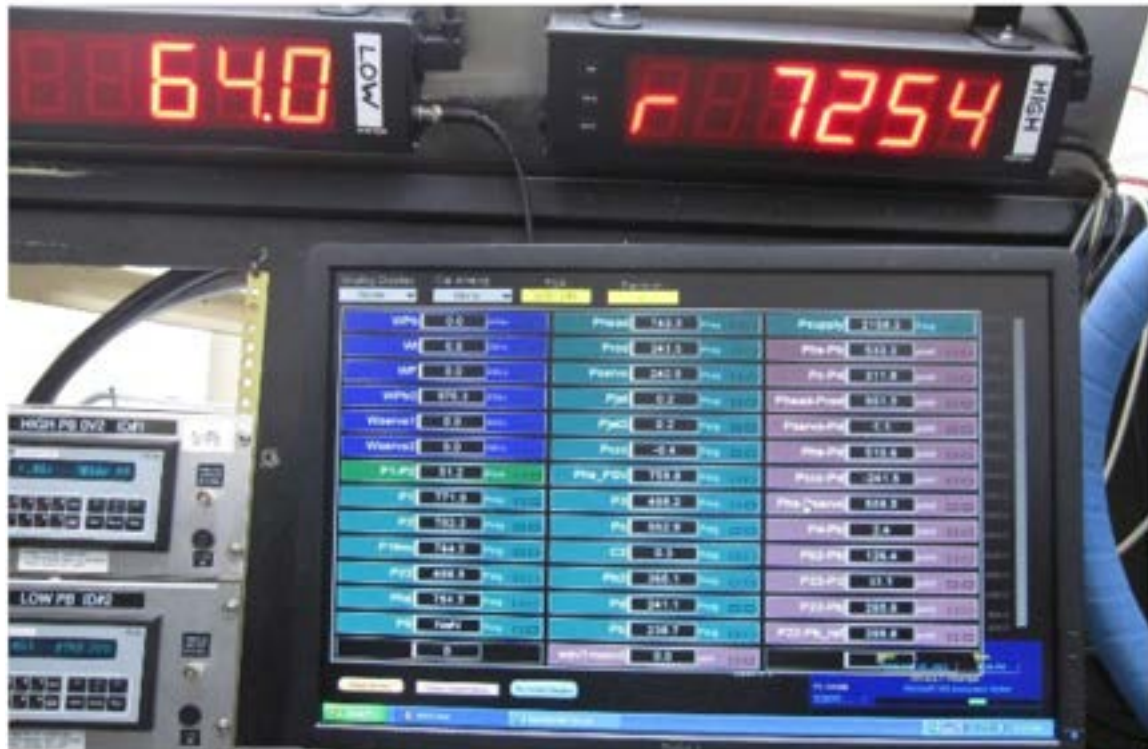
Figure 55: About Cruise Test

- (7) With these input values, the metered fuel flow rate from the FMU (WF) was recorded as 7253 PPH (limit is 6968-7326 PPH).

- (8) When Woodward shipped the event FMU, the as-shipped value for WF was 7207 PPH. So for this test point, WF correlated well with the as-shipped value. It was concluded that the event FMU worked normally about cruise conditions.
- (9) Based on the results of the various leak checks and the modified ATP testing, it is concluded that the event FMU operated normally after replacing the packings and retightening the P1 bypass valve port fitting. No disassembly of the FMU was needed to further support the investigation.

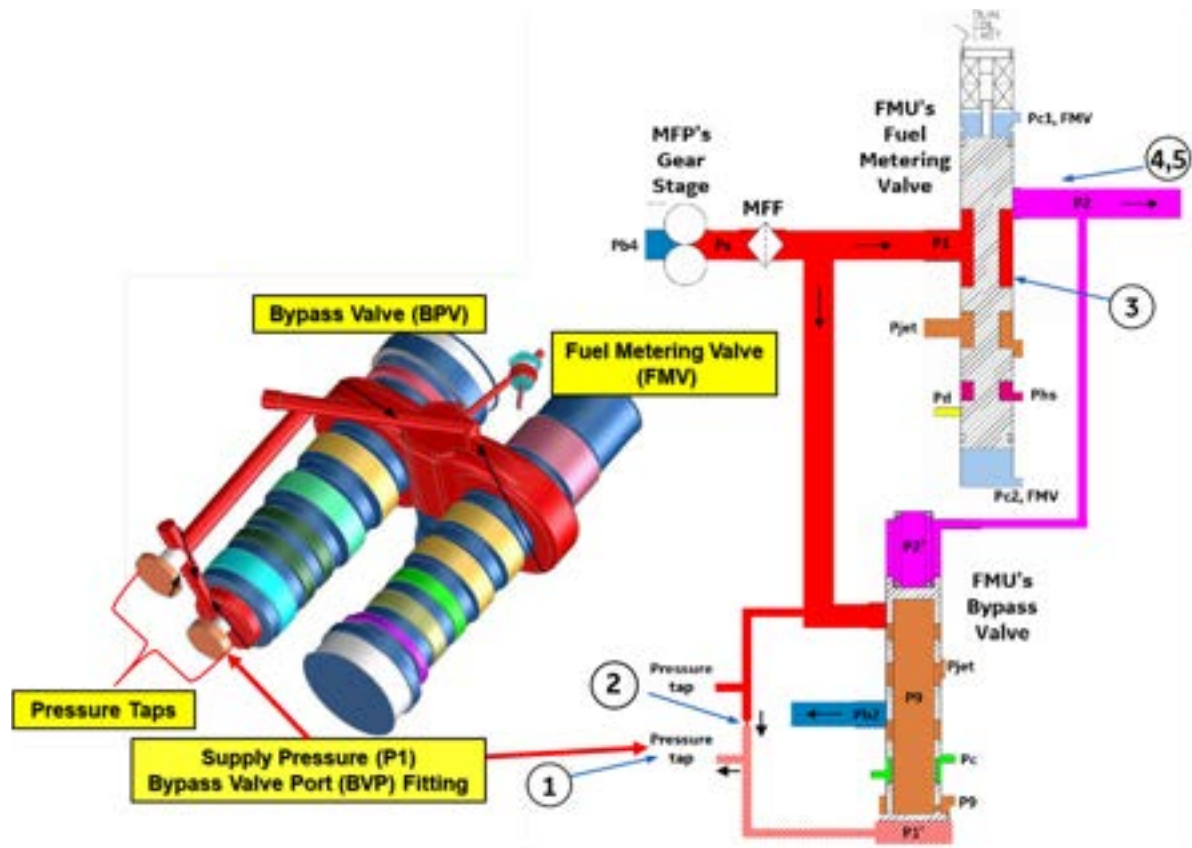
Figure 57: Internal structure of the FMU

- (3) The external fuel leak occurred at the P1 BVP fitting, i.e. the P1 sense line of the bypass valve (BPV). See ① in the figure above.
- (4) The leak caused the BPV to sense a different, lower pressure (P1') because flow across the damping orifice was metered. See ② in the figure above.
- (5) The BPV moved to a more closed position, resulting in higher delta pressure across the FMV, and therefore more flow thru the FMV. See ③ in the figure above.
- (6) FADEC commanded the FMV to a more closed position to maintain fan speed. See ④ in the figure above.
- (7) FADEC calculated fuel flow based on FMV position. The actual flow was higher than calculated, due to the higher delta pressure across the FMV. See ⑤ in the figure above.
- (8) When FADEC demanded additional fuel flow to protect against flame-out, additional fuel was sufficient to result in N1 reaching the FADEC overspeed limit.

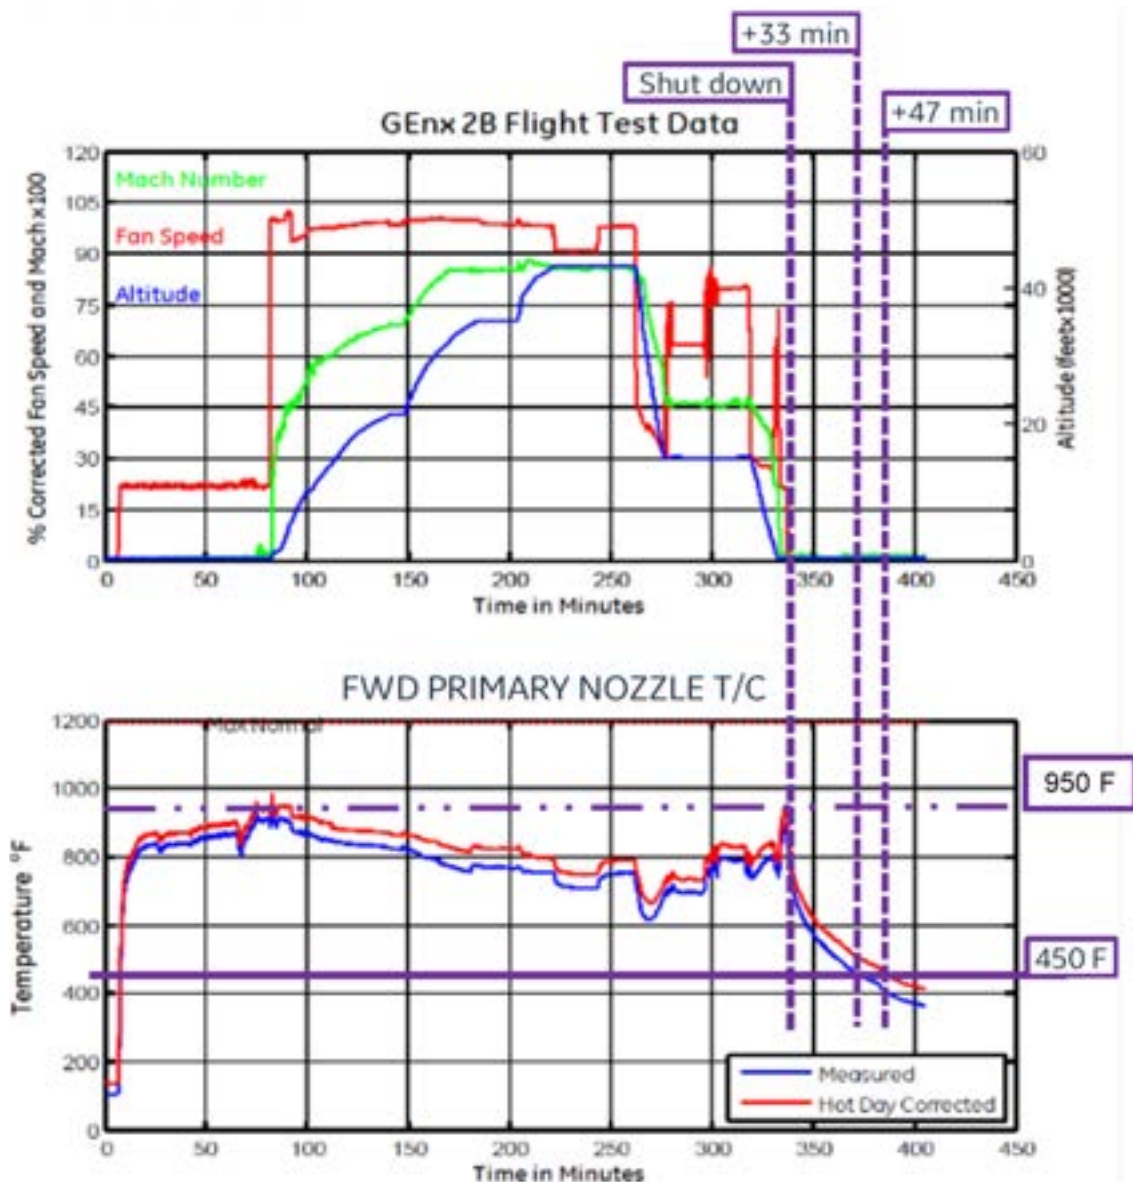
Figure 58: Post-Shutdown Surface Temperatures of Genx-2B Engine

- (2) During normal operation, even at ground idle or after the engine shutdown, the surface temperature of multiple parts in the aft section of the core compartment exceed 450 degrees Fahrenheit (°F), which is the auto-ignition temperature of the fuel in still air.
- (3) After the engine shutdown, forward primary nozzle temperatures was above 450 °F for at least 33 minutes as tested, and 47 minutes when corrected for hot day conditions.

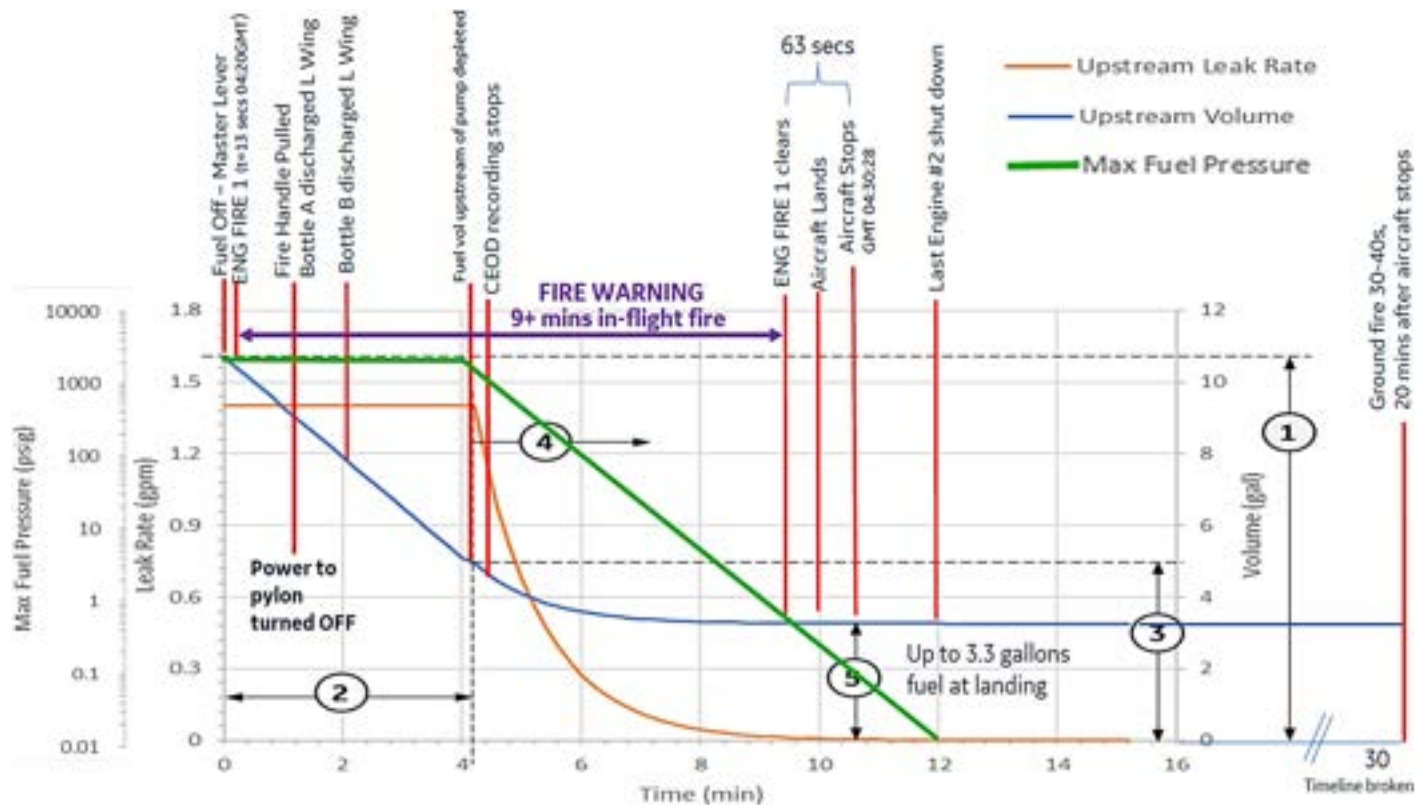
Figure 61: Timeline of Upstream Fuel Volume / Leak Rate with Key Events

- (4) When fuel was shut off, 9.7 gallons of fuel ((A): 4.7 gallons + (B) : 5 gallons) were trapped between the spar valve and HPSOV. This volume expanded to 10.7 gallons due to the thermal expansion of the fuel. The upstream leak was from the P1 bypass valve port fitting of the FMU. See ① in the figure above.
- (5) The upstream static volume of fuel ((A)) was being drained by the boost pump. Gear stage performance (and the FMU leak rate) was maintained. The FMU leakage continued at the rate of around 1.4 gallons per minute (gpm). See ② in the figure above.
- (6) The upstream static volume of fuel ((A)) was depleted around 4 minutes after shutdown until the trapped fuel from the spar valve to the inlet of the main fuel pump was exhausted. 5 gallons of fuel remained in the total upstream recirculating system ((B)). See ③ in the figure above.

- (7) Gear stage performance degraded as recirculating bypass volume (C) was reduced. The pump performance (therefore FMU leak rate) was assumed to decay linearly with respect to the remaining bypass volume. See ④ in the figure above.
- (8) Bypass volume (C) was depleted. The remaining volume approaches 3.3 gallons in the total upstream system. FMU leak was no longer pressure driven but due to gravity/drip only that occurred about 10 minutes after engine shutdown, shortly before landing. See ⑤ in the figure above.

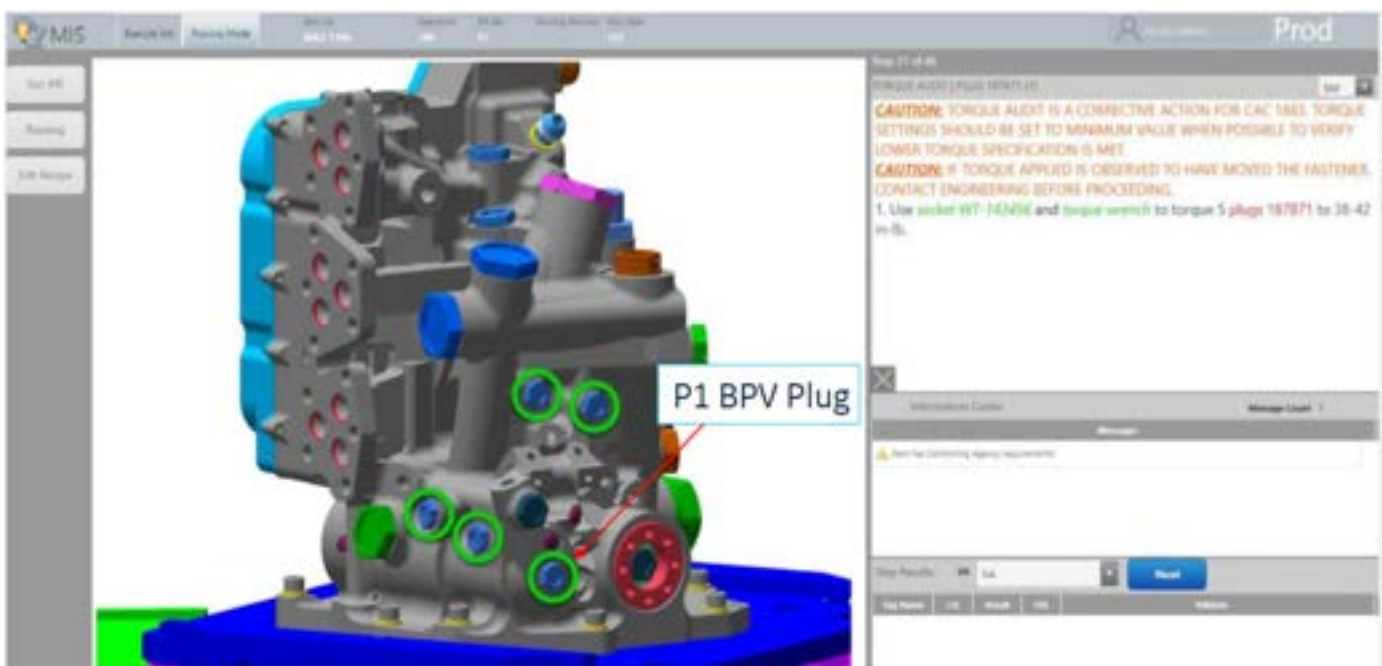
Figure 62: Revised MIS Instructions to Include Torque Audit

- (1) The assembly process at the time of unit assembly was to install 7 similar fittings and then tighten them. There was no one-over-one torque verification in place at the time of this unit's manufacture date, 20 November 2019.
- (2) Production Manufacturing Integration System (MIS) instructions for assembling the FMU were revised to include the torque audit on 30 December 2019. Torque audit is 100% torque verification. All threaded plugs are independently verified to proper torque value by an independent operator prior to safety cabling and final inspection.

- (3) After the occurrence, the repair and overhaul facilities also established the torque verification procedure of the P1 bypass valve port fitting on 4 October 2021. The fitting is independently verified to proper torque value by an independent operator prior to safety cabling and final inspection.

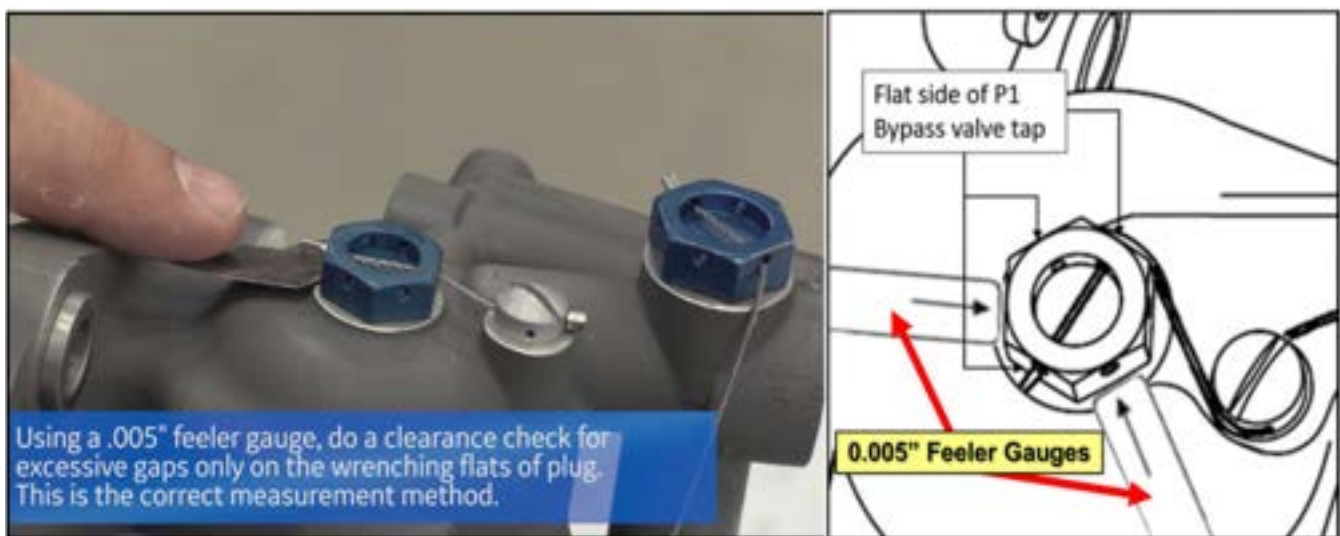
Figure 65: 0.005" Shim Check

- (1) GE issued SB 73-0092 R00, namely FMU Bypass Valve Plug Clearance Inspection, on 3 December 2021. The Service Bulletin is applicable to all GENx-2B engines with specific FMU criteria.
- (2) The SB provides inspection criteria and both on-wing and off-wing instructions of 0.005" shim check to verify that the P1 bypass valve port fitting on the FMU is properly installed.

- (3) Also, the SB provides the instructions to correct any defect and defines all of the hardware required.
- (4) Since the concerned FMU can also be installed on GENx-1B model turbofan engines, a similar SB was issued for all GENx-1B engines with specific FMU criteria, reference SB 73-0100 R00.

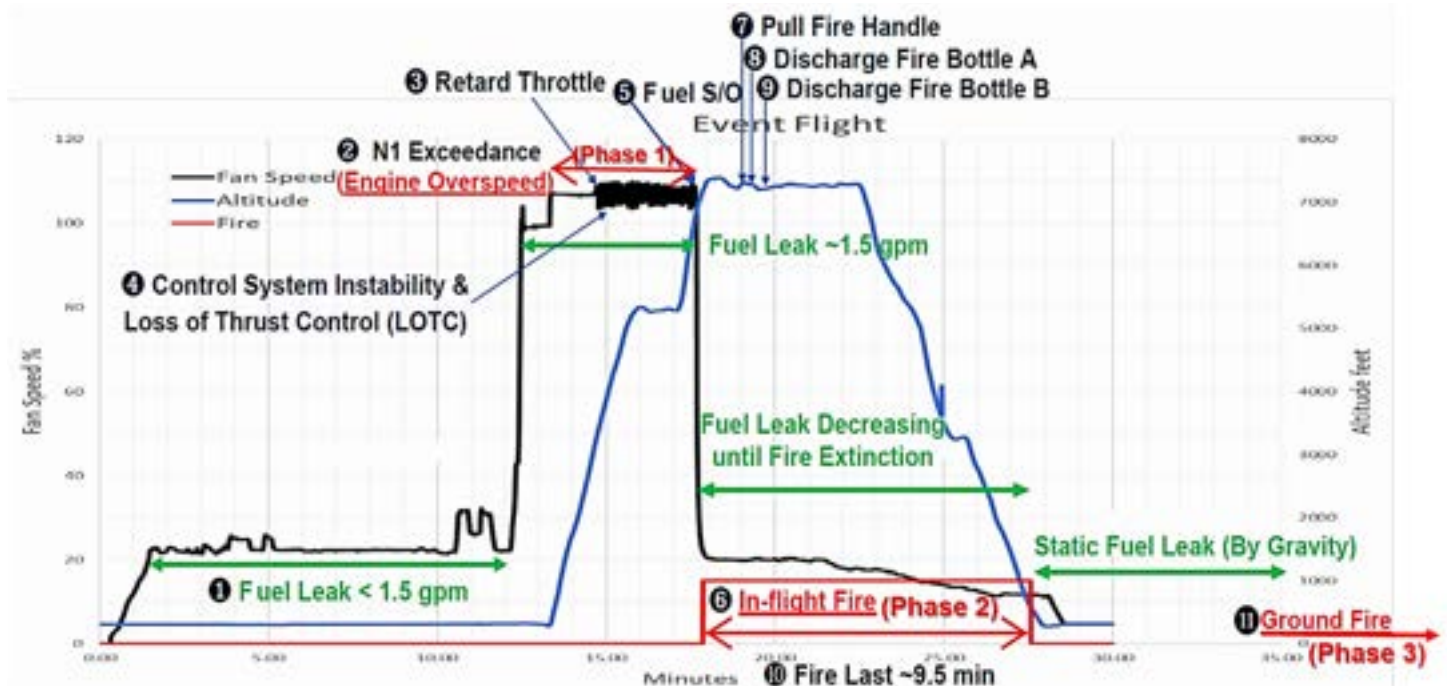
Figure 66: Three Key Phases of the Event

- (1) The FMU leak started at idle. See ❶ in the figure above.
- (2) During the take-off roll, the N1 exceedance warning was annunciated. See ❷ in the figure above.
- (3) The engine did not respond to throttle reduction. The engine control system became unstable and LOTC occurred. See ❸ and ❹ respectively in the figure above.
- (4) Fuel was shut off and the fire started 12 seconds after engine shutdown due to a reduction in under-cowl airflow and ignition on the hot surfaces. See ❺ and ❻ respectively in the figure above.
- (5) The flight crew pulled the fire handle to isolate the engine from the aircraft and discharged fire extinguisher bottle A. See ❼ and ❽ respectively in the figure above.
- (6) The fire warning remained and the flight crew immediately discharged the fire extinguisher bottle B. See ❾ in the figure above.
