Serious incident between the Cessna Citation 525 CJ
registered **F-HGPG**
operated by Valljet
and the Embraer 170
registered **F-HBXG**
operated by HOP!
on 12 January 2022
en route south of Auxerre (Yonne)

Safety investigations

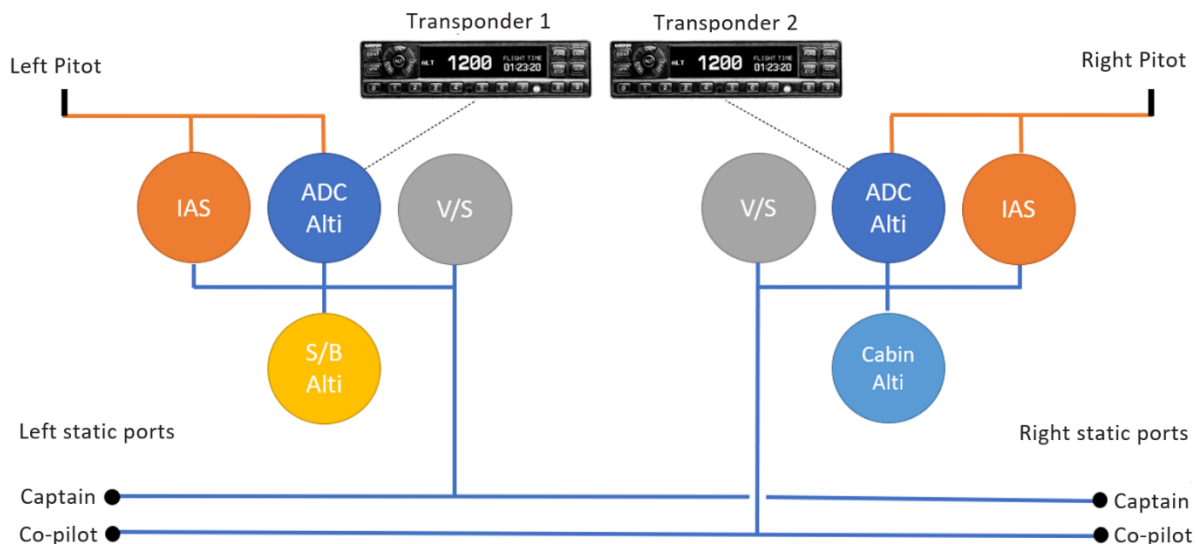
Figure 2: schematic diagram of F-HGPG air data systems (source: BEA)

Based on the operating principle of the airspeed indicators, the main effect, in climb, of a partial or total obstruction of a Pitot tube or the associated hoses will be an increase in the airspeed indicated by the corresponding system.

The technical examinations carried out on the air-data system after the serious incident did not identify with certitude, the cause of the fault. However, the symptoms reported by the pilots during the occurrences (see paragraph 1.11.2) in 2017, 2019, 2021 and 2022 (increase in indicated airspeed during climb, difference between the two altimeters and disappearance of anomalies during descent) suggest that:

- the fault was probably situated in the hoses between the Pitot tube and the airspeed indicator of system 1. It might have been a total or partial obstruction in one place;
- the cause of the obstruction was very probably environmental (liquid water or ice which would have disappeared during the descent).

The presence of a low point in the left Pitot tube hose could have created conditions conducive to partial or total obstruction.

Following the examinations carried out with the BEA which led to the removal and replacement of the Pitot tube of system 1 and the hose with the elimination of the low point, the aeroplane was returned to service at the beginning of March 2022. At mid-April 2023, no fault of the air data system had been reported again.
