# AIRCRAFT ACCIDENT REPORT 2/2023

Report on the accident to  
**Sikorsky S-92A, G-MCGY**  
at Derriford Hospital, Plymouth, Devon  
on 4 March 2022

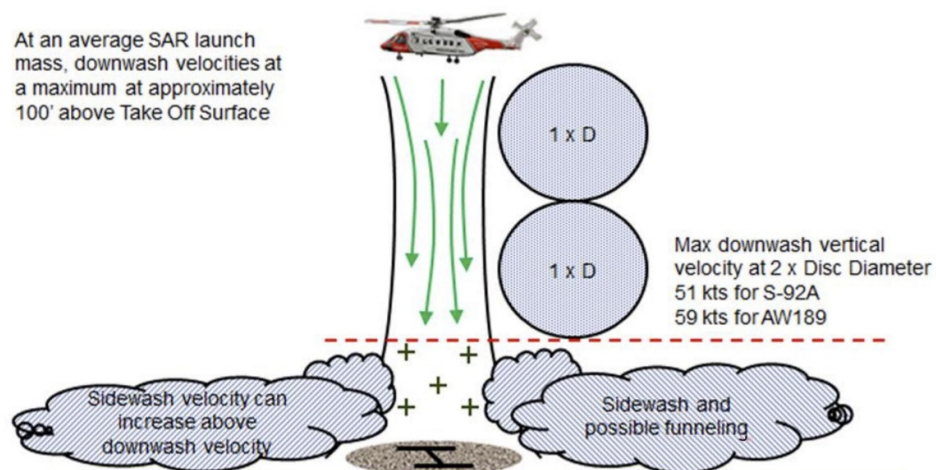
**Figure 2**

The helicopter operator's Operations Manual (OM) contained a section that described downwash and its hazards. It stated that the maximum downwash velocity for the S92 is about 51 kt (26 m/s). The manual indicated that this occurs approximately 100 ft (two rotor diameters) below the helicopter (Figure 2). GMCGY passed through 100 ft agl about 25 seconds before landing. At this time, it had about 68% twin-torque power applied.

Diagram of maximum downwash from operator's OM

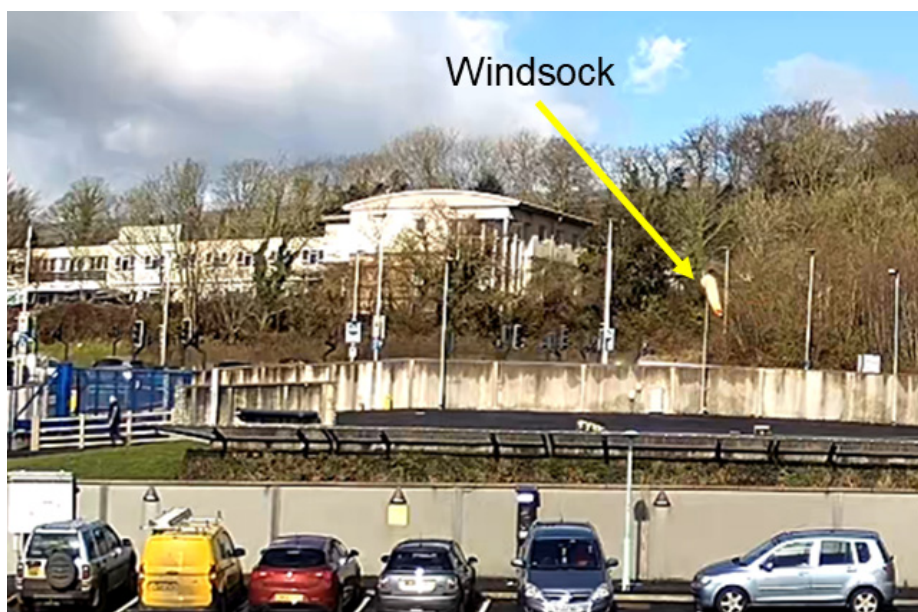
**Figure 3**

CCTV of the HLS windsock at DH indicated that the wind was light from the north-west. A still image taken from the recording shortly prior to the helicopter landing is shown in Figure 3.

Picture of the windsock at DH HLS shortly before the helicopter landed

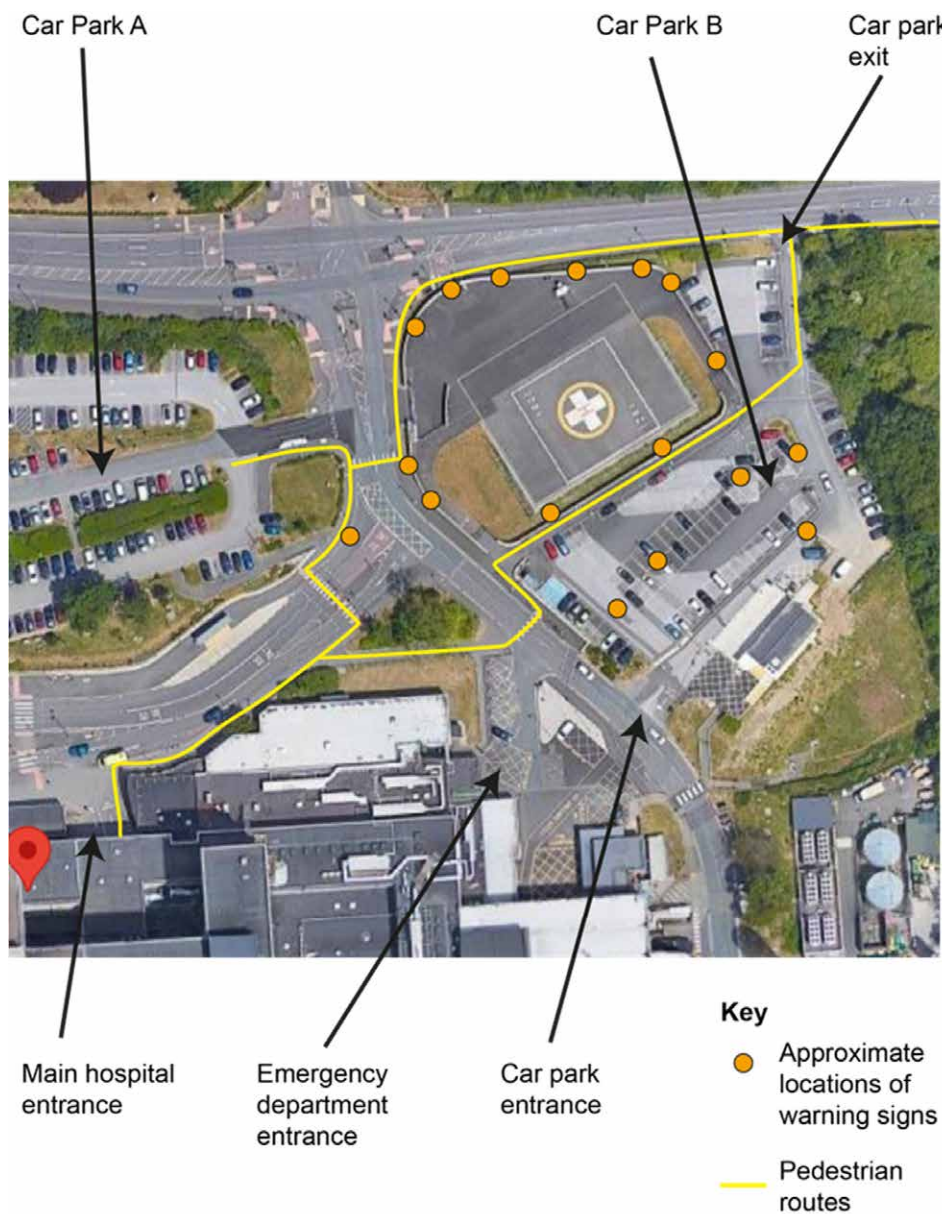
**Figure 7**

approaching the hospital from the east along the public road (Miller Way) which is on the north side of the HLS (Figure 7). There is also a pedestrian route passing to the north of the HLS along this public road.

Overview of the HLS pedestrian environment  
 © 2023 Google, Image © Landsat / Copernicus

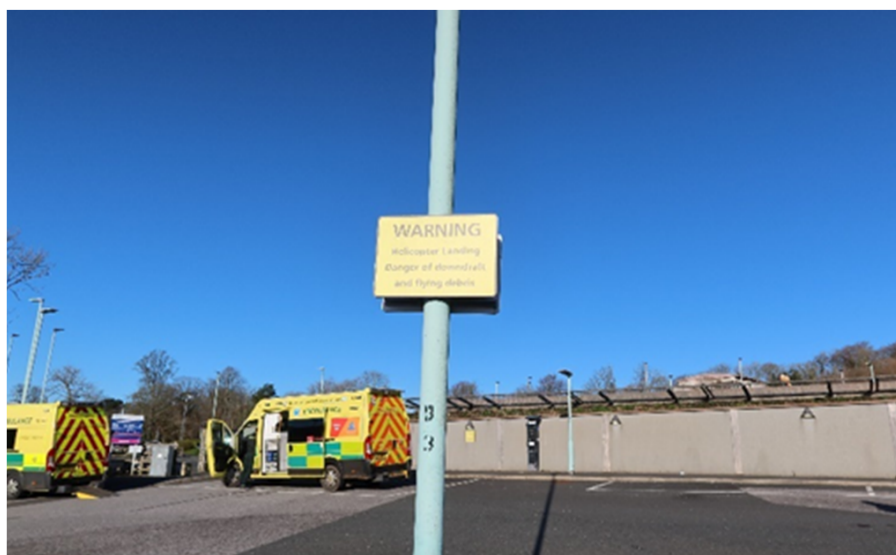
**Figure 9**

Warning signs stating ‘*Helicopter Landing Danger of downdraft and flying debris*’ were attached to the outside perimeter of the HLS at regular intervals (Figure 8). The same sign was also mounted on lighting posts and bollards at other locations throughout the car park and on the road (Figure 9).

Warning sign repeated in Car Park B

These safety signs were not installed when the helipad opened. DH reported they were installed at a later date as part of the action taken in response to downwash complaints and incidents. The timeline and decision process were not documented in the risk assessment or post-incident investigation documentation that were provided to the AAIB.

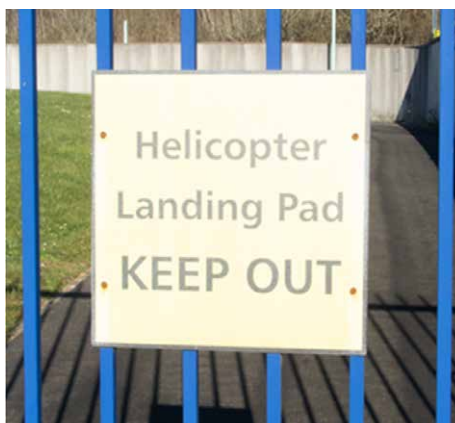
**Figure 10**

The HLS gates were marked with a specific instruction to '*KEEP OUT*' (Figure 10).

Sign attached to the HLS gates

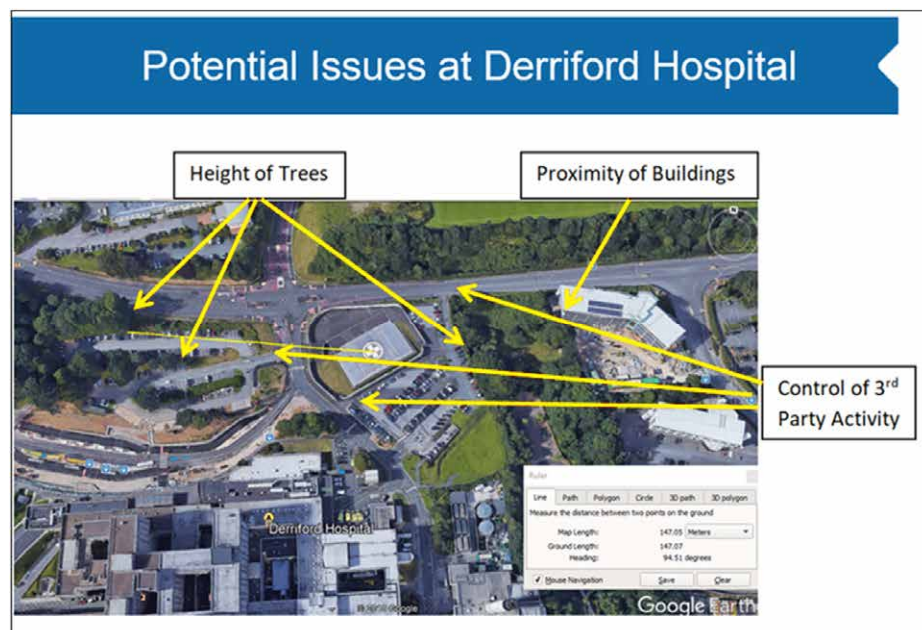
**Figure 19**

During a 2020 meeting with the DH HLS risk assessor, the operator's representative recalled delivering a presentation that included one slide that highlighted the control of third parties around the HLS as an issue (Figure 19). The slide pack for this presentation included more than 50 slides and covered multiple aspects including regulation, safety management and helicopter performance. He reported delivering the same presentation to the DH Head of Estate Site Management in 2019. The hospital risk assessor recalled that the material presented was "really technical" and "didn't register."

Based on slide from the helicopter operator's presentation to the hospital Trust in 2019 and 2020 (arrow colours changed to improve accessibility)

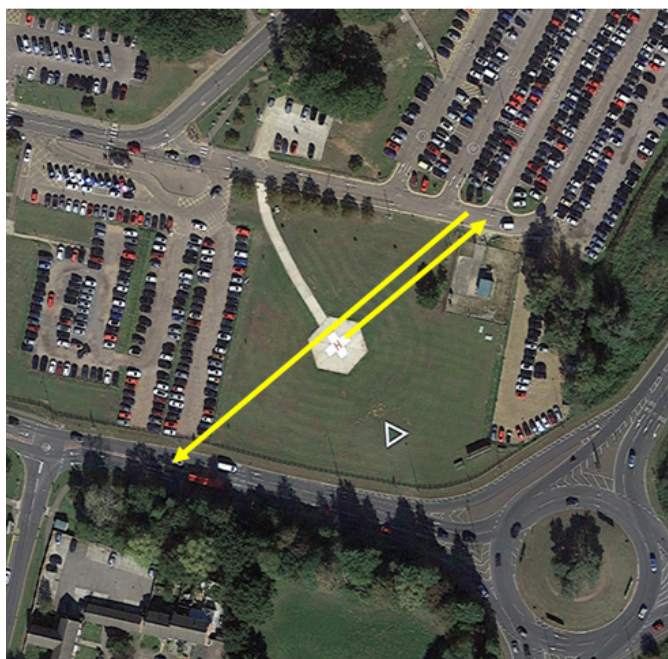
**Figure 20**

The QEH HLS is situated within a grassed level area in the south-east corner of the hospital grounds (Figure 20). The grassed area has a hospital car park 36 m to the west of the centre of the HLS. To the south, 48 m from the centre of the HLS, runs a major road and, 49 m from the centre of the HLS to the north, is an access road to another hospital car park.

The crew of the helicopter were unaware of this incident when they departed. The helicopter's operator was notified by QEH after the vehicle owners made the hospital's Emergency Planning Officer aware of the damage.

The HLS at QEHS, King's Lynn showing the rearward takeoff departure track  
© 2022 Google

As a result of this incident the hospital has established a monthly road sweeping programme.

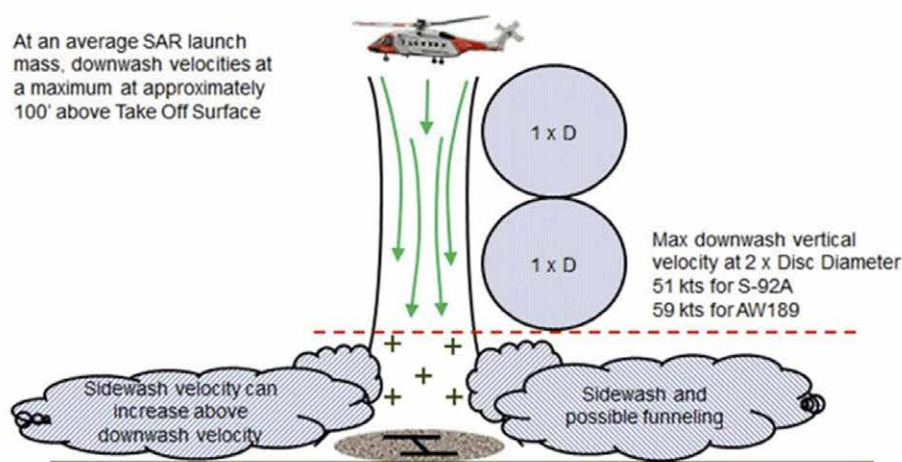
**Figure 8-10 Downwash and Sidewash**

The further effects of downwash occur when objects funnel the downwash (as shown below) once it has hit the ground: this effect is known as sidewash and may see the 2D value of the air increase velocity again, possibly by up to 10 knots.

In summary, the airstream under a high-density disc aircraft may approach that of a Category 1 Hurricane (64 knots sustained).

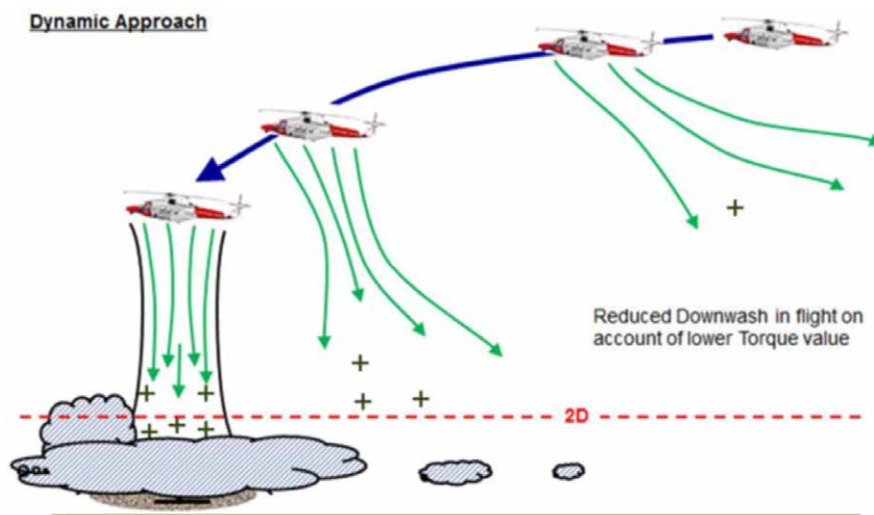
**Figure 8-11 Dynamic Approach**

*A steeper than normal dynamic manoeuvre, if available as an option, will be the best way to reduce the time that downwash has to build during the approach and affect the site below: in other words, delaying the point at which the downwash ‘touches down.’ This may be PC 2 rather than PC 1 and is shown below:*
