الهيئة العامة للطيران المدني
GENERAL CIVIL AVIATION AUTHORITY

Serious Incident

AAIS Case N° AIFN/0004/2021

Smoke/Fire from Windshield Window

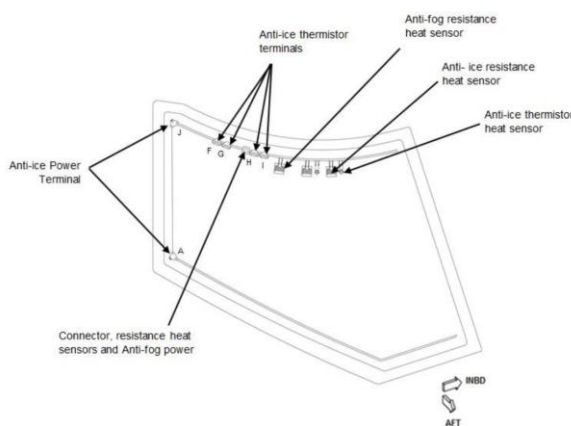
Figure 2. Windshield terminal locations - Left windshield

The windshield terminal references are shown in figure 2 which refers to the *component maintenance manual (CMM)*.
