# Aviation Investigation Final Report

| <b>Location:</b> | Broomfield, Colorado | <b>Incident Number:</b> | DCA21FA085 |
| <b>Date &amp; Time:</b> | February 20, 2021, 13:09 Local | <b>Registration:</b> | N772UA |
| <b>Aircraft:</b> | Boeing 777-222 | <b>Aircraft Damage:</b> | Minor |

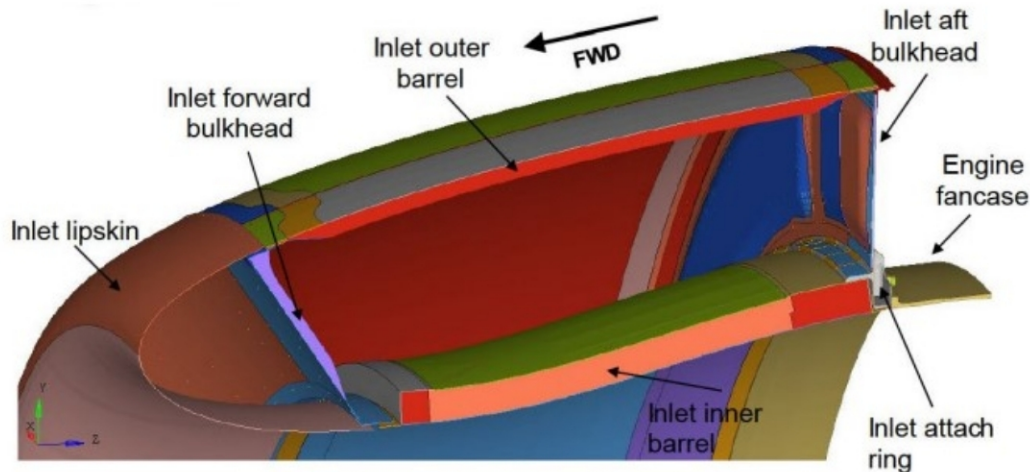
**Figure 4.** Inlet cross-section drawing for 777-200 (Source: Boeing).

The engine inlet is a cantilevered structure attached to the forward flange of the engine fan case through the inlet attach ring with 52 bolts. The inlet consists of two concentric cylindrical structures joined together by forward and aft bulkheads (see figure 4). The hollow aluminum lip skin is attached to the forward bulkhead and provides an aerodynamic surface for the leading edge of the inlet and a passage for engine anti-ice air. The inlet aft bulkhead consists of the aluminum inlet attach ring and aluminum outer ring chord with a CFRP honeycomb sandwich composite web. The inlet forward bulkhead consists of the aluminum inner and outer ring chords with a stiffened aluminum web.

The inlet outer barrel comprises three CFRP honeycomb sandwich panels. A section of the outer barrel in the lower right quadrant is comprised of a titanium skin, where the anti-ice exhaust duct is located. The inlet inner barrel is comprised of two CFRP honeycomb sandwich panels. The inner face sheet of the inner barrel is perforated for noise suppression and the outer face sheet is solid.
