State of Israel Ministry of Transport and Road Safety Accidents and Incidents Aviation Investigation

Safety Investigation Report - Final (Final Investigation Report)

Incident File No. 38-21

Fuel Leak that led to Engine Shutdown followed by diversion to an Alternate

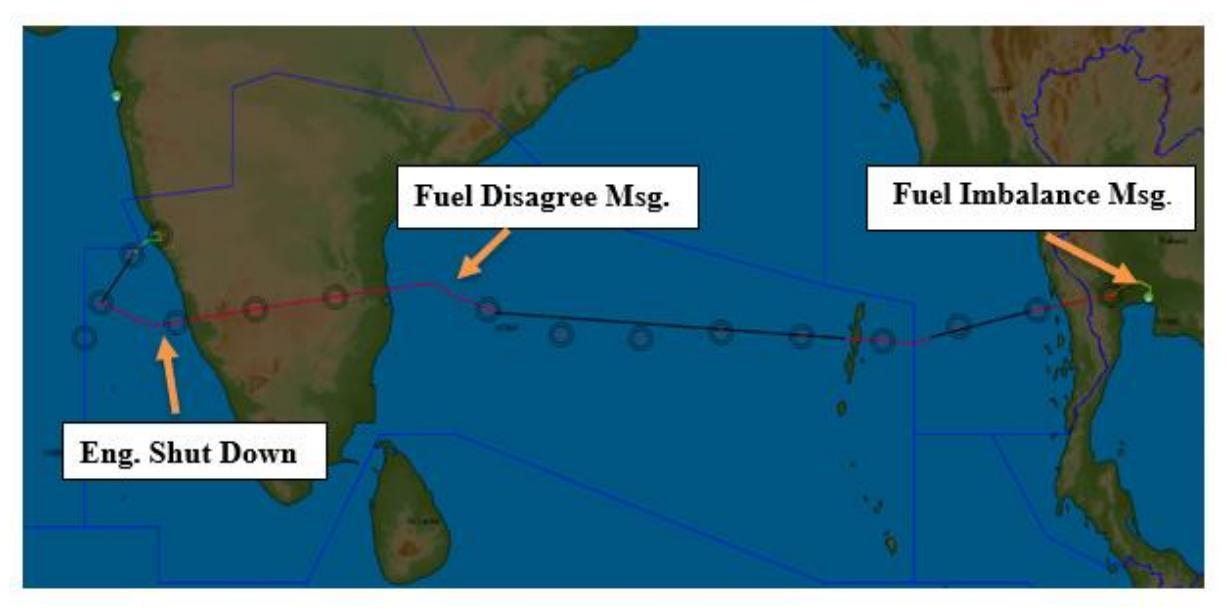
Figure 2 - Actual flight route

The crew decided to divert to a nearby airport, Goa (GOI), located about 120 miles from their position at that time (Figure 2).

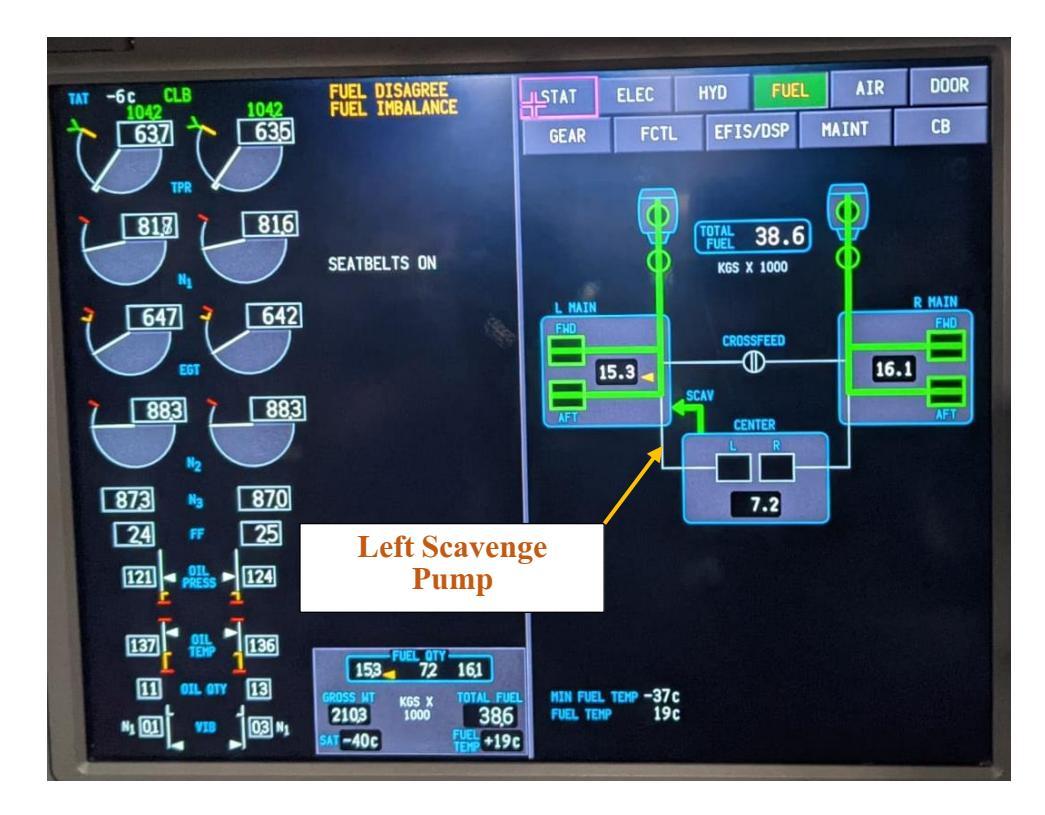
Figure 3 - "SYNOPTIC" display after turning off CENTER pumps and activation of the scavenge pump

- According to the "Fuel Imbalance" checklist the crew should not be balancing fuel between the wing tanks when Center Tank O/J pumps are ON.
- The "Fuel Disagree" checklist refers/directs the crew to deal with the wing "having the lower fuel quantity".
- The fuel leak test per the "Fuel Leak" checklist was "interrupted", due to the activation of the LH Center Scavenge pump after about 20 minutes, which interfered with the process (see Figure 3).

When L Main tank decreased to approximately 15,200 kg (see explanation in paragraph 1.6.9), the L Scavenge pump of the Center Tank began operating and started filling the L Main Tank with fuel from the Center tank (see Figure 3). At this stage, R Main Tank fuel quantity was above 16,600 kg and therefore R Scavenge pump was not operating (yet).

The crew was surprised by the trend reversal, checked the fuel display at the synoptic page and saw that the Center tank's L Scavenge pump commenced operating and began filling the L Main Tank (see Figure 3).

- While dealing with the "Fuel Leak" discrepancy at the stage of confirming a fuel leak (a difference of 500 kg within 30 minutes), the procedure was "disrupted" by the LH Scavenge pump activation (see Figure 3, which displays only LH Scavenge pump operation). See also flow chart of the "Fuel Leak" (U)NNC by the crew, as conducted in real time. See Appendix 3 FCOM UN-ANNUNICATED NNC "FUEL LEAK".
- The leak source in this event could not be detected per the "Fuel Leak" checklist (see explanation in paragraph 2.5).

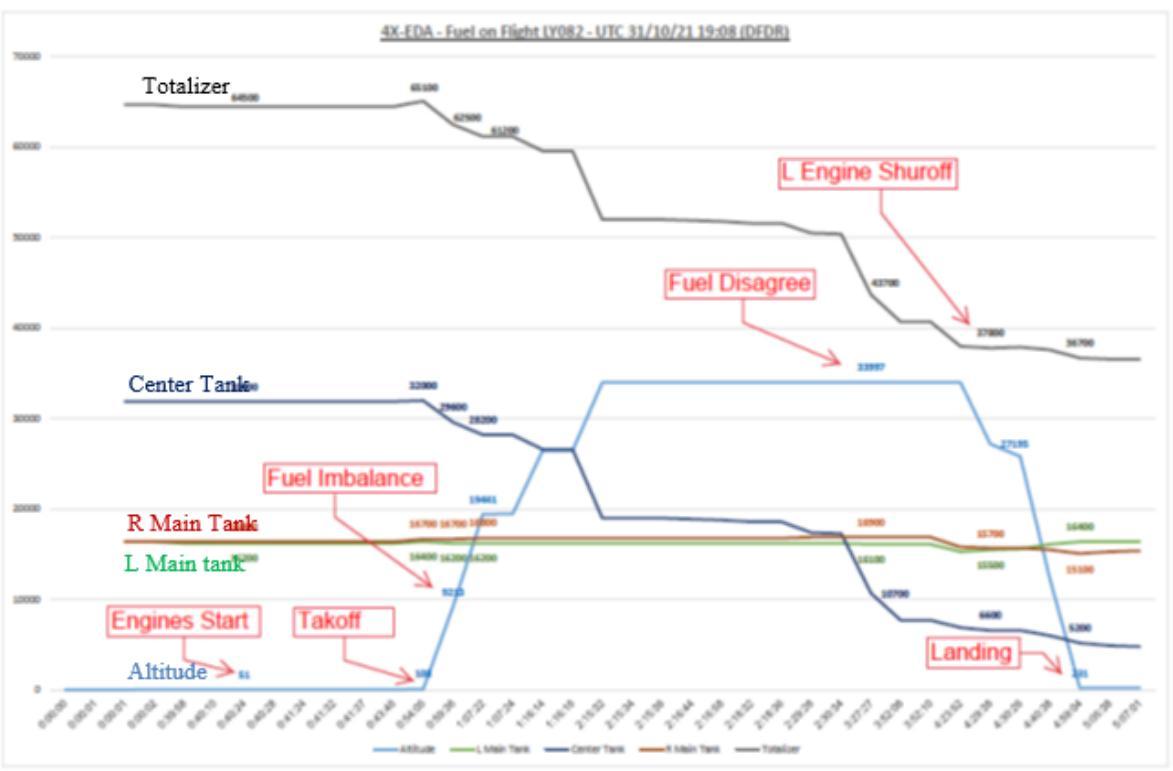
Figure 4 - Flight sequence of events and fuel chart

(Time history from recorded data)
