Centro de Investigação e Prevenção de Acidentes Aeronáuticos

Preliminary Report

Classification:	ACCIDENT
Type of Occurrence:	#ICE - FORMAÇÃO DE GELO #LOC-I - PERDA DE CONTROLE EM VOO
Date:	9 August 2024

Date (UTC):	9 August 2024
Time:	16:22
City:	VINHEDO - SÃO PAULO - BRASIL
Aerodrome:	OUTSIDE THE AERODROME
Local:	RESIDENTIAL AREA OF THE CITY
Damage to third parties:	YES

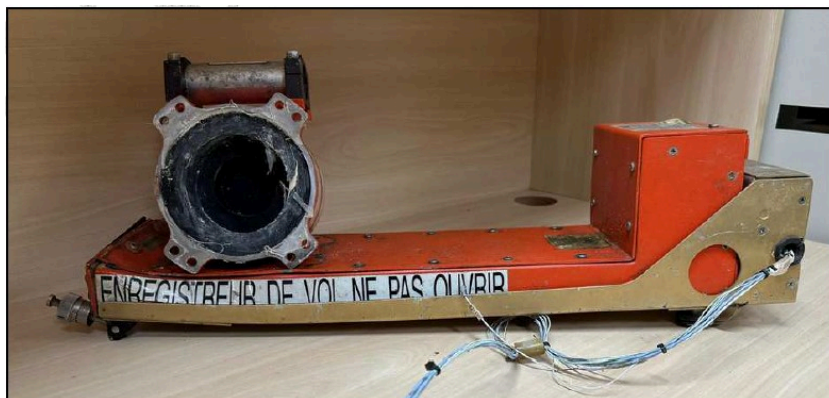
Figure 29 - Flight Data Recorder installed in the PS-VPB.

The aircraft was equipped with an FA2100 FDR L3 digital FDR, model 2100-2/4043, Part Number 2100-4043-00, Serial Number 000585479, with a maximum capacity of 256 words per second, ARINC 573/717 communication bus. The Flight Data Acquisition Unit (FDAU) installed in the aircraft had the Part Number ED34A350.

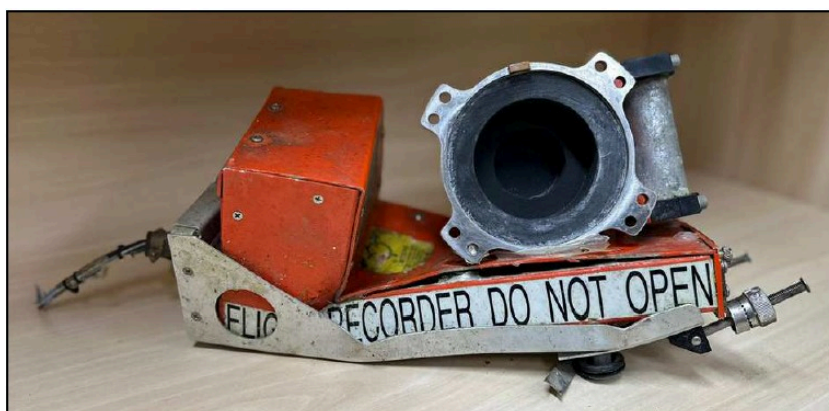
Figure 30 - Cockpit Voice Recorder installed in the PS-VPB.

Additionally, the aircraft was equipped with an FA2100 CVR L3 digital CVR, PN 2100- 1020-02, SN 01753, with software PN 840-E1657-01, capable of recording three High Quality channels of 30 minutes each, one High Quality Combined channel of 30 minutes each, and two Standard Quality channels of 120 minutes each.
