# Investigation Report

Type of Occurrence:	Serious Incident
Date:	20 December 2012
Location:	Phuket, Thailand
Aircraft:	Airplane
Manufacturer:	Airbus Industries
Type:	A330-223
Injuries to Persons:	No injuries
Damage:	Minor damage to aircraft
Other Damage:	None
State File Number:	BFU 6X015-12

Bundesstelle für  
Flugunfalluntersuchung

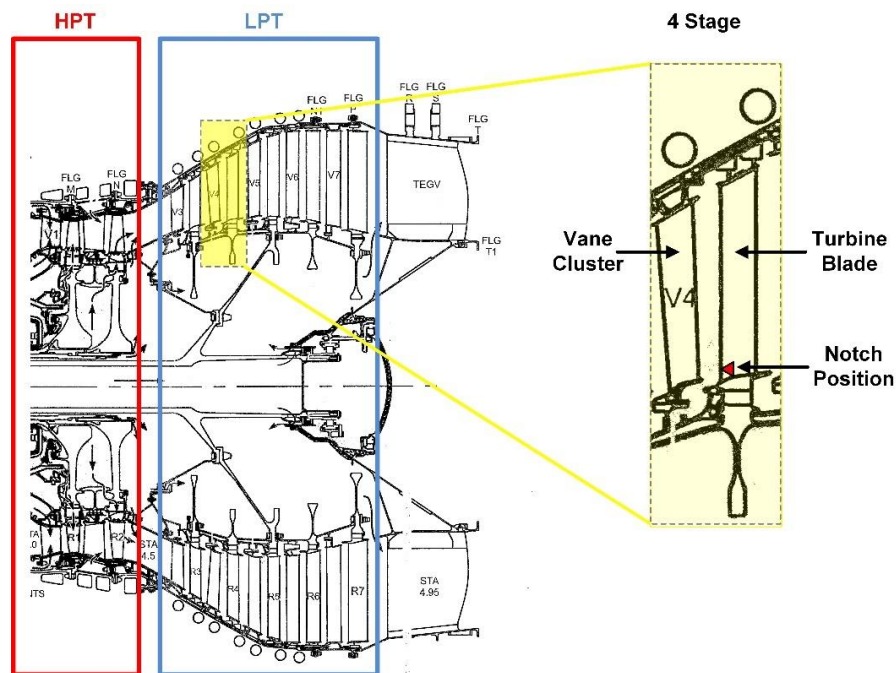
Fig. 8: Section drawing of the PW4000 turbine including depiction of the 4<sup>th</sup> turbine stage

The vane clusters Nos. 1, 4, to 38, 43 and 44 were engaged in the housing. The vane clusters Nos. 39, and 42 were not engaged in the housing. At the inner end they were displaced forward. The vane clusters Nos. 41 and 42 showed circumferential rub marks on their inner platform rear face. The trailing edge of the inner ends of the airfoils on vane cluster No. 42 also showed rub marks. The 4<sup>th</sup> rotor stage had a notch rubbed in on the leading edge of the blades in the transition area of the platform (Fig. 8 and Fig. 22).

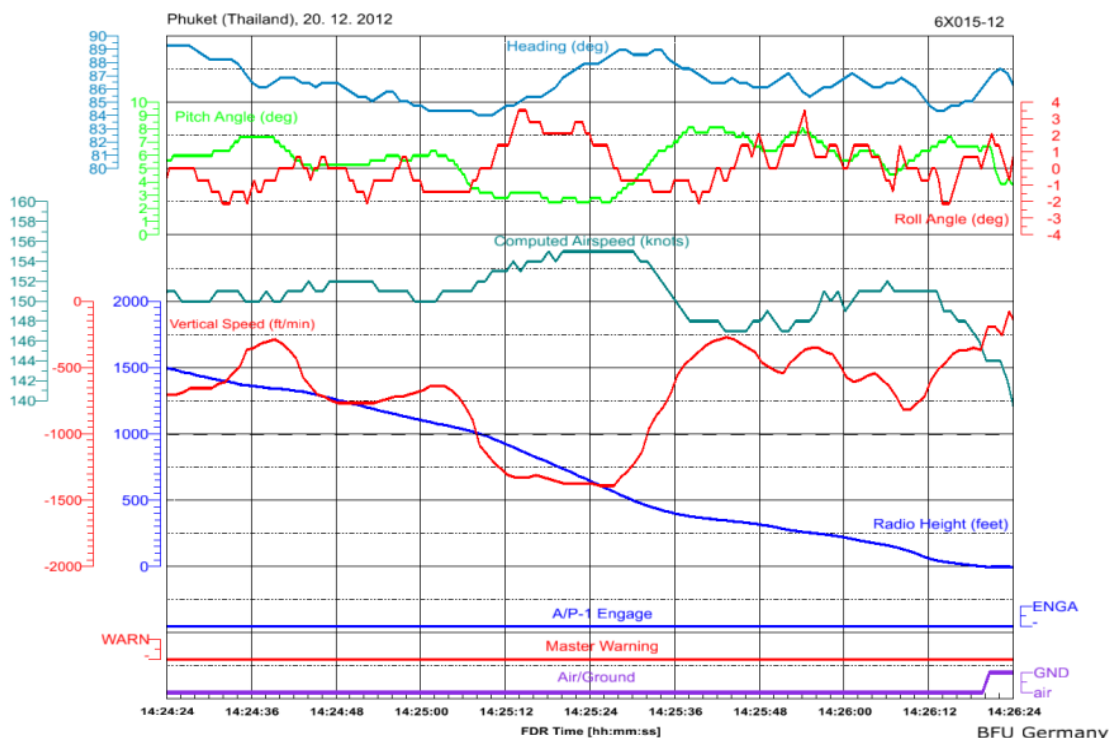
Fig. 20: FDR parameters: approach and landing

The  $V_{LS}$  for Config 2 position was 150 kt. The  $V_{APP}$  of the actual configuration was 165 kt. In fact, approach speed was between 147 kt and 155 kt, which means in a range requiring correction. During final approach between 1,000 ft AGL and 200 ft AGL maximum allowable vertical rate of descent (1,000 ft/min) was exceeded. In this flight phase, the criteria for a stabilized approach were no longer met. Despite these difficulties in meeting the parameters, the flight crew was able to land the aircraft in the Touchdown Zone.

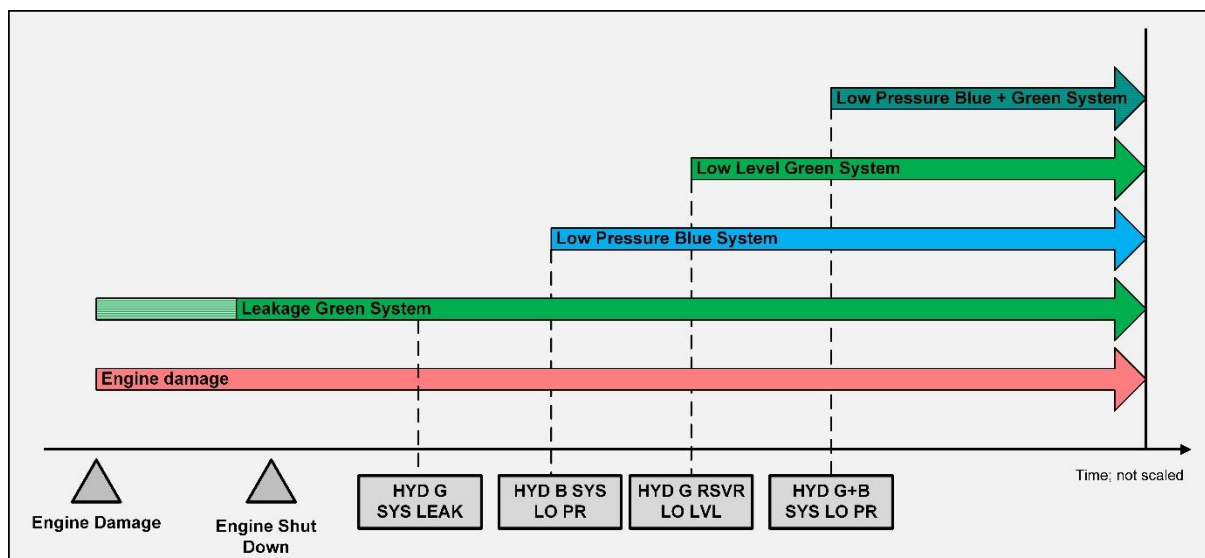
pressure because of lack of windmilling (decreasing RPM of the N2 rotor). It was not possible to anticipate the leakage of the green hydraulic system.

Fig. 26: Schematic sequence of events, which resulted in double hydraulic system failure

The boxes correspond with the ECAM indications. The green-white dashed line depicts a phase where it is unknown whether leakage had already occurred. Green and blue and green-blue dashed lines, respectively, correspond with the depicted hydraulic systems.

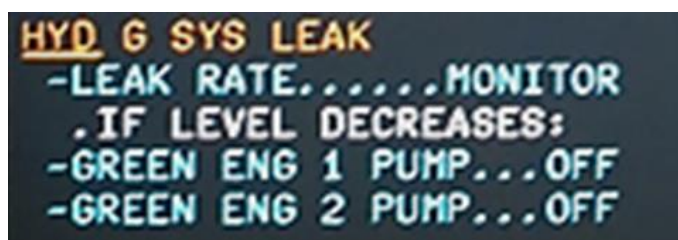
The completion of the ECAM actions is of particular importance. The flight crew was made aware of the leakage of the green hydraulic system for the first time by the warning HYD G SYS LEAK.

Fig. 27: ECAM HYD, G SYS LEAK

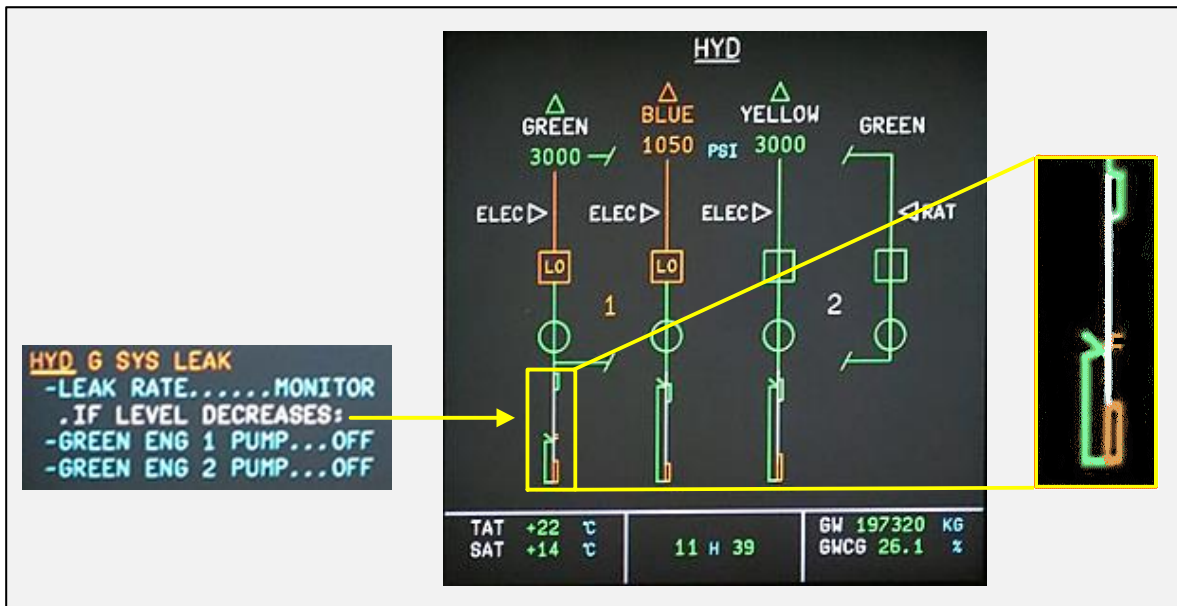
now)” is contradictory and shows that the flight crew had not assessed the available information correctly. It is obvious that the hydraulic pressure was interpreted as Leak Rate.

At the hydraulic page, only the reservoir and the hydraulic pressure were indicated, but not the leak rate.

Fig. 28: Indication of the hydraulic levels

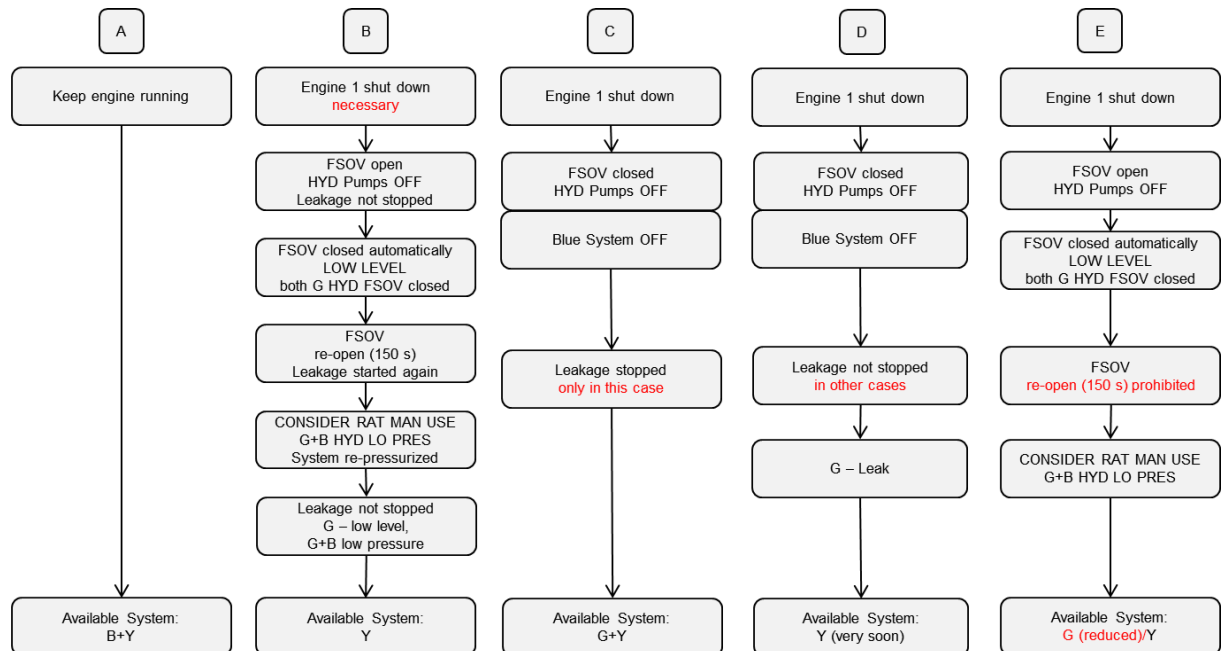
The BFU assessed whether and under which conditions, the redundancy of the complete hydraulic system (Green, Blue and Yellow) could have been improved (Fig. 29).

Fig. 29: Scenarios for possible actions and their consequences during this occurrence
