# Flight preparation event involving Airbus A350-941, 9V-SHH

Brisbane Airport, Queensland, on 27 May 2022

AO-2022-032 Final – 15 March 2024

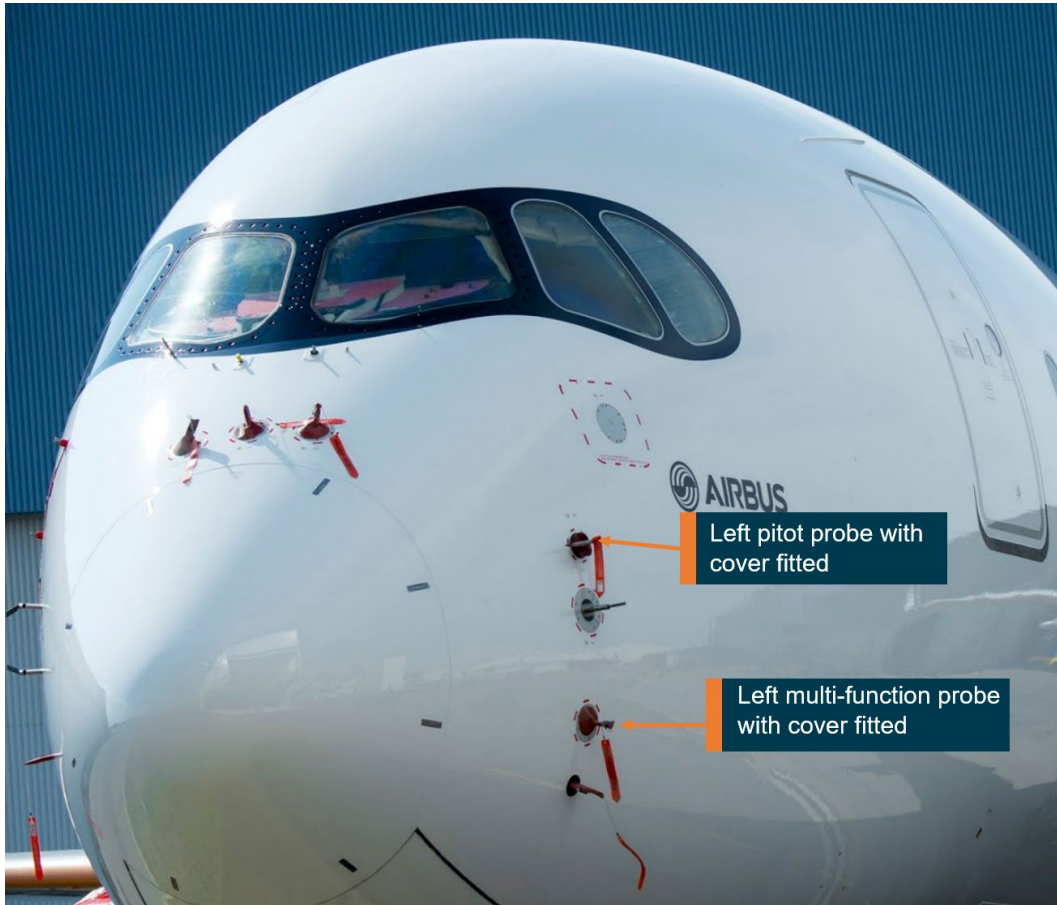
**Figure 4: Airbus A350 aircraft showing left side probes with covers fitted**

Pitot probes (or part of the multi-function probes) are components of the aircraft’s pitot-static system. The Airbus A350 has 4 probes, which are attached to the nose of the aircraft (Figure 4). The pitot probe consists of a tube pointing directly into the airflow, measuring the stagnation pressure called total pressure. This total pressure information and the static pressure delivered by static ports on the fuselage are used to compute the aircraft’s indicated airspeed and Mach number. If the tube is partially or completely blocked, airspeed indications will be inaccurate. Airspeed is a critical parameter for flight.
