Final Report

**EgyptAir A320 Aircraft crash in the Mediterranean, registered SU-GCC,
flight number MSR804, from Charles De-Gaulle Airport, Paris to Cairo
International Airport, on 19/05/2016**

EGAI2016-01

October 2024

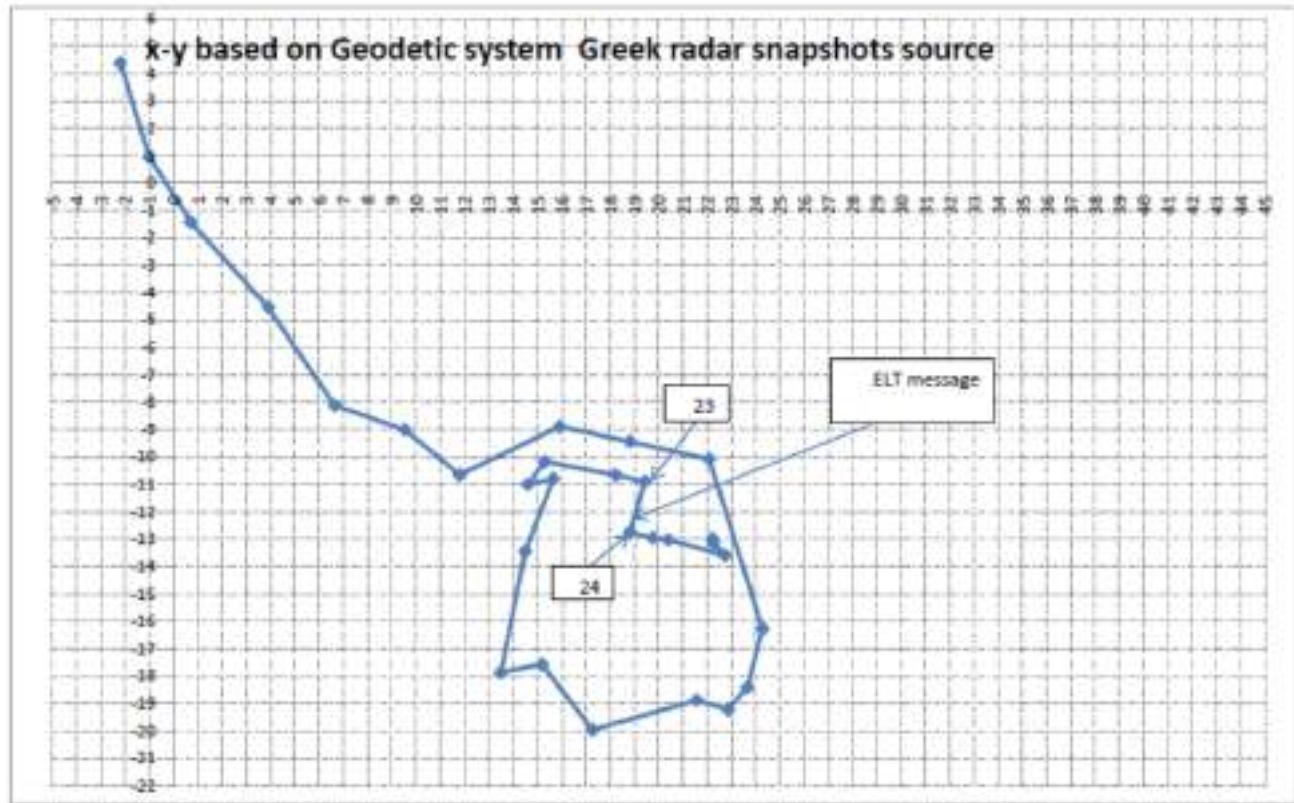
- There were at least 6 radar return points from snapshots Greek radar data after the ELT message (covering 1 minutes, 51seconds after ELT message).
- It can be concluded that the aircraft was still in the air when the ELT message was originated, excluding the probability that the ELT message was originated because of hitting the water.

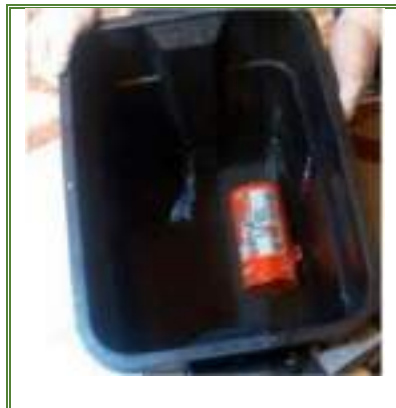
Figure 1.11/2: CSMU received in water

The CSMU was removed from the container of fresh water and examined. There were no visible markings on the CSMU indicating the part or serial number. The CSMU had damage indicative of significant impact forces including:

- Chips in the paint;
- Significant gouges in the external surface of the CSMU case;
- 3 of the 4 mounting brackets that secure the CSMU to the chassis broken off;
- Shearing of the flex cable between the CSMU and the chassis;
- Absence of the one of two Underwater Locator Beacon (ULB) mounting brackets and the ULB;
- Structural failure of the second ULB bracket.

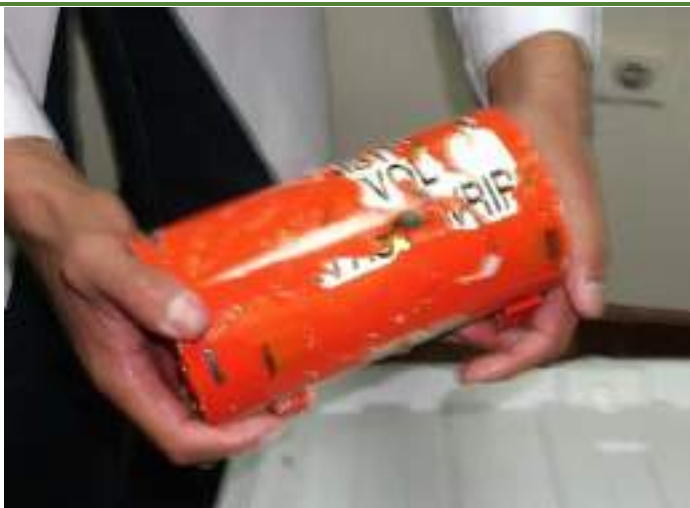
The CSMU was removed from the container of fresh water and examined. There were no visible markings on the CSMU indicating the part or serial number. The CSMU had damage indicative of significant impact forces. The CSMU had damage indicative of significant impact forces including:

- Chips in the paint;
- Significant gouges in the external surface of the CSMU case;
- 2 of the 4 mounting brackets that secure the CSMU to the chassis broken off;
- Shearing of the flex cable between the CSMU and the chassis;
- Absence of the one of two Underwater Locator Beacon (ULB)
- Mounting brackets and the ULB;
- Structural failure of the second ULB bracket

Figure 1.11/4 : Missing decals, paint chips and gouges in the CSMU

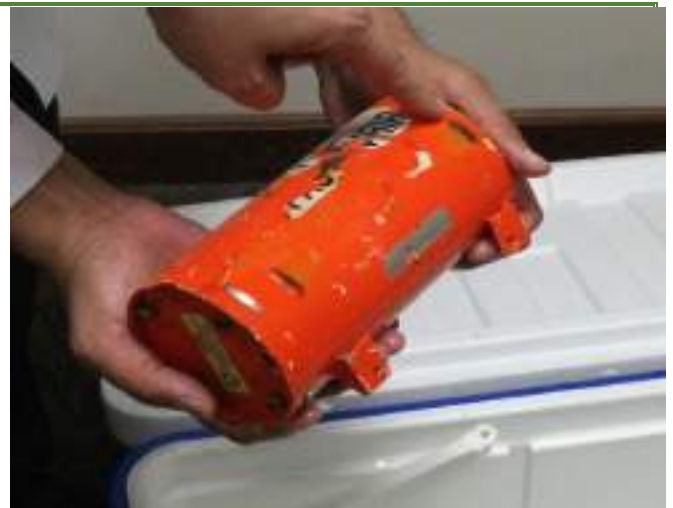
Figure 1.11/5: Two of four mounting brackets missing

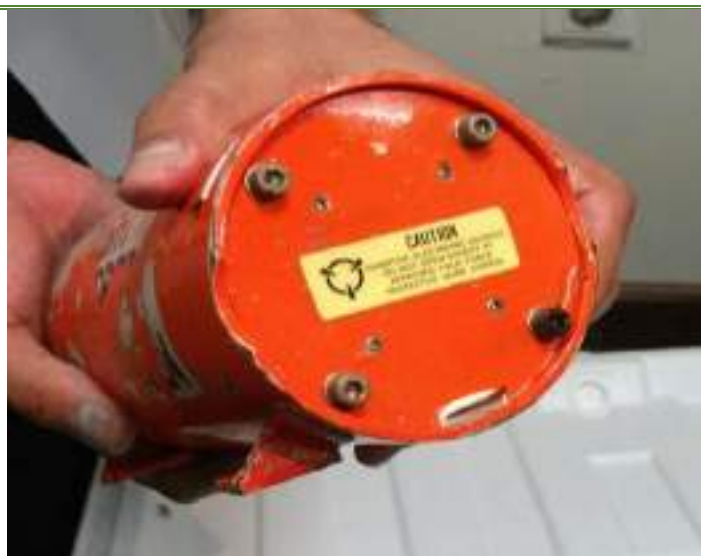
Figure 1.11/6 : Sheared flex cable

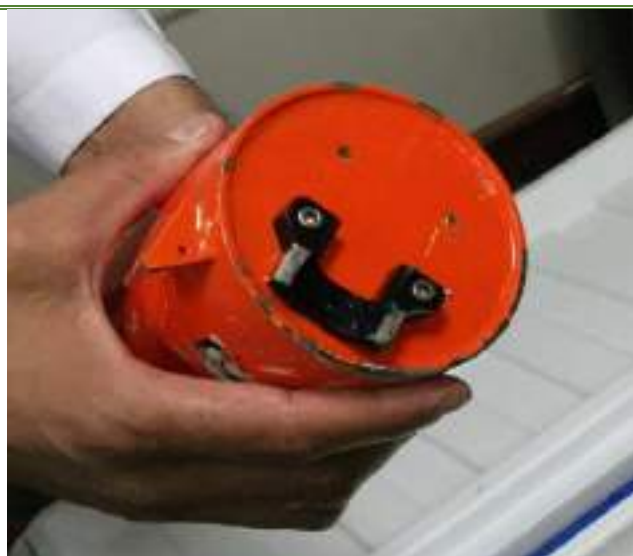
Figure 1.11/7:ULB bracket failure
and the second bracket missing

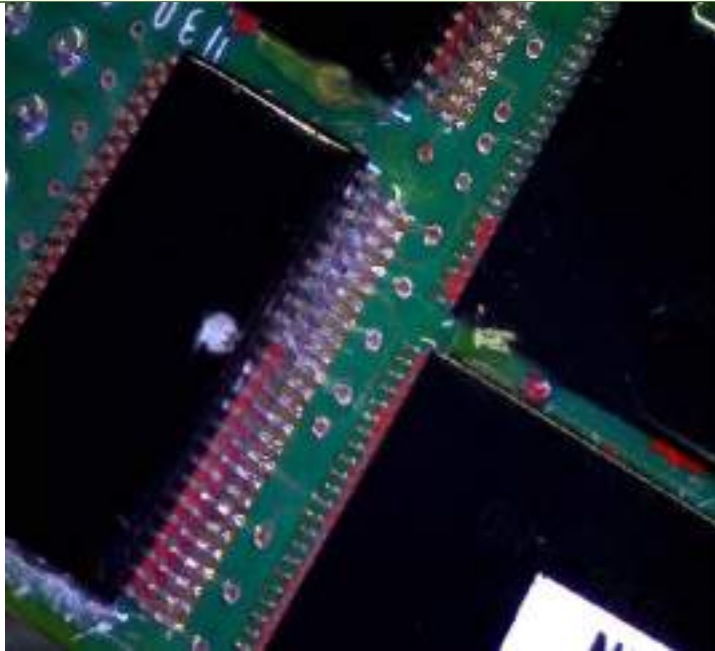
The board was then examined with the electronic microscope. The effects of the bath were clearly visible on the pins of the chipset U29. A new electrical check was then performed:

- Pins 12 and 13 were still shorted.
- The impedance between ground and Vcc reached 3 k Ω , a value more consistent with the expected test results.

Figure 1.11/9: Chip U29 pins 39 to 48 before bath

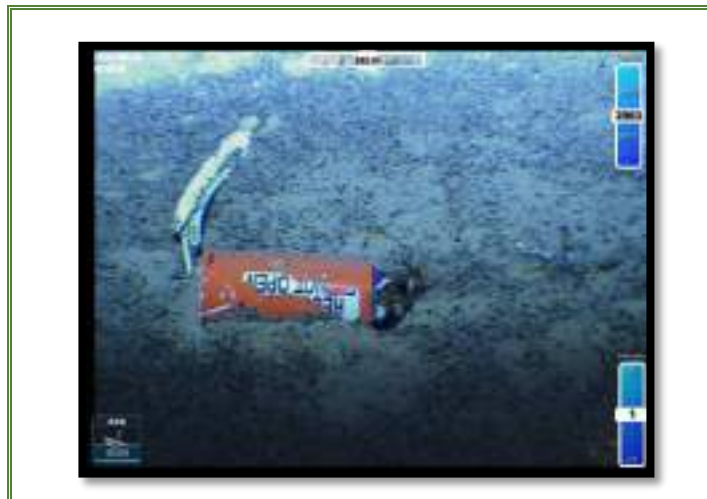
Figure 1.12/3: The memory unit belonging to one of the aircraft flight recorders at the depth of 3020 meter from the sea surface

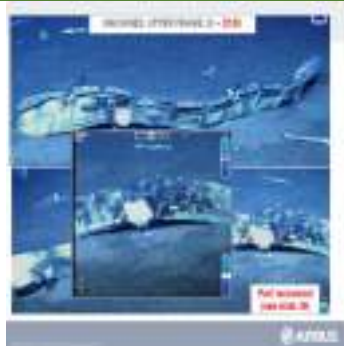
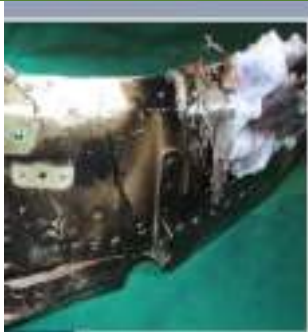
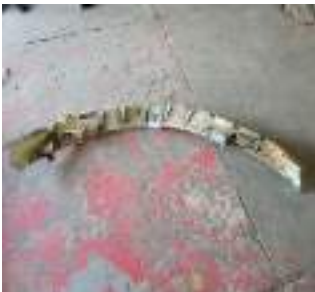
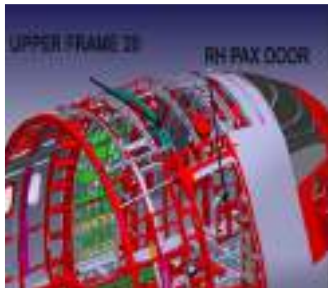
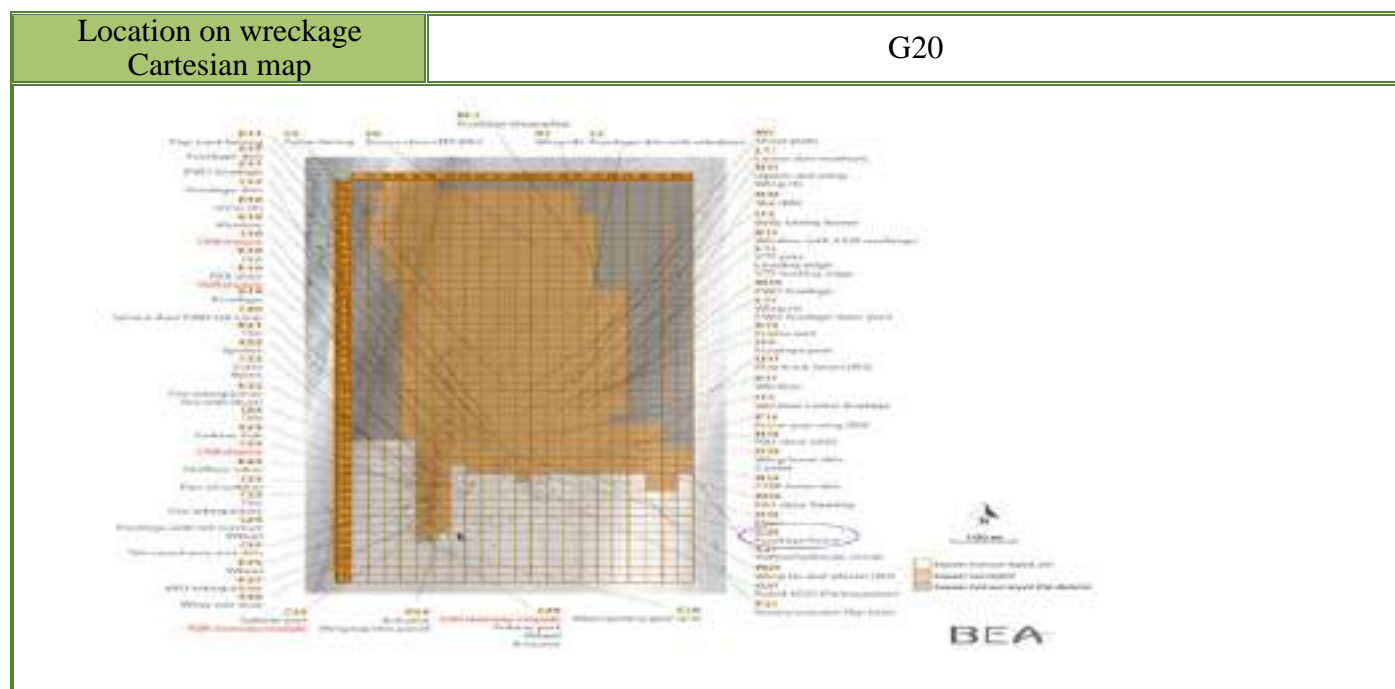
Figure 1.12/10: Upper Central Segment of frame 20

Part/ piece position on the aircraft	- Upper central part connecting the two aft edges of left and right passenger door.
description	A part of aircraft frame with the dimensions of 190 cm ×15 cm consisting of flange-web-flange
Remarks on piece/ Part	<ul style="list-style-type: none"> - The original crescent shape has deflected backward out of its original vertical plane. - A bend was found in the center and edge. - a change in the original metal color was identified on both edges

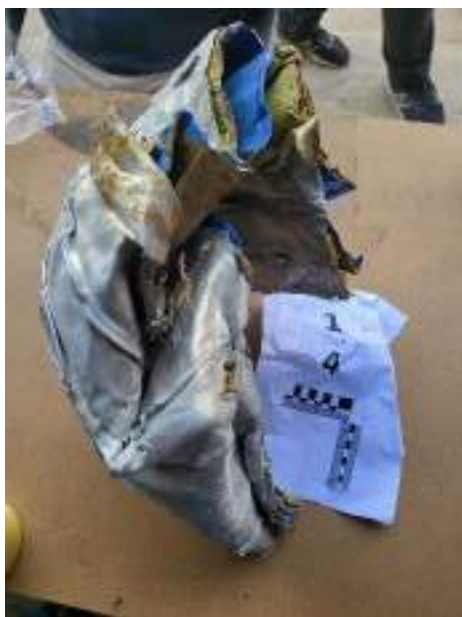
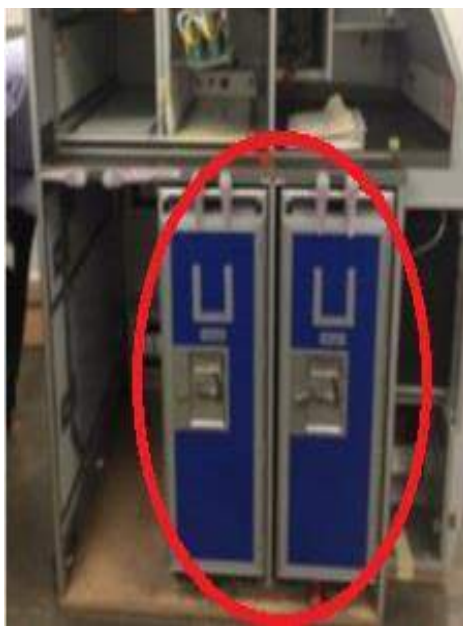
Figure 1.12/13: Food trolley

Description	Food trolley
No	1/4
Diving no.	Recovered floating part
Location on wreckage map	None

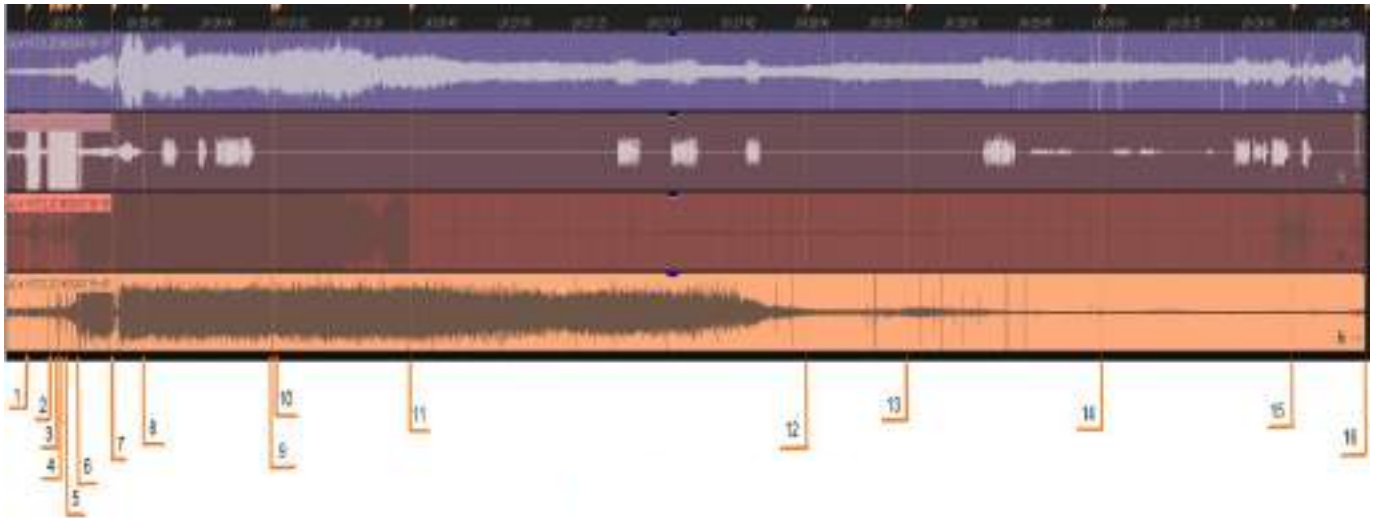
Figure 2.10/1: CVR Sequence of events

NO.	UTC Time	Event
1	00:25:24	1 st Hissing Sound
2	00:25:27	Unidentified word
3	00:25:29	2 nd Hissing Sound
4	00:25:30	F/O calling: “Fire Fire”
5	00:25:31	Female flight attendant calling: “ Fire”
6	00:25:32	PIC calling: “Fire”
7	00:25:35	PIC calling: “Extinguisher, Extinguisher quickly bring extinguisher quickly”
8	00:25:42	PIC calling: “close the door”
9	00:25:48	Ch.2 mic. disconnected

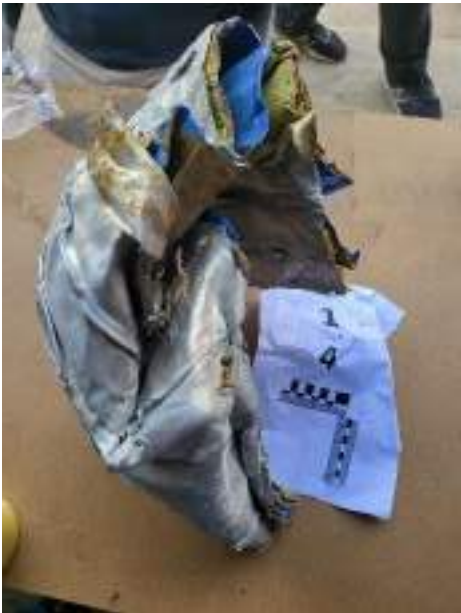
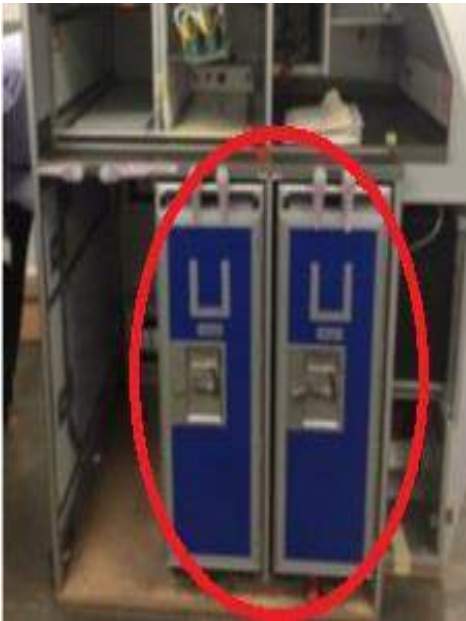
Figure 2.11/1: Food trolleys

- Two sides of two trolleys were twisted inside-out together with a part of galley composite wall stuck within. The trolley tray tracks were so worn out probably due to gas wash.

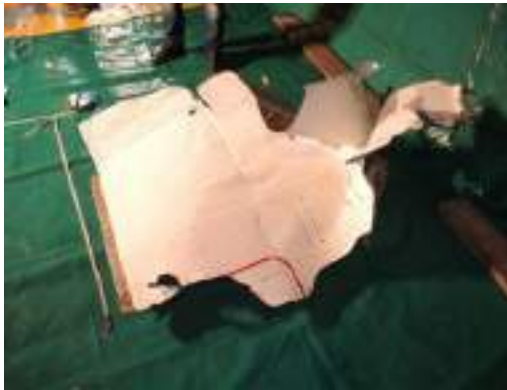
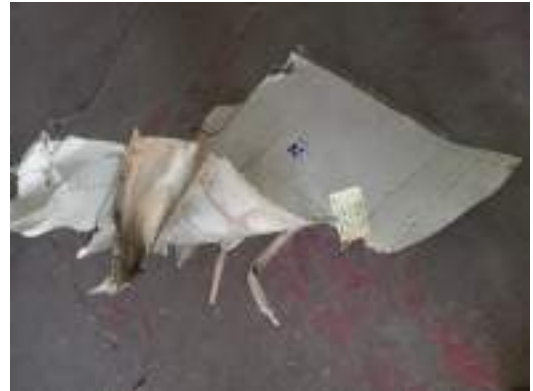
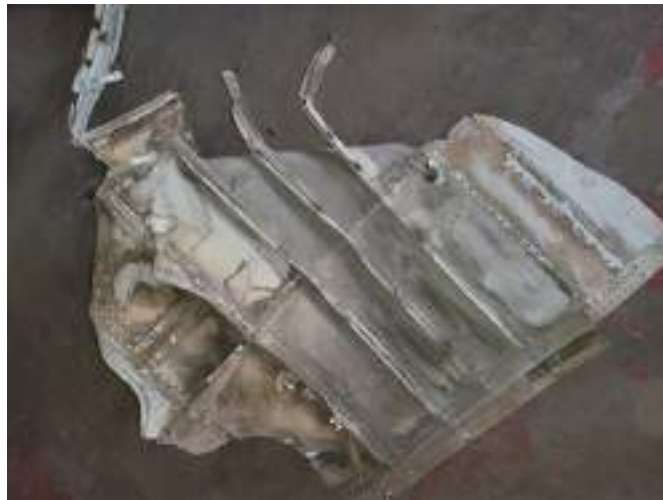
Figure 2.11/4 : Forward fuselage with static port (part No. 37)

- Outward deformation of the forward edge skin.
- Front lower corner of part rolled outward with dark color on the internal side.
- All edges are torn off except the back edge.

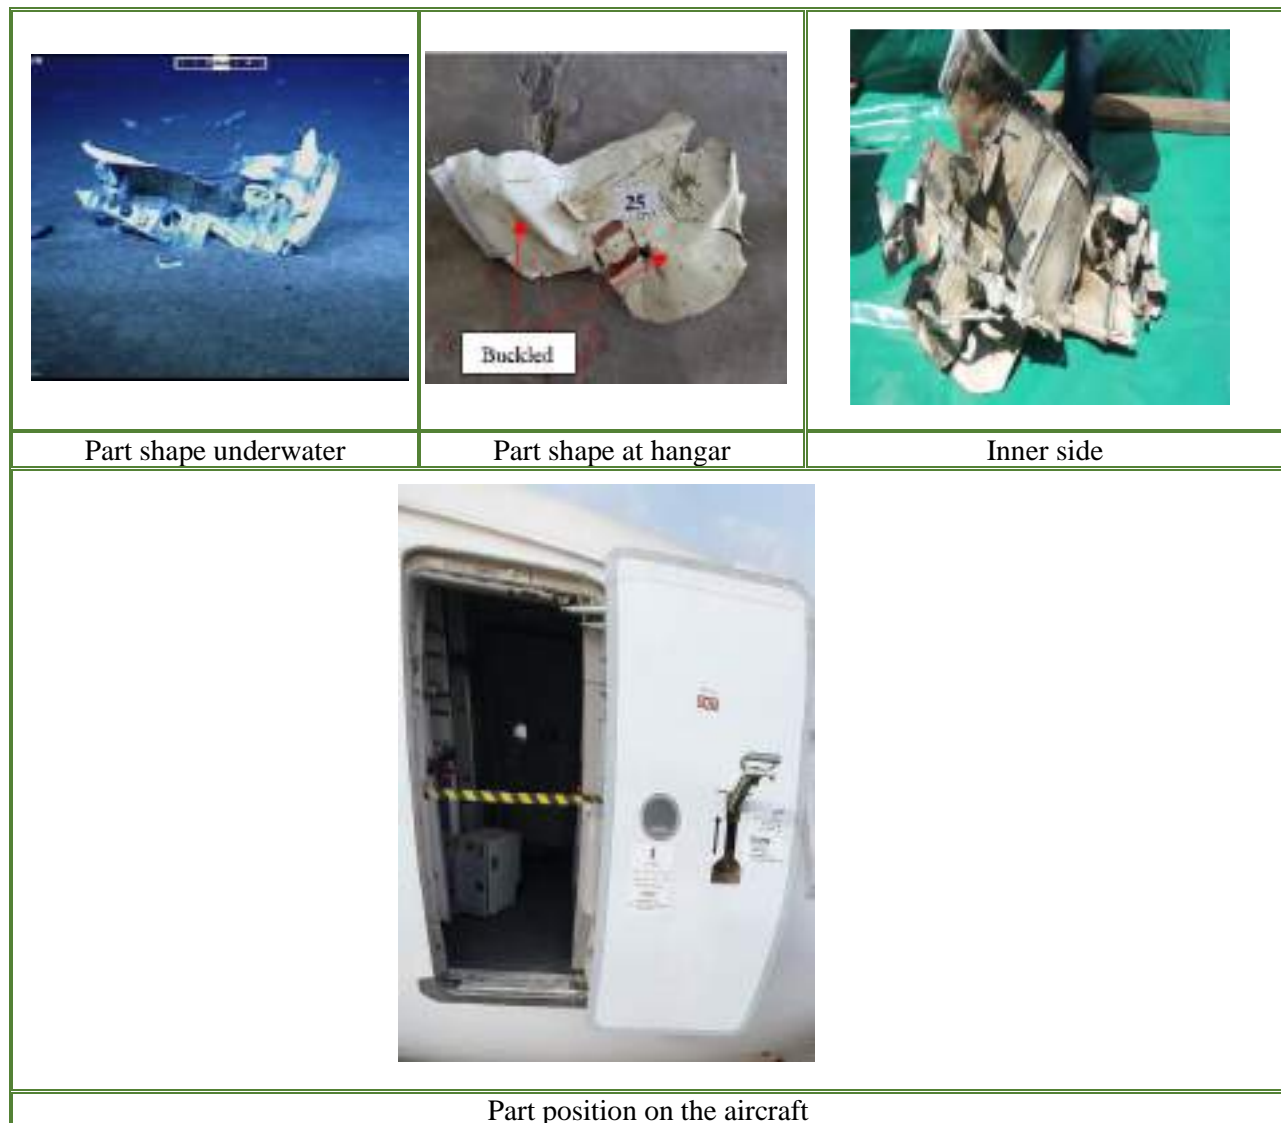
Figure 2.11/5 : FWD PAX RHS DOOR

- Upper third part of the FWD RHS PAX door.
- Almost two thirds of the FWD RHS PAX door lower part was torn away and completely dethatched. The piece shows buckling outwards in 2 locations. Inner side of the remaining part shows dark spots.

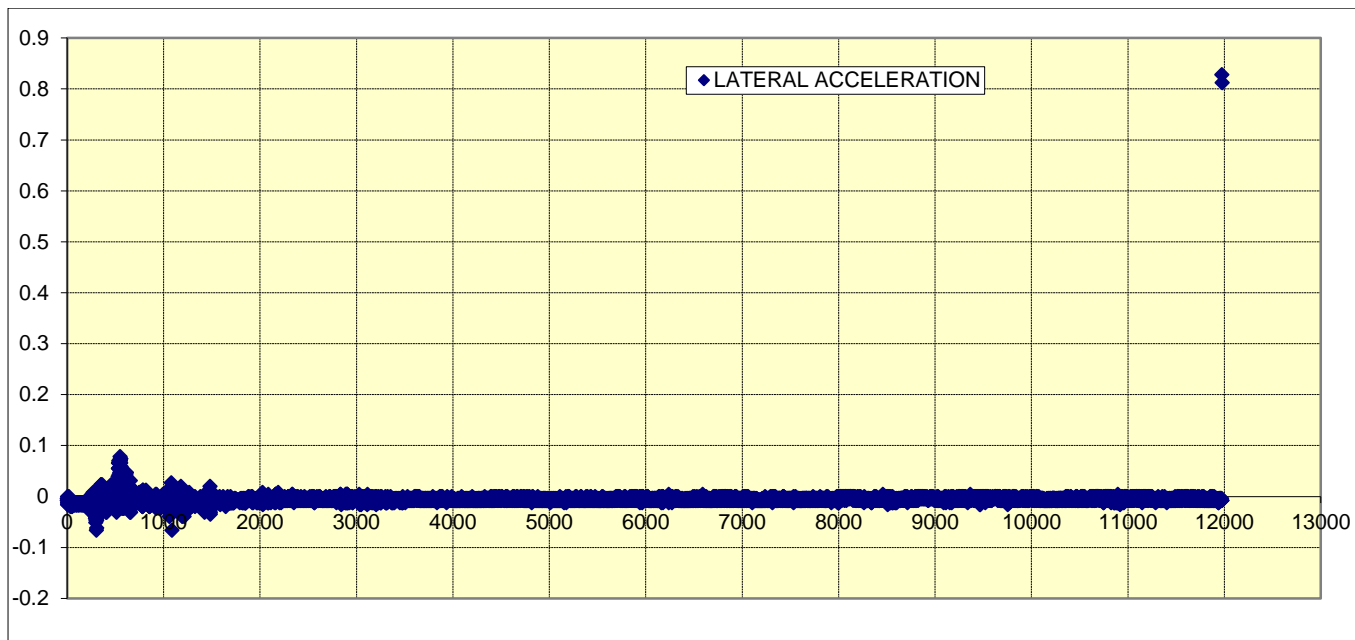
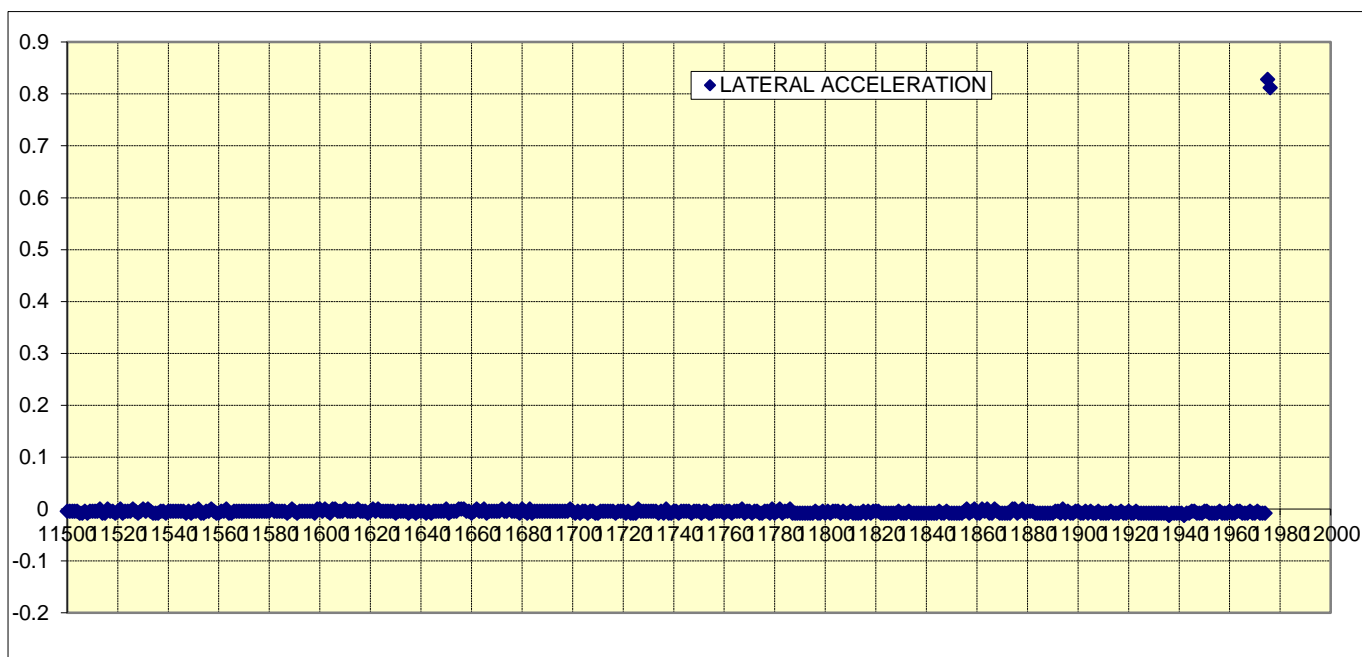
- Lateral Acceleration, closer view at the end of the recording

UTC	Lateral acceleration	Plot time
24:29:42	-0.008	11973
24:29:43	-0.008	11974
24:29:44	0.828	11975
24:29:45	0.812	11976

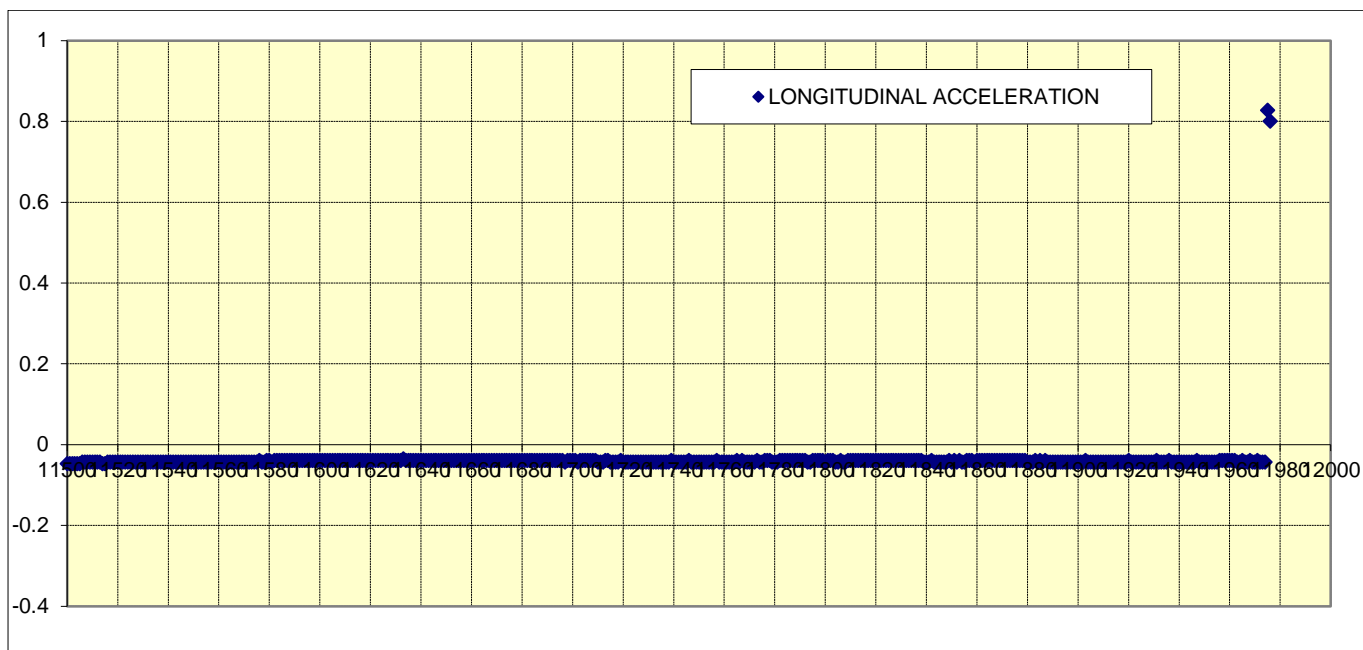
Longitudinal acceleration

(last portion of the flight)

UTC	Longitudinal acceleration	Plot time
24:29:42	-0.043	11973
24:29:43	-0.043	11974
24:29:44	0.828	11975
24:29:45	0.801	11976

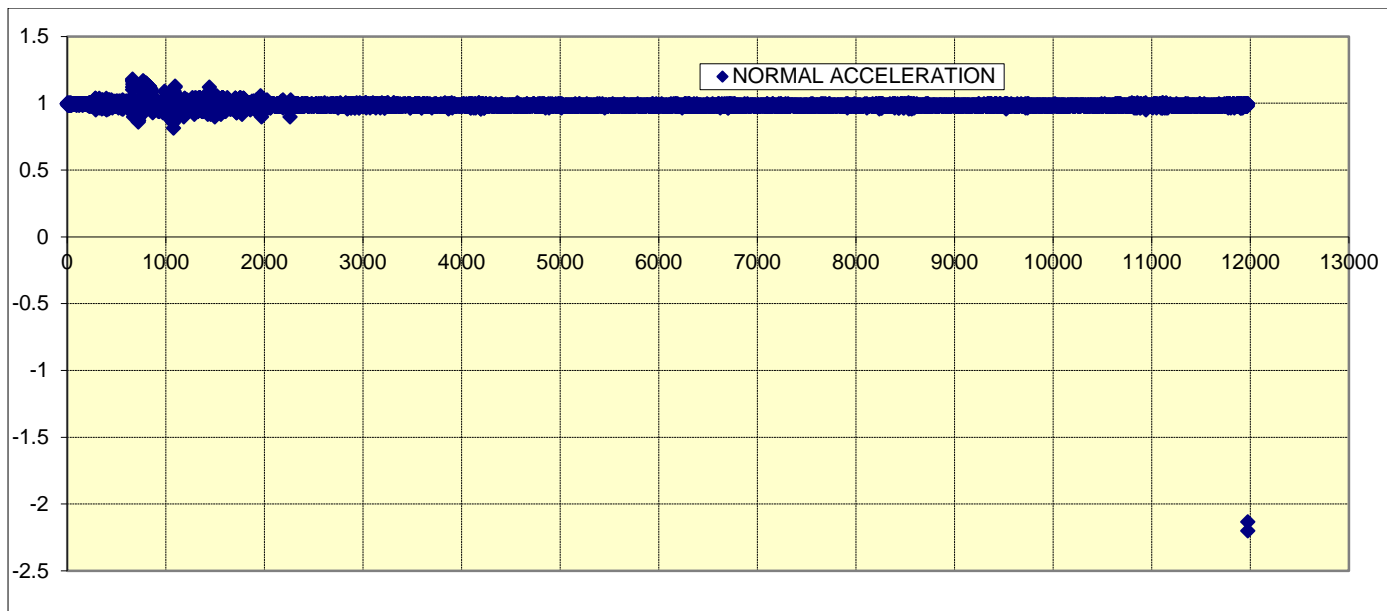
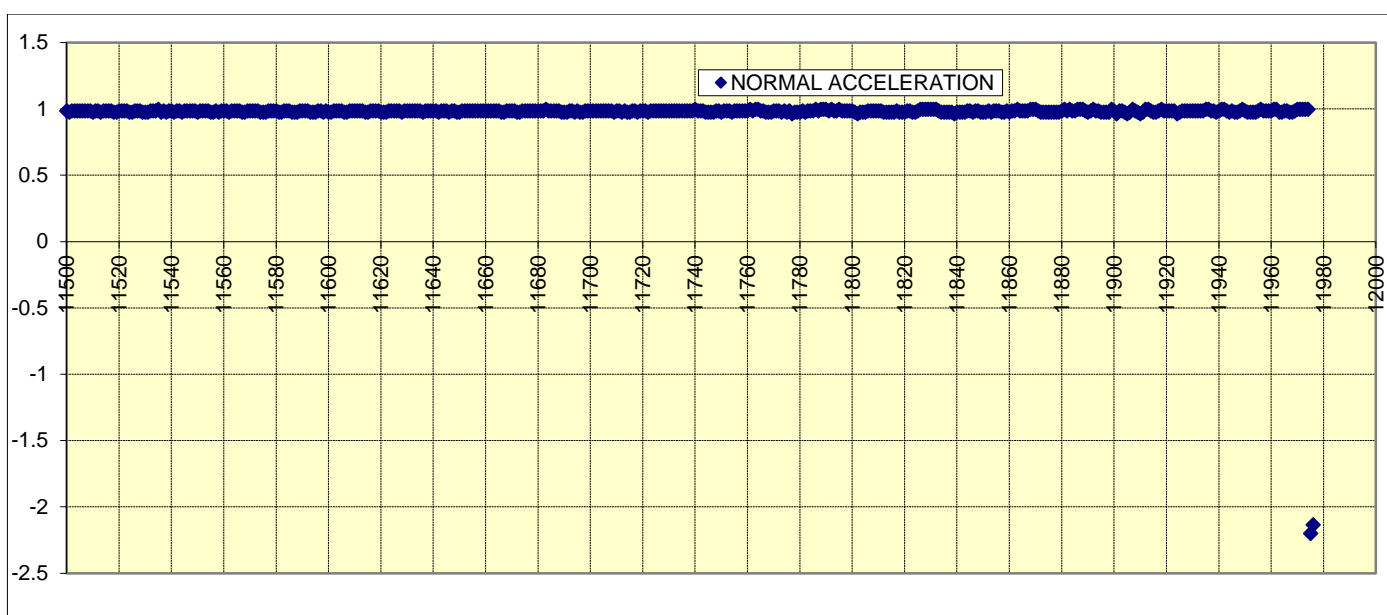
Normal Acceleration, closer view at the end of the flight

UTC	normal acceleration	Plot time
24:29:42	0.977	11973
24:29:43	0.997	11974
24:29:44	-2.134	11975
24:29:45	-2.2	11976

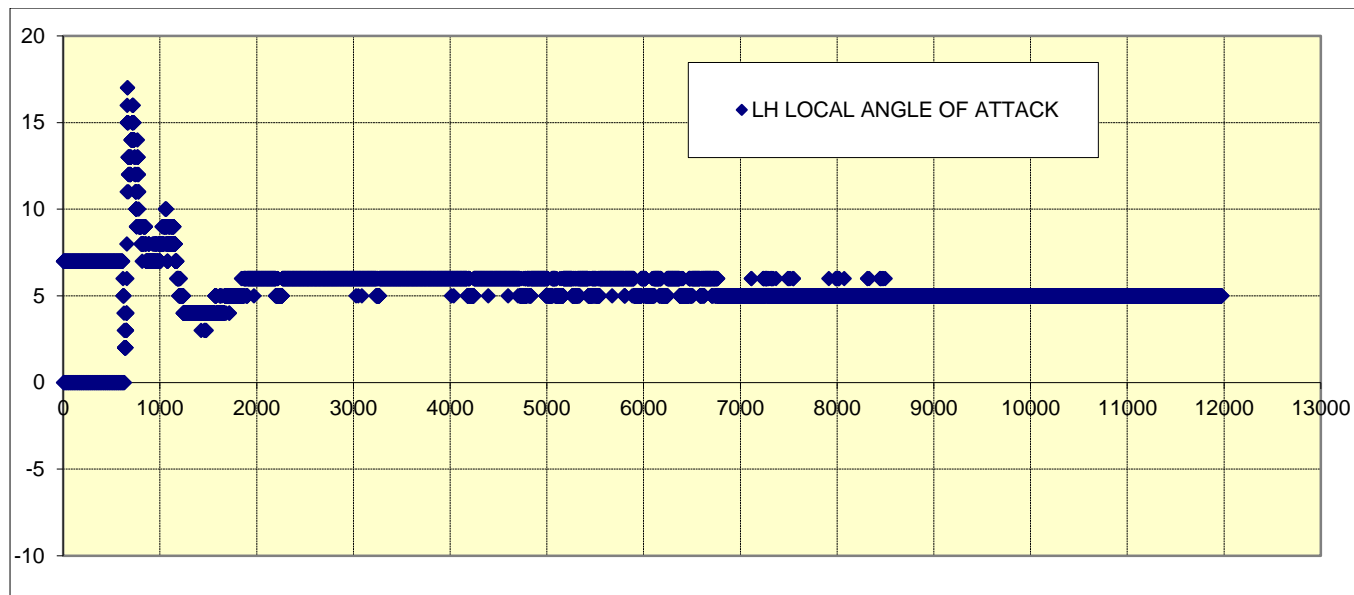
LH local Angle of Attack was varying between 6 degrees and 5 degrees

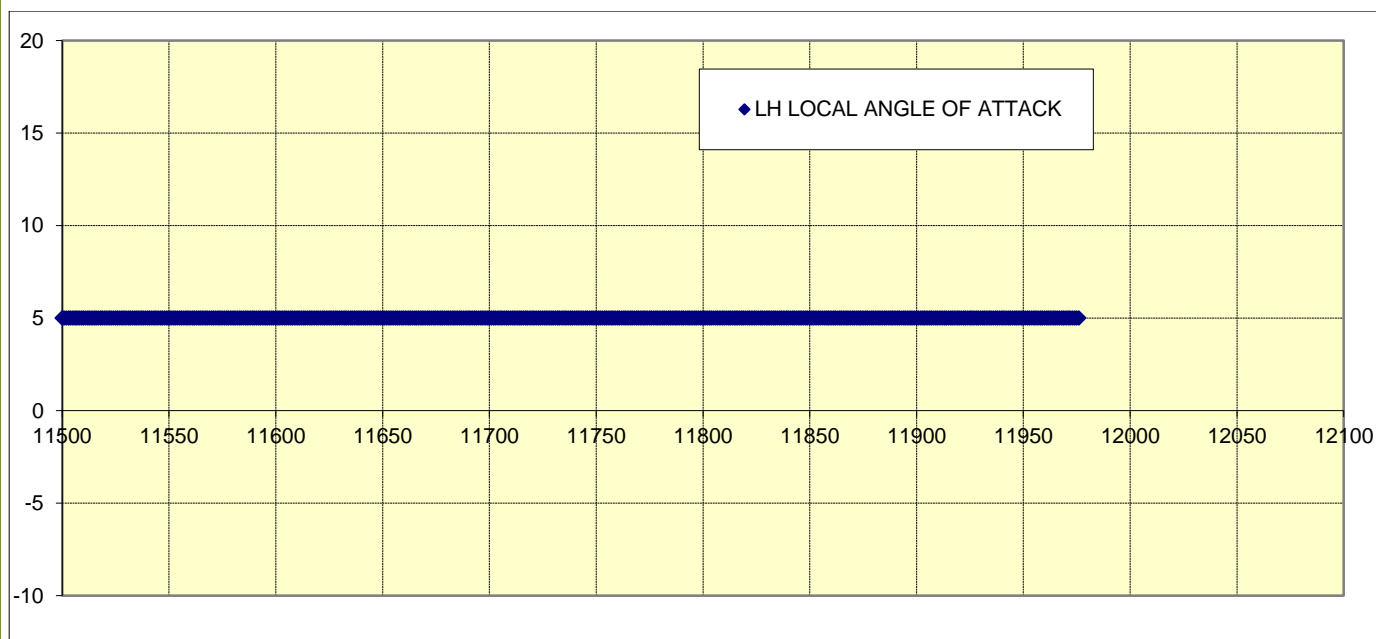
– LH local Angle of Attack, closer view at the end of the flight

LH local Angle of Attack showed a fixed value of 5 degrees for almost the last 3500 seconds of the recording

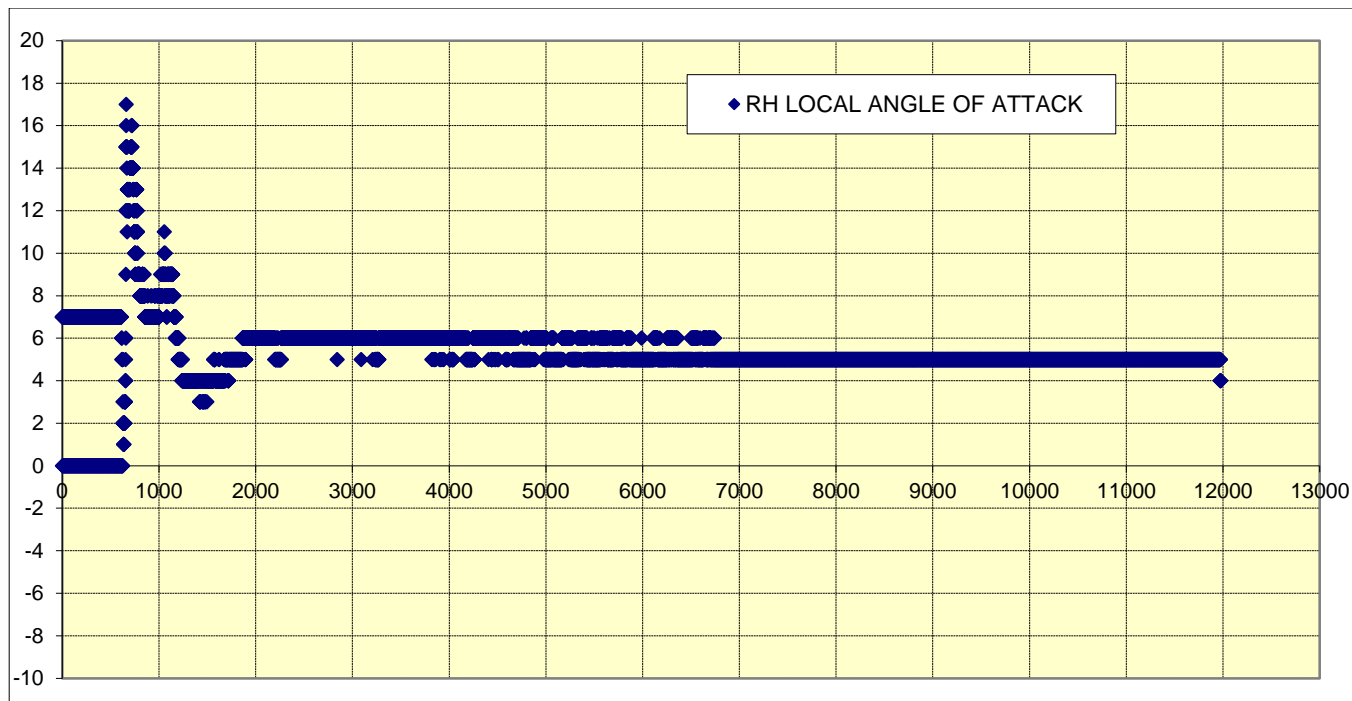
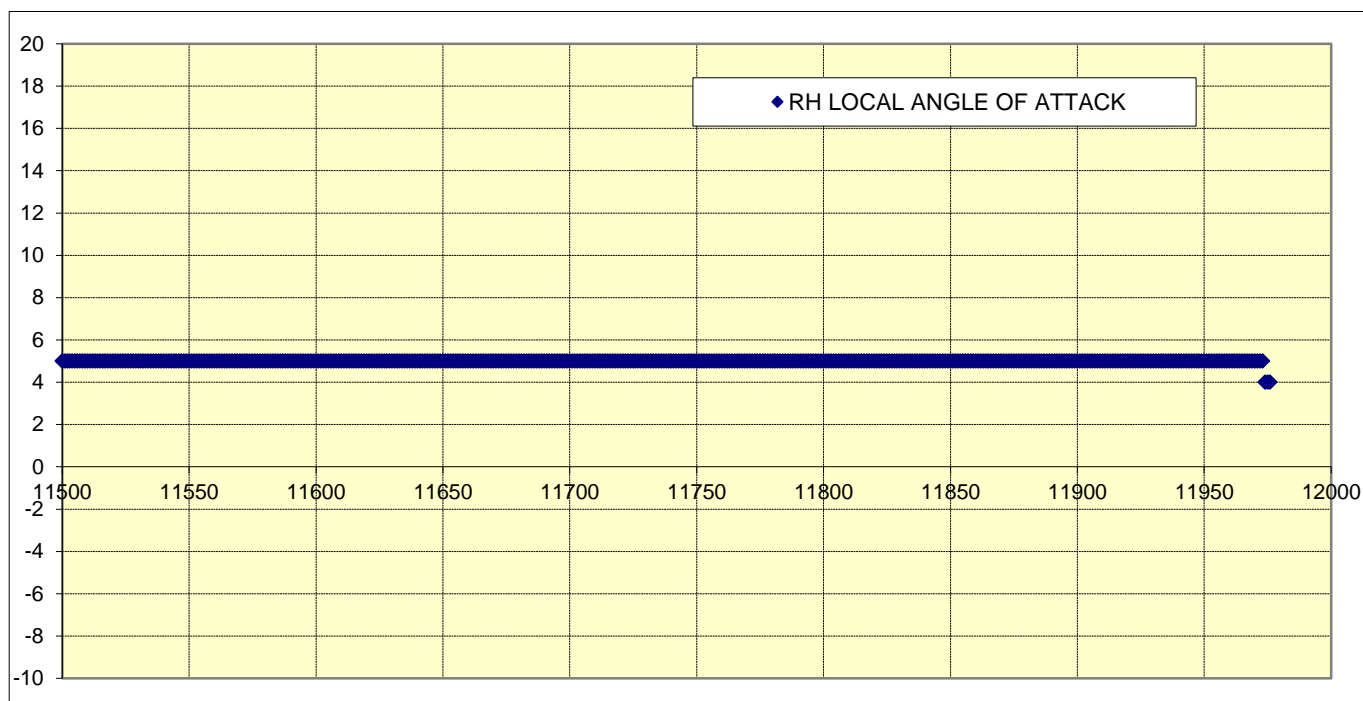
RH local angle of attack shown at the end portion of the recording

At almost 00:29:42 UTC (11973 seconds on the plot) RH angle of attack changed from a constant value of 5 degrees to -4 degrees till the end of the recording 00:29:45 UTC (11976 seconds on the plot)

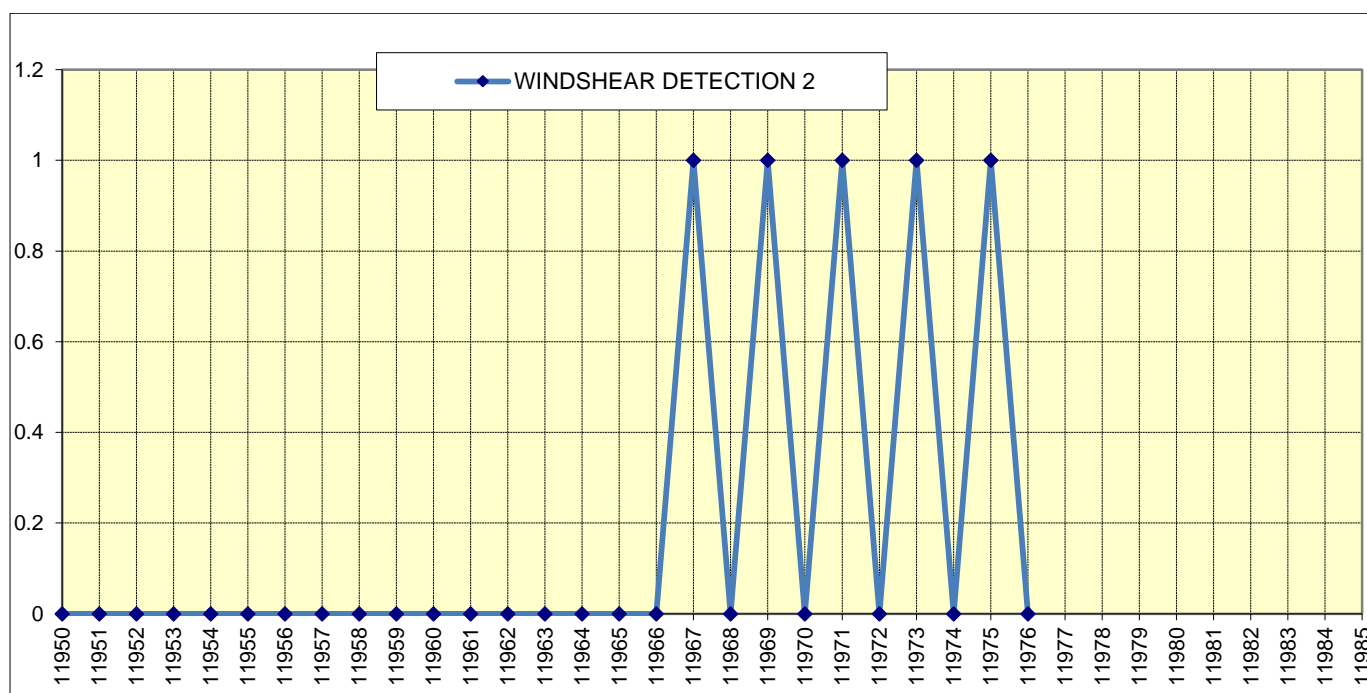
Windshear detection 2 shown at the end of the recording

No windshear detected until 00:29:35 UTC (11966 seconds on the plot) then started reciprocating between ON and OFF until the end of the recording at 00:29:45 UTC (11976 seconds on the plot) (about 10 seconds)

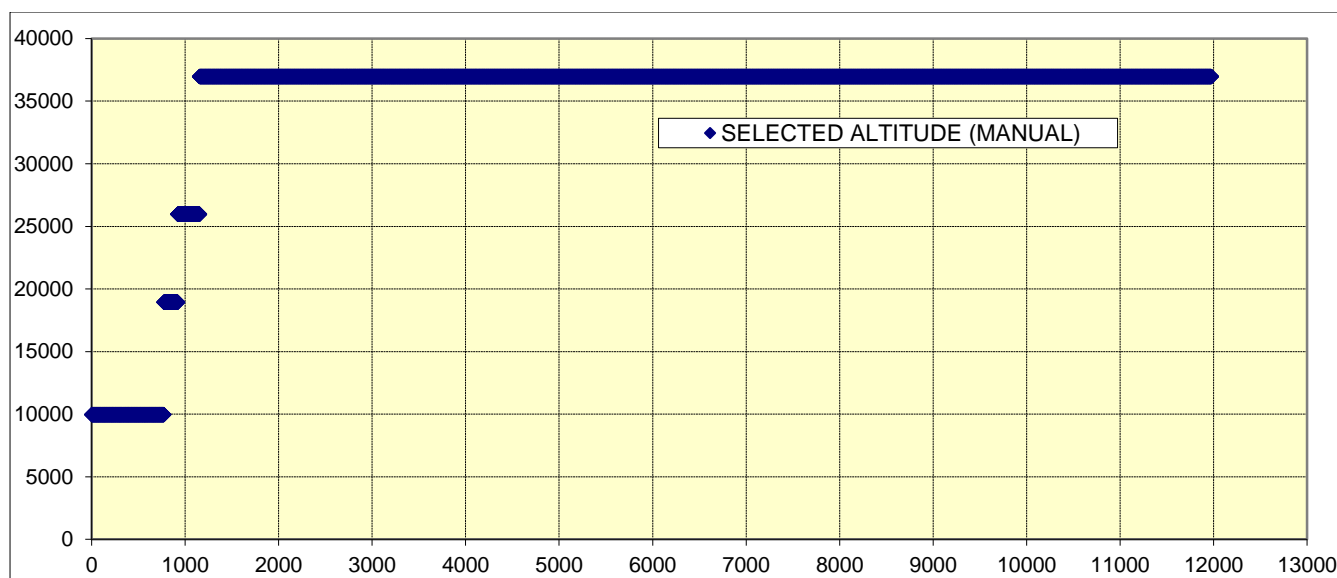
- SELECTED ALTITUDE (MANUAL)

Selected altitude was 37000 ft

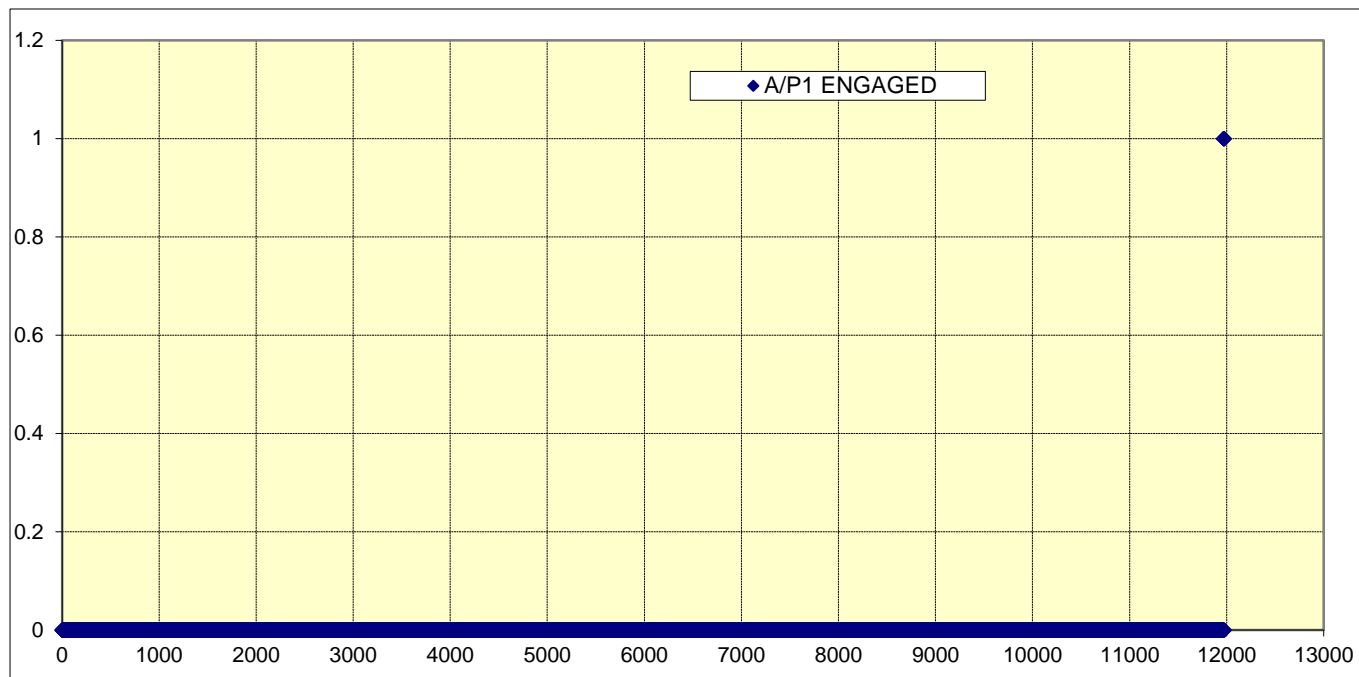
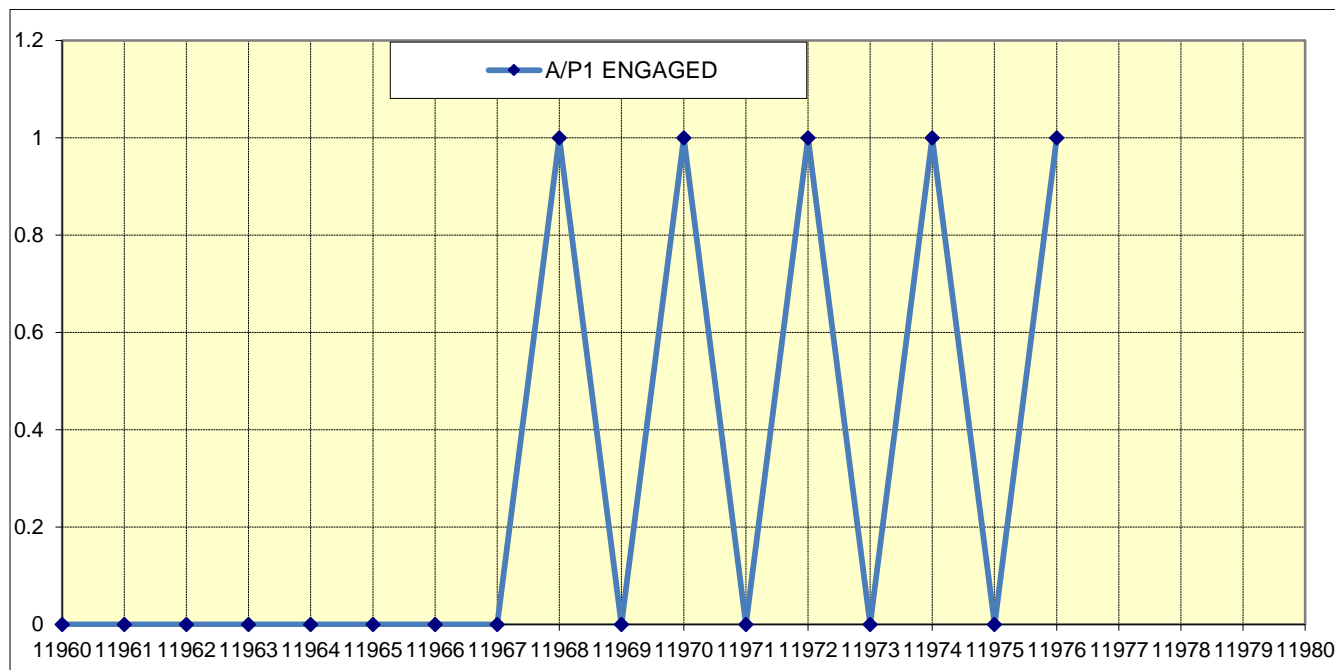
– A/P1 ENGAGED

A/P 1 engaged shown near the end of recording

A/P 1 was not engaged throughout the whole recording time until 00:29: 36 UTC (11967 seconds on the plot), then it started reciprocating between ON and OFF until the end of the recording at 00:29:45 (11976 seconds on the plot) (about 9 seconds)
