Final Report

**EgyptAir A320 Aircraft crash in the Mediterranean, registered SU-GCC,
flight number MSR804, from Charles De-Gaulle Airport, Paris to Cairo
International Airport, on 19/05/2016**

EGAI2016-01

October 2024

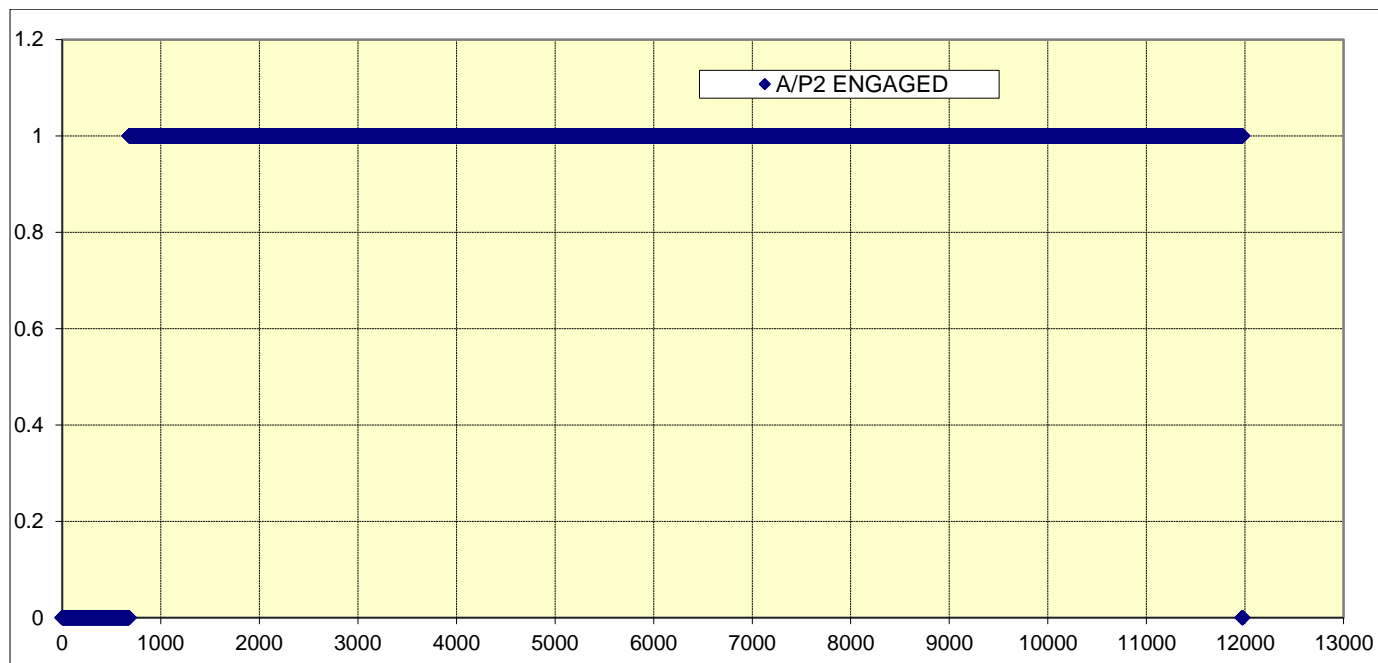
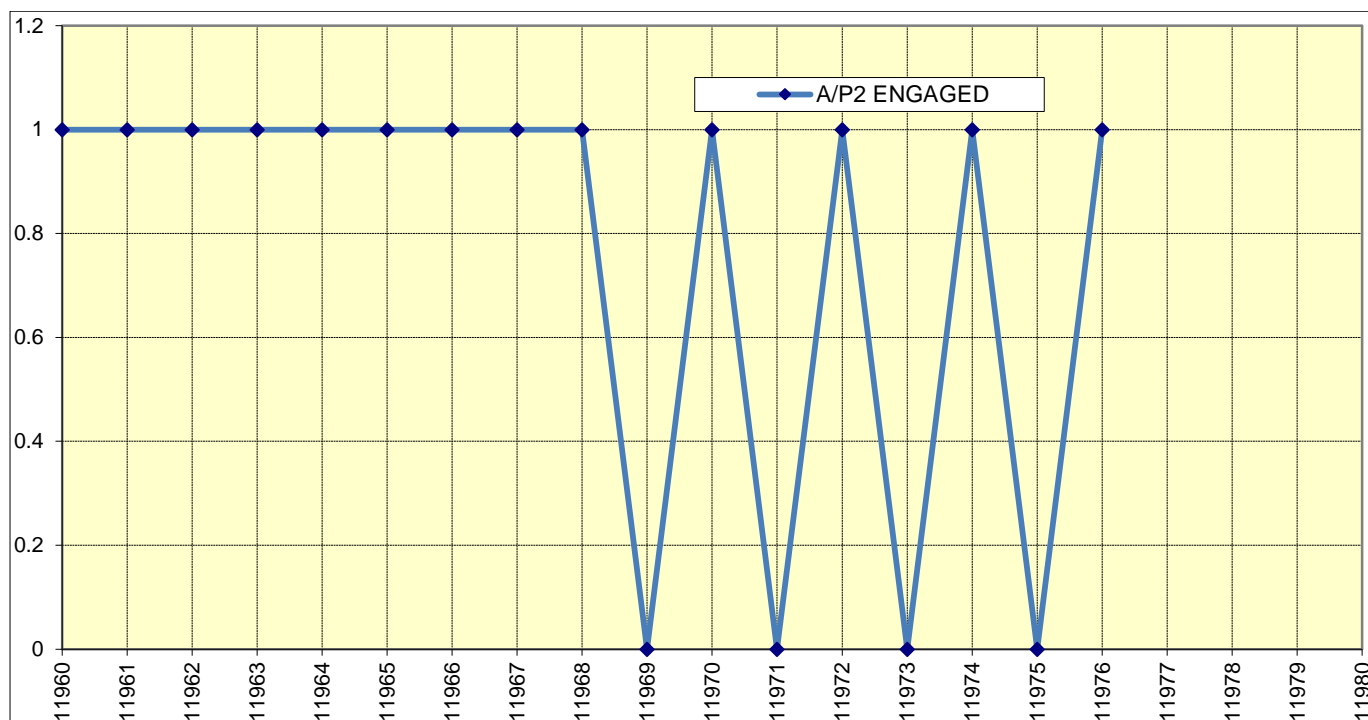
- A/P2 ENGAGED

A/P 2 engaged shown near the end of recording

A/P 2 was engaged almost throughout the whole recording time until 00:29: 37 UTC (11968 seconds on the plot), then it started reciprocating between ON and OFF until the end of the recording at 00:29:45 (11976 seconds on the plot) (about 8 seconds)

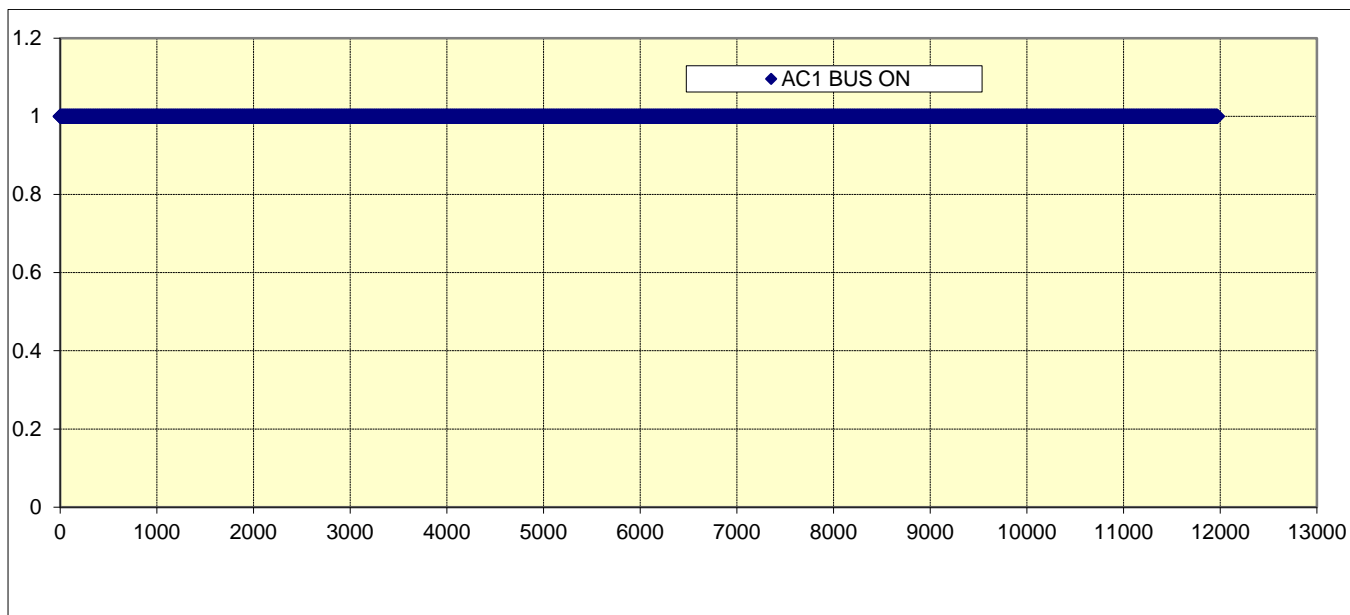
- AC1 BUS ON
(1 powered)

AC1 BUS was powered throughout the whole recording

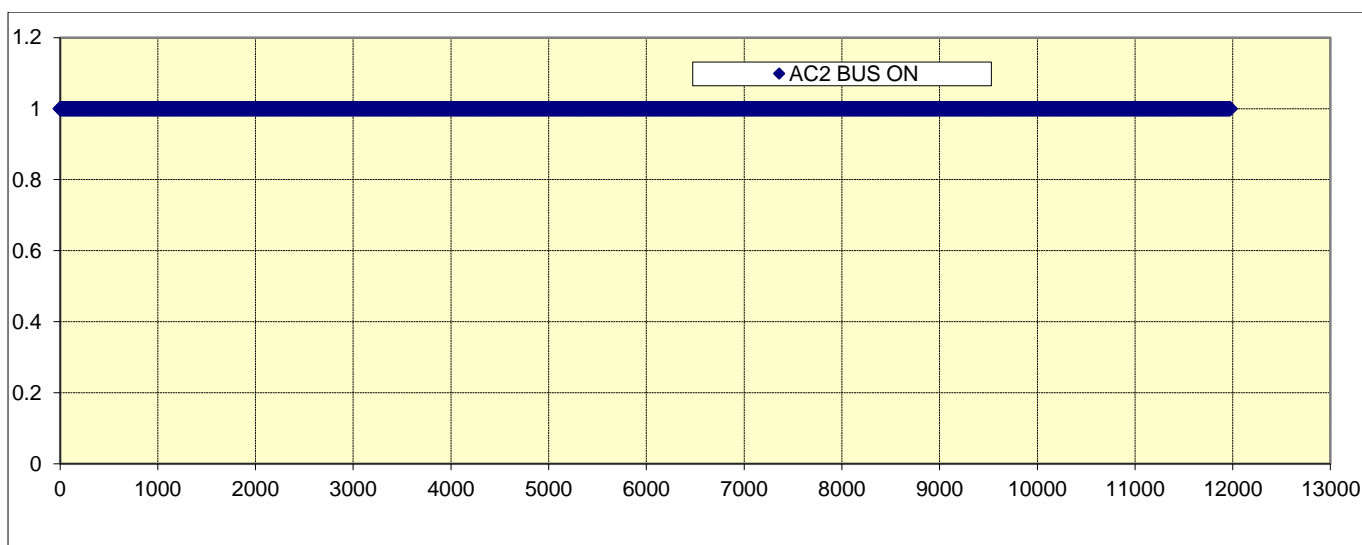
- AC2 BUS ON
(1 powered)

AC2 BUS was powered throughout the whole recording

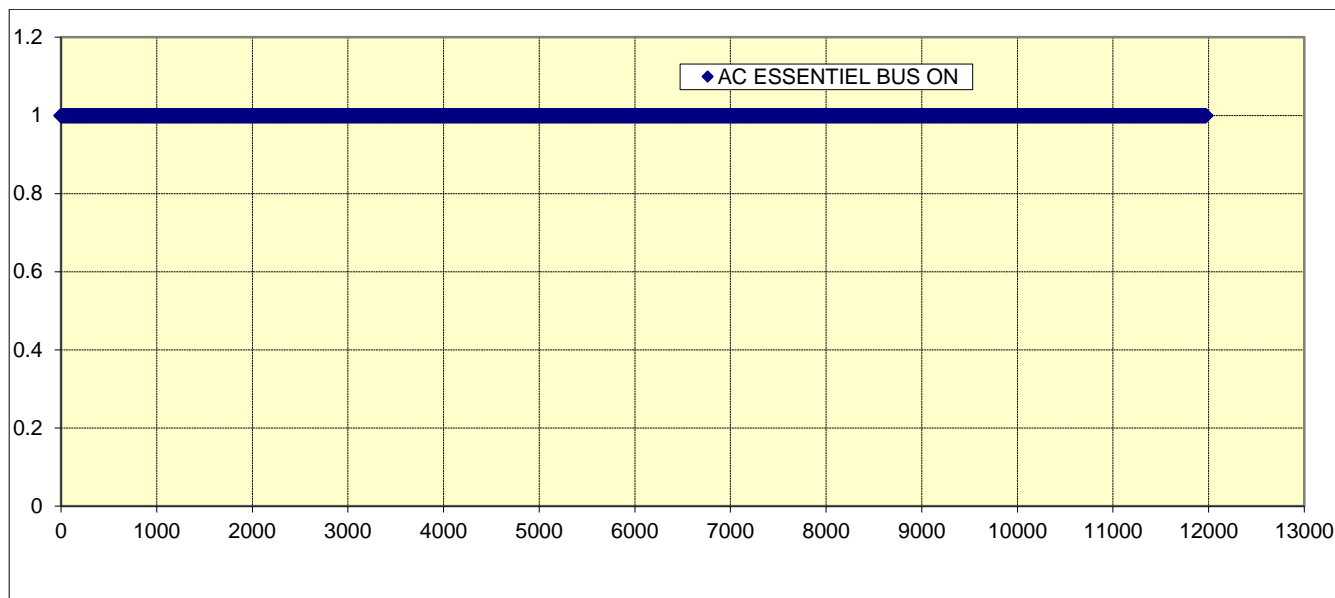
- AC ESSENTIEL BUS ON
(1 powered)

AC essential BUS was powered throughout the whole recording

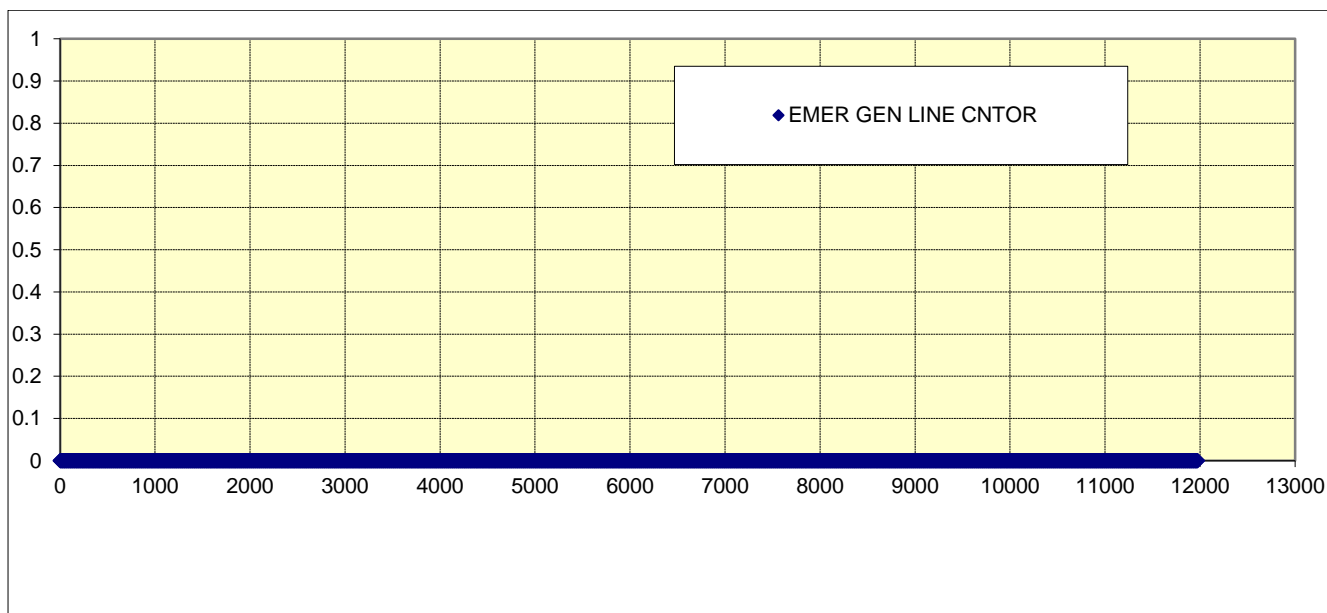
- EMER GEN LINE CONTACTOR

Emer Gen Line Contactor was off throughout the whole recording

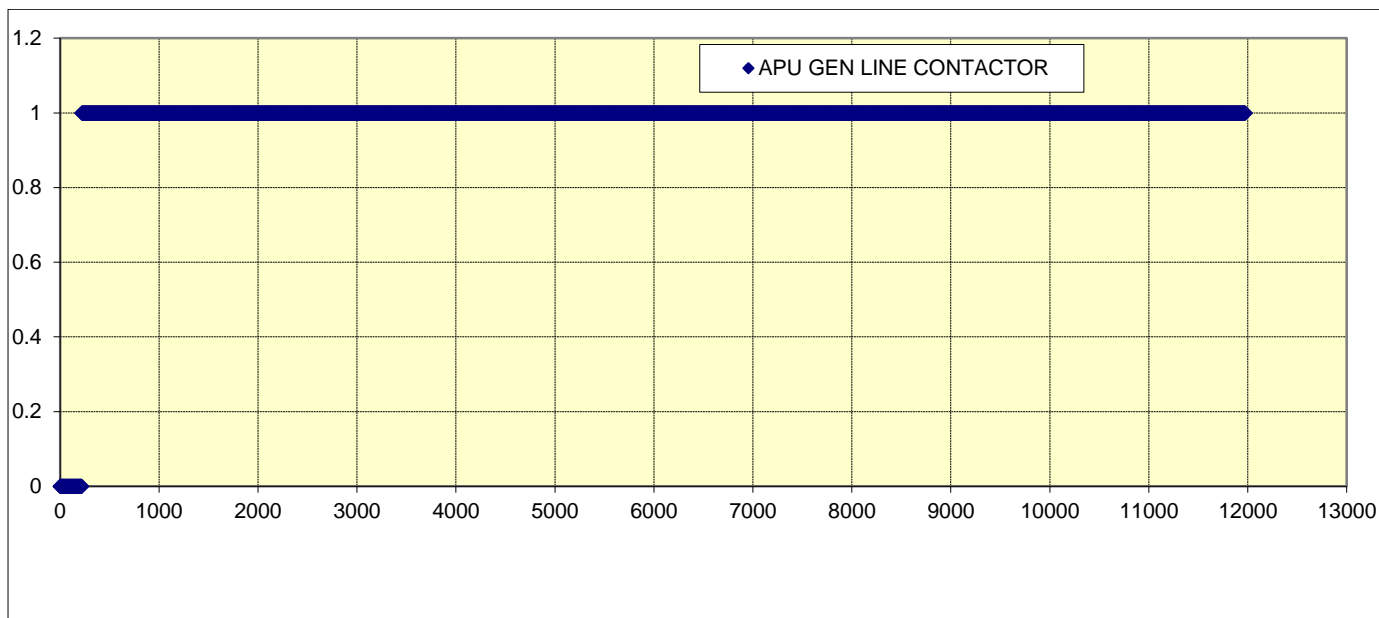
- APU GEN LINE CONTACTOR

APU Gen line contactor was off throughout the whole recording

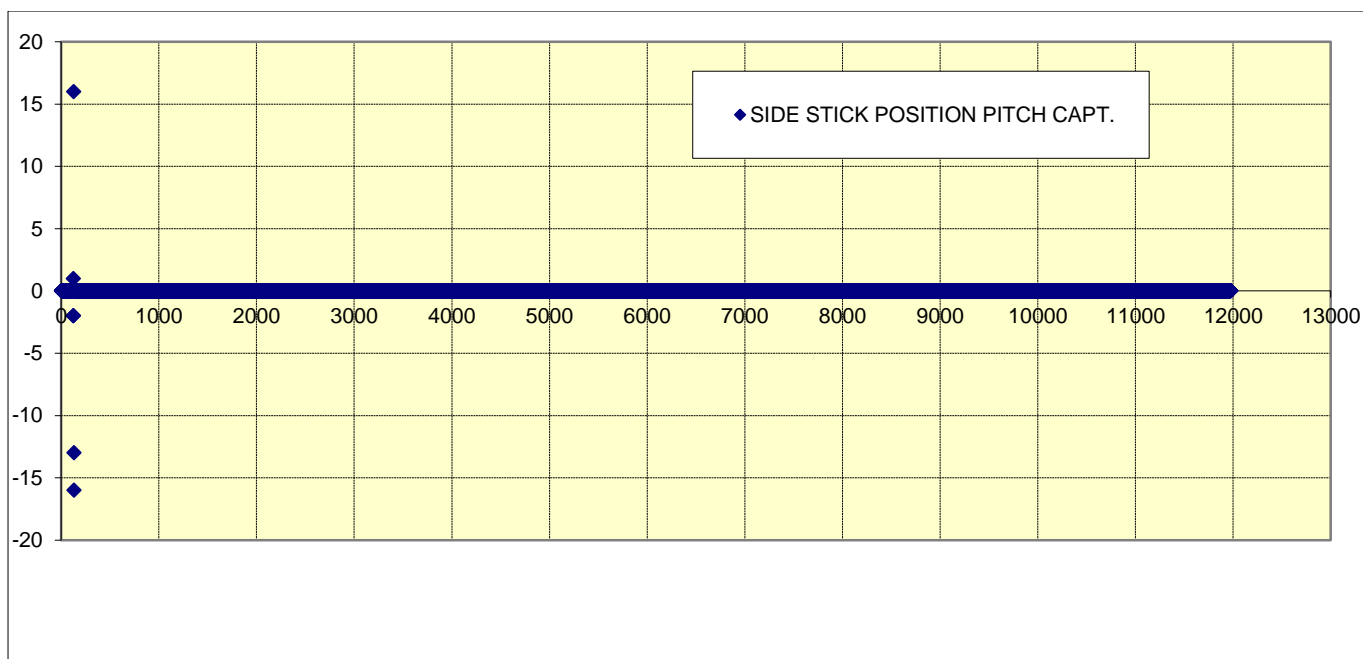
- SIDE STICK position pitch Capt

No pitch movement on the captain side stick during cruise throughout the recording

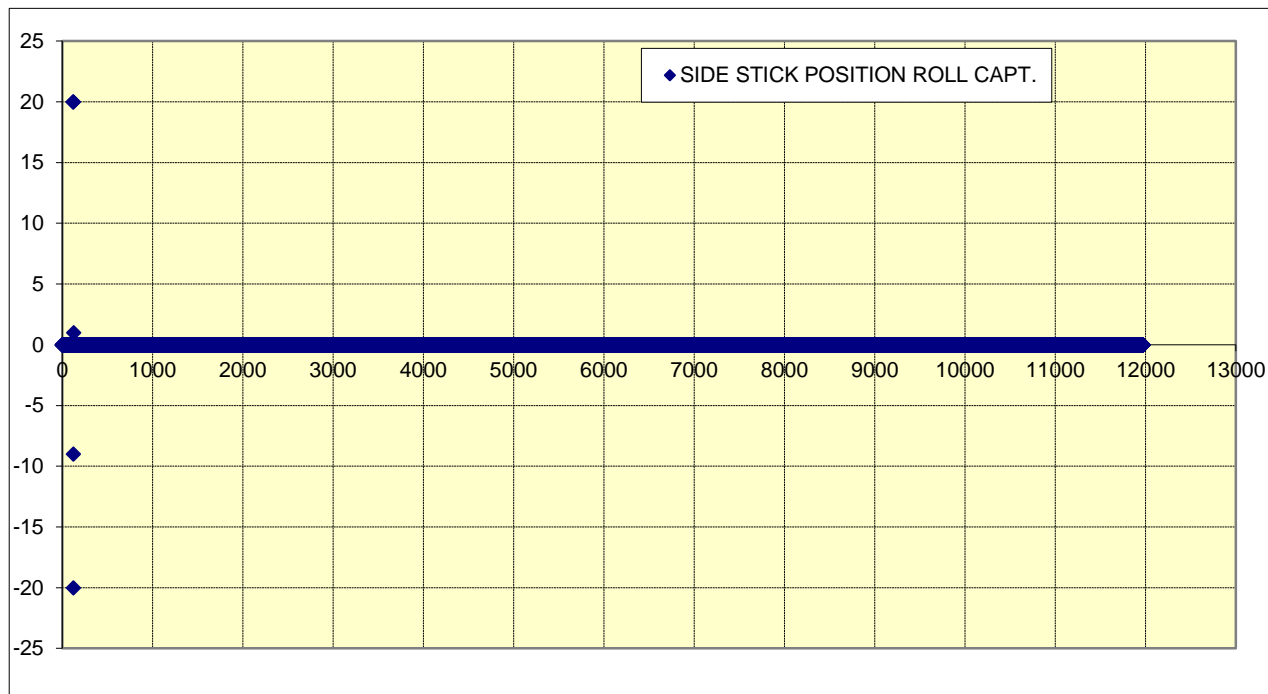
- SIDESTICK position roll Capt

No roll movement on the captain side stick during cruise throughout the recording

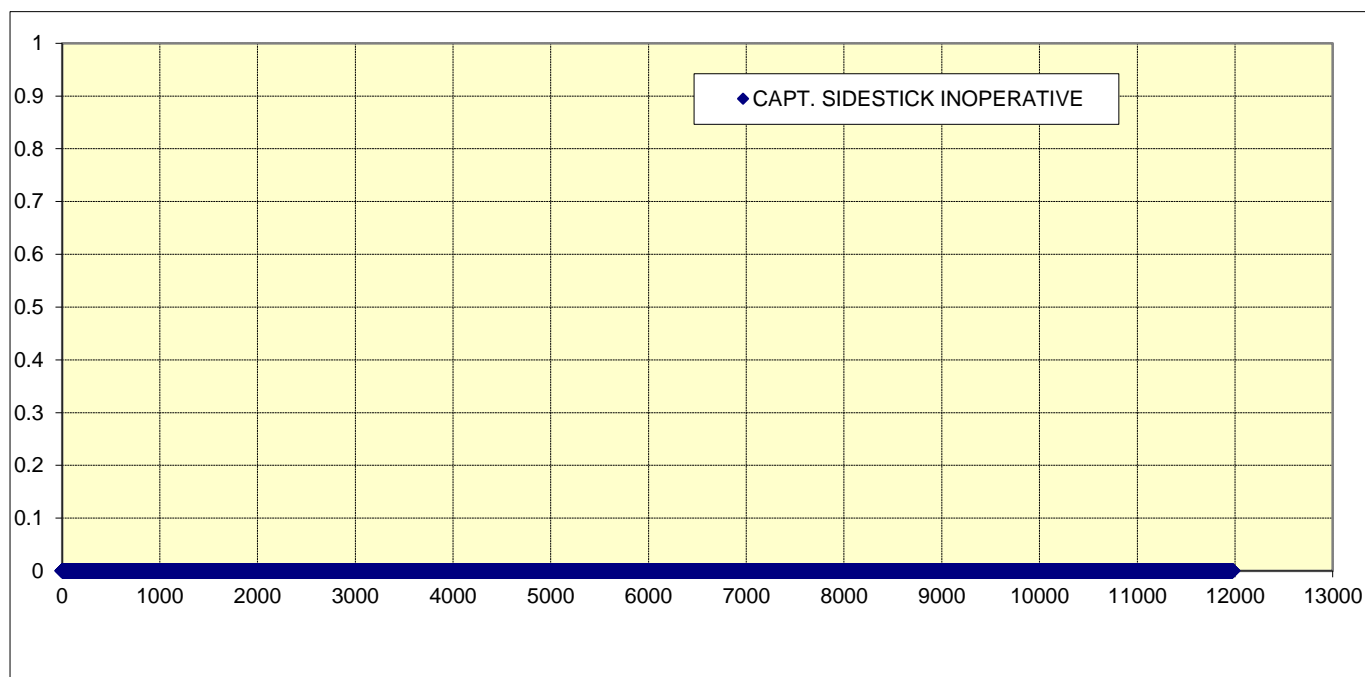
- CAPT. SIDESTICK INOPERATIVE

No evidence of CAPT. SIDESTICK INOPERATIVE condition

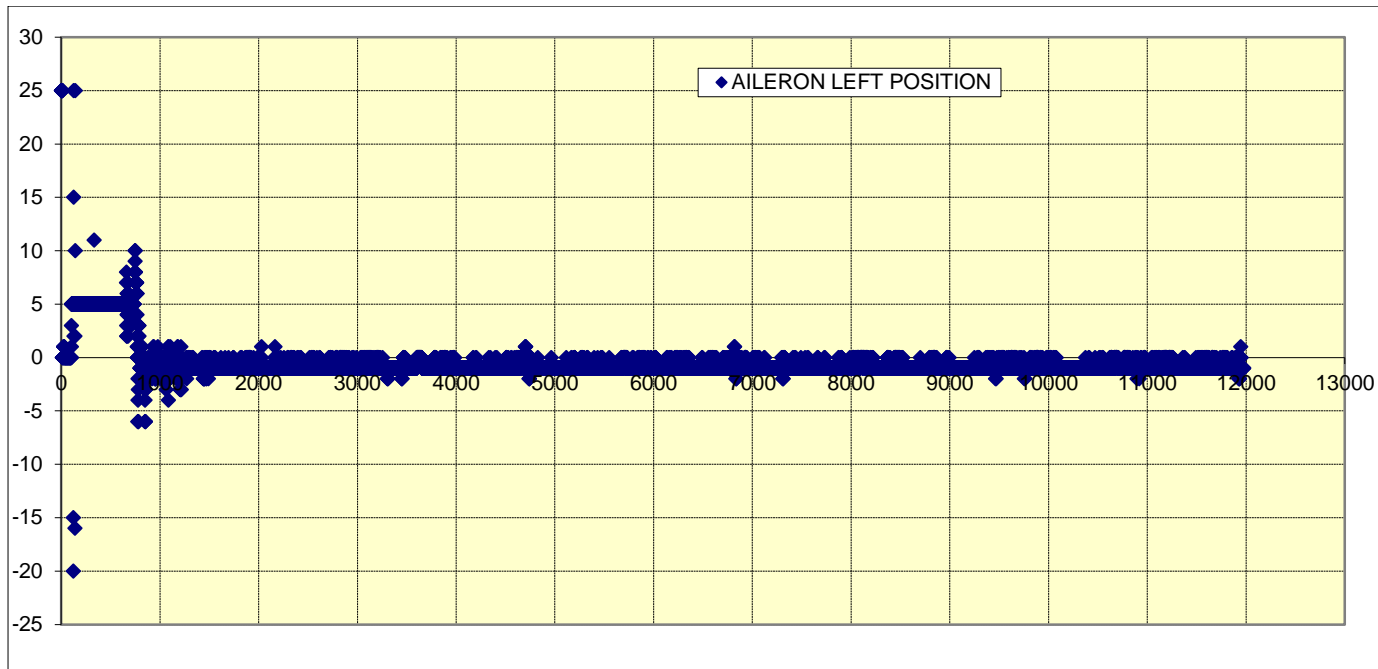
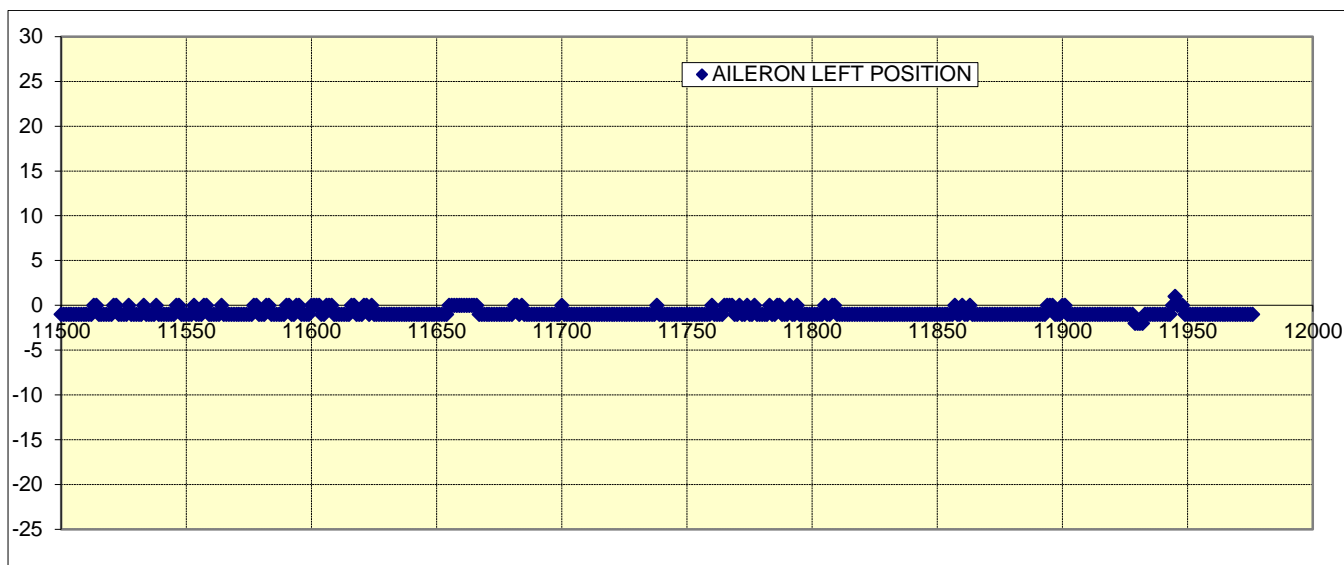
- AILERON LEFT POSITION

Position shown at the last portion of the recording

Left aileron position was -1 degree almost throughout the whole flight, varying between 0 and -1 degrees (except for very few points it reached -2 degree and +1 degree)

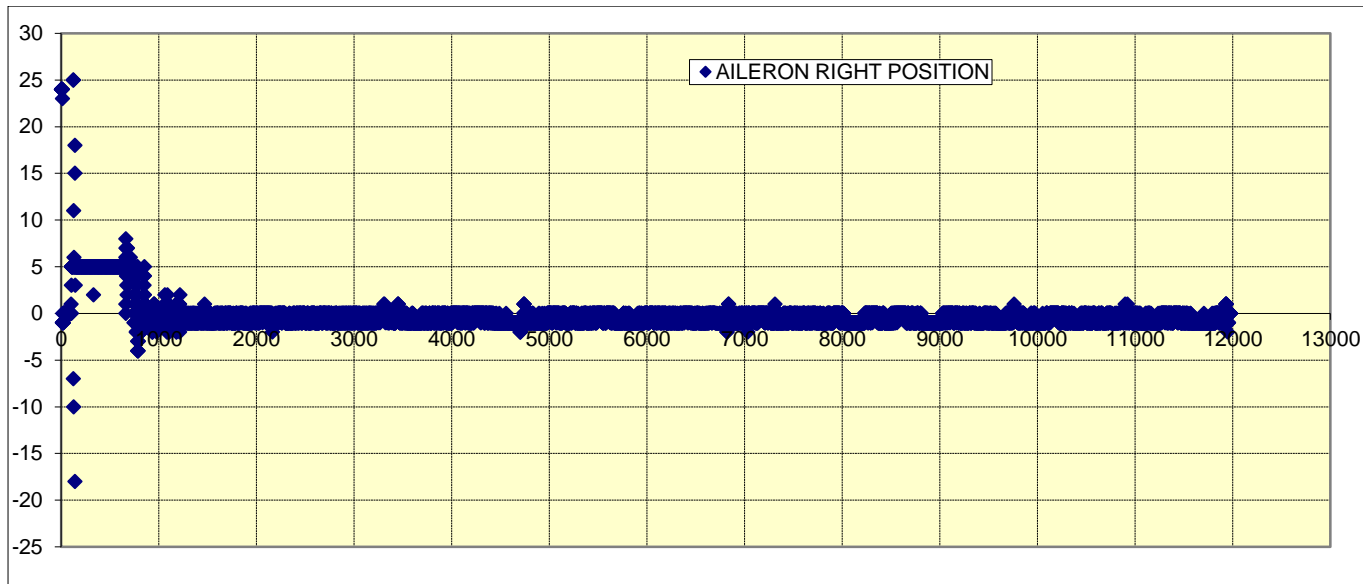
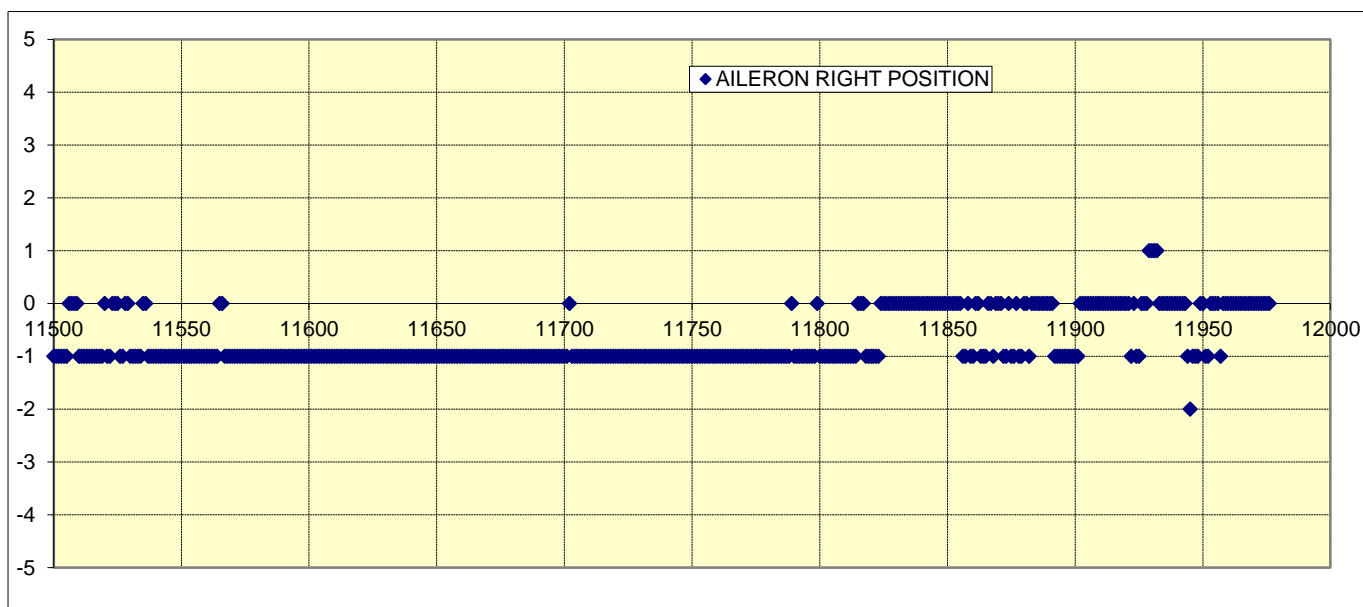
- AILERON RIGHT POSITION

Aileron Right position viewed at the end portion of the recording

Right Aileron movements were almost between 0, -1 degrees (0 at the end of recording)

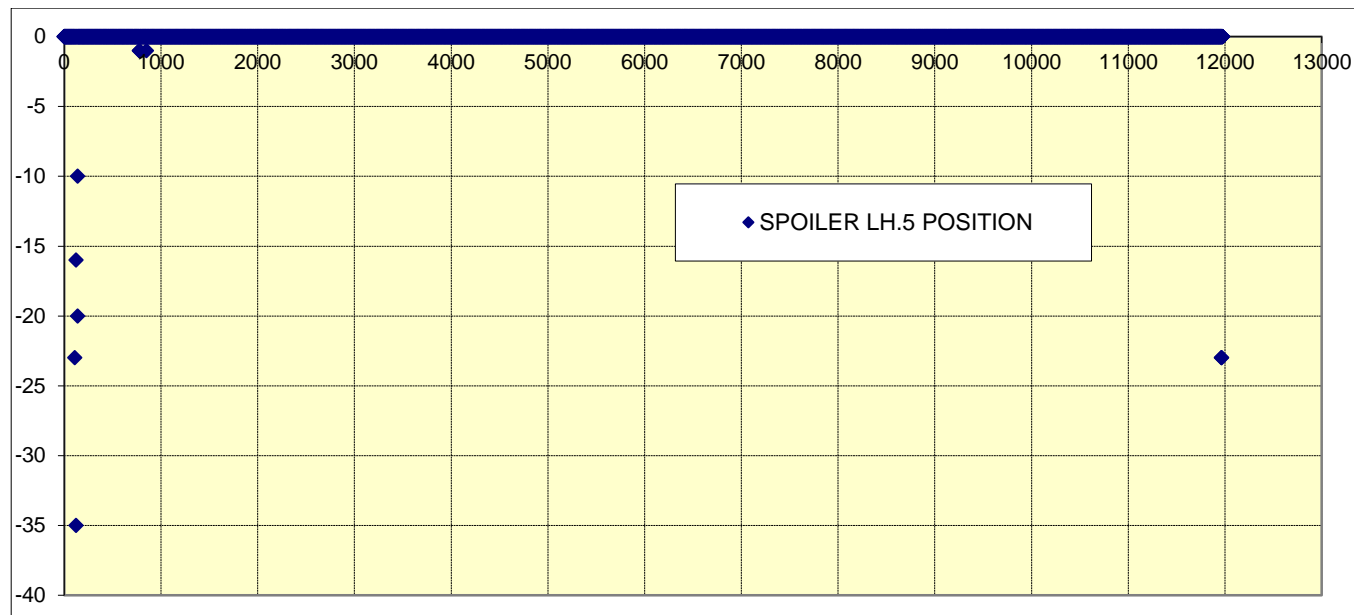
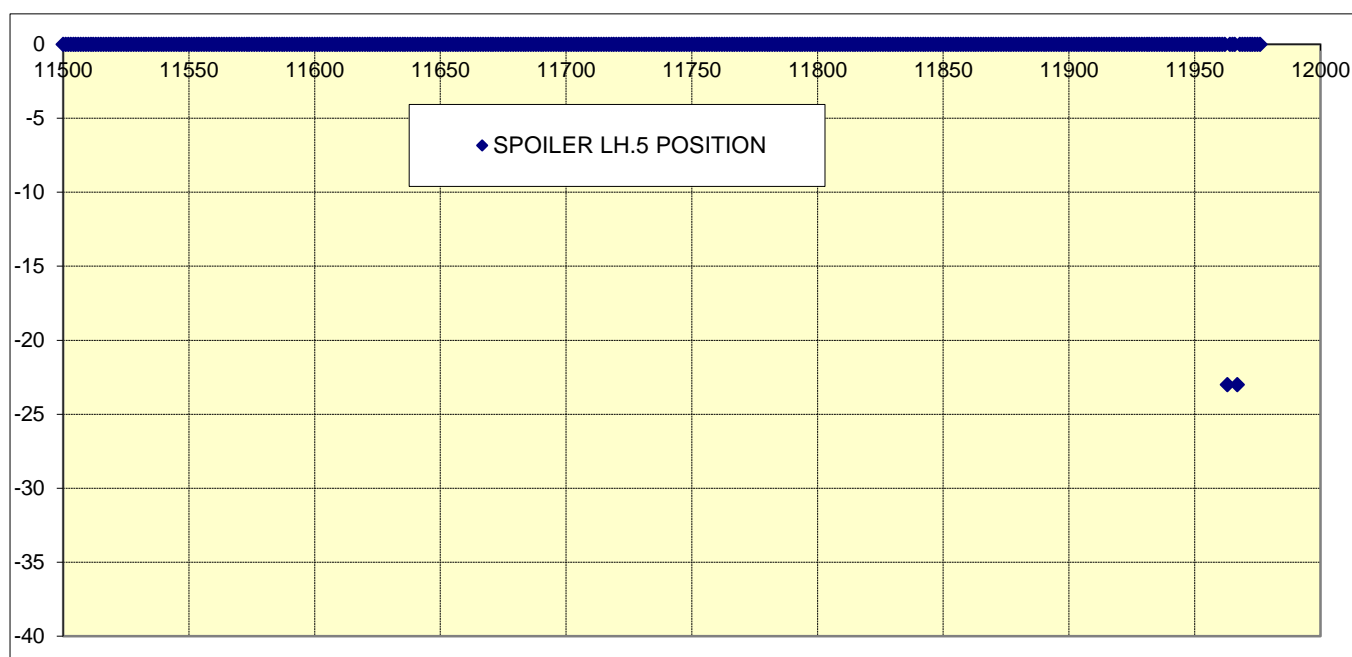
- SPOILER LH.5 POSITION

LH spoiler #5 shown at the end portion of the recording

LH spoiler #5 showed up position throughout the flight

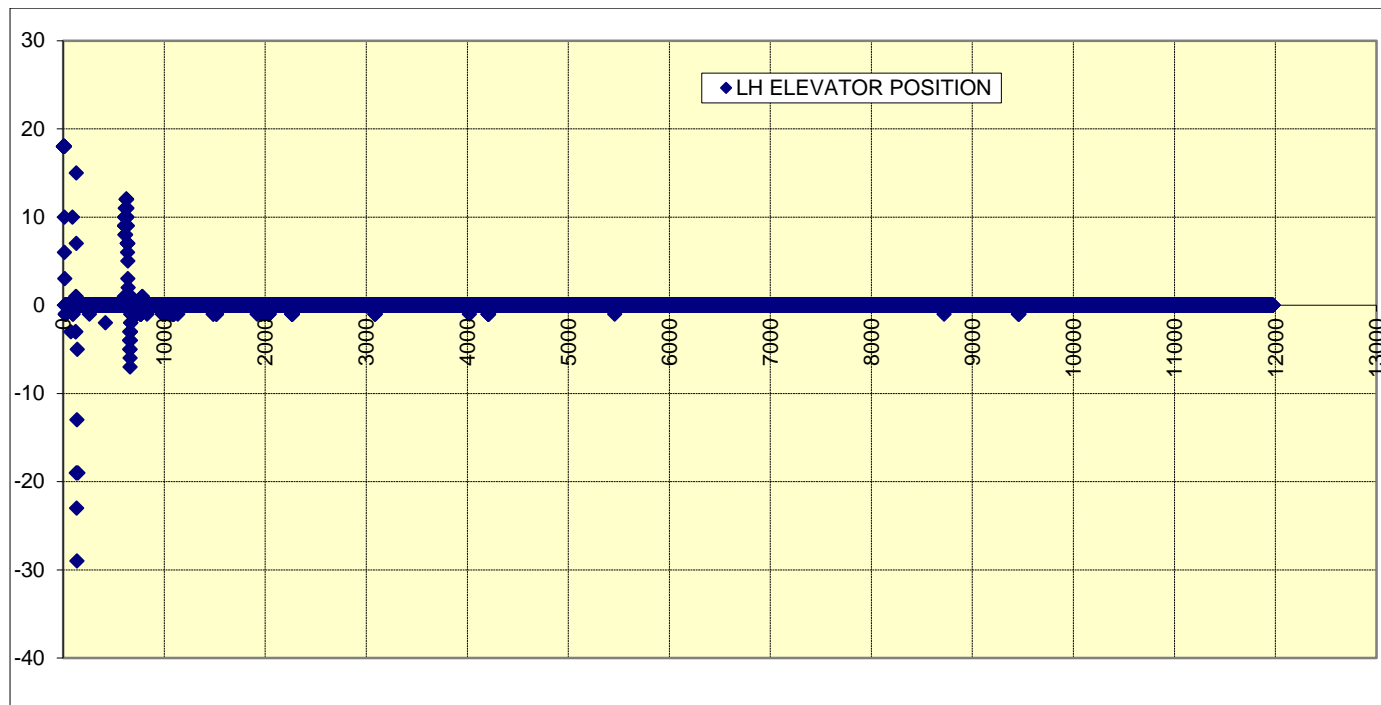
-LH ELEVATOR POSITION

Left elevator showed a value of 0 degree throughout the cruise [hase up to the end of recordingRH

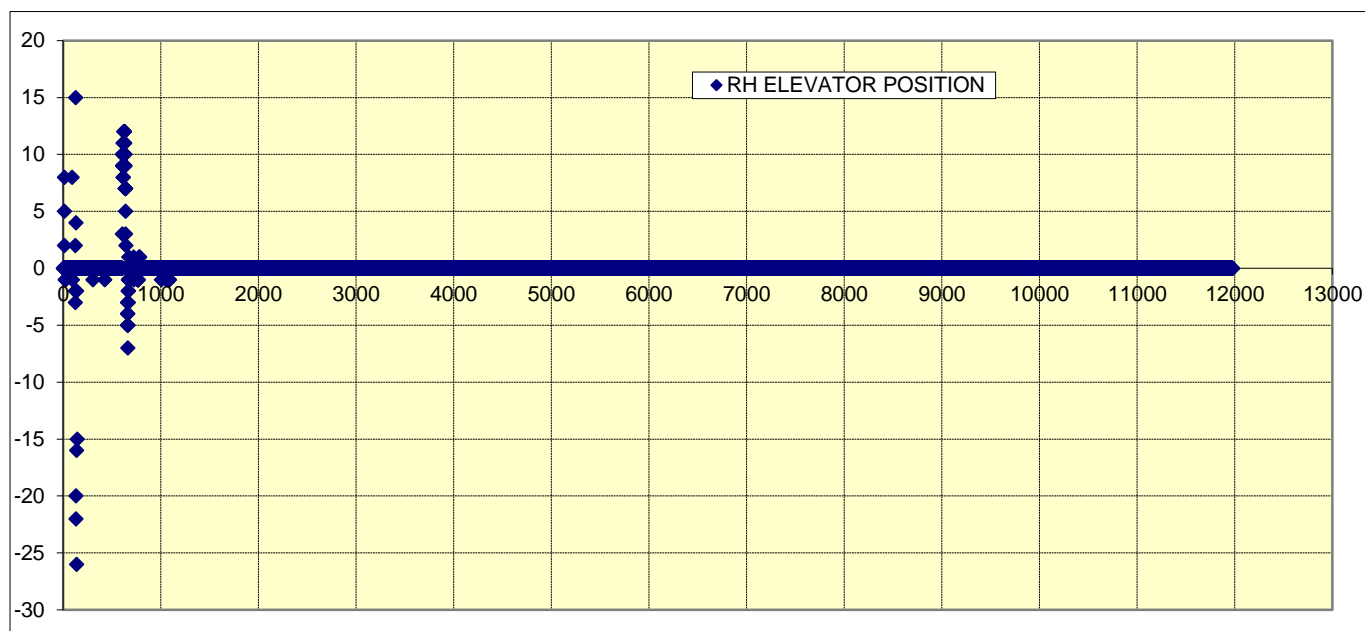
- ELEVATOR POSITION

Right elevator showed a value of 0 degree throughout the cruise [hase up to the end of recording

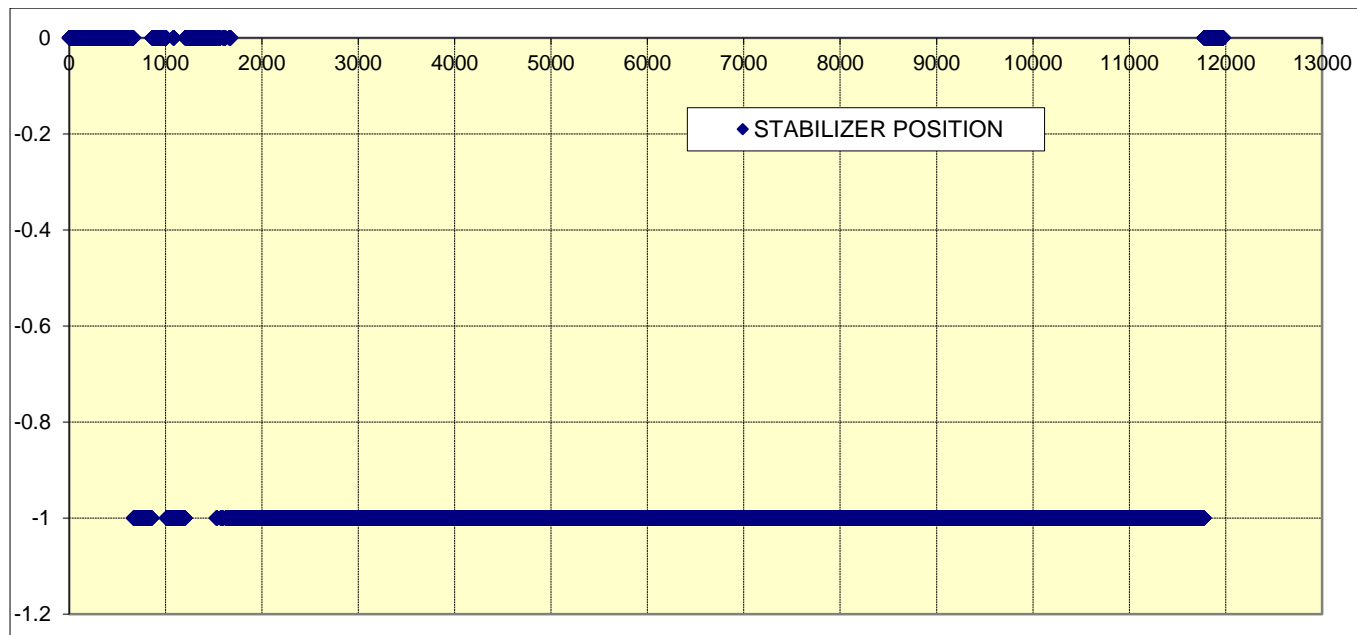
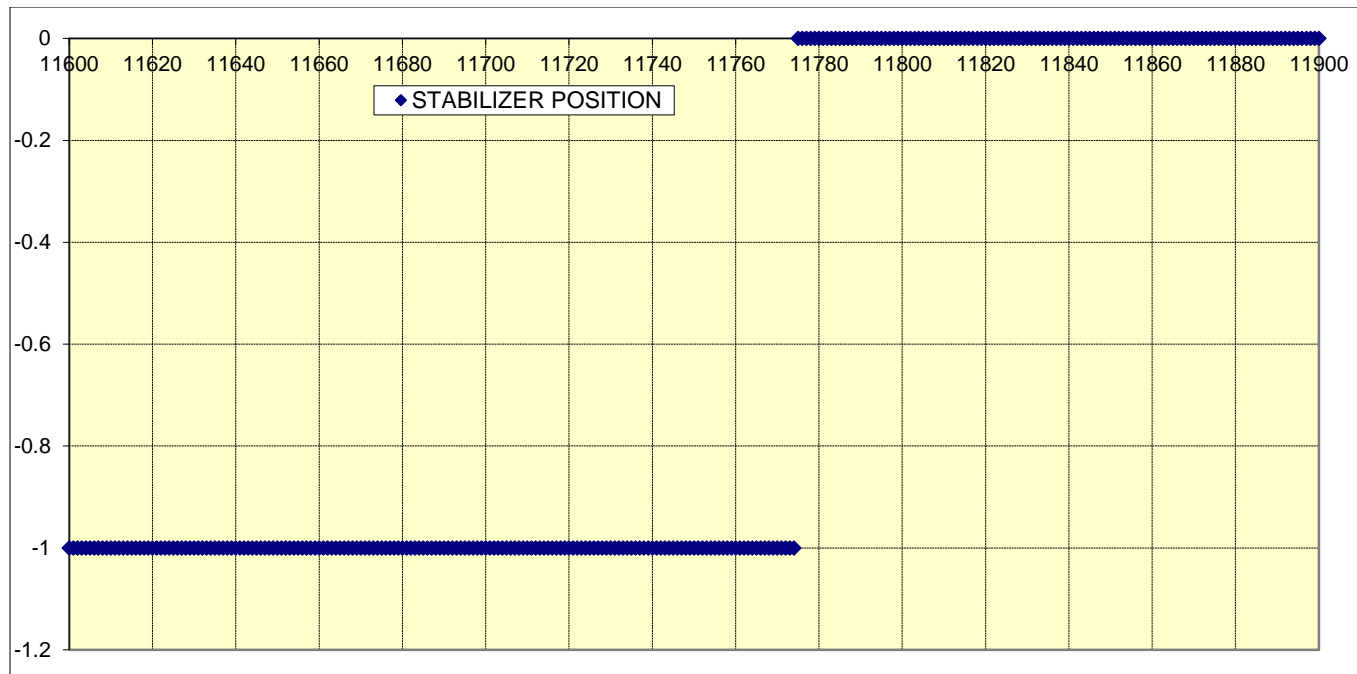
- STABILIZER POSITION

Stabilizer position showed a position of -1 throughout most of the recording time up to 00:26:23 UTC (11774 Seconds on the plot) then it moved to 0 and remained at 0 up to the end of recording at 00:29:45 UTC

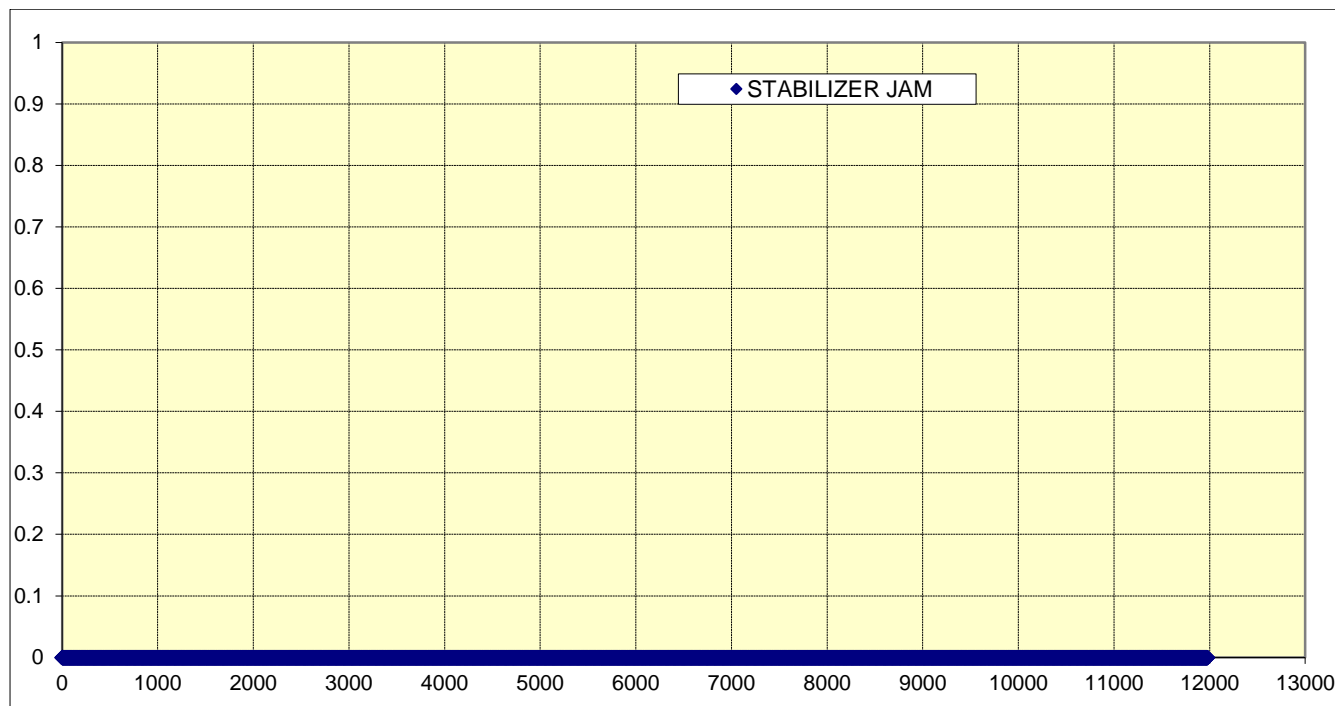
– STABILIZER JAM
(1 jammed)

No stabilizer jam

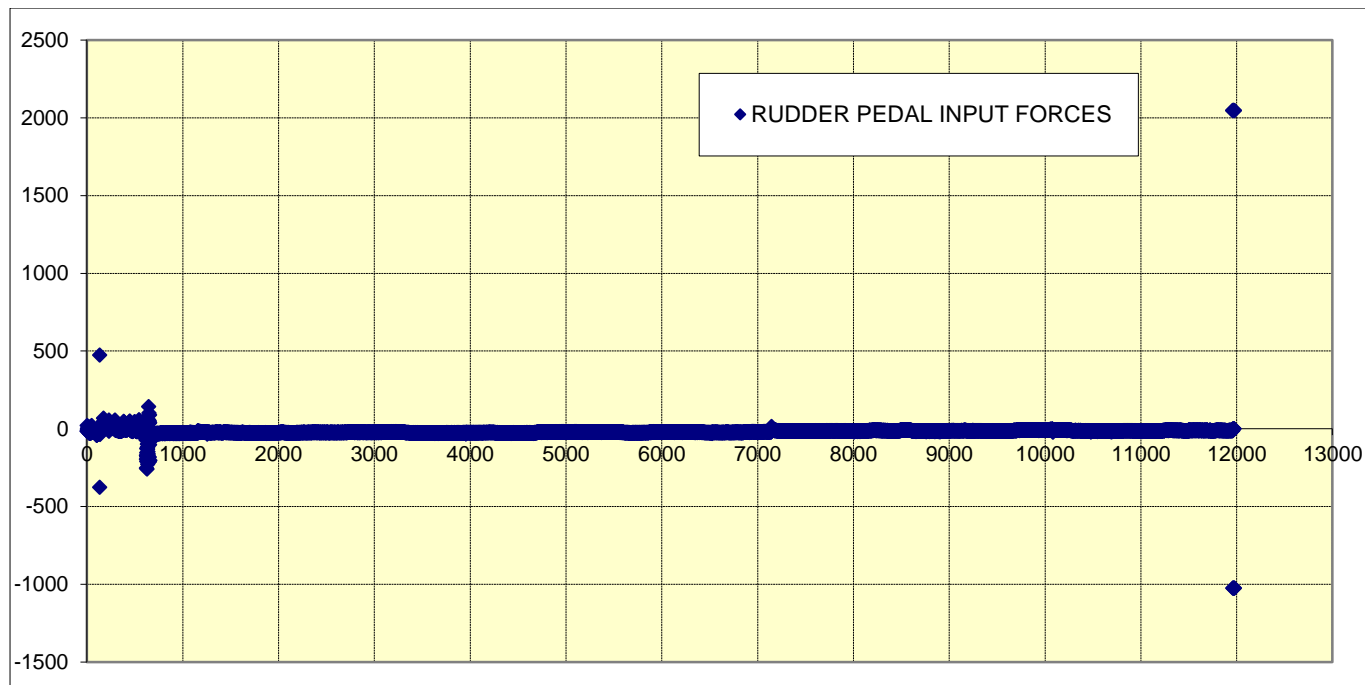
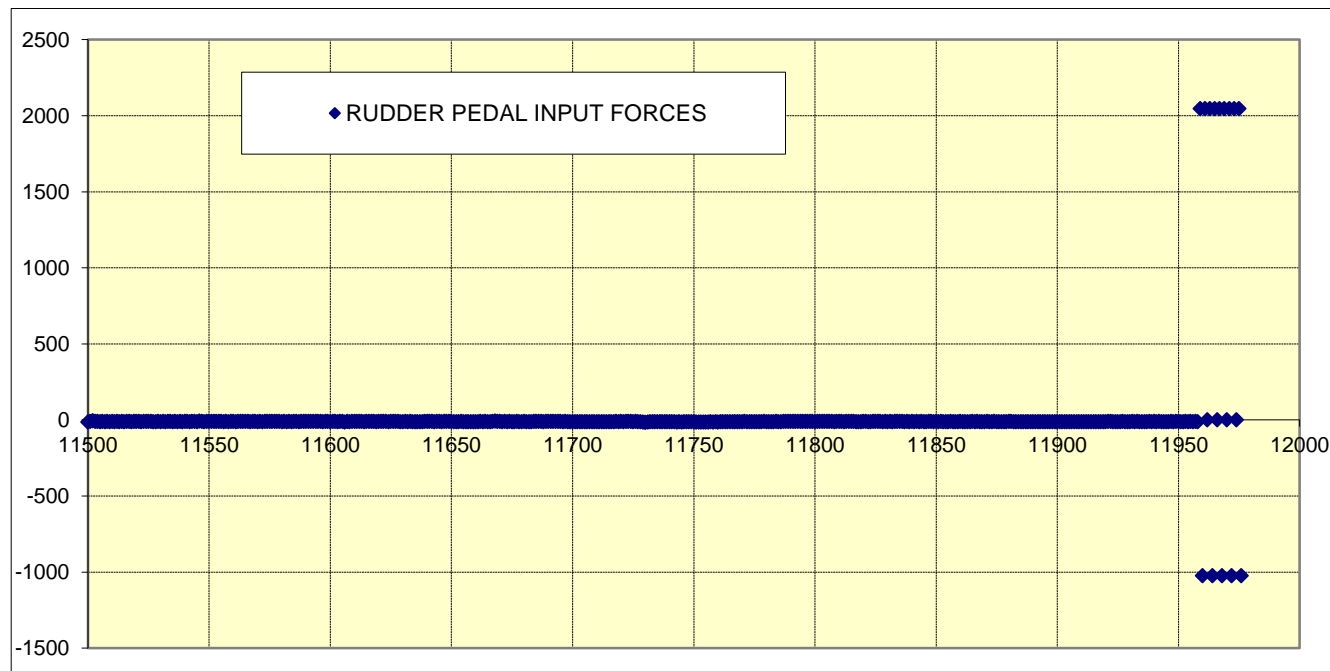
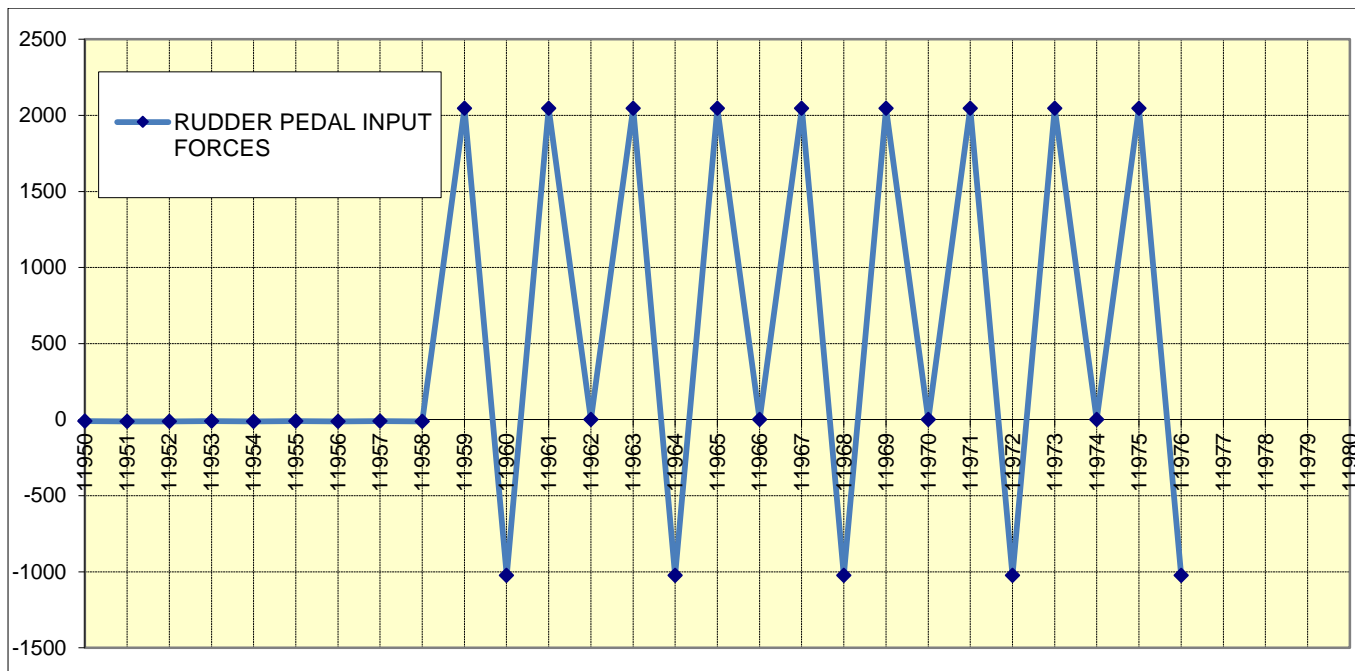
– RUDDER PEDAL INPUT FORCES

Rudder pedal input forces, closer view at the end of the recording

Rudder Pedal Input forces shown at the end of recording

Rudder Pedal Input forces showed a constant value of 0 up to 00:29:27 (11958 seconds on the plot) then it started varying between 2047 and -1024 up to the end of recording 00:29:45 (11976 seconds on the plot)
