Final Report

**EgyptAir A320 Aircraft crash in the Mediterranean, registered SU-GCC,
flight number MSR804, from Charles De-Gaulle Airport, Paris to Cairo
International Airport, on 19/05/2016**

EGAI2016-01

October 2024

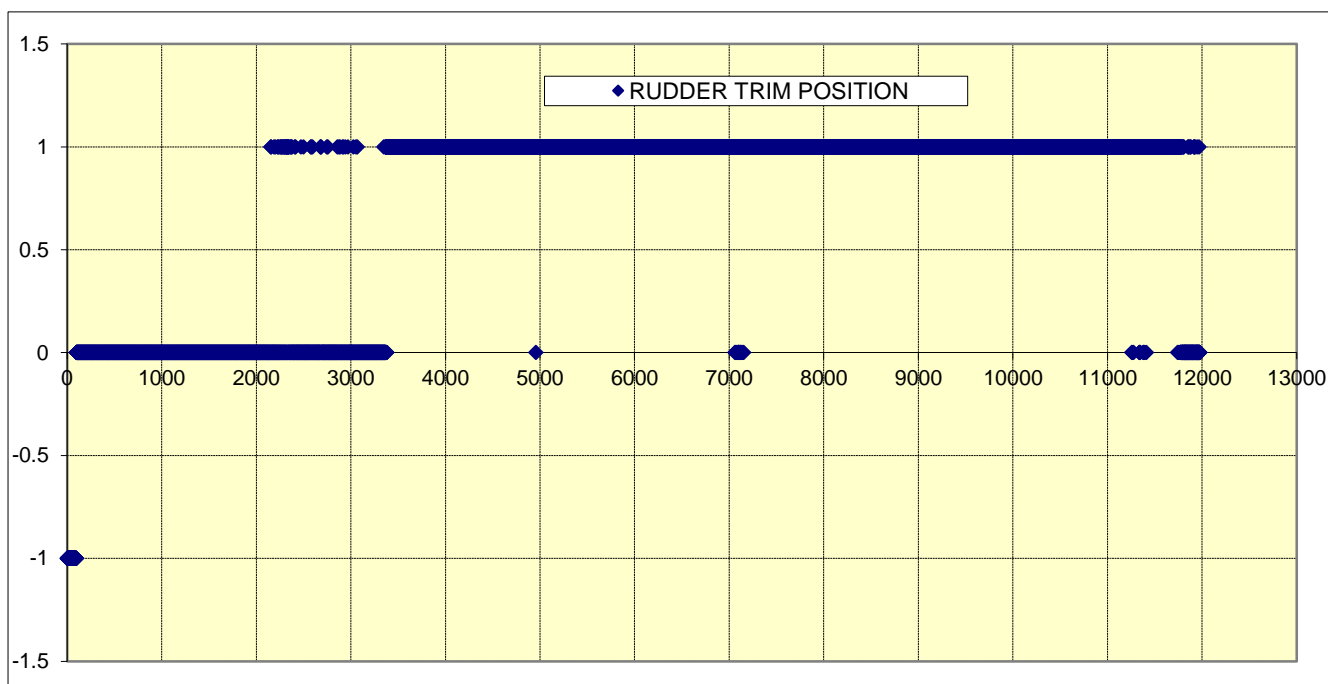
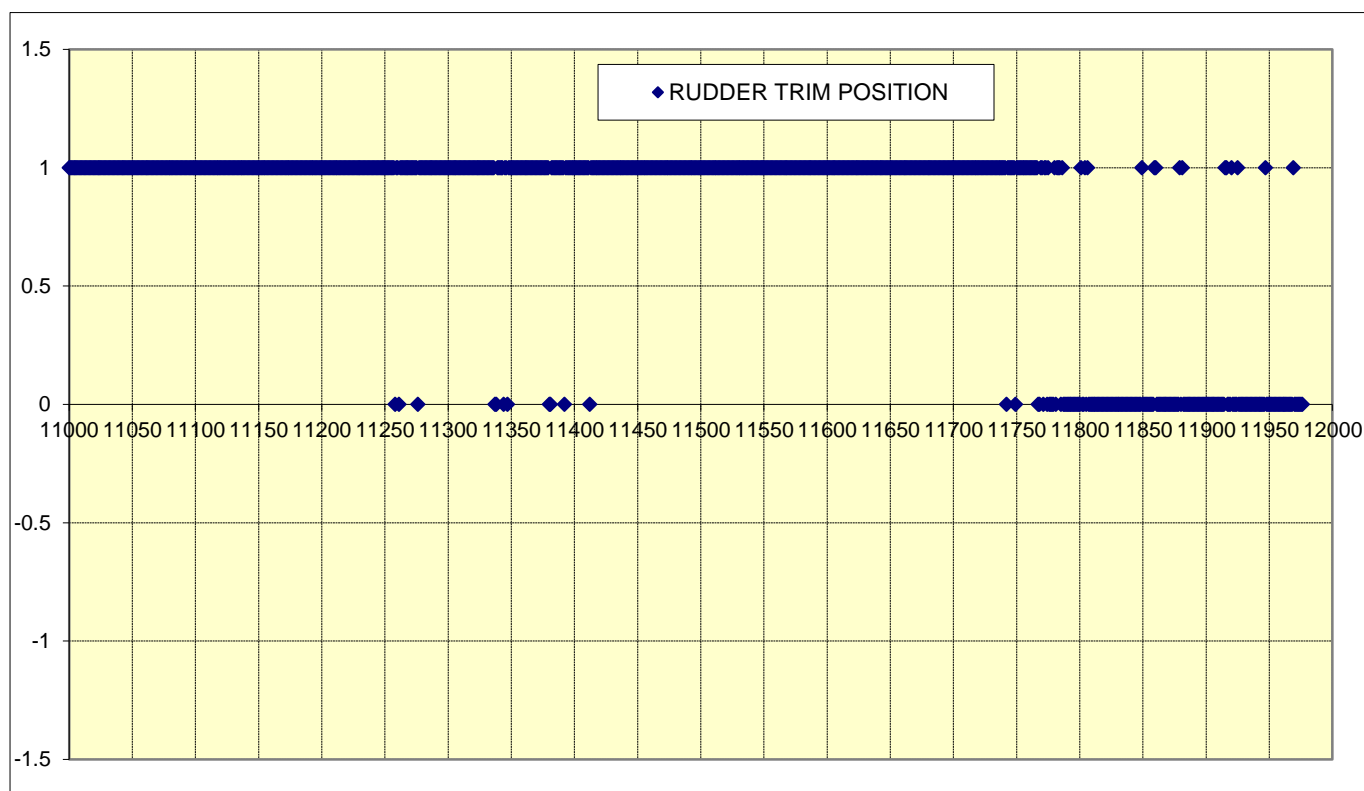
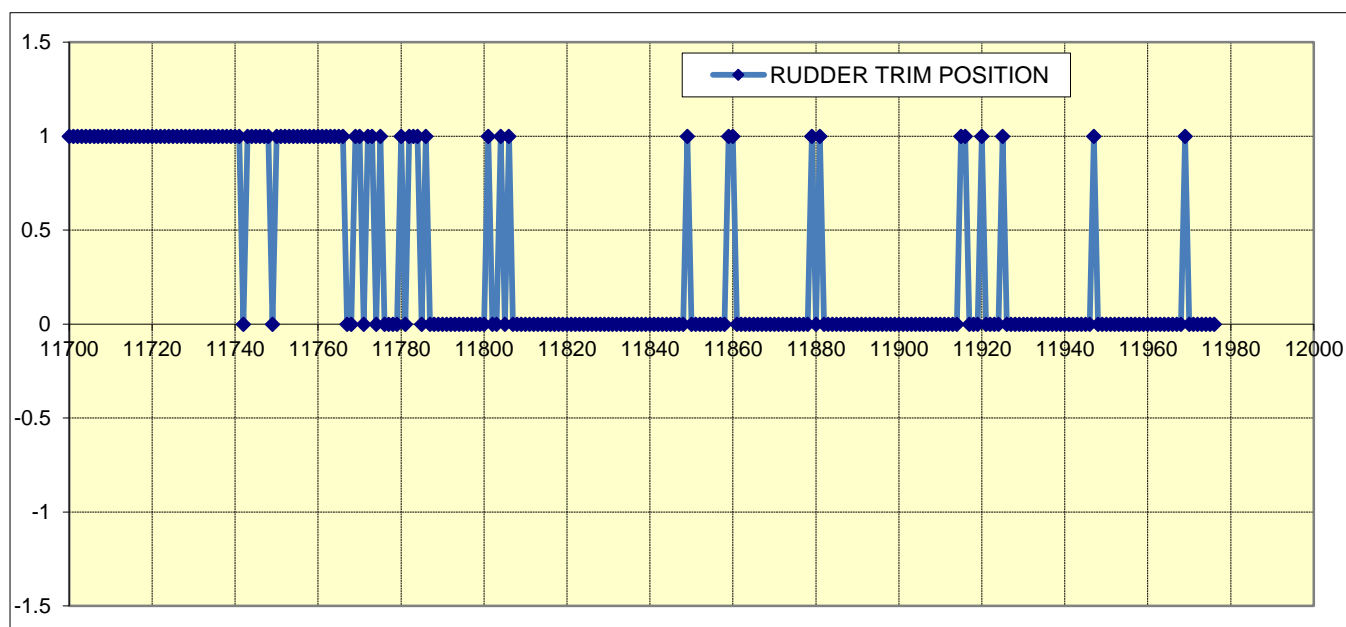
- RUDDER TRIM POSITION

Rudder trim position, closer view at the end of the recording

Rudder trim position showed a value of 1 most of the cruise flight. At 00:25:58 (11749 seconds on the plot) the rudder trim position started variation between 1 and 0 until the end of the recording at 00:29:45

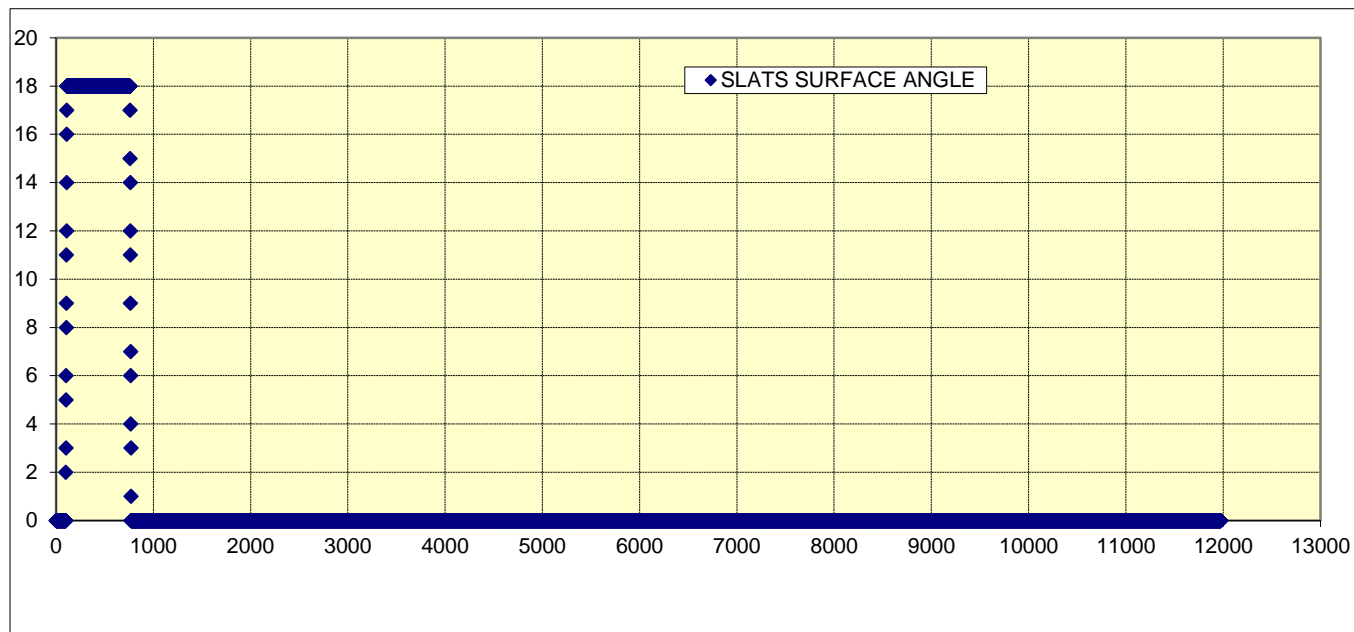
- SLATS surface angle

Slats remained retracted up to the end of the recording

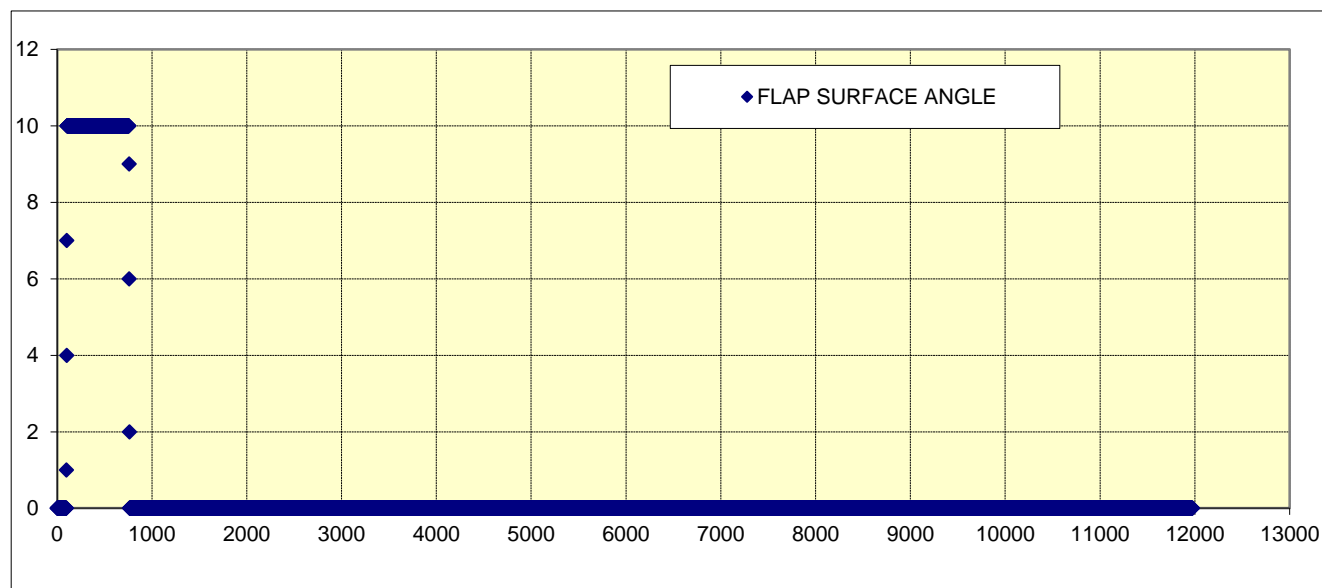
- FLAP SURFACE ANGLE

Flaps remained retracted up to the end of the recording

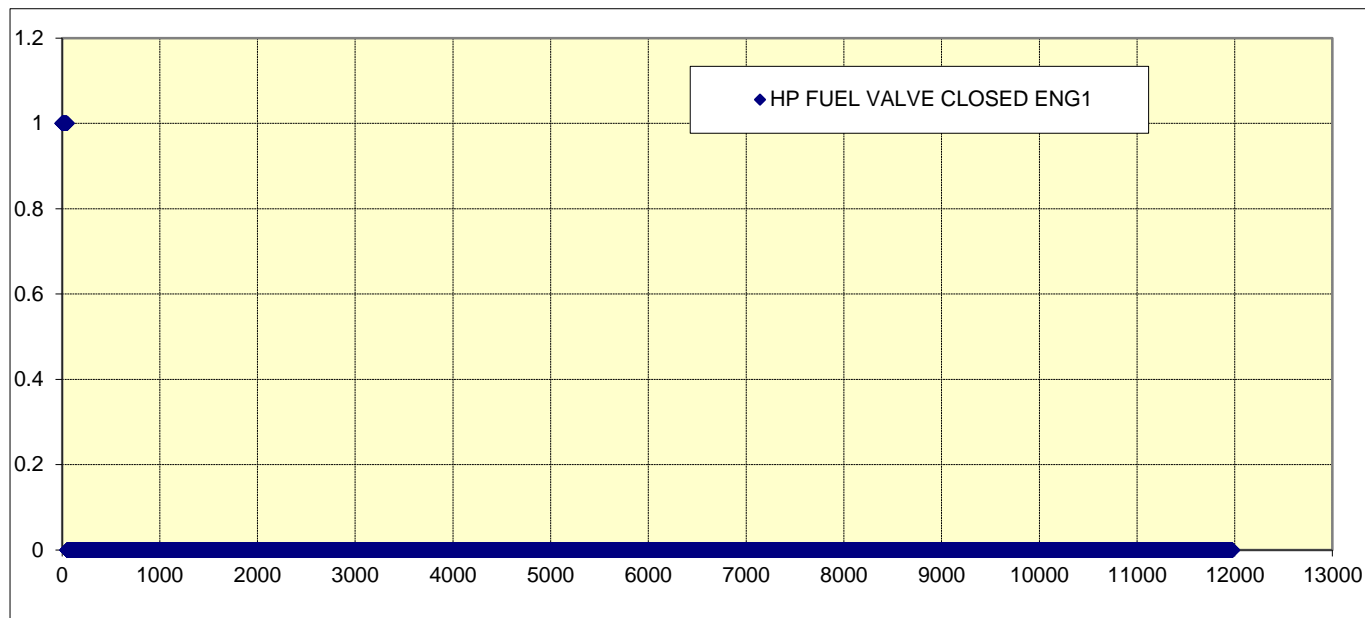
- HP FUEL VALVE CLOSED ENG1

HP FUEL VALVE CLOSED ENG1 was not closed throughout the whole recording

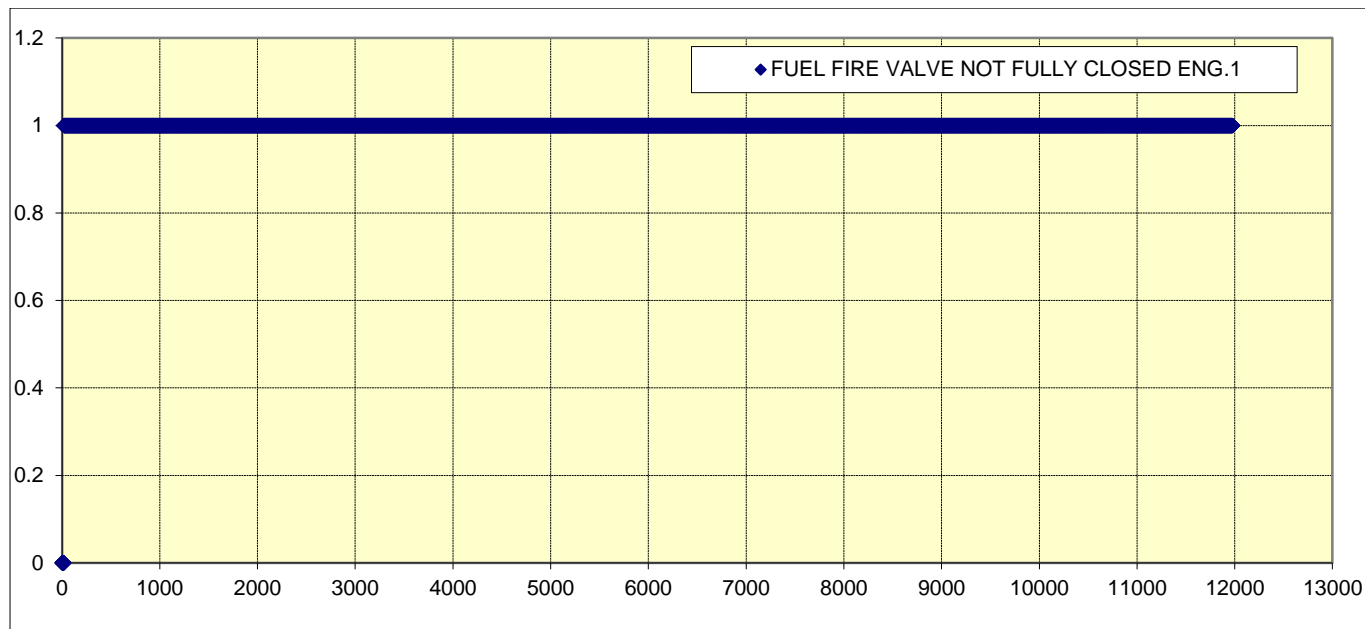
- FUEL FIRE VALVE NOT FULLY CLOSED ENG.1

FUEL FIRE VALVE was NOT FULLY CLOSED ENG.1 throughout the whole recording time

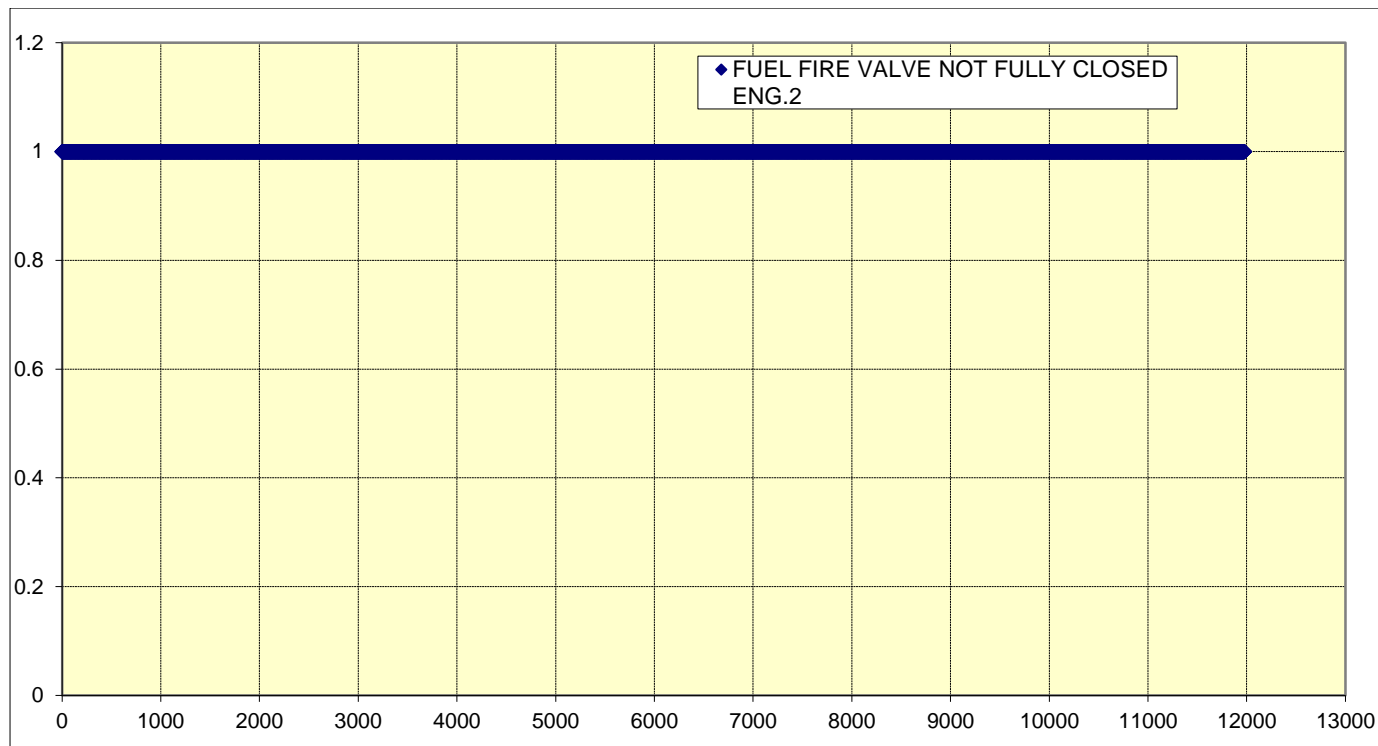
- FUEL FIRE VALVE NOT FULLY CLOSED ENG.2

FUEL FIRE VALVE was NOT FULLY CLOSED ENG.2 throughout the whole recording time

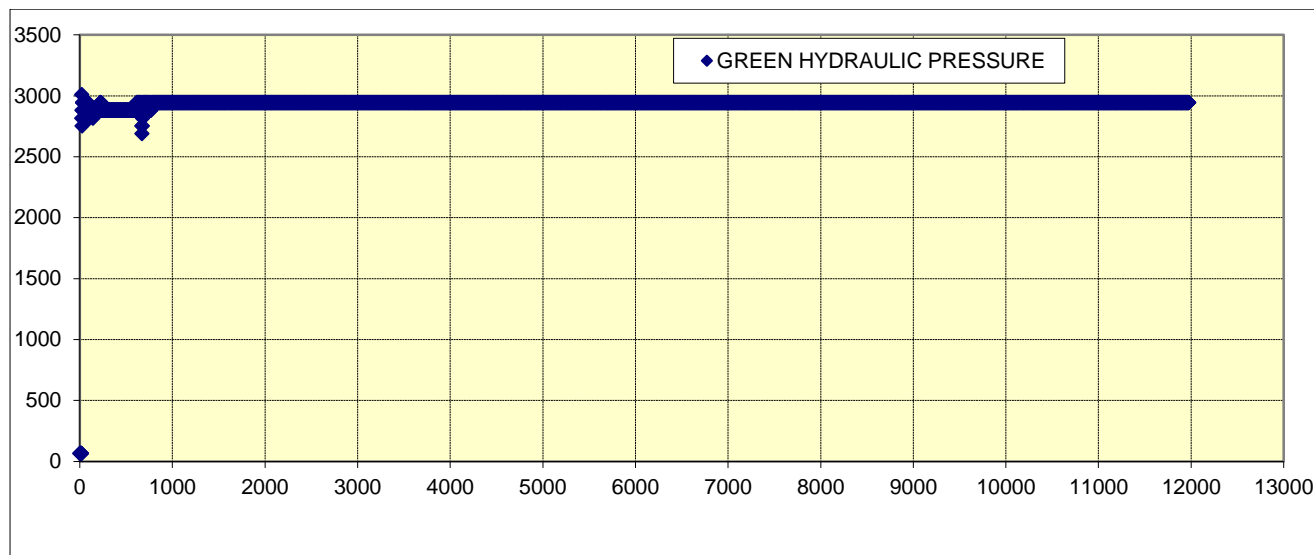
- GREEN HYDRAULIC PRESSURE

Green hydraulic pressure was almost 2944 psi throughout the whole recording

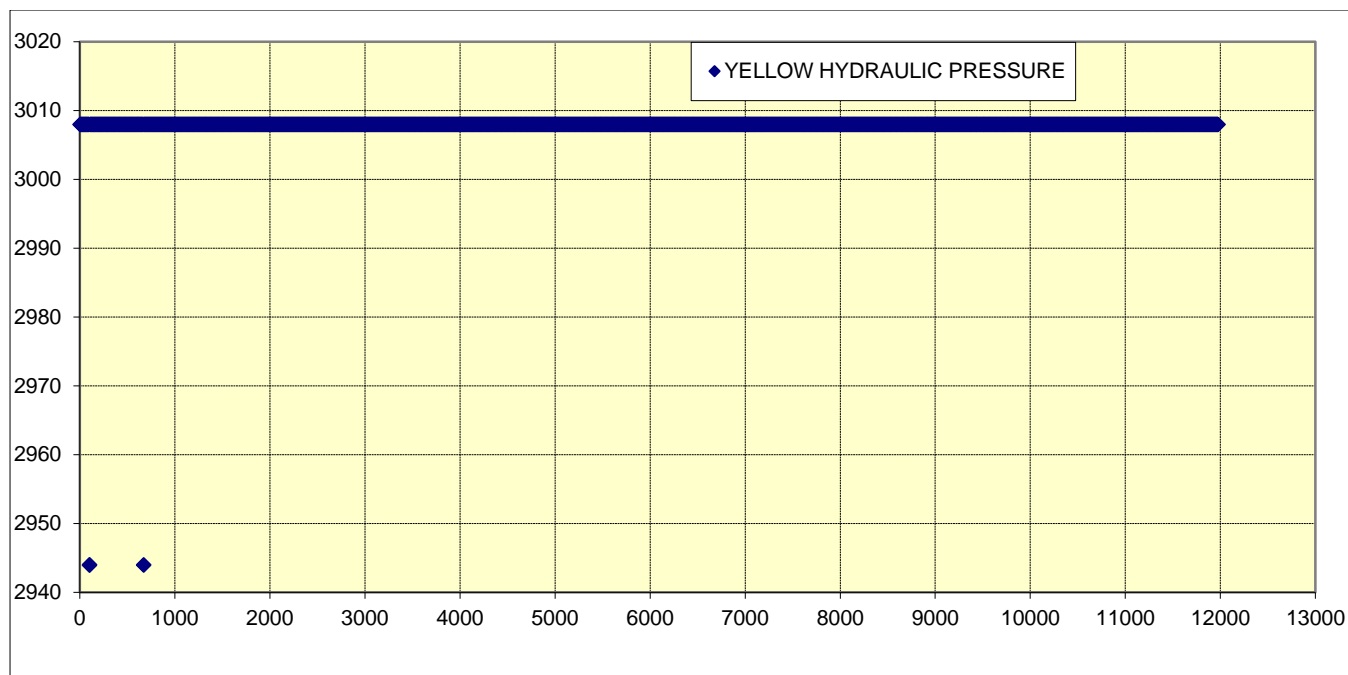
- YELLOW HYDRAULIC PRESSURE

Yellow hydraulic pressure was almost 3008 psi throughout the whole recording

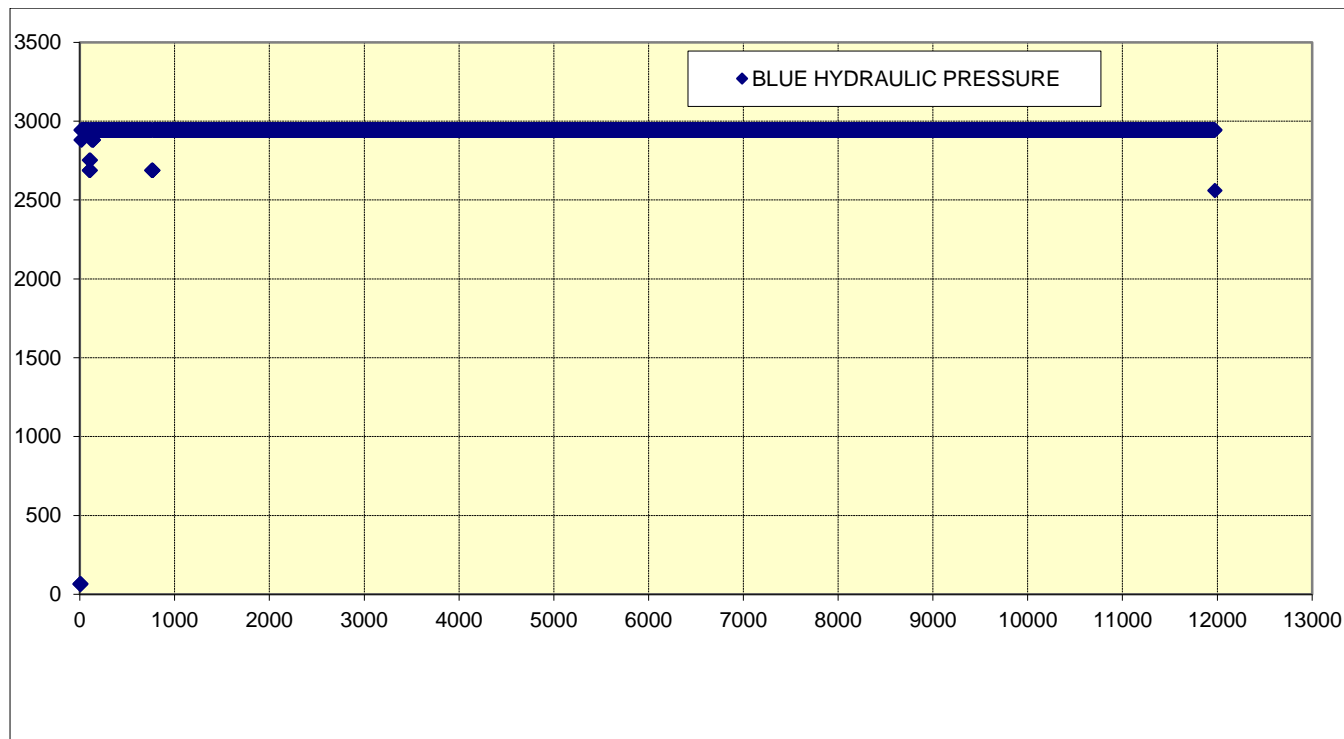
- BLUE HYDRAULIC PRESSURE

Blue hydraulic pressure was almost 2994 psi throughout the whole recording

Note: only at the last recorded point (11976 seconds on the plot) the Blue hydraulic pressure dropped to 2560 psi

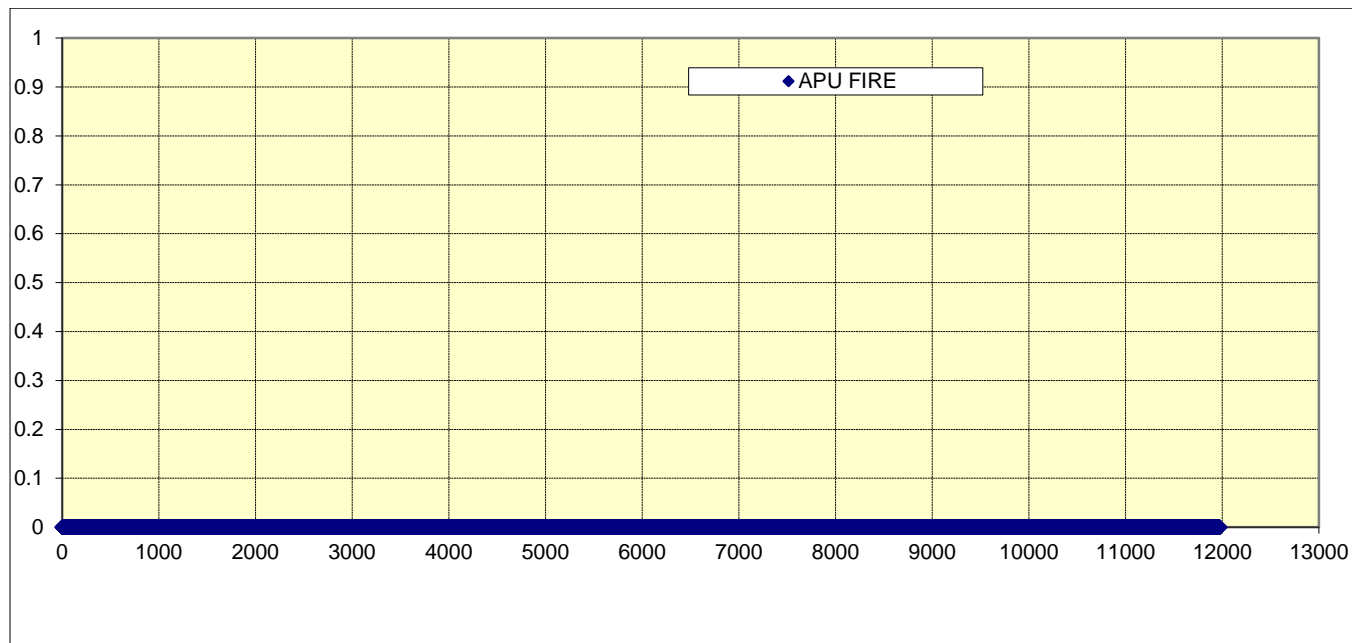
- APU FIRE
(1 fire)

No APU fire detected

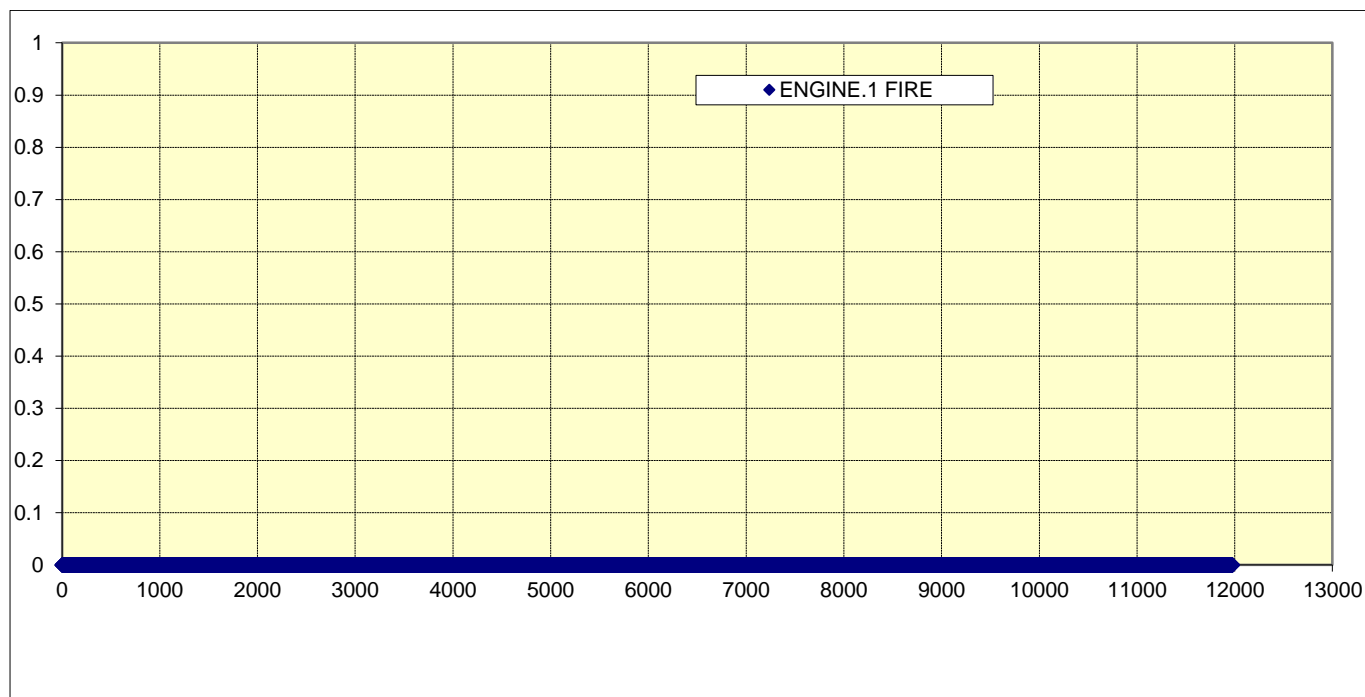
- ENGINE.1 FIRE
(1 fire)

No fire detected in engine 1

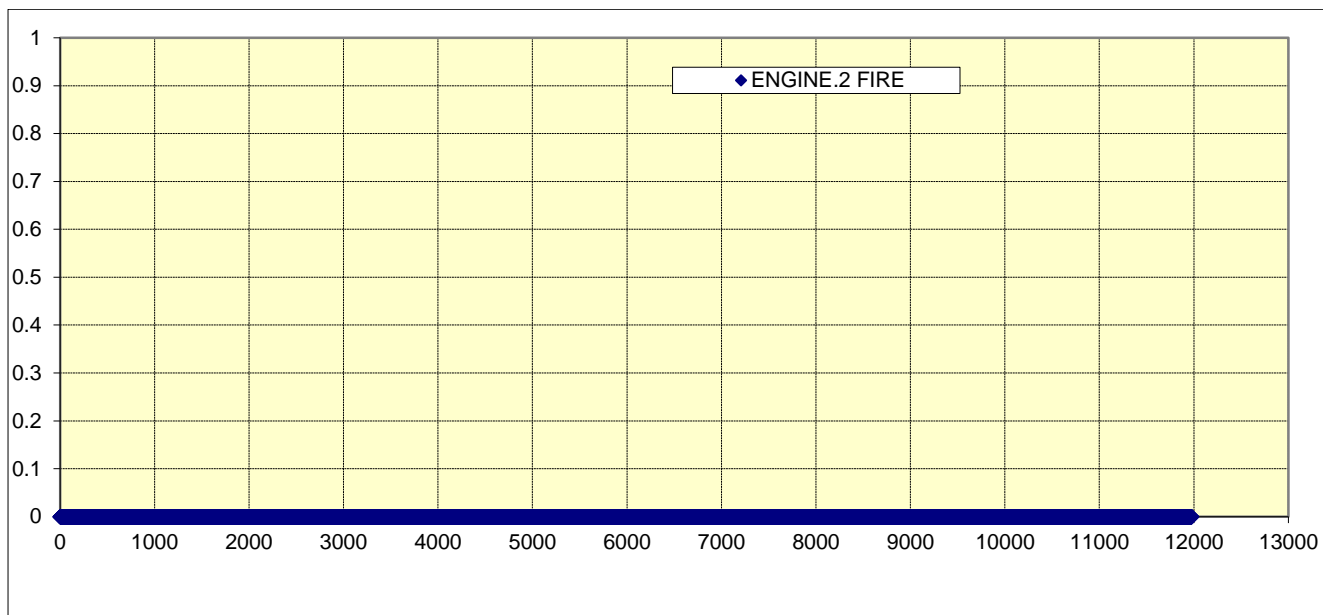
- ENGINE.2 FIRE

No fire detected in engine 2

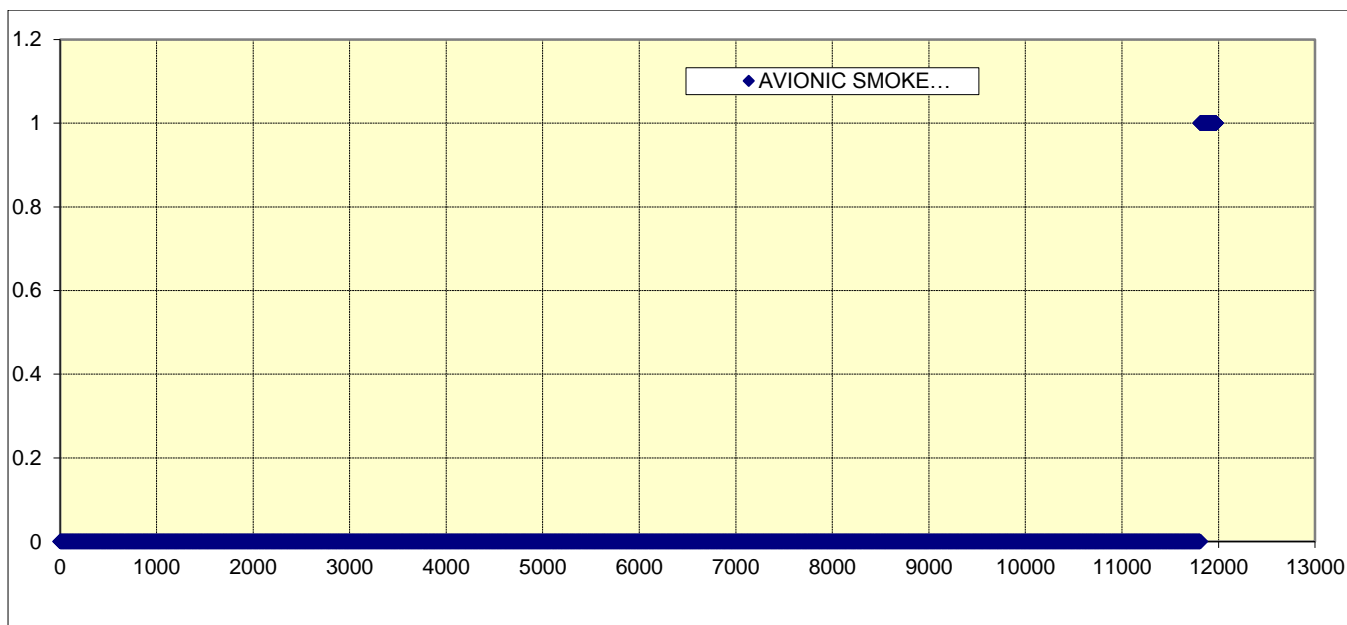
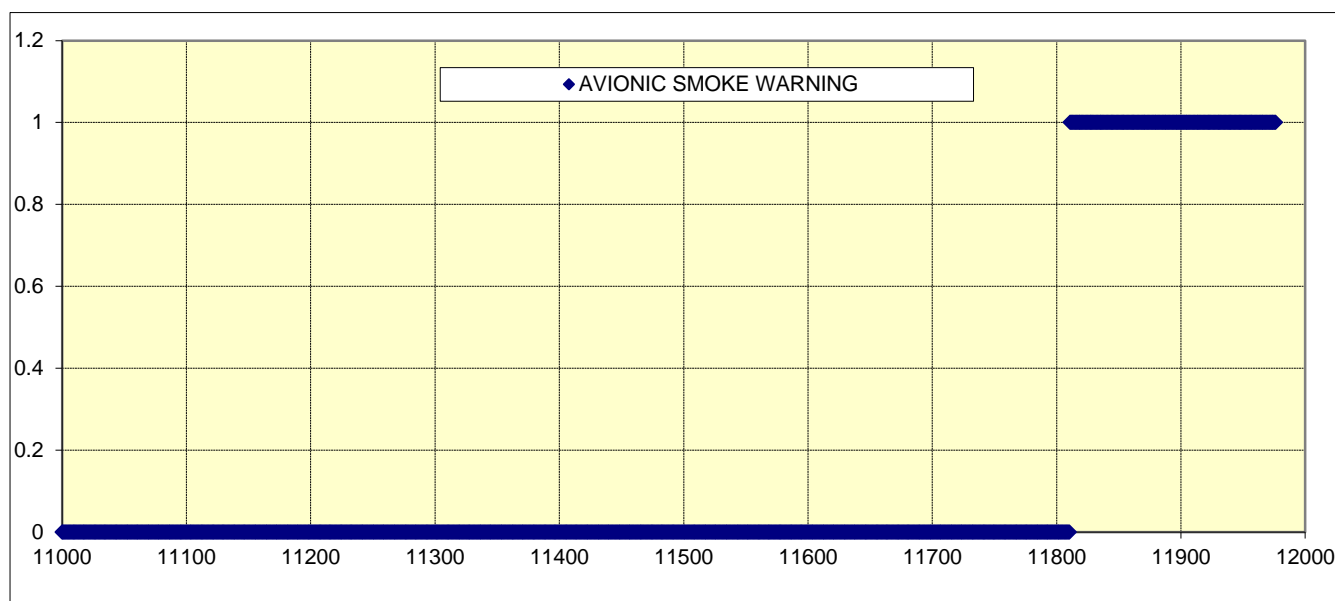
- AVIONIC SMOKE WARNING

Avionic smoke warning (closer view at the end of the recording)

Avionic smoke started at 00:27:00 UTC (11811 seconds plot time) and continued to the end of the recording 00:29:45 UTC

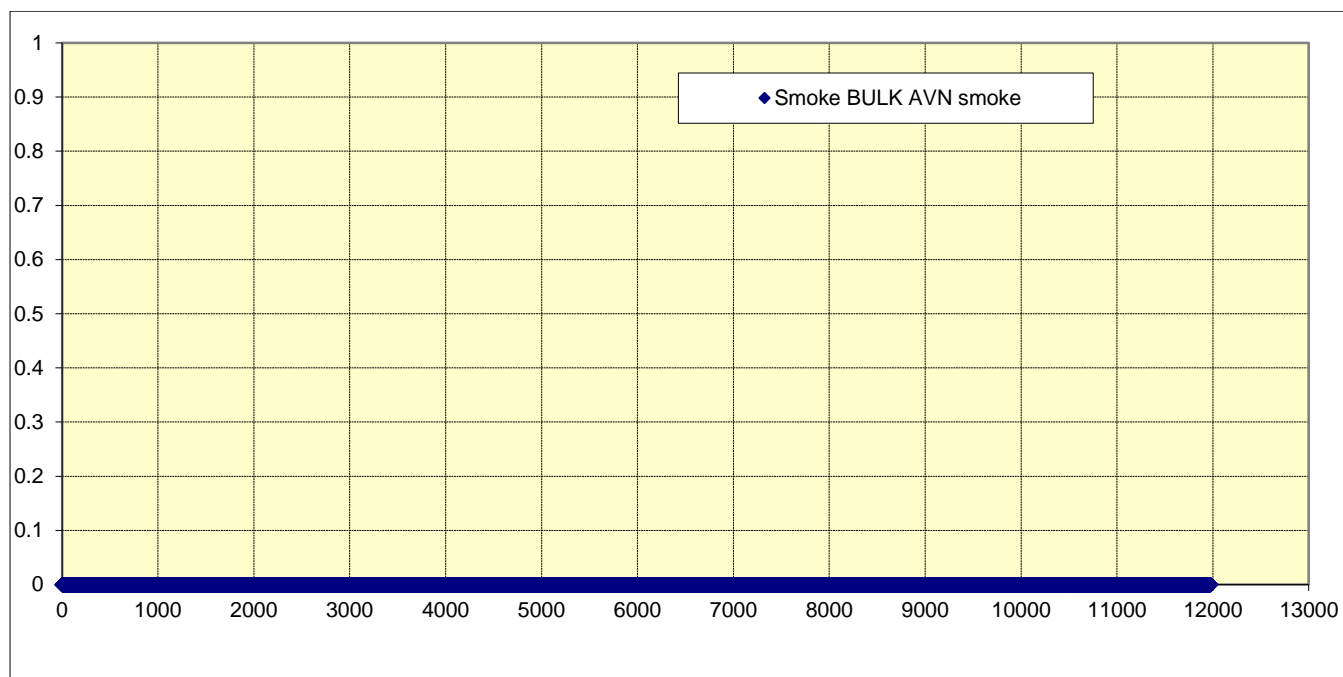
- Smoke BULK AVN smoke
(1 smoke)

No bulk avionics smoke detected

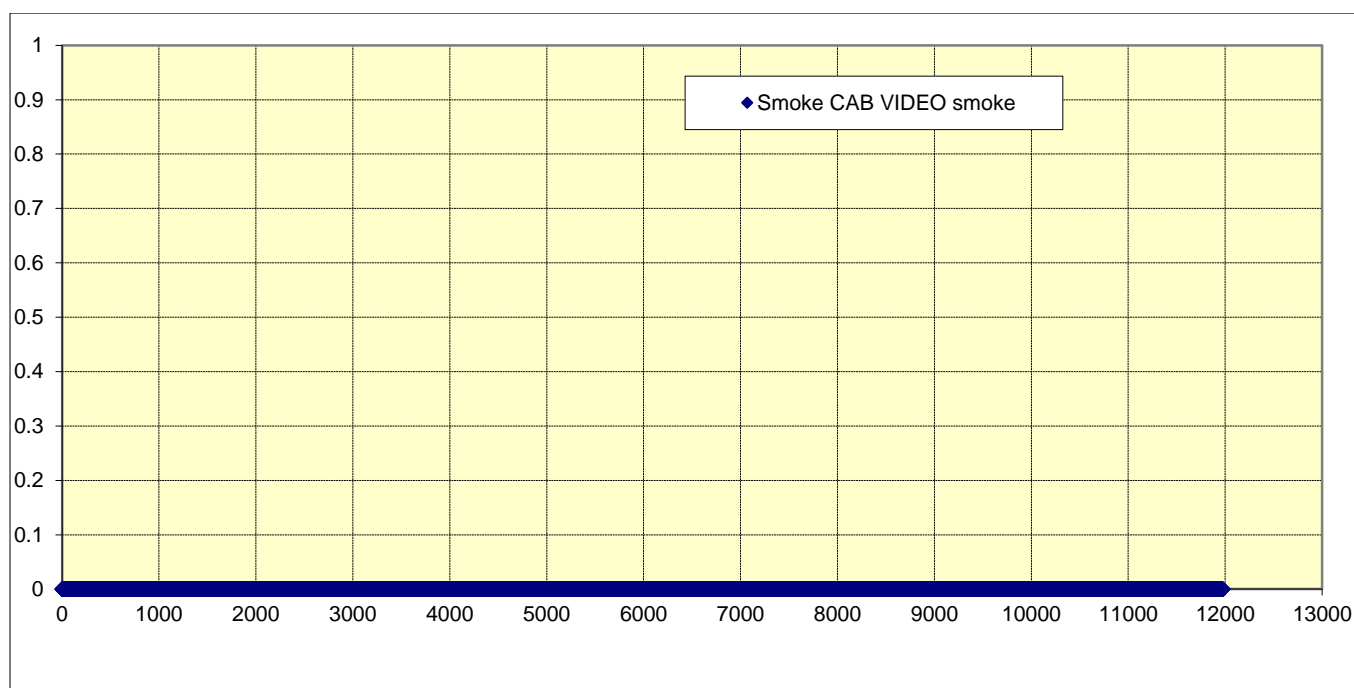
- Smoke CAB VIDEO smoke
(1 smoke)

No smoke in cabin video

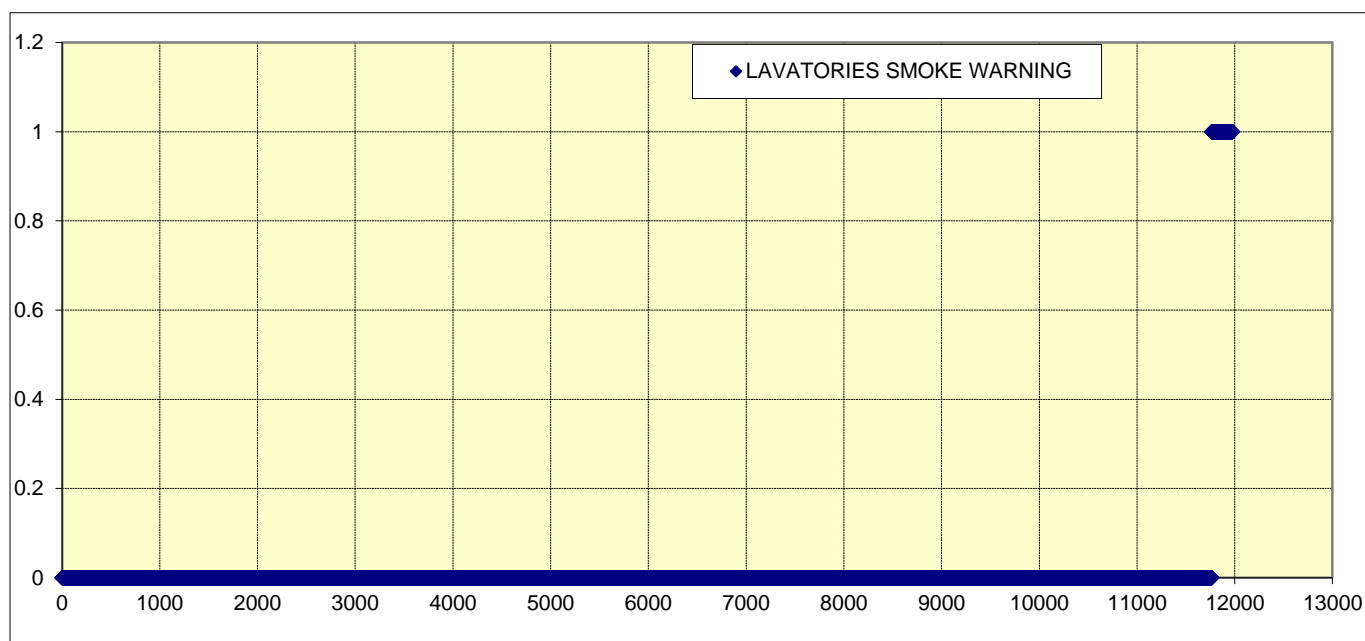
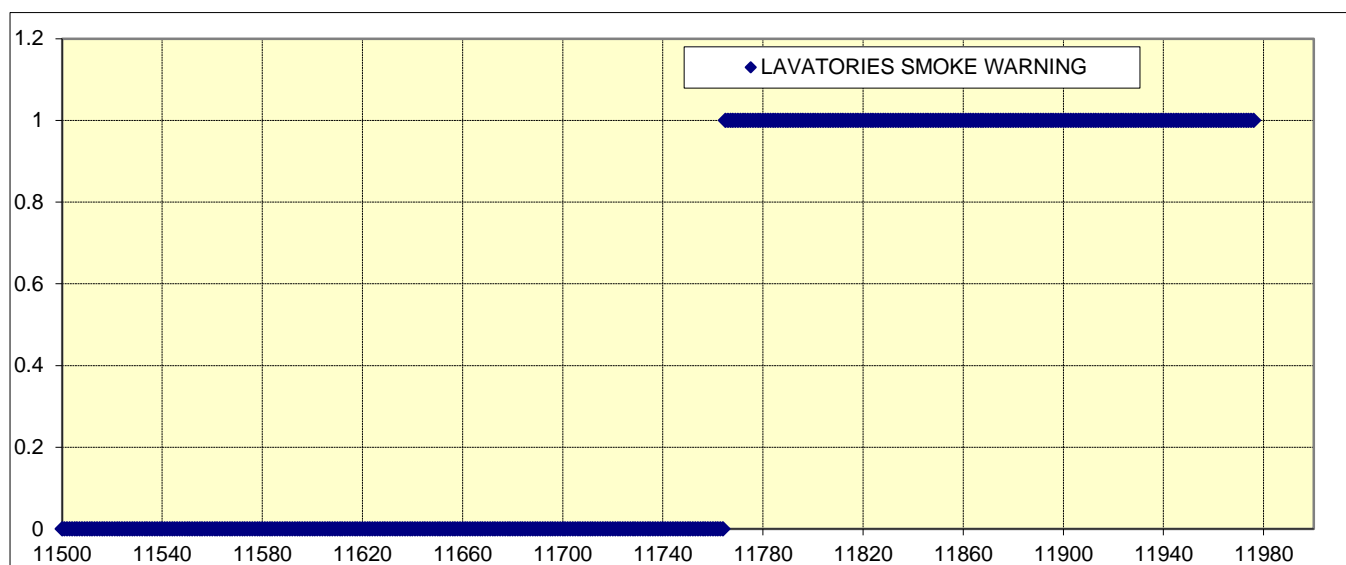
- LAVATORIES SMOKE WARNING
(1 smoke)

Lavatories smoke warning (closer view at the end of the recording)

Lavatory smoke started at 00:26:14 UTC (11765 seconds plot time) and continued to the end of the recording 00:29:45

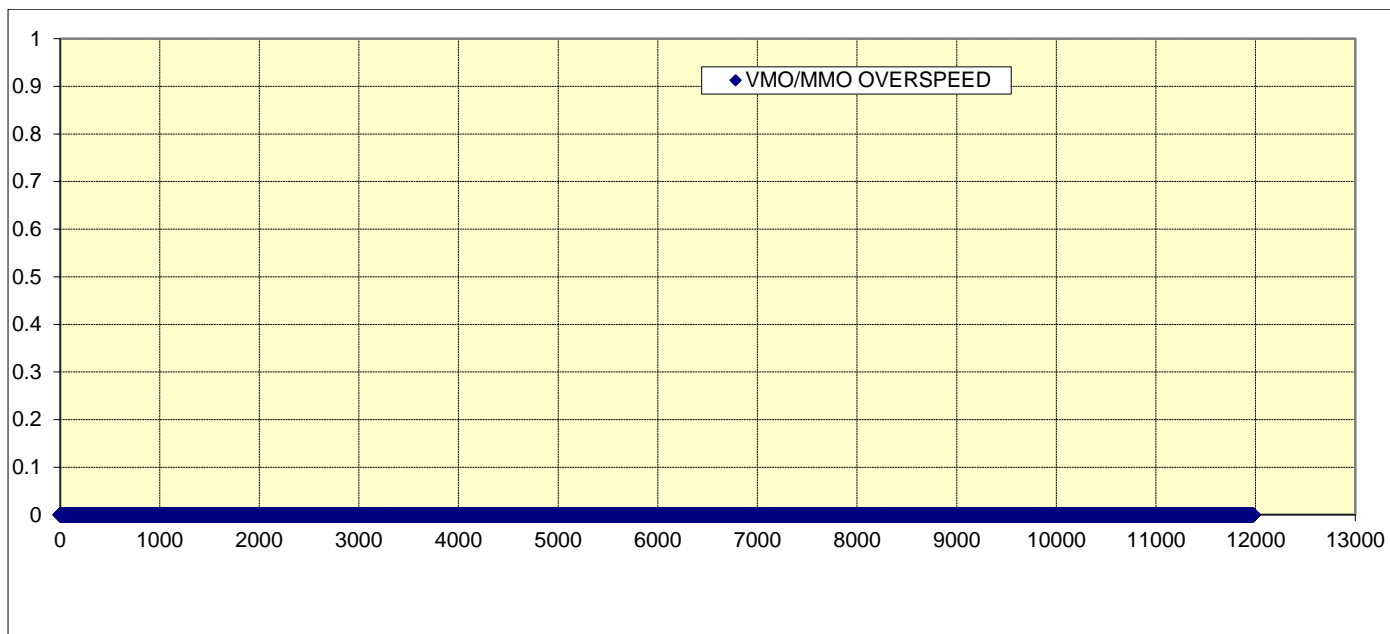
– VMO/MMO OVERSPEED
(1 Overspeed)

No overspeed throughout the whole recording

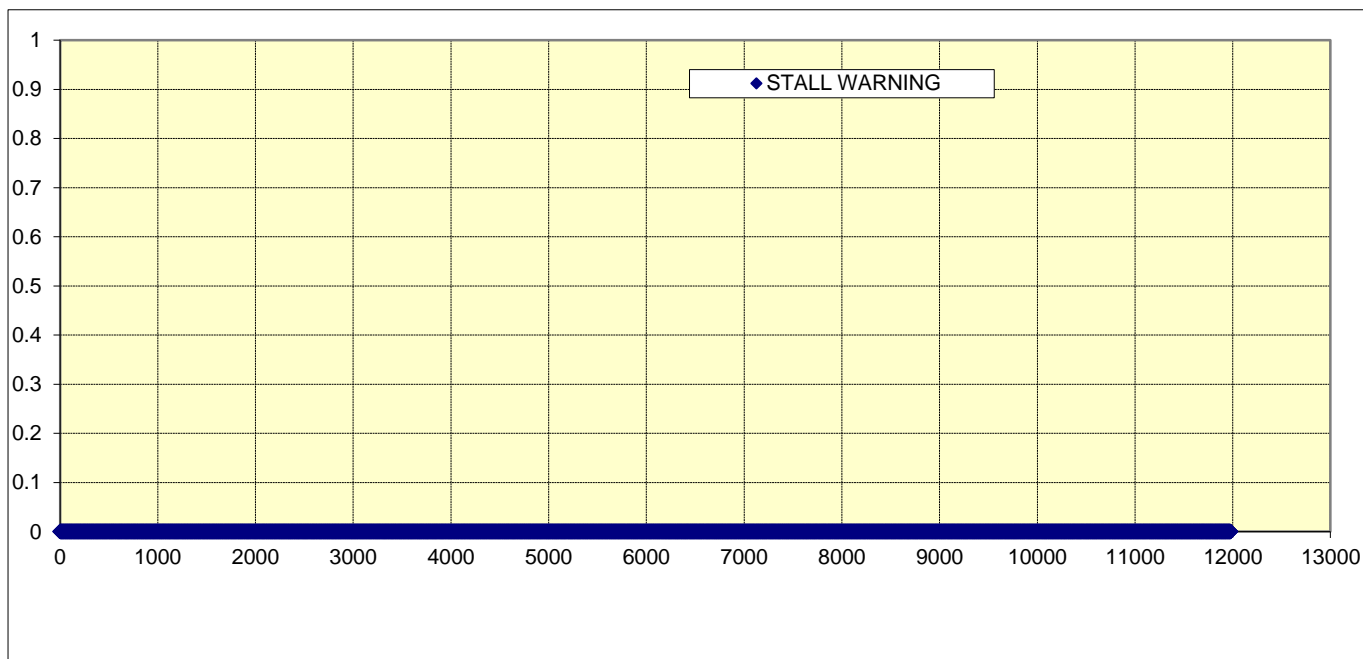
– STALL WARNING
(1 warning)

No stall throughout the whole recording

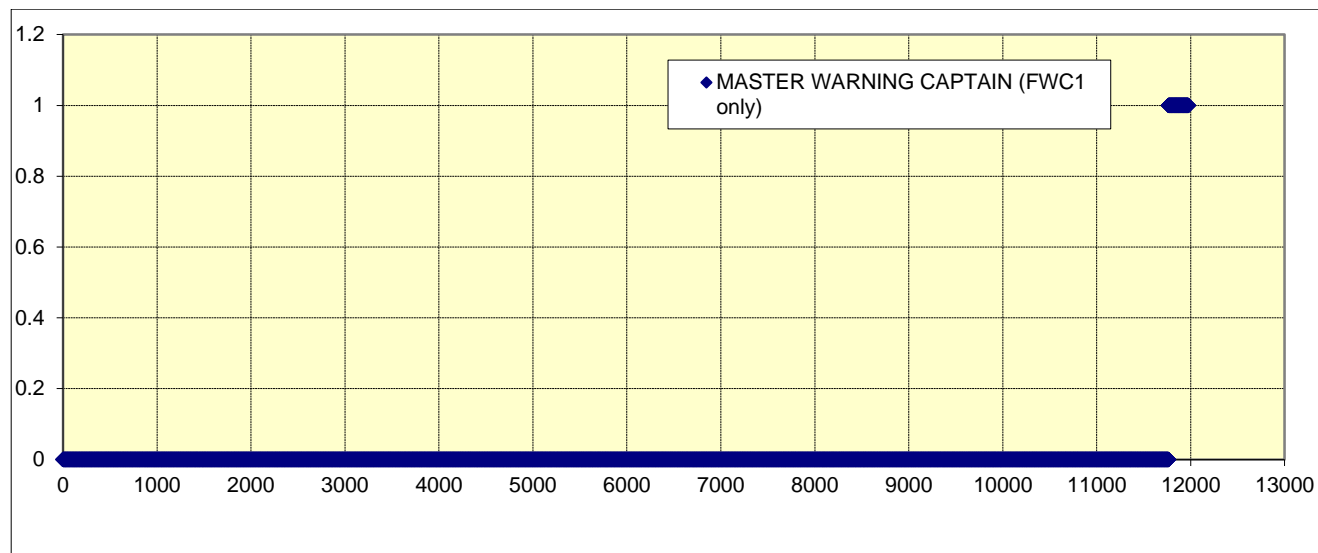
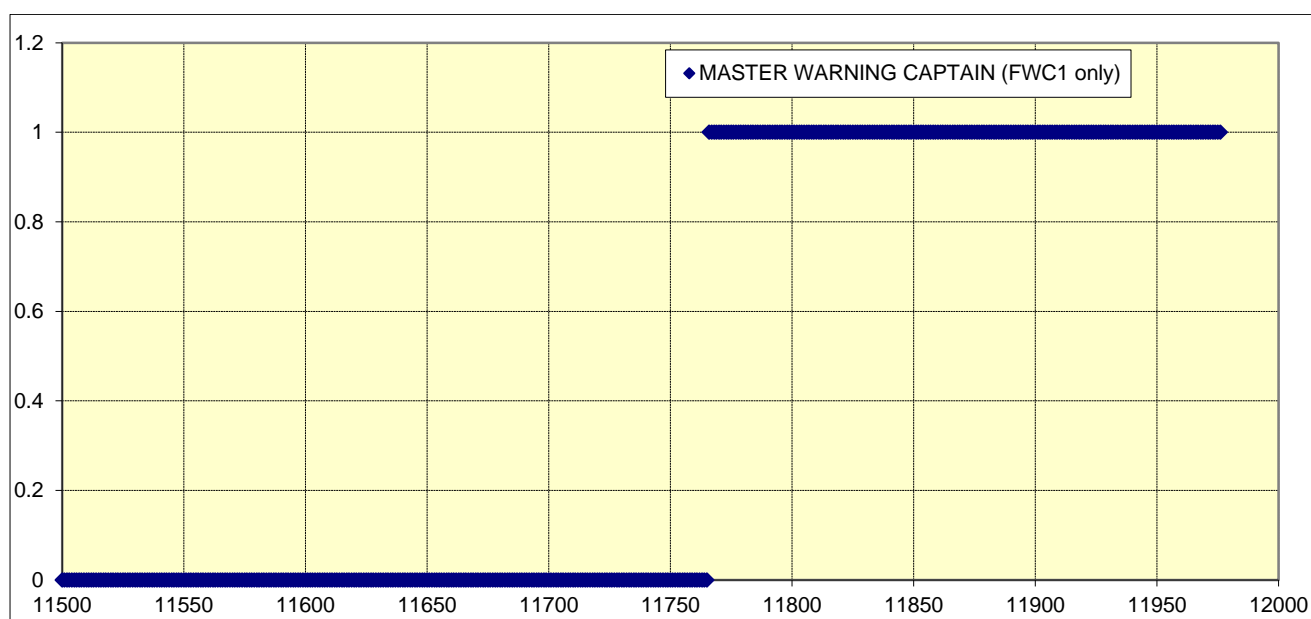
- MASTER WARNING CAPTAIN (FWC1 only)

Master warning Captain FWC1 only (closer view at the end of the recording)

"Master warning Captain FWC1 only" started at 00:26:15 UTC (11766 seconds plot time) continued up to the end of the recording at 00:29:45 (11976 seconds plot time)

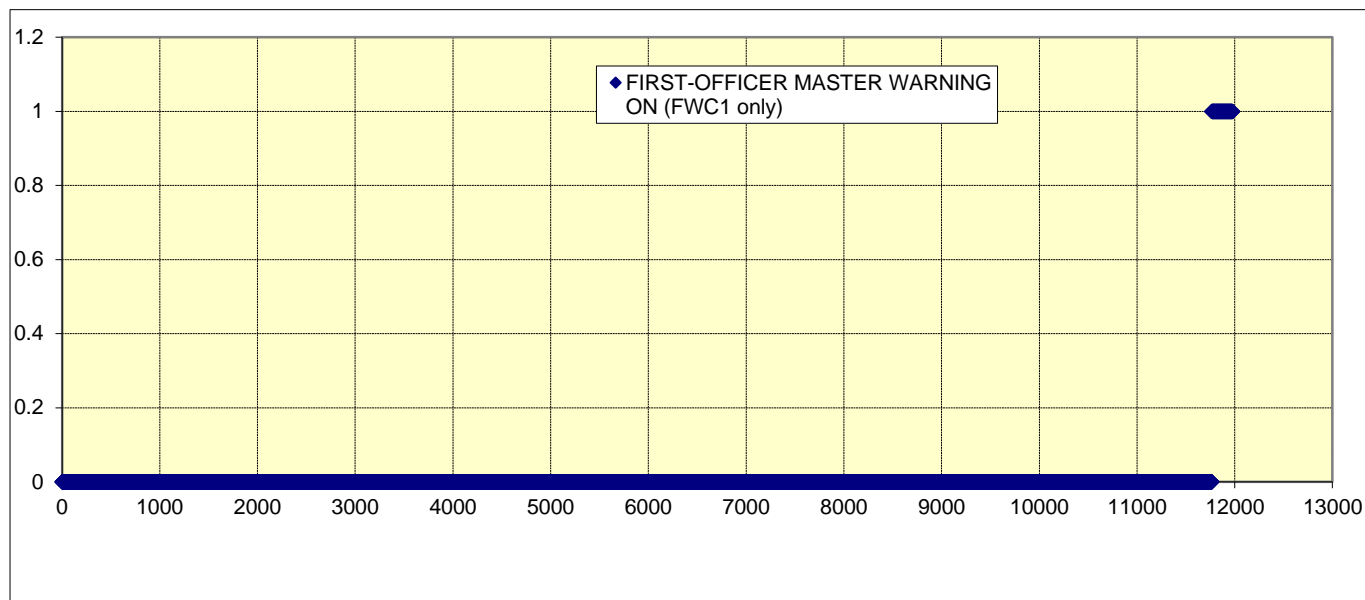
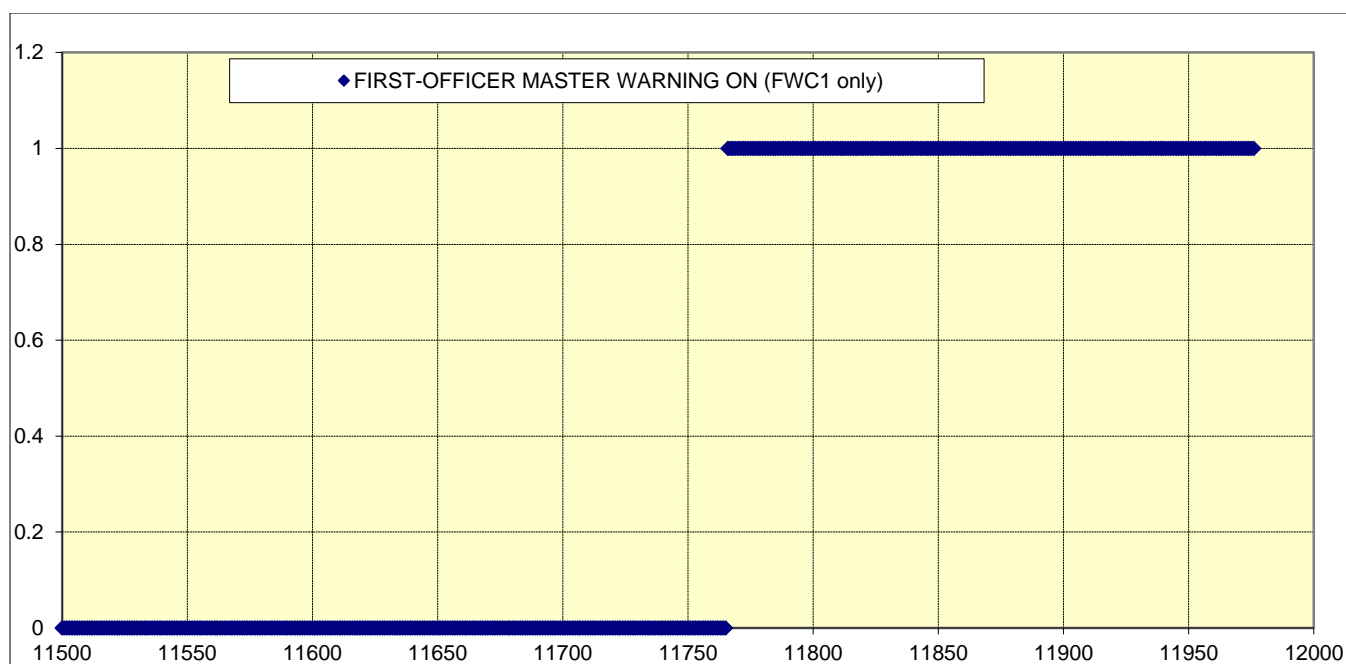
– FIRST-OFFICER MASTER WARNING ON (FWC1 only)
(1 Master warning)

Master warning First Officer FWC1 only (closer view at the end of the recording)

"Master warning F/O FWC1 only" started at 00:26:15 UTC (11766 seconds plot time) continued up to the end of the recording at 00:29:45 (11976 seconds plot time)
