Final Report

**EgyptAir A320 Aircraft crash in the Mediterranean, registered SU-GCC,
flight number MSR804, from Charles De-Gaulle Airport, Paris to Cairo
International Airport, on 19/05/2016**

EGAI2016-01

October 2024

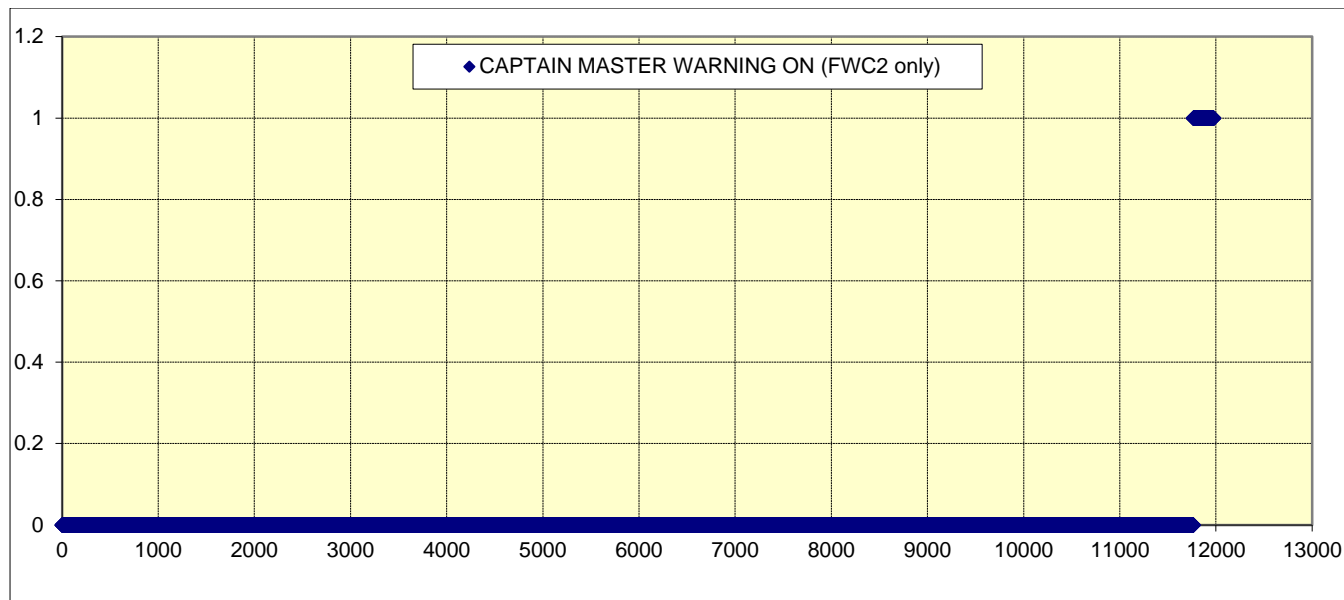
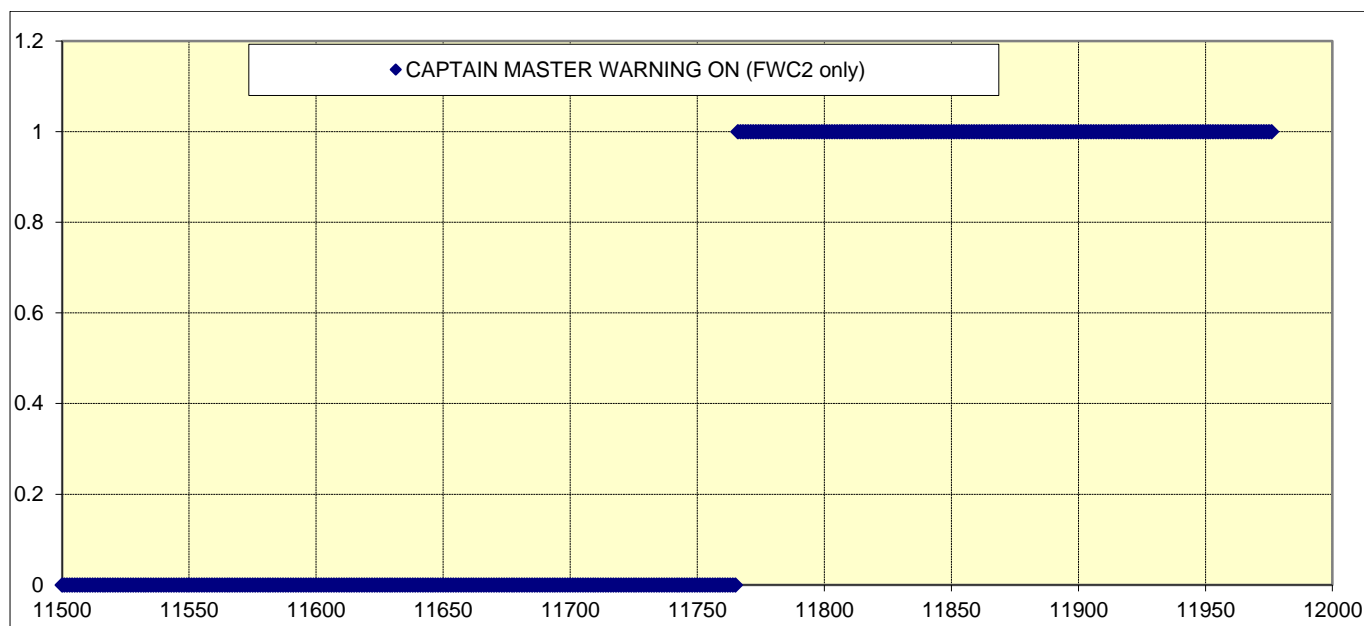
– CAPTAIN MASTER WARNING ON (FWC2 only)

Master warning Captain ON FWC2 only (closer view at the end of the recording)

"Master warning Captain FWC2 only" started at 00:26:15 UTC (11766 seconds plot time) continued up to the end of the recording at 00:29:45 (11976 seconds plot time)

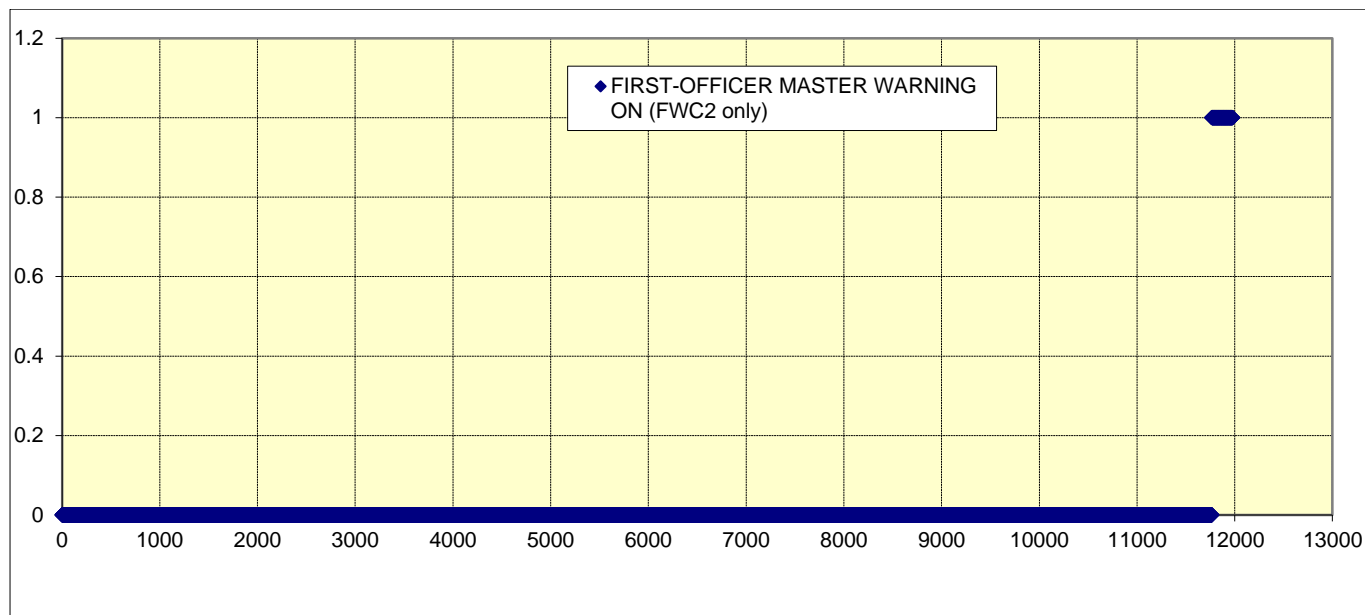
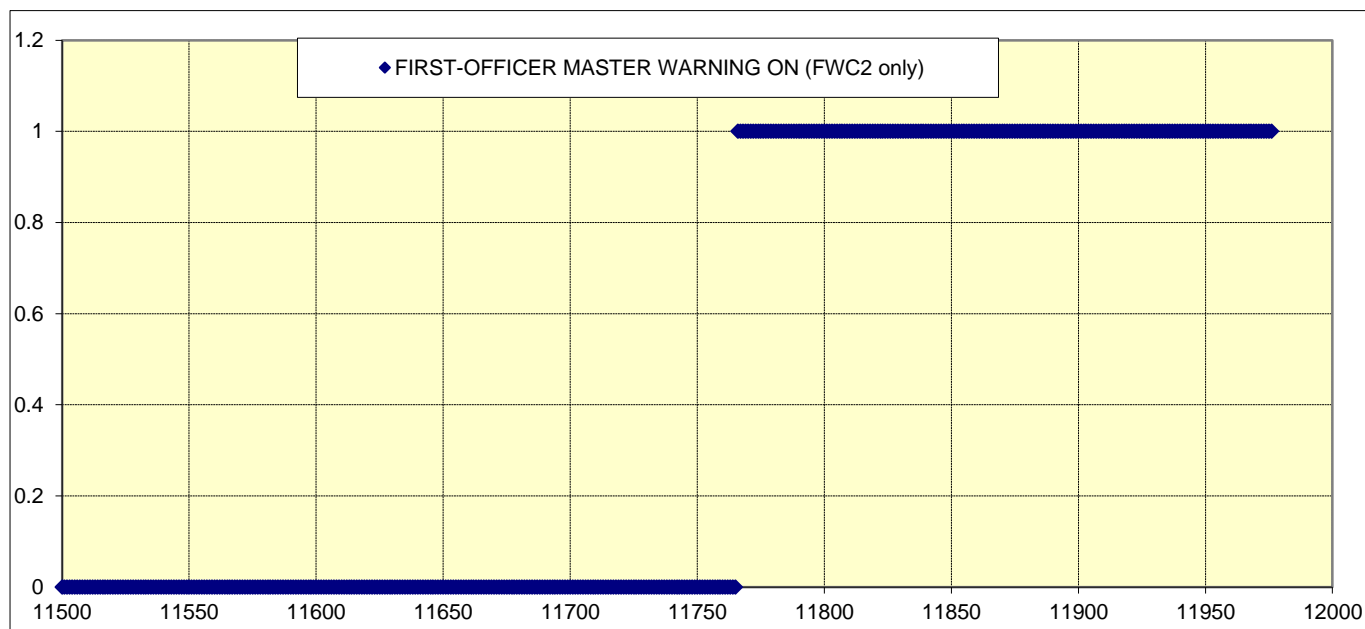
- FIRST-OFFICER MASTER WARNING ON (FWC2 only)

Master warning First Officer FWC2 only (closer view at the end of the recording)

"Master warning F/O FWC2 only" started at 00:26:15 UTC (11766 seconds plot time) continued up to the end of the recording at 00:29:45 (11976 seconds plot time)

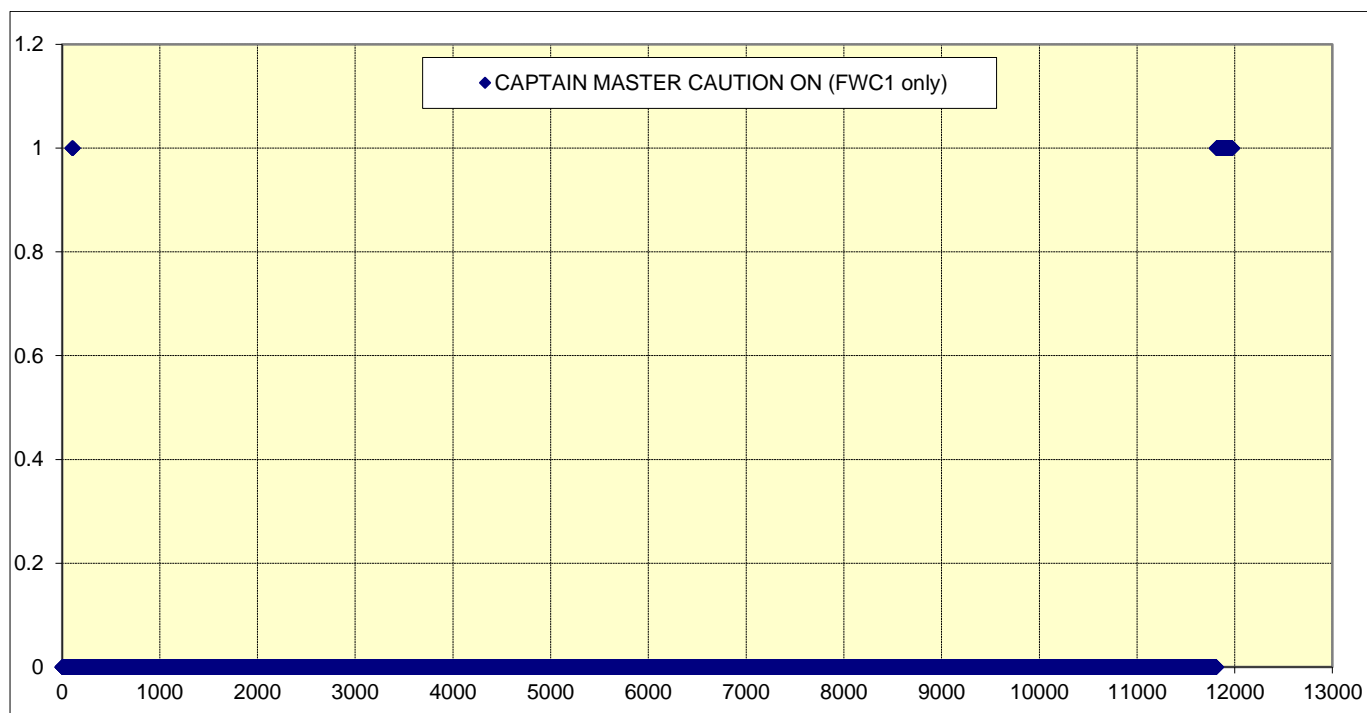
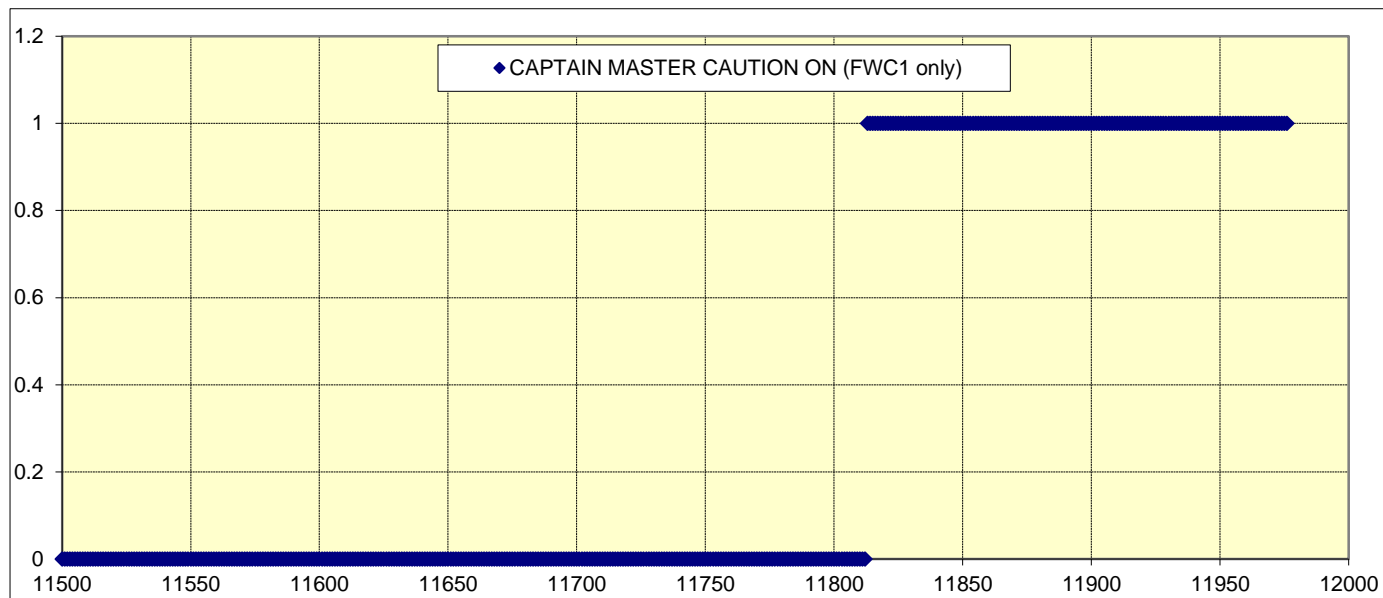
- CAPTAIN MASTER CAUTION ON (FWC1 only)

Captain Master Caution on FWC1 only (closer view at the end of the recording)

"Master Caution Captain FWC1 only" started at 00:27:02 UTC (11813 seconds plot time) continued up to the end of the recording at 00:29:45 (11976 seconds plot time)

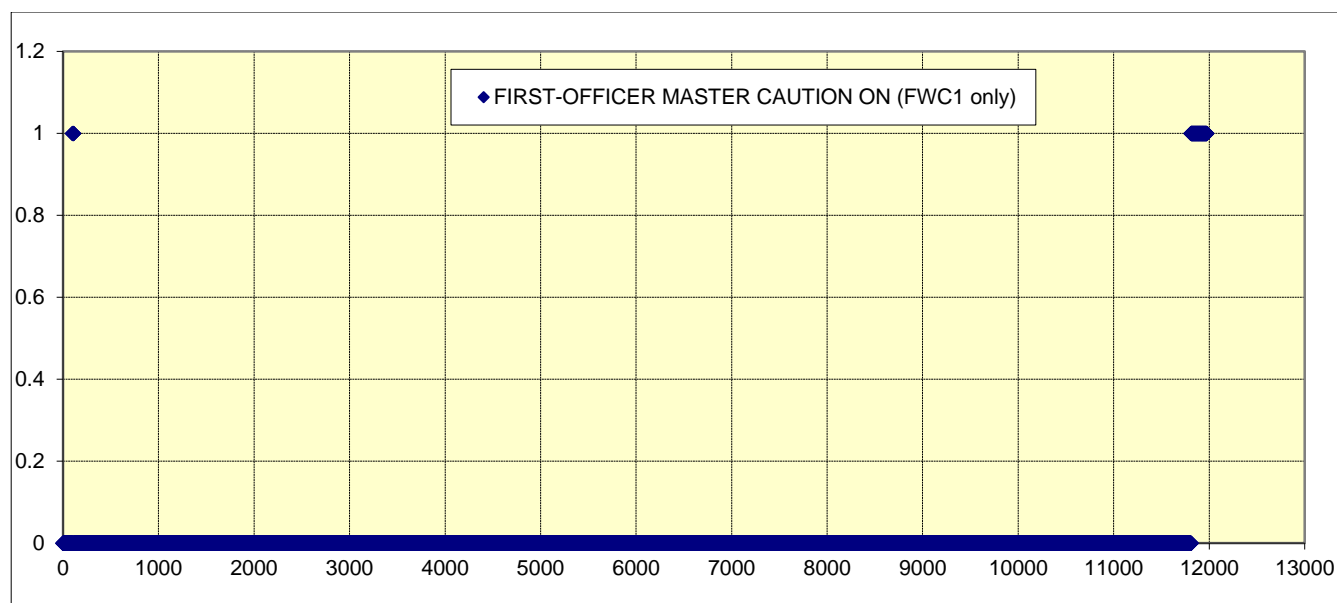
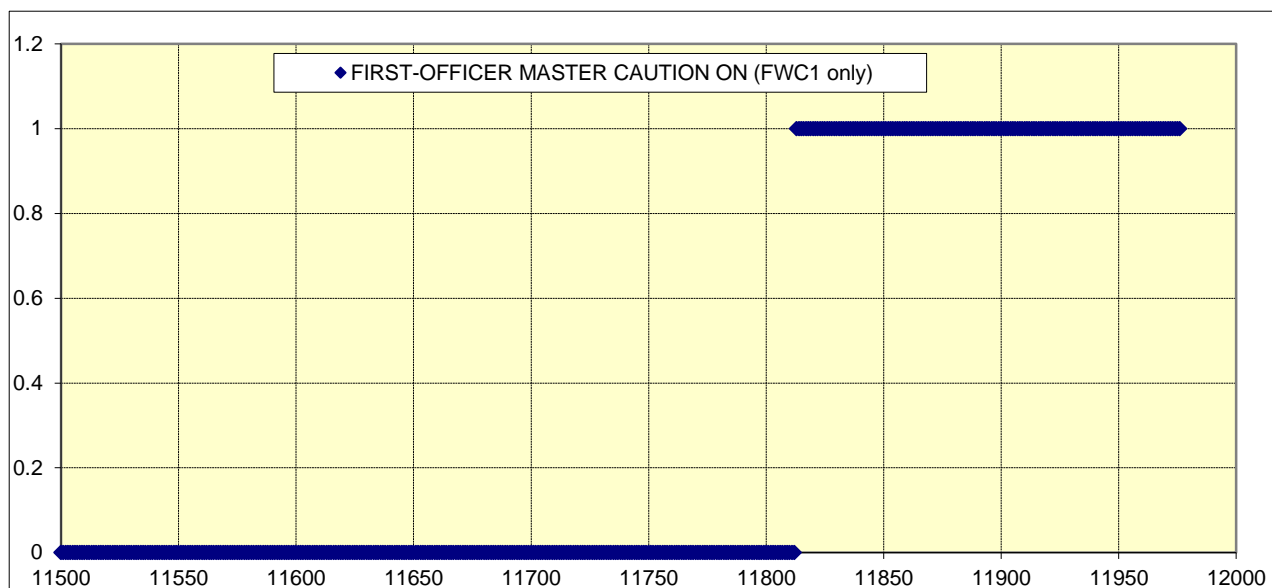
- FIRST-OFFICER MASTER CAUTION ON (FWC1 only)

"Master Caution F/O FWC1 only" started at 00:27:02 UTC (11813 seconds plot time) continued up to the end of the recording at 00:29:45 (11976 seconds plot time)

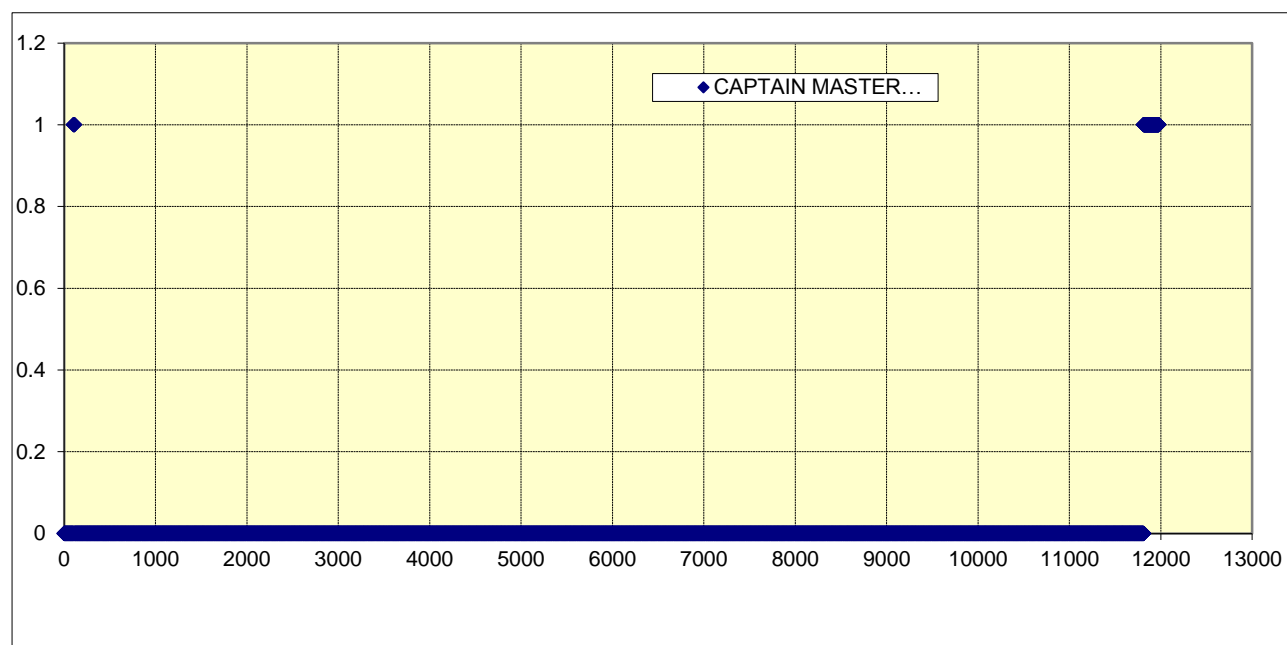
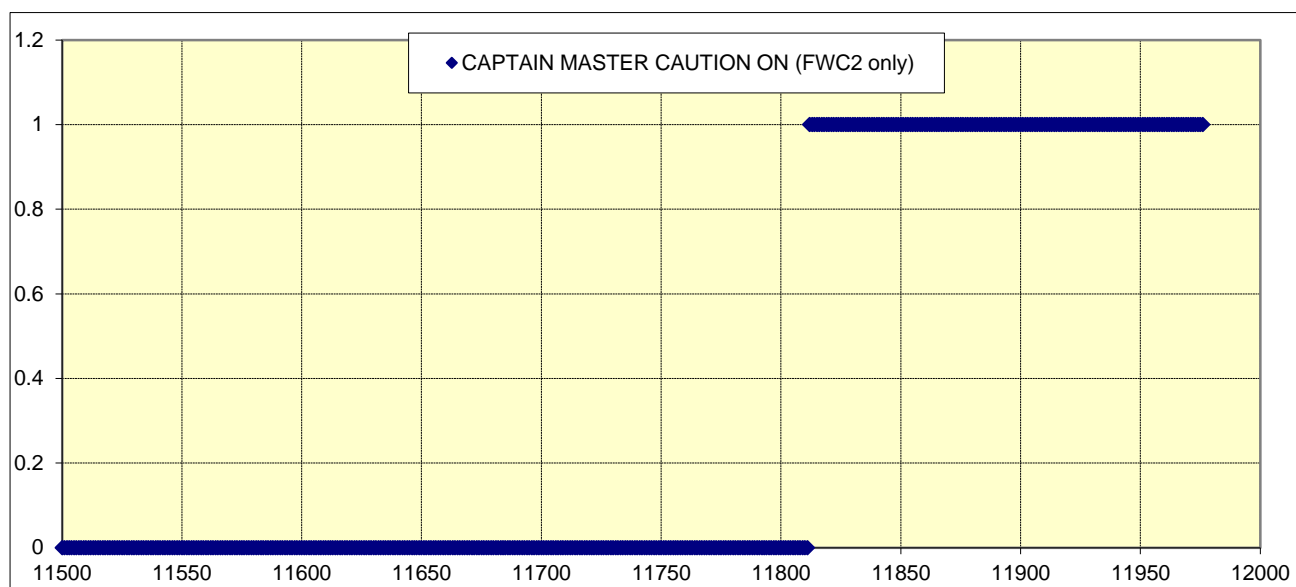
- CAPTAIN MASTER CAUTION ON (FWC2 only)
(1 Master Caution)

Captain Master Caution on FWC2 only (closer view at the end of the recording)

"Master Caution Captain FWC2 only" started at 00:27:01 UTC (11812 seconds plot time) continued up to the end of the recording at 00:29:45 (11976 seconds plot time)

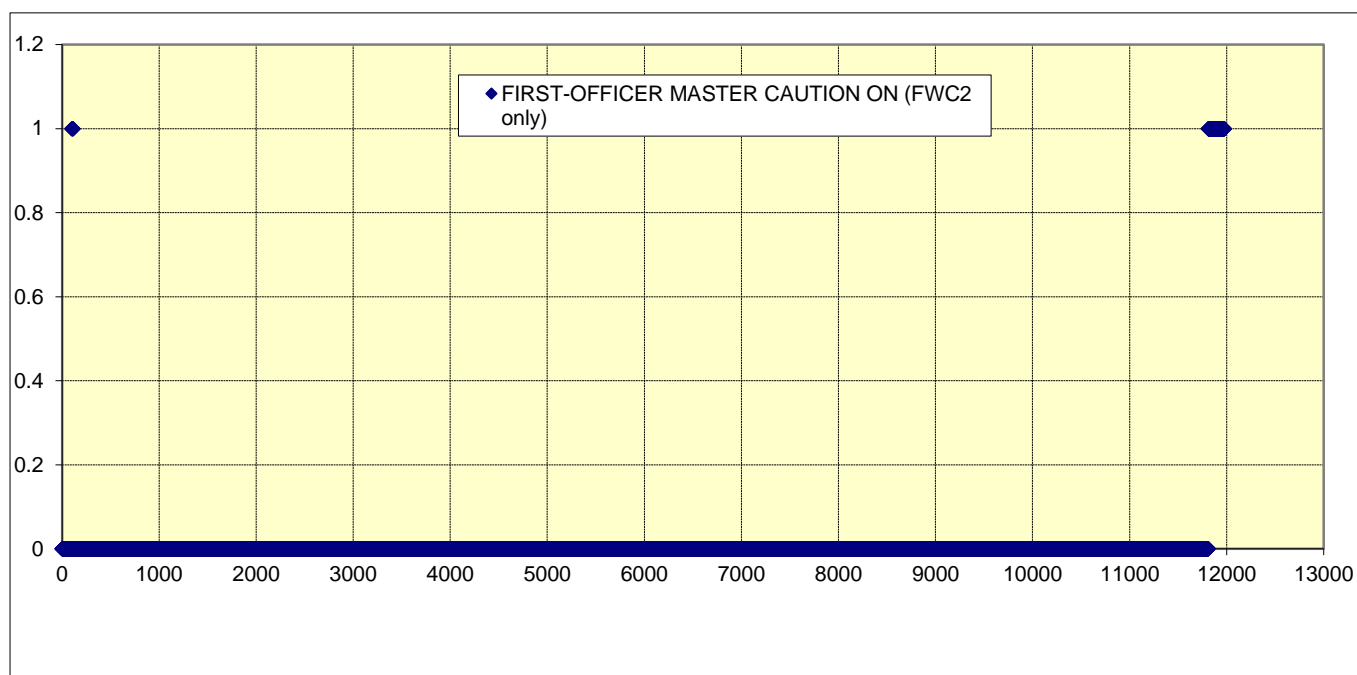
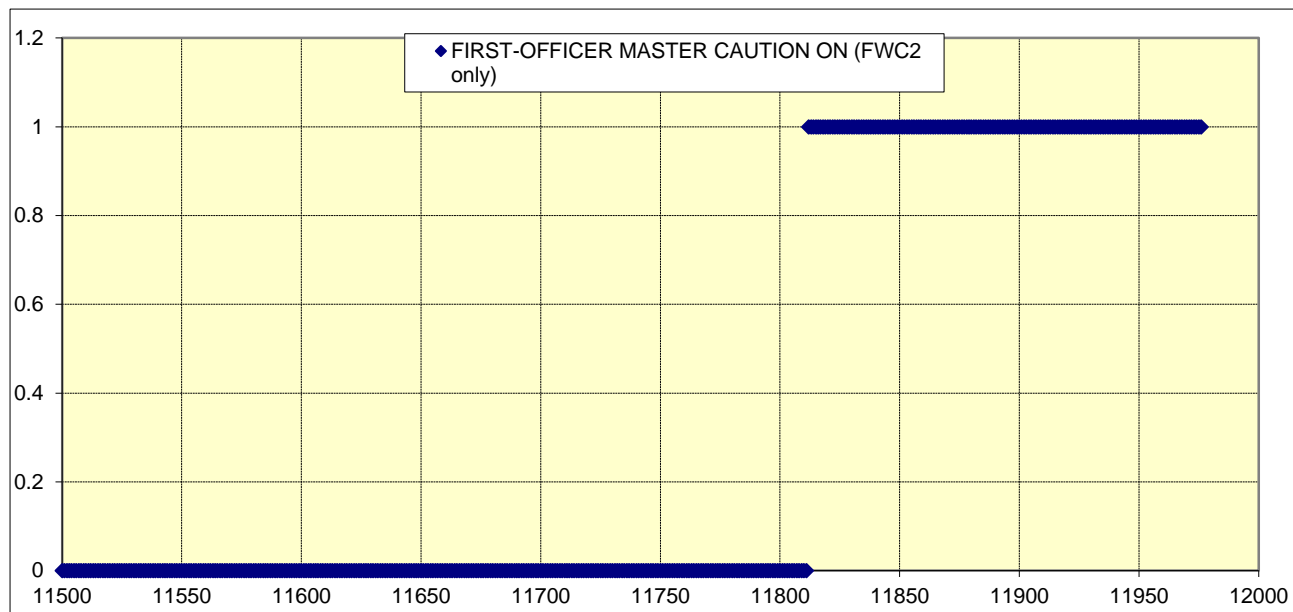
- FIRST-OFFICER MASTER CAUTION ON (FWC2 only)
(Master Caution)

"Master Caution F/O FWC2 only" started at 00:27:01 UTC (11812 seconds plot time) continued up to the end of the recording at 00:29:45 (11976 seconds plot time)

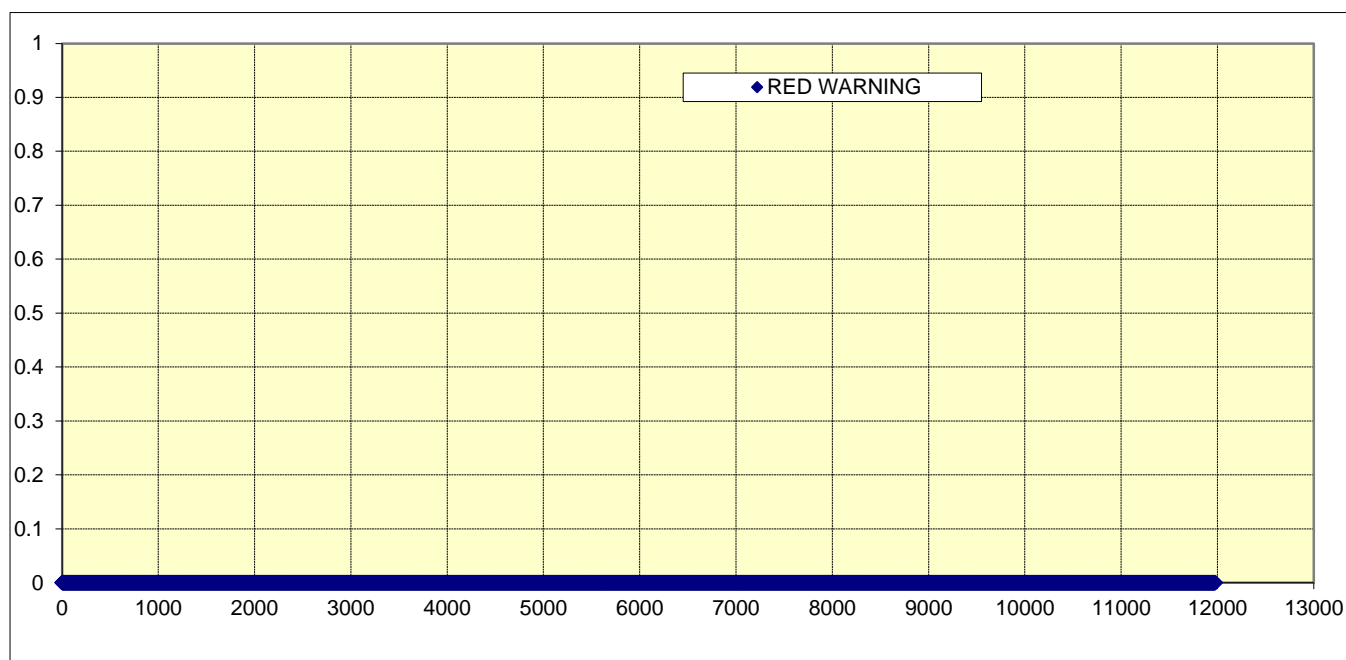
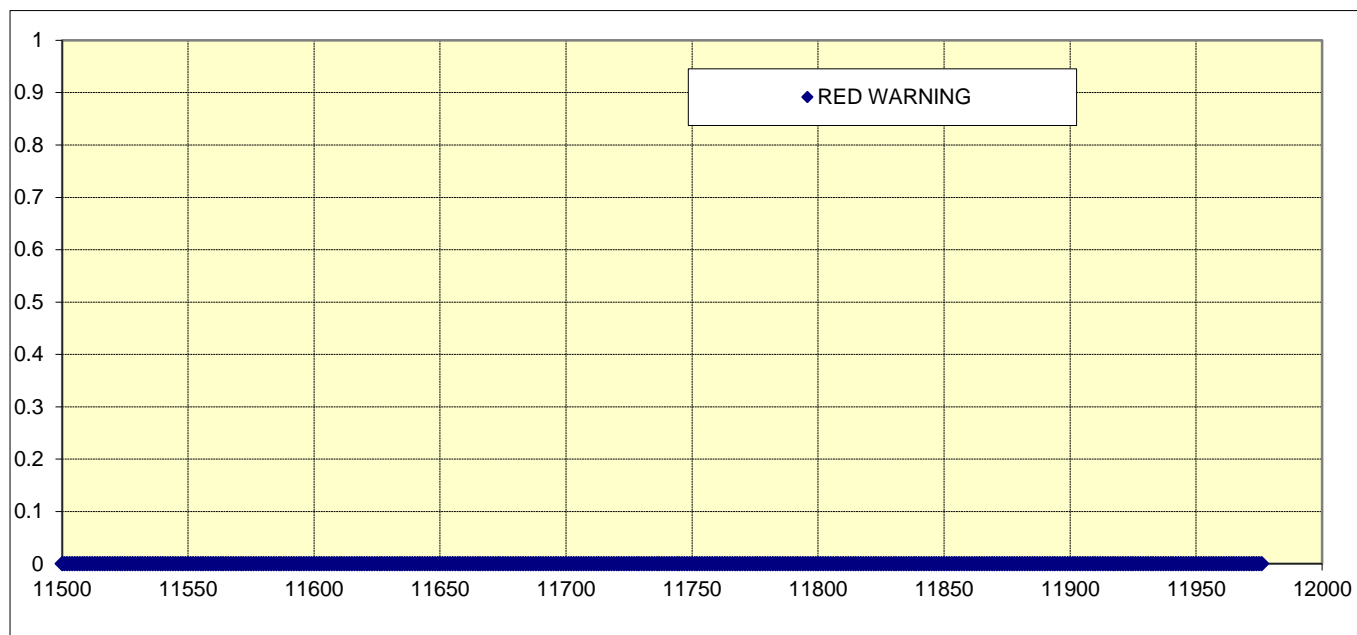
- RED WARNING

Red Warning shown at the end portion of the recording

No detected Red Warning

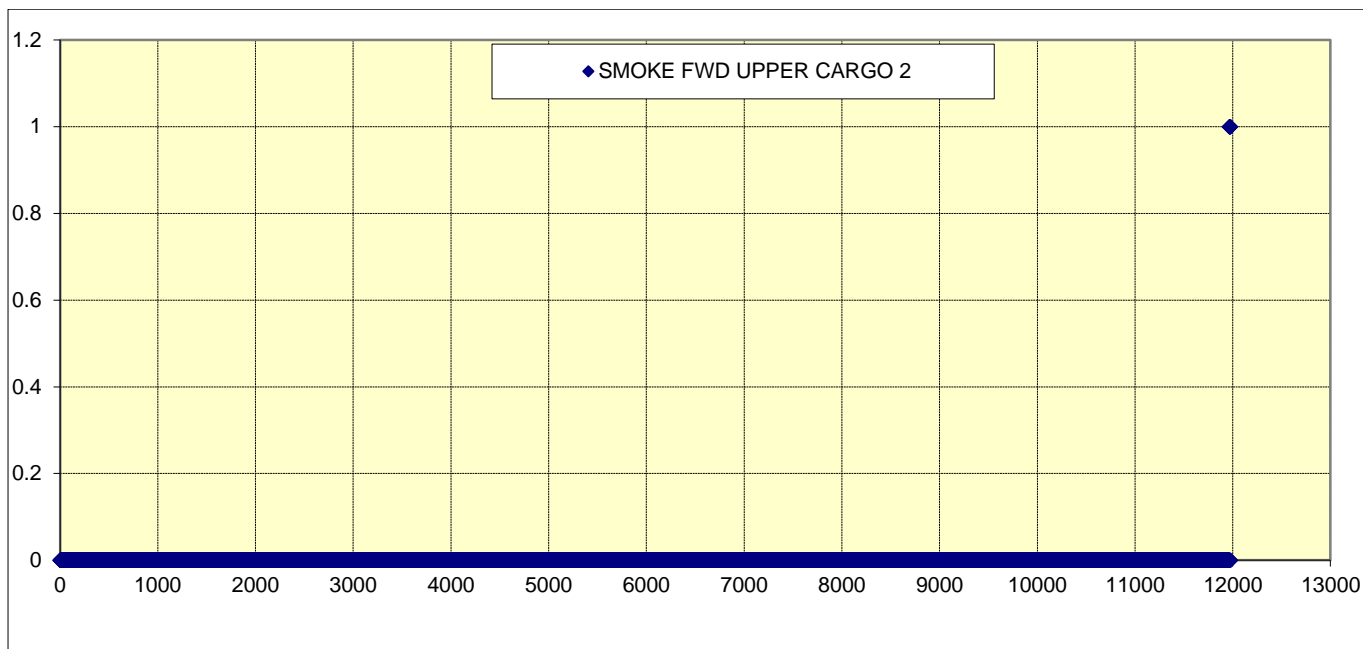
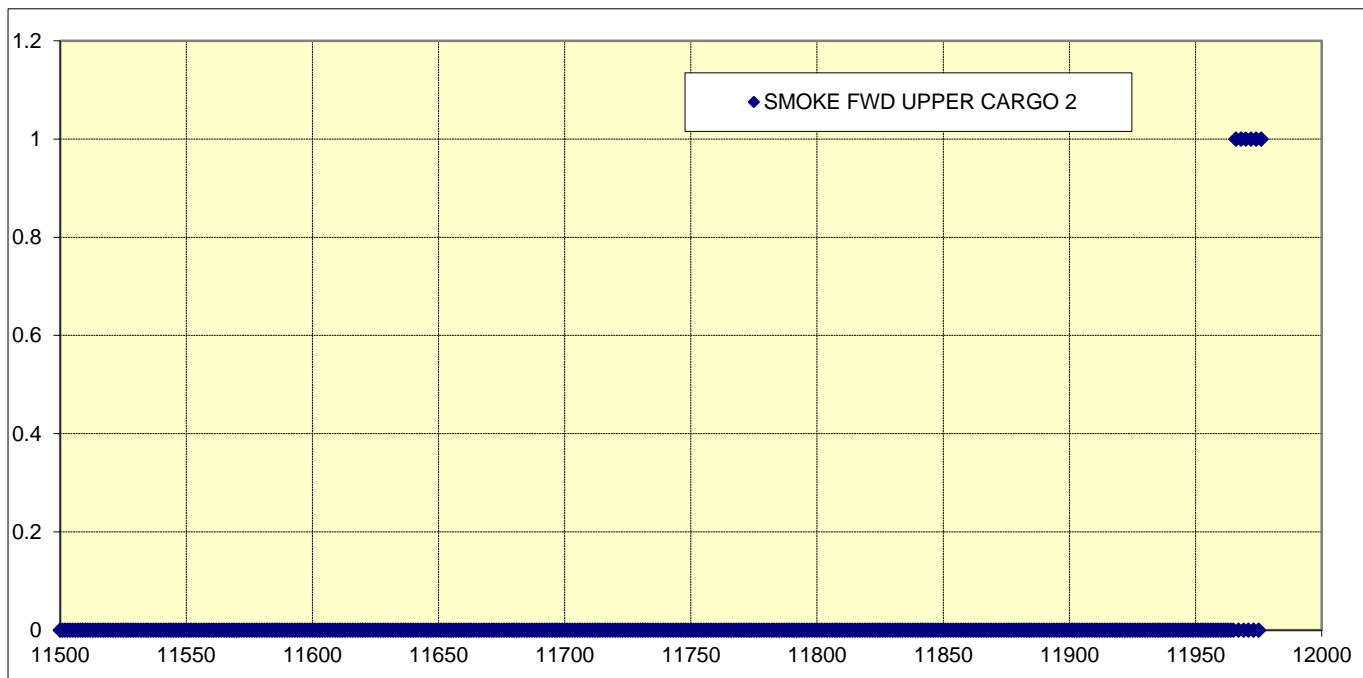
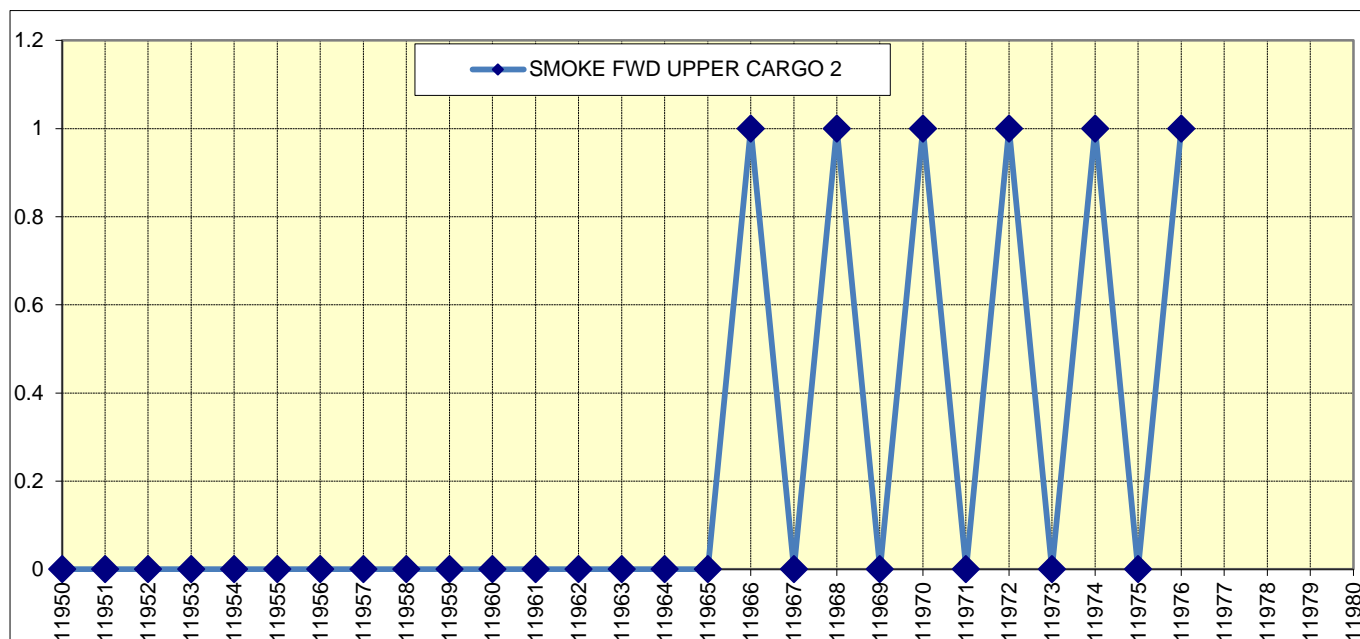
– SMOKE FWD UPPER CARGO 2
(1 smoke warning)

SMOKE FWD UPPER CARGO 2 at the last portion of the recording

SMOKE FWD UPPER CARGO 2 very close to the recording end

Smoke FWD upper cargo 2 showed smoke six times in the interval between 00:29:34 UTC (11965 seconds plot time) and the end of recording 00:29:45 UTC (11976 seconds plot time)

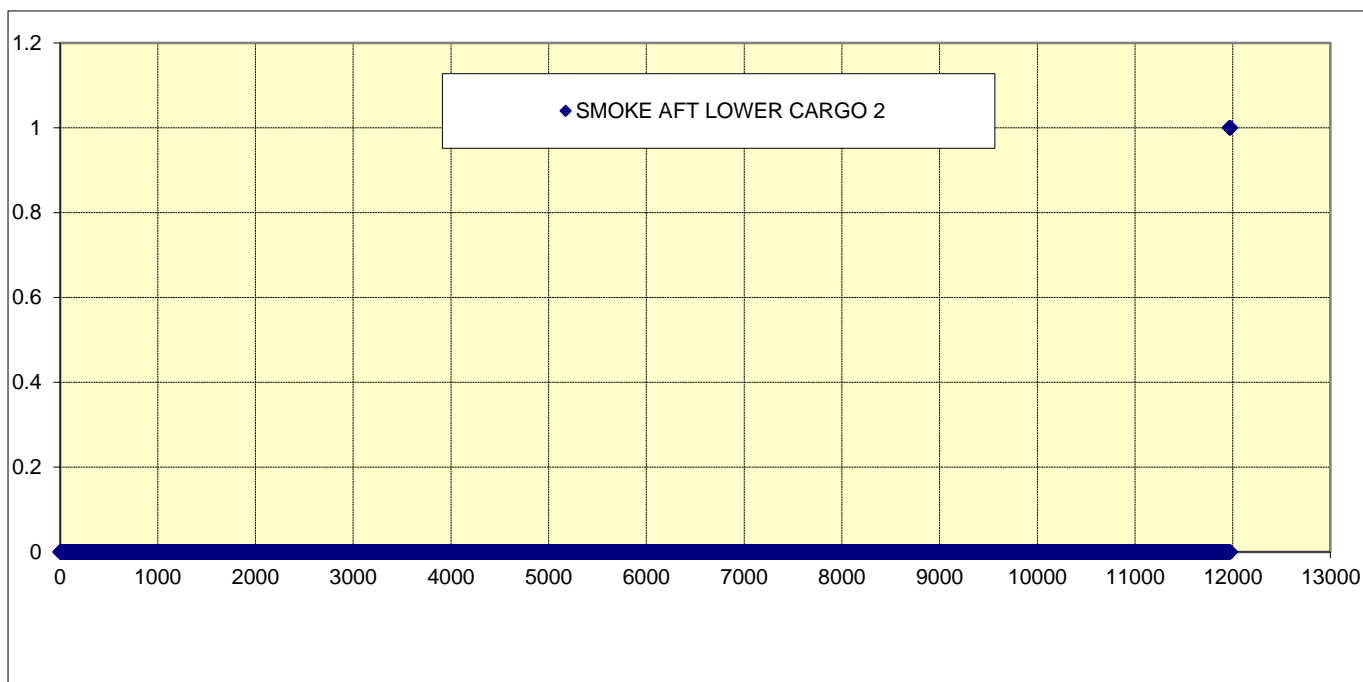
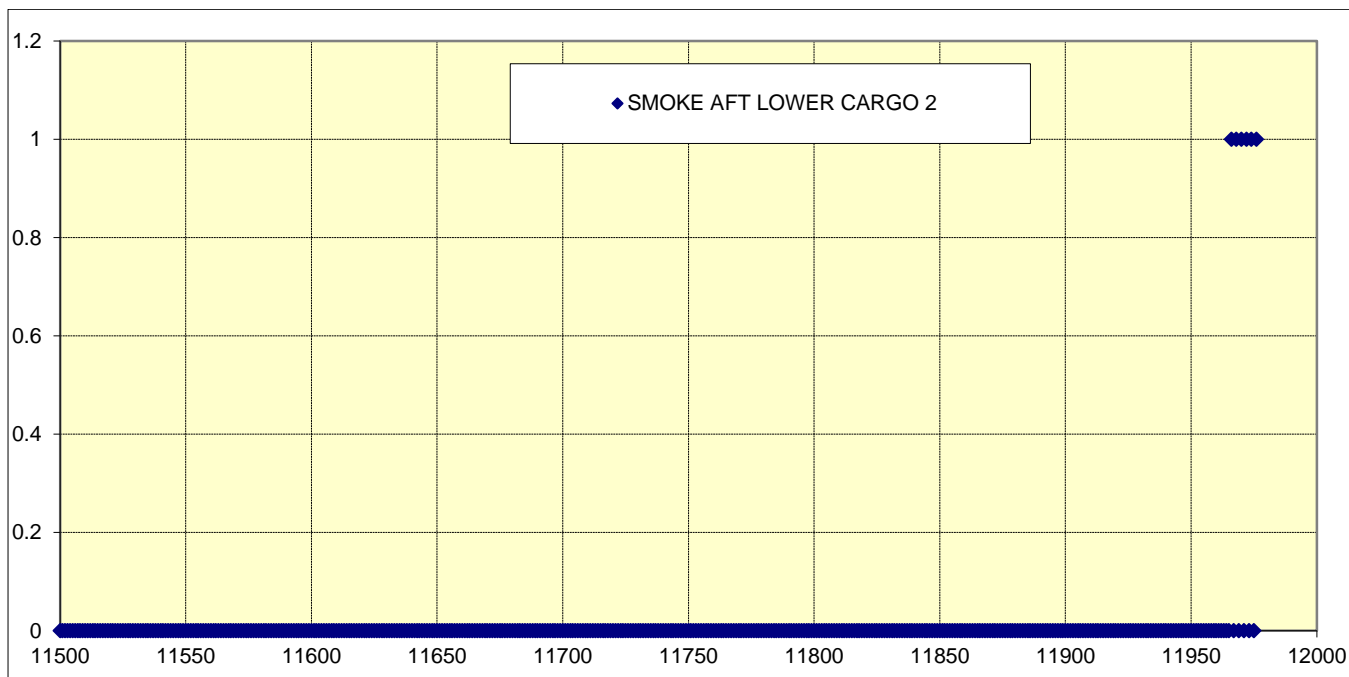
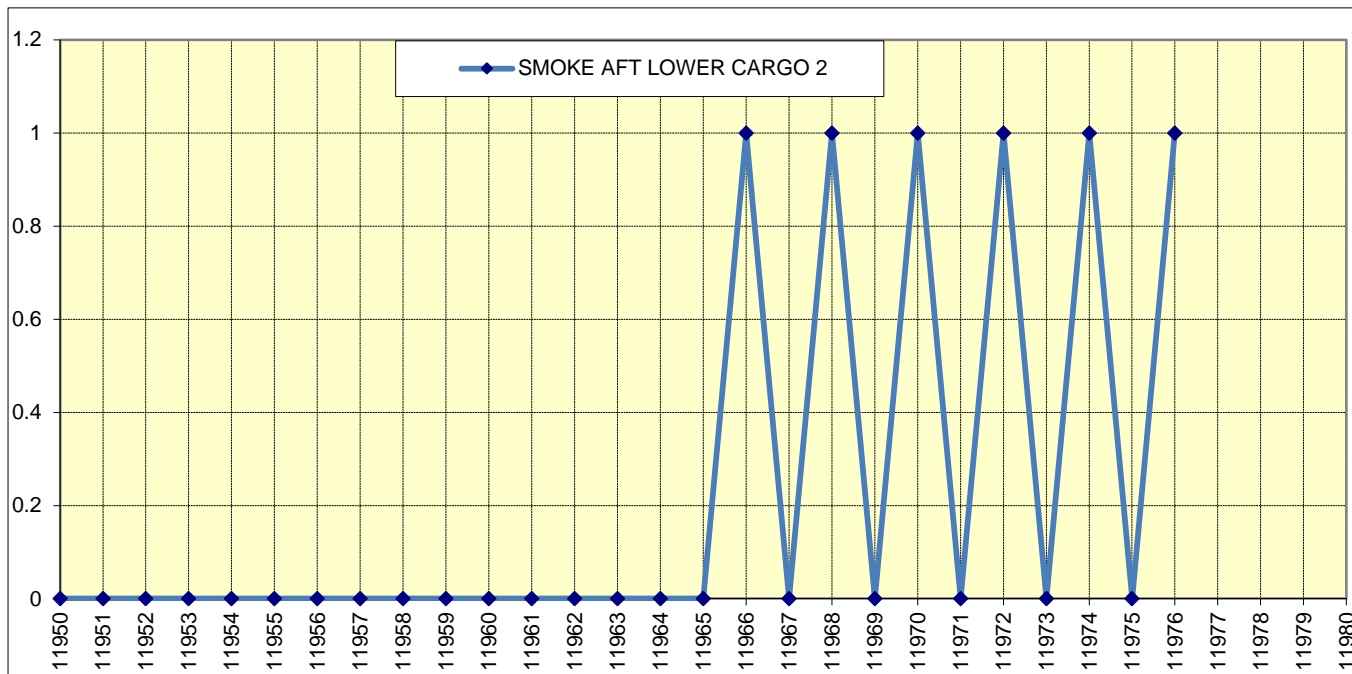
- SMOKE AFT LOWER CARGO 2
(1 smoke warning)

SMOKE AFT LOWER CARGO 2 shown at the end portion of the recording

SMOKE AFT LOWER CARGO 2 very close to the recording end

Smoke AFT lower cargo 2 showed smoke six times in the interval between 00:29:34 UTC (11965 seconds plot time) and the end of recording 00:29:45 UTC (11976 seconds plot time)

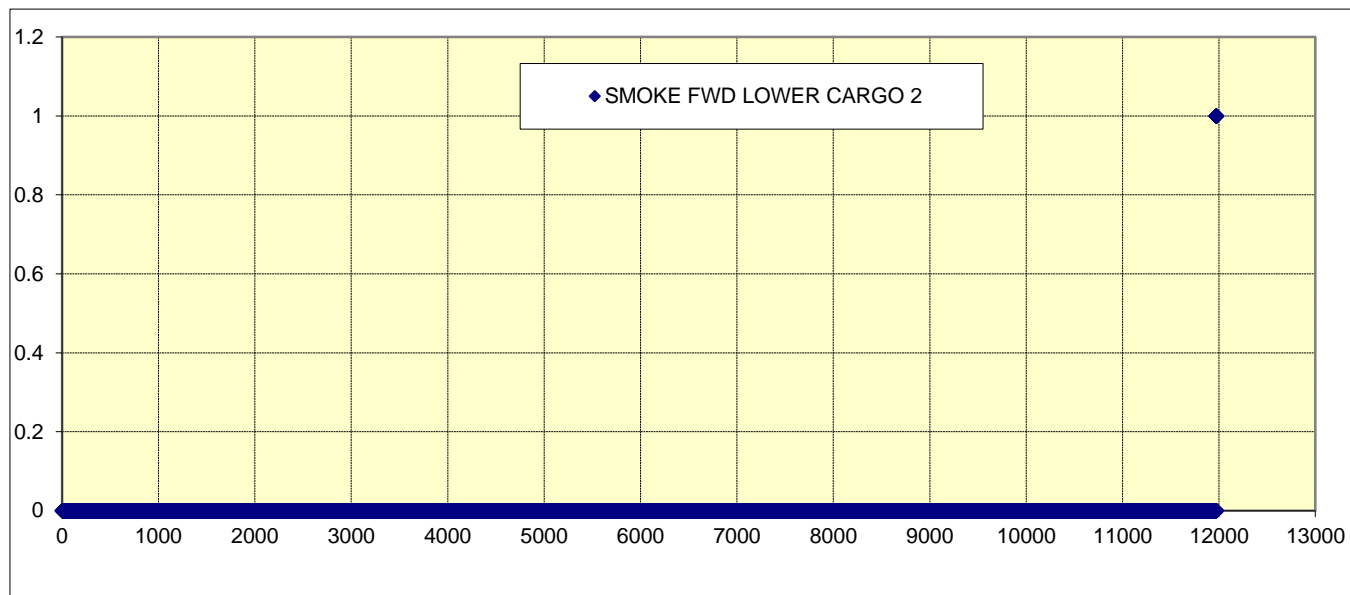
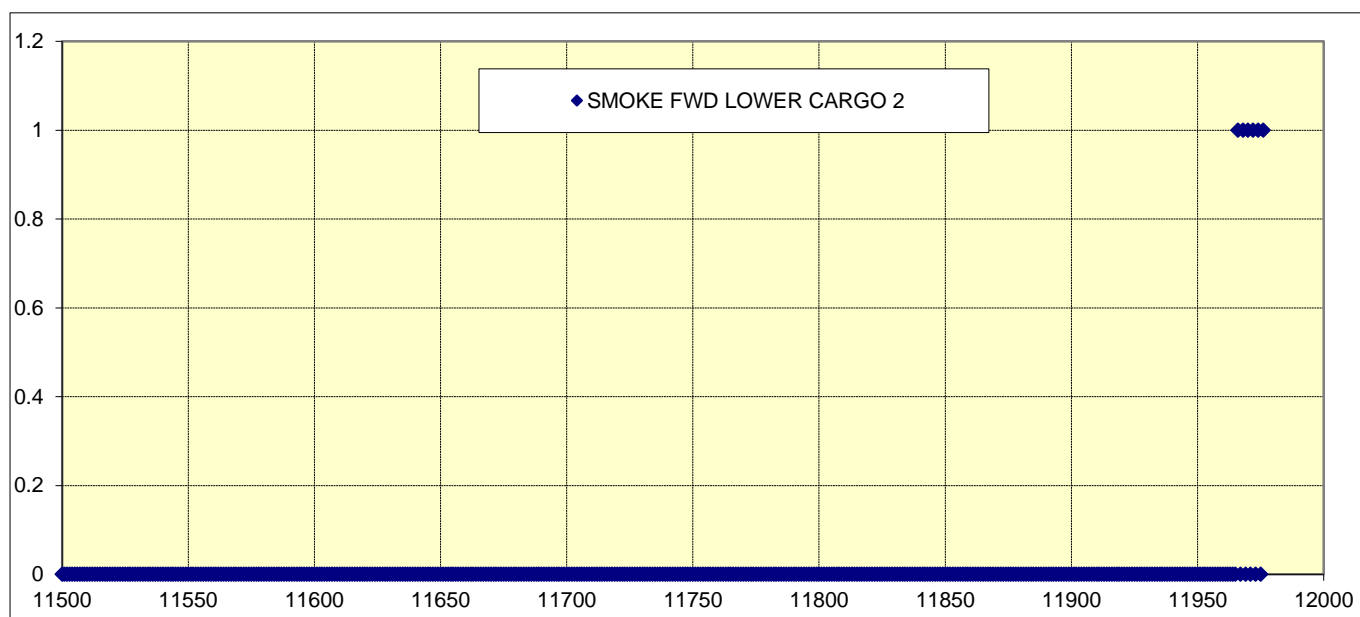
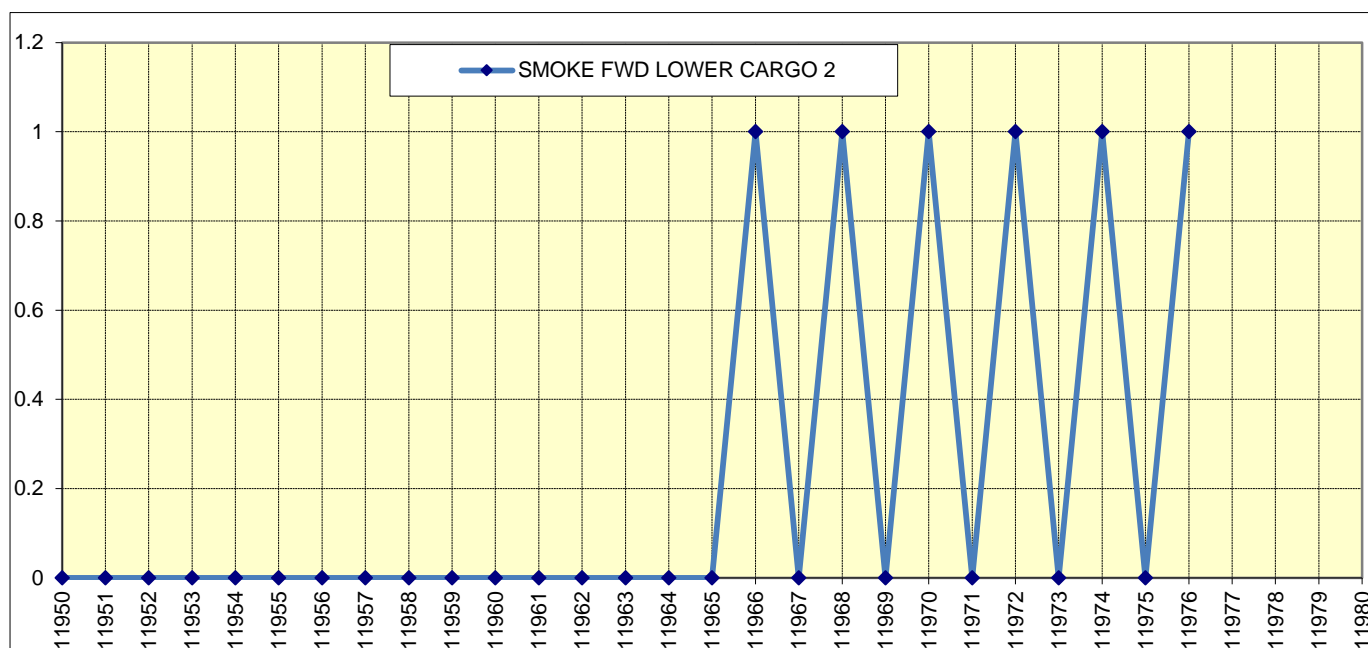
- SMOKE FWD LOWER CARGO 2
(1 smoke warning)

SMOKE FWD LOWER CARGO 2 shown at the end portion of recording

SMOKE FWD LOWER CARGO 2 very close to the recording end

Smoke FWD lower cargo 2 showed smoke six times in the interval between 00:29:34 UTC (11965 seconds plot time) and the end of recording 00:29:45 UTC (11976 seconds plot time)

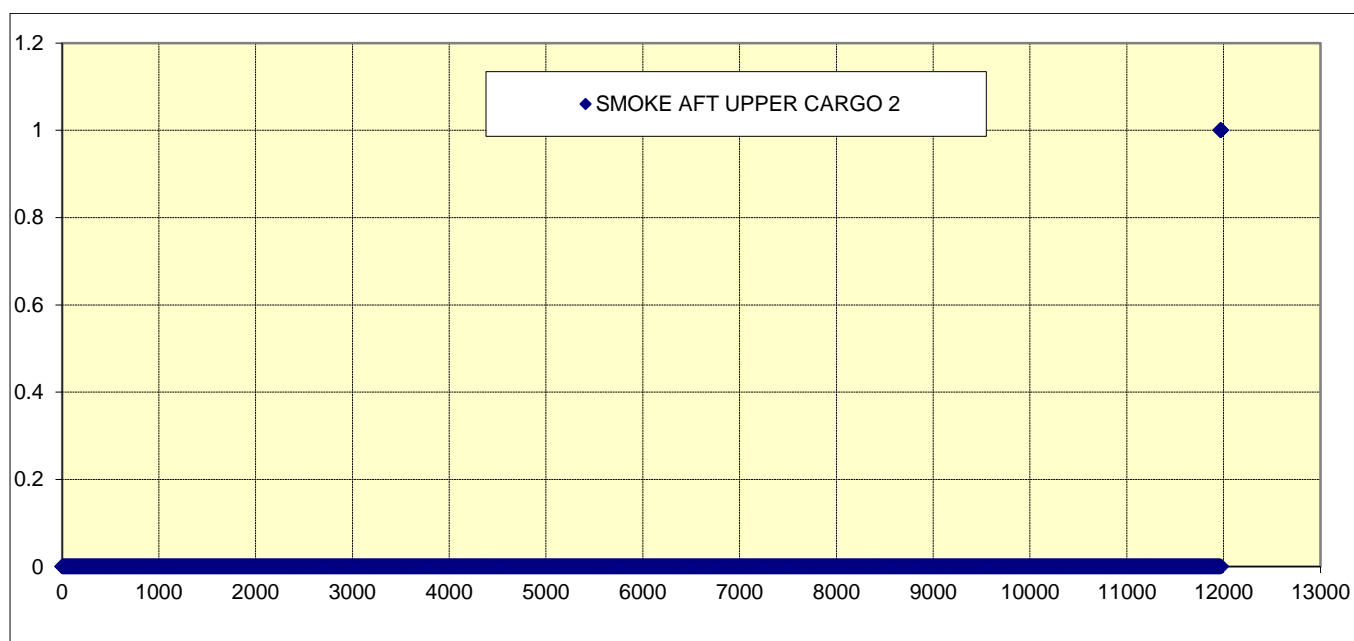
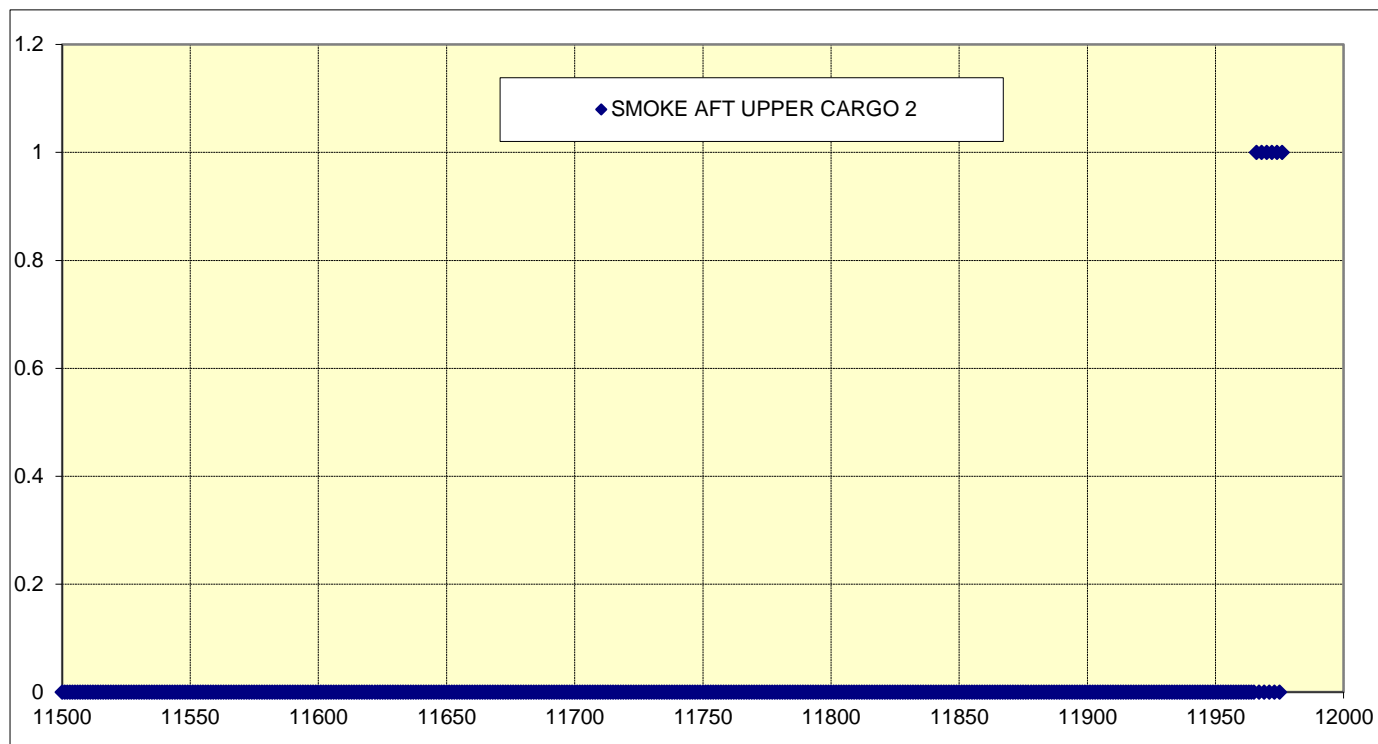
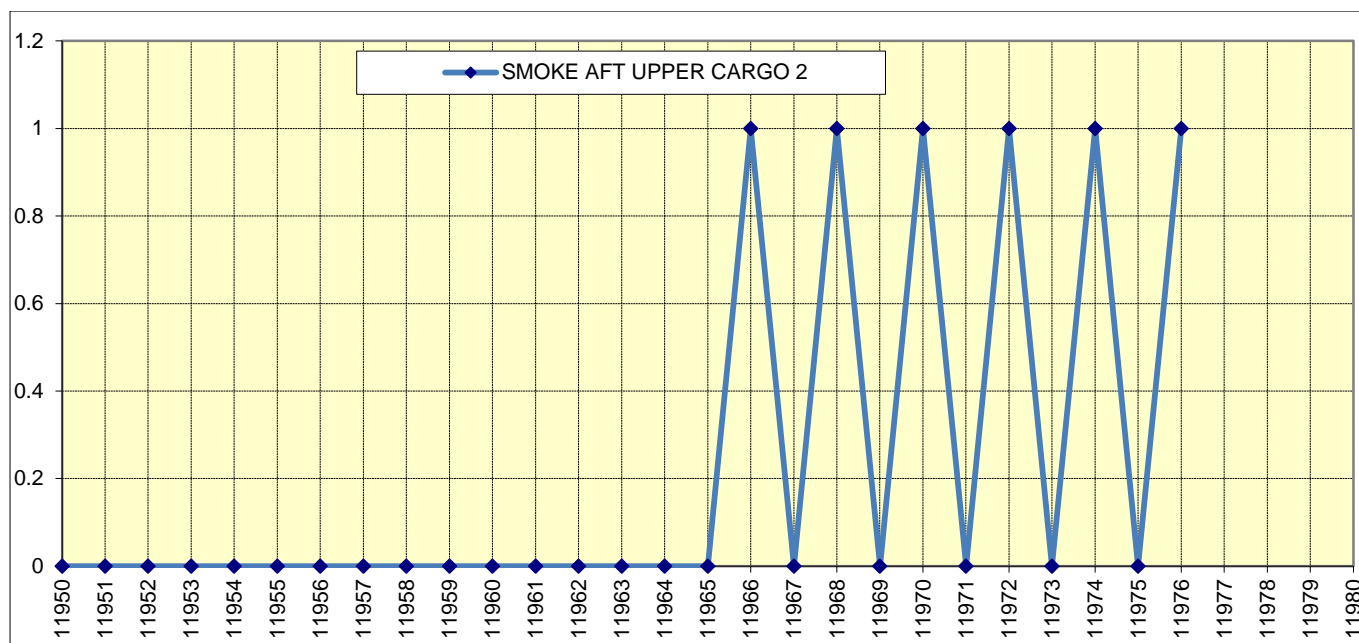
- SMOKE AFT UPPER CARGO 2

SMOKE AFT UPPER CARGO 2 t the end portion of recording

SMOKE AFT UPPER CARGO 2 very close to the recording end

Smoke AFT UPPER cargo 2 showed smoke six times in the interval between 00:29:34 UTC (11965 seconds plot time) and the end of recording 00:29:45 UTC (11976 seconds plot time)
