Final Report

**EgyptAir A320 Aircraft crash in the Mediterranean, registered SU-GCC,
flight number MSR804, from Charles De-Gaulle Airport, Paris to Cairo
International Airport, on 19/05/2016**

EGAI2016-01

October 2024

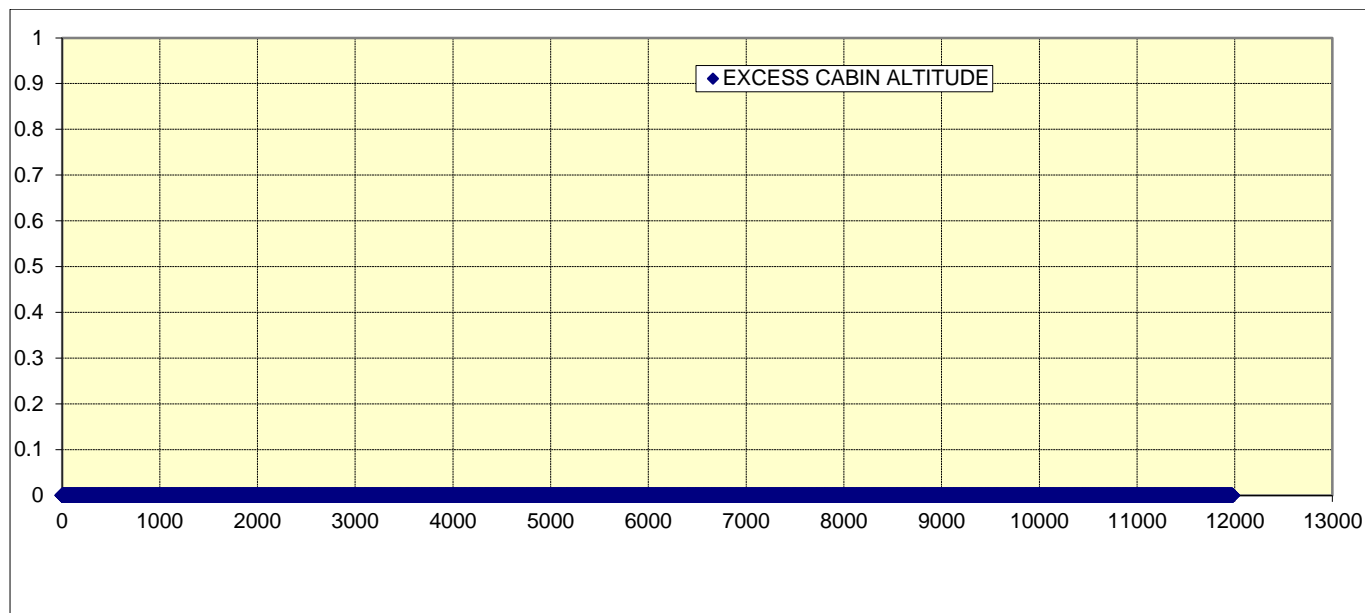
- EXCESS CABIN ALTITUDE

No Cabin Altitude Excess

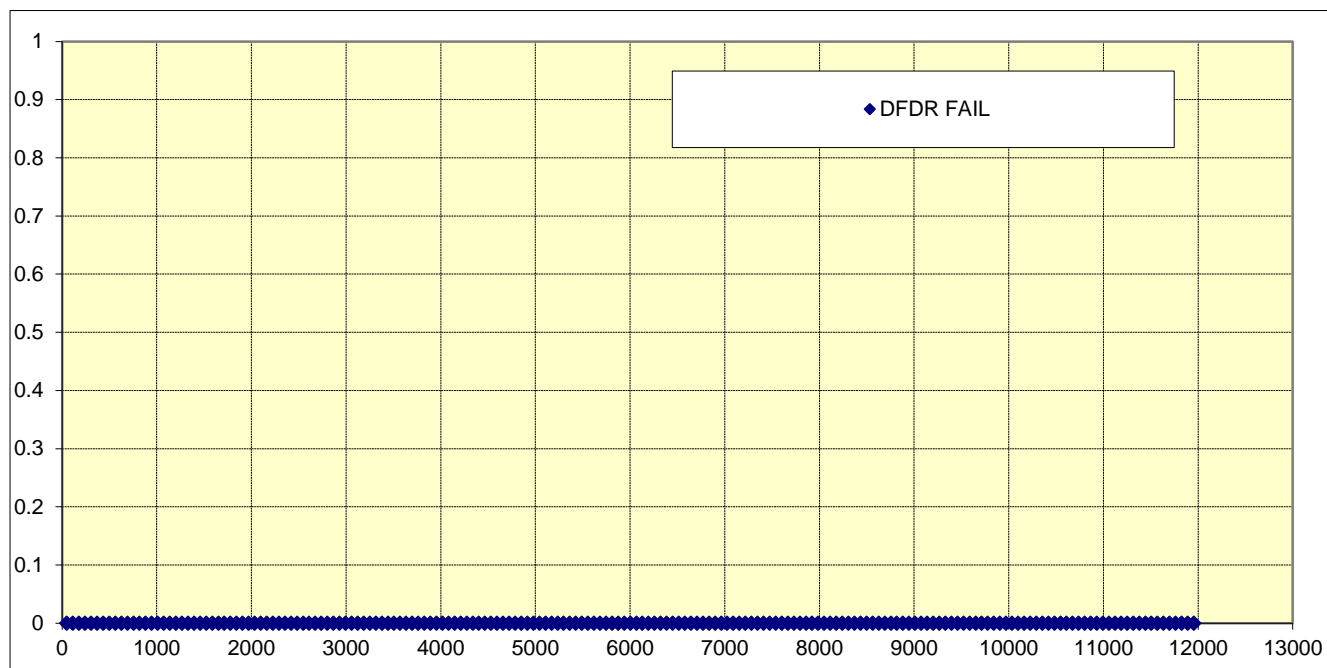
- DFDR FAIL (Digital Flight Data Recorder Fail)

- No detected failure up to the end of the valid data

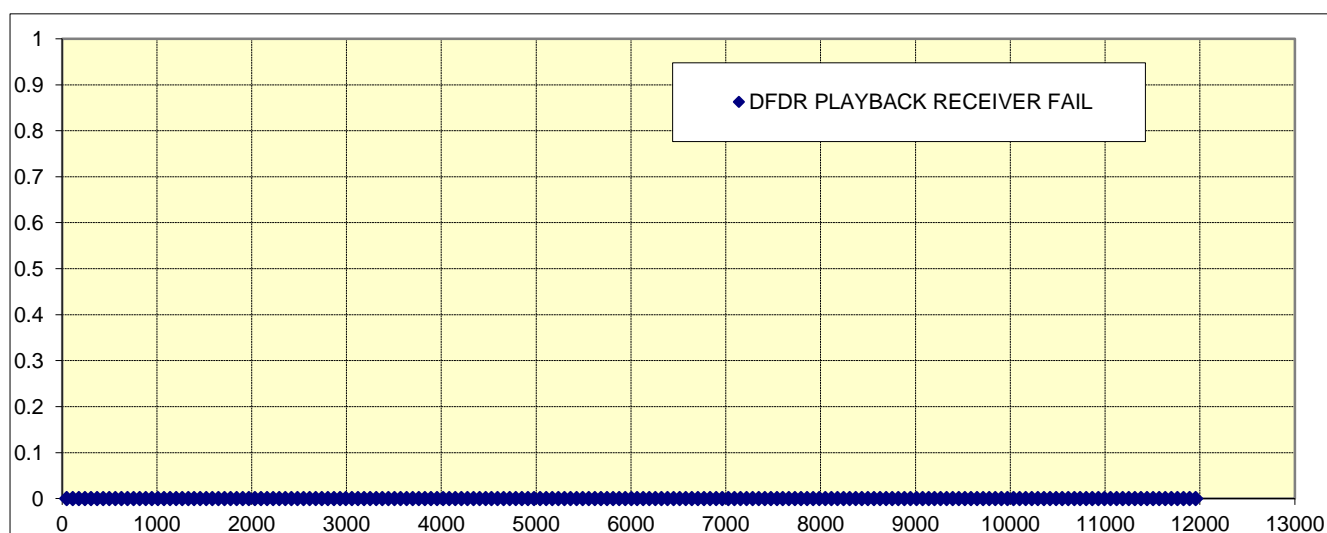
- DFDR PLAYBACK RECEIVER FAIL (Digital Flight Data Recorder Playback receiver fail)

- No detected failure up to the end of the valid data

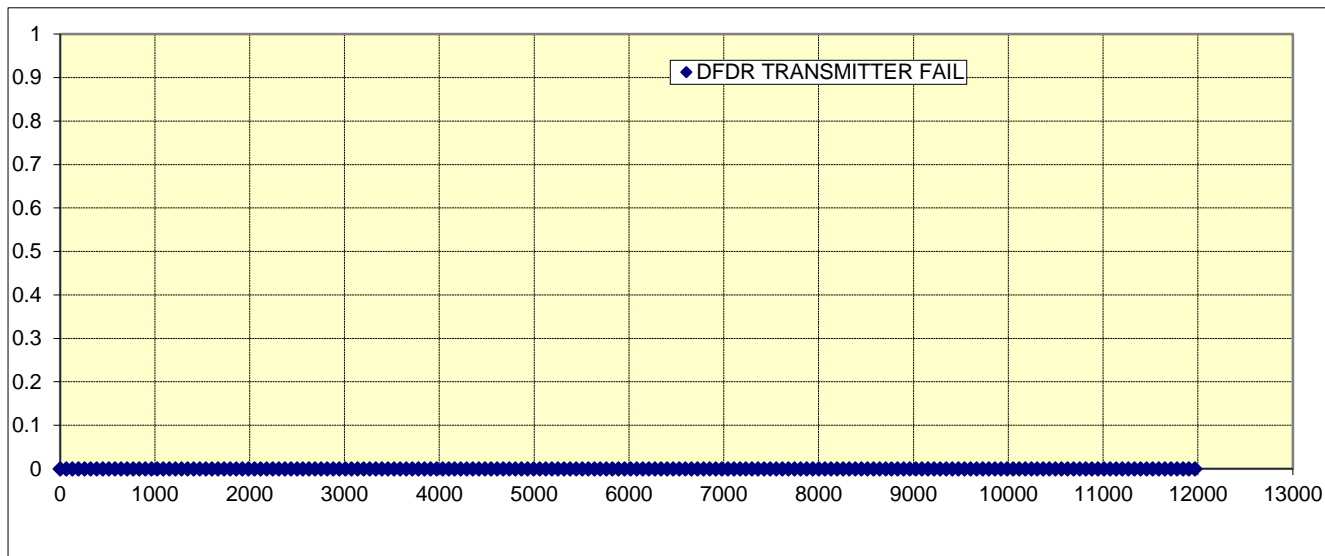
- DFDR TRANSMITTER FAIL (Digital Flight Data Recorder Transmitter fail)

- No detected failure up to the end of the valid data

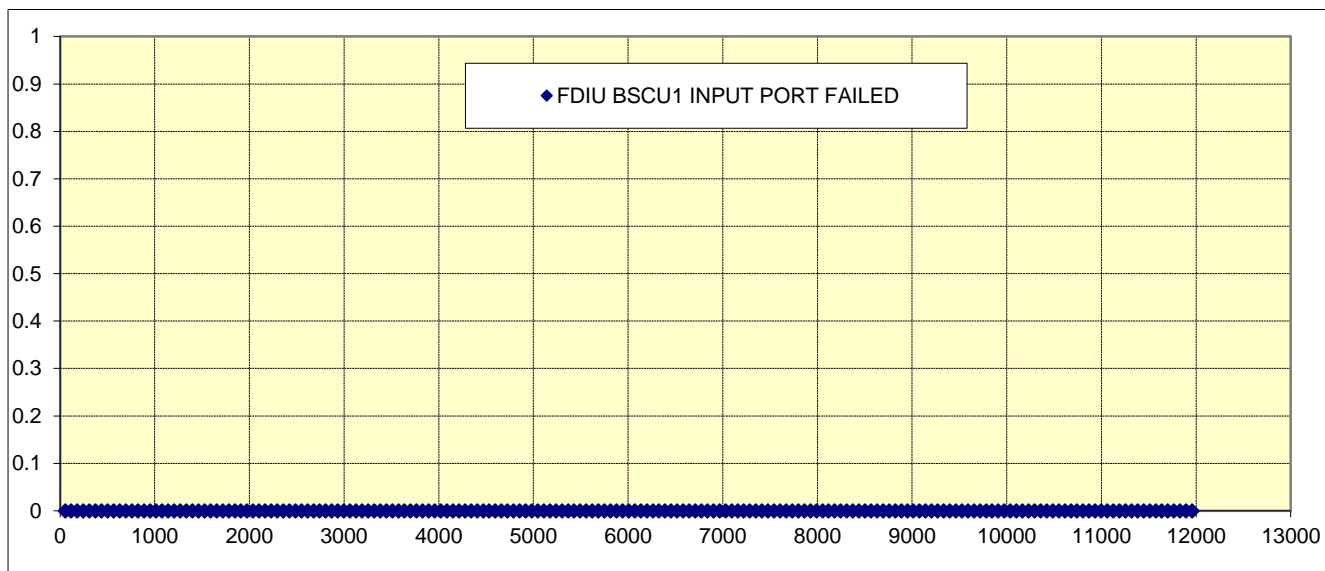
- FDIU BSCU1 INPUT PORT FAILED (Flight Data Interface Unit Braking/Steering Control Unit 1 input port failed)

- No detected failure up to the end of the valid data

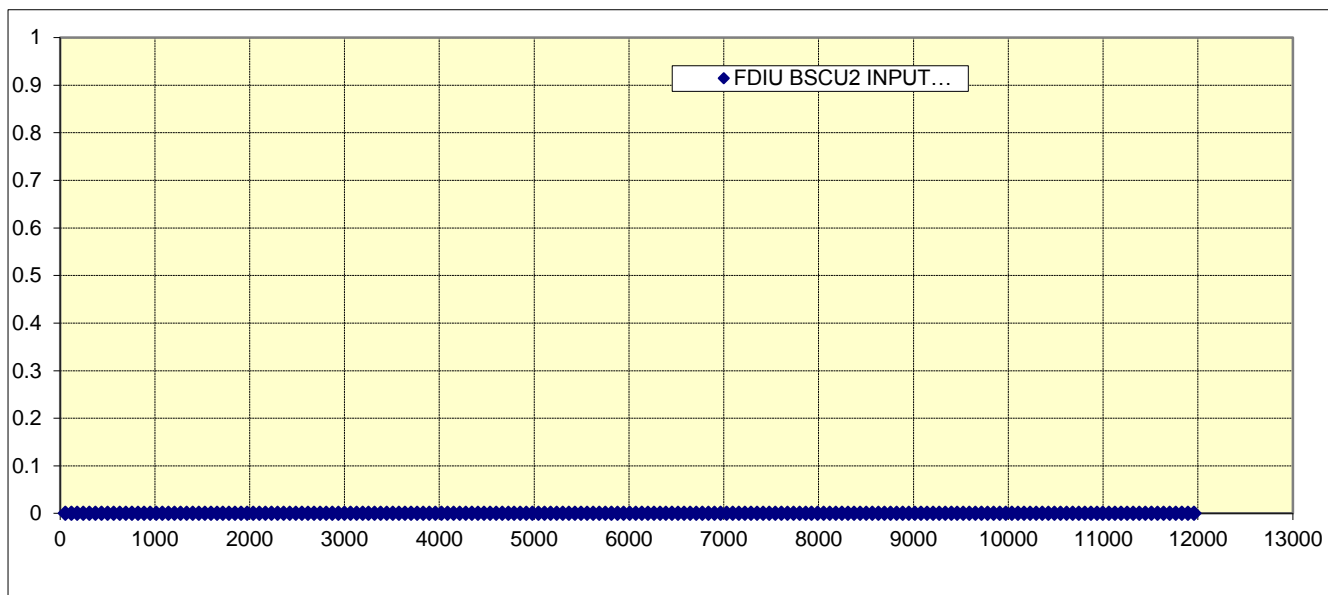
- FDIU BSCU2 INPUT PORT FAILED (Flight Data Interface Unit Braking/Steering Control Unit 2 input port failed)

- No detected failure up to the end of the valid data
- FDIU CFDIU INPUT PORT FAILED (Flight Data Interface Unit Centralized Fault Display Interface Unit input port failed)

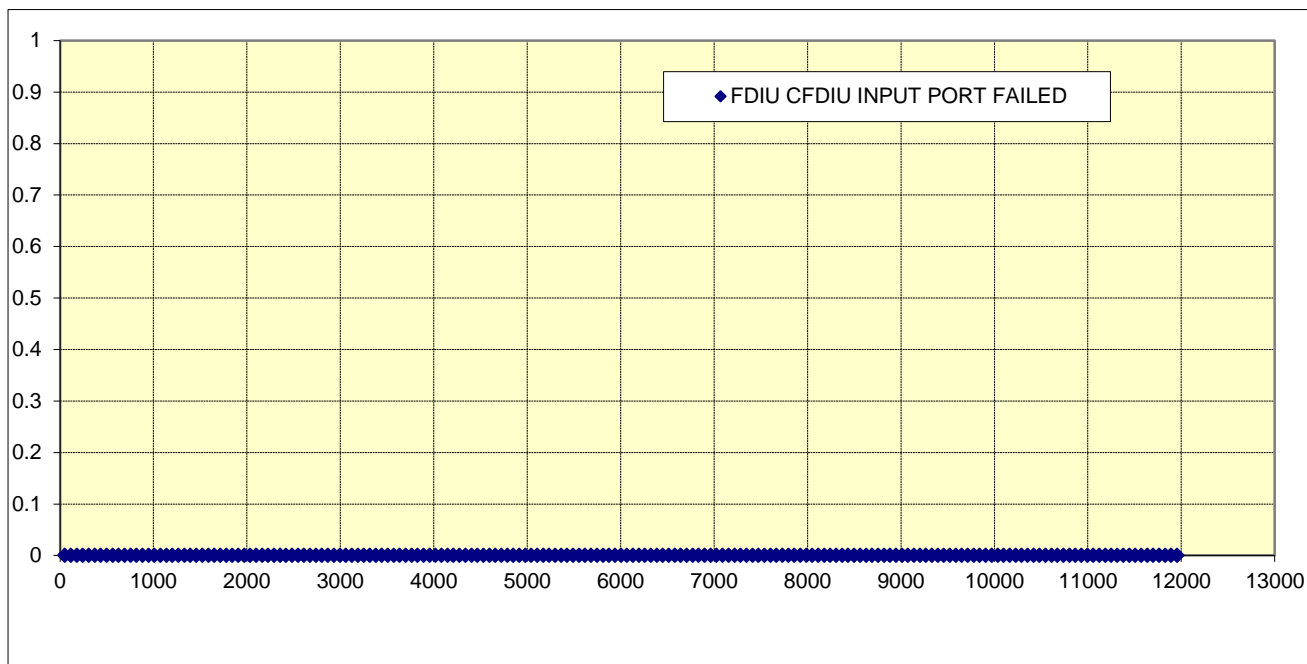
- No detected failure up to the end of the valid data

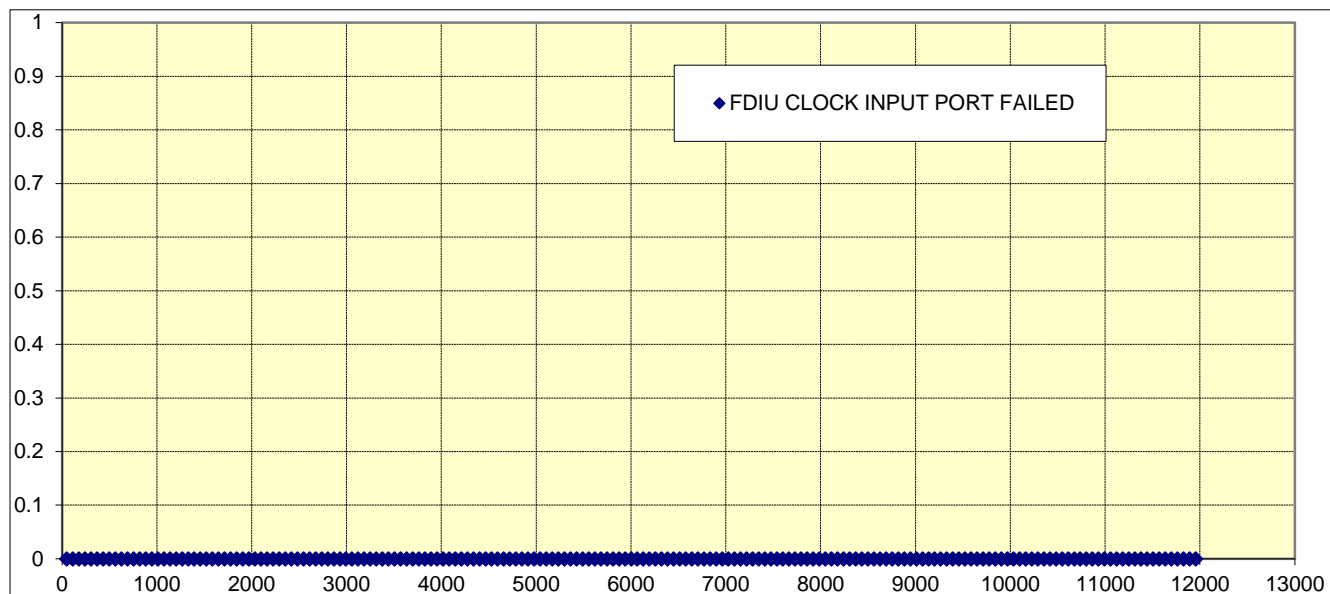
- FDIU CLOCK INPUT PORT FAILED (Flight Data Interface Unit Clock input port failed)

- No detected failure up to the end of the valid data
- FDIU DMC1 INPUT PORT FAILED (Flight Data Interface Unit Display Management Computer 1 input port failed)

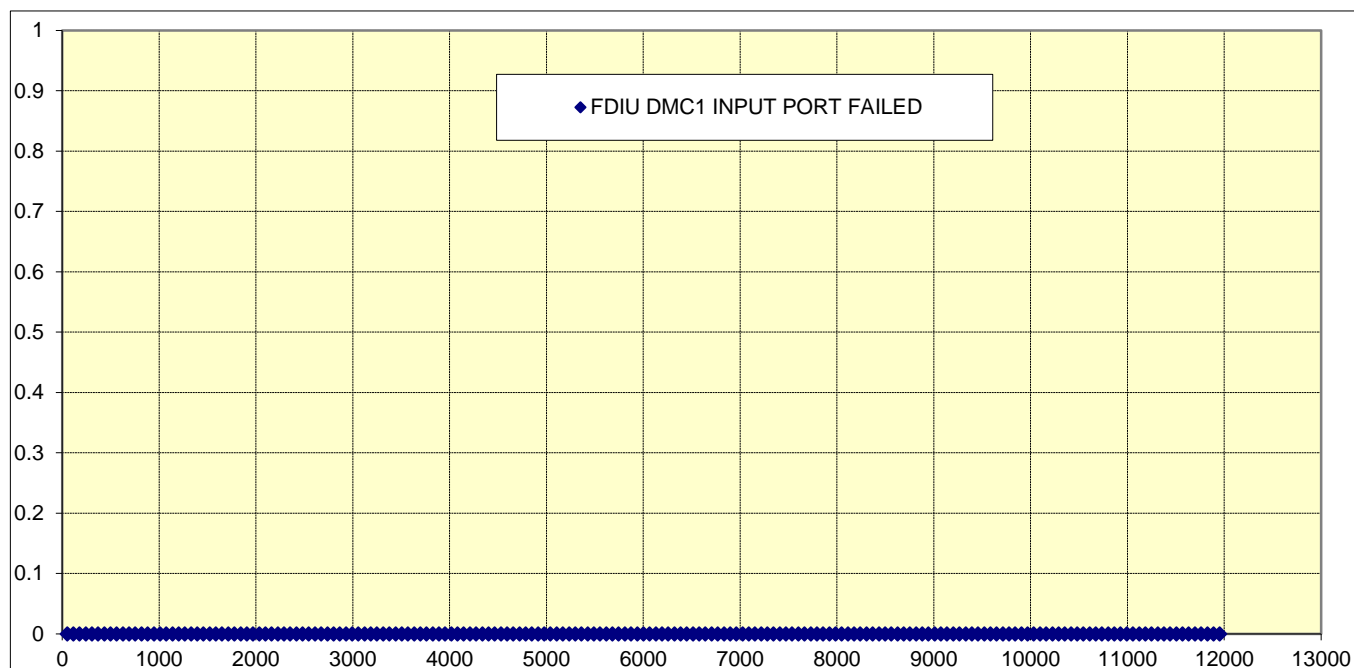
- No detected failure up to the end of the valid data

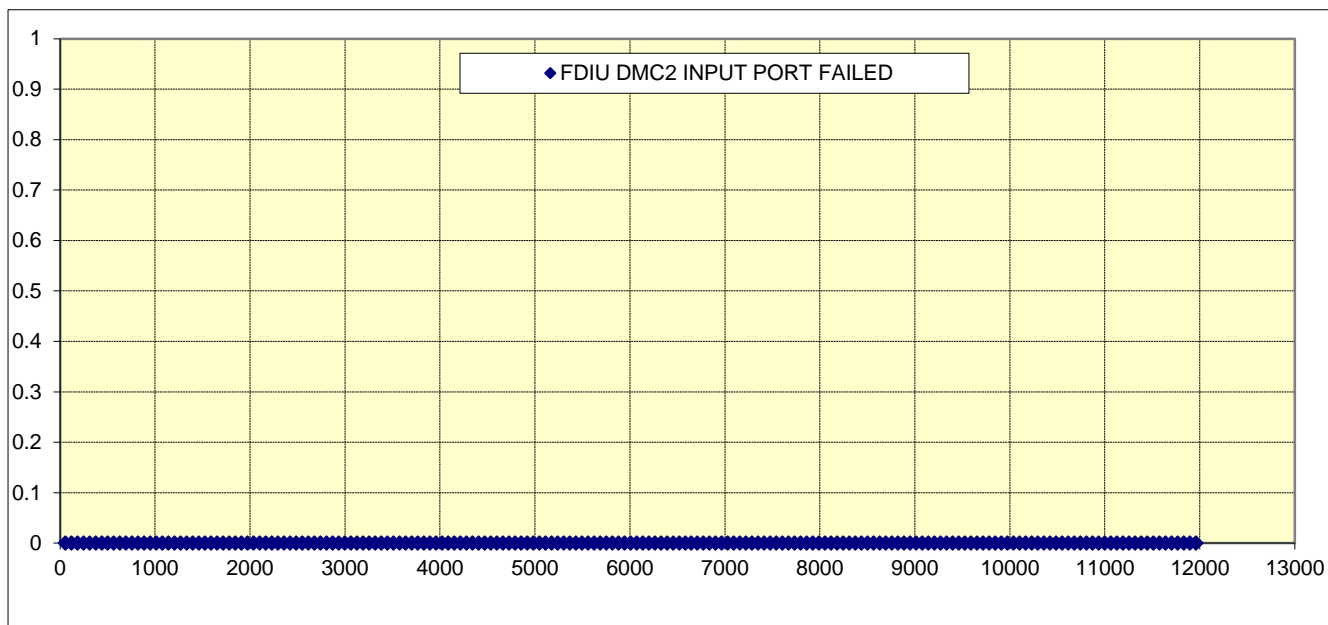
- FDIU DMC2 INPUT PORT FAILED (Flight Data Interface Unit Display Management Computer 1 input port failed)

- No detected failure up to the end of the valid data

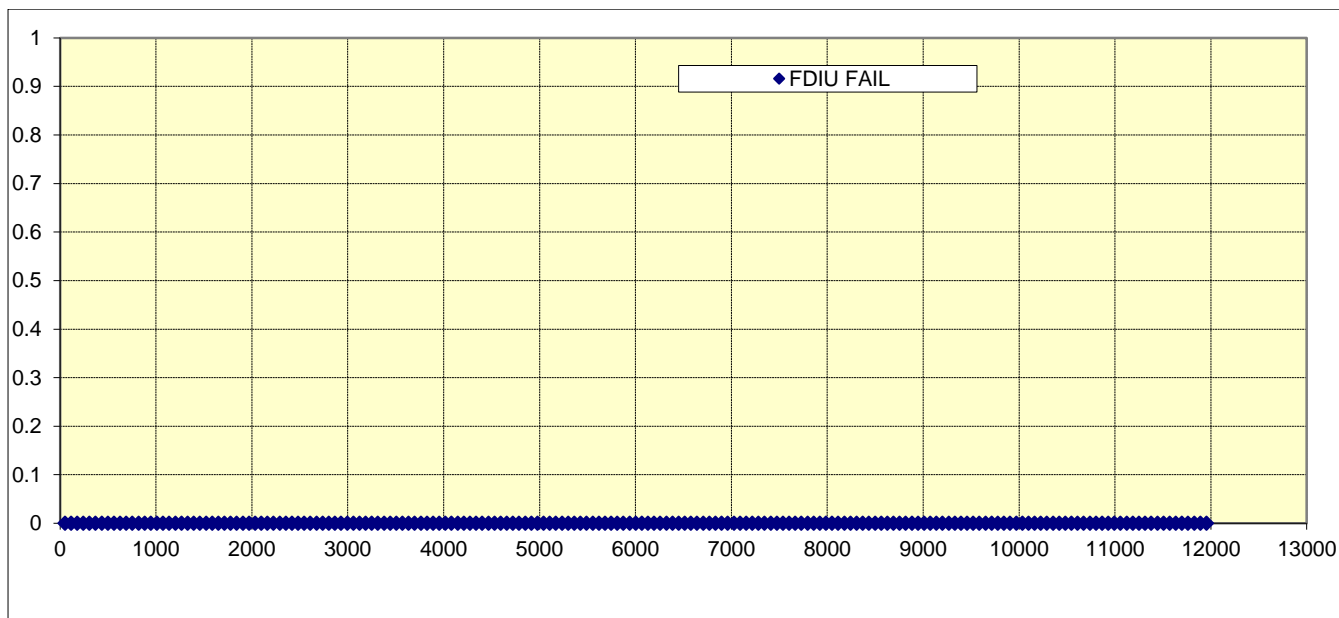
- FDIU FAIL (Flight Data Interface Unit)

- No detected failure up to the end of the valid data

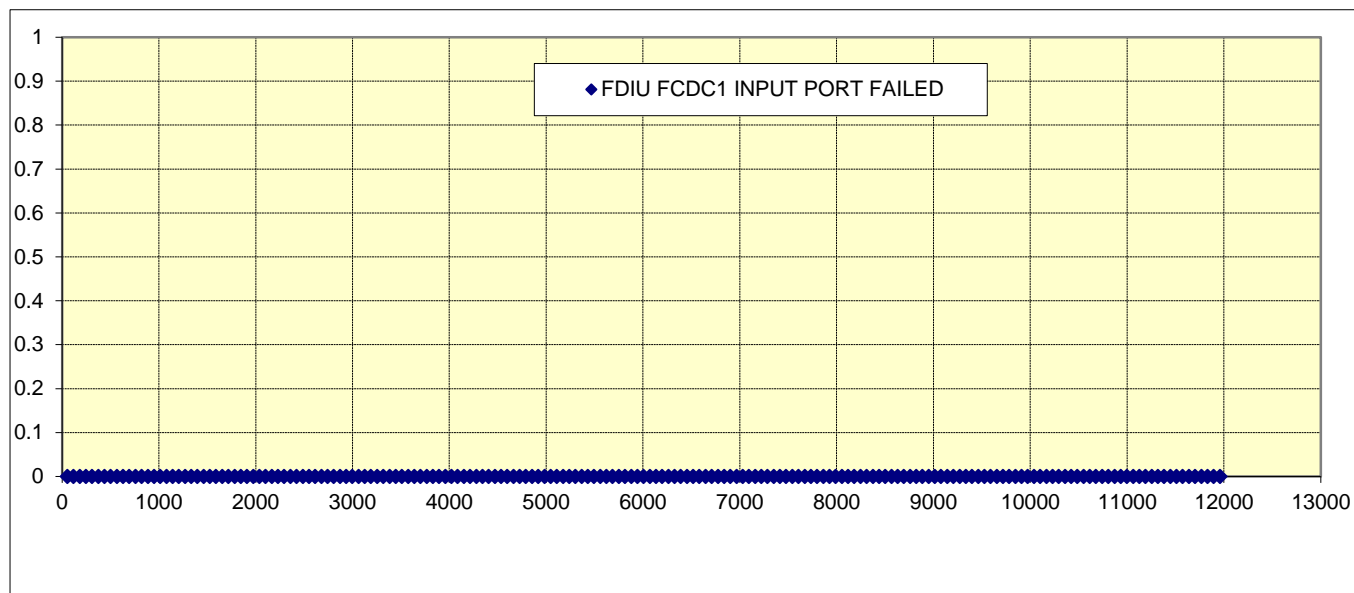
- FDIU FCDC1 INPUT PORT FAILED (Flight Data Interface UnitFlight Control Data Concentrator 1 failed)

- No detected failure up to the end of the valid data

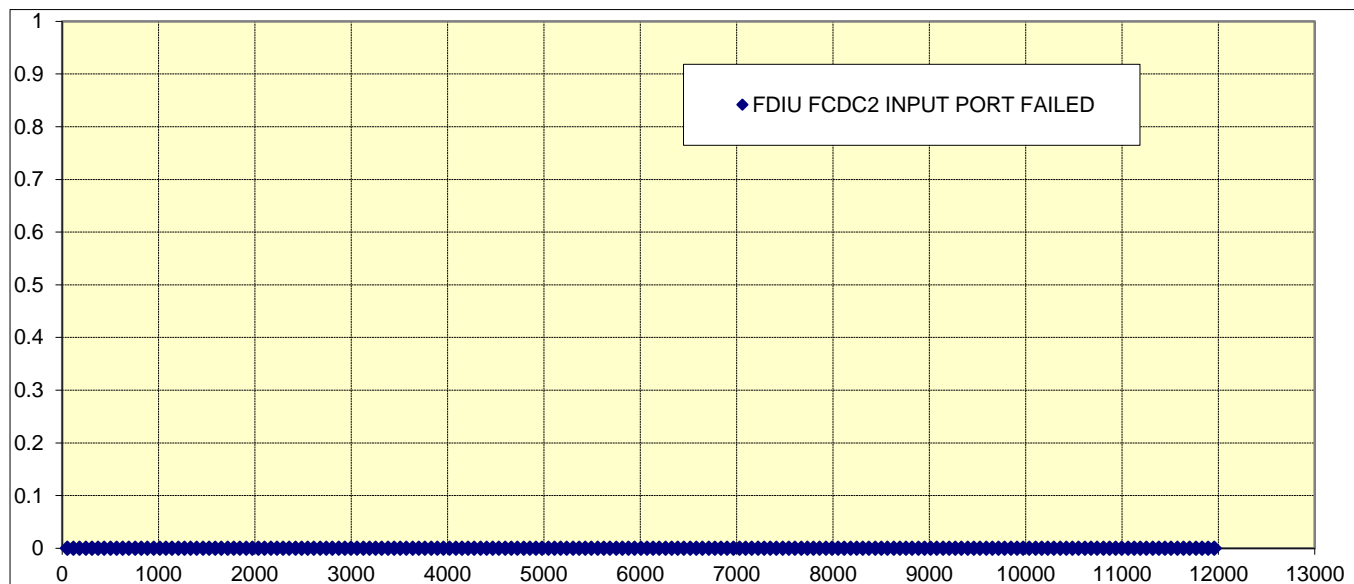
- FDIU FCDC2 INPUT PORT FAILED (Flight Data Interface UnitFlight Control Data Concentrator 2 failed)

- No detected failure up to the end of the valid data

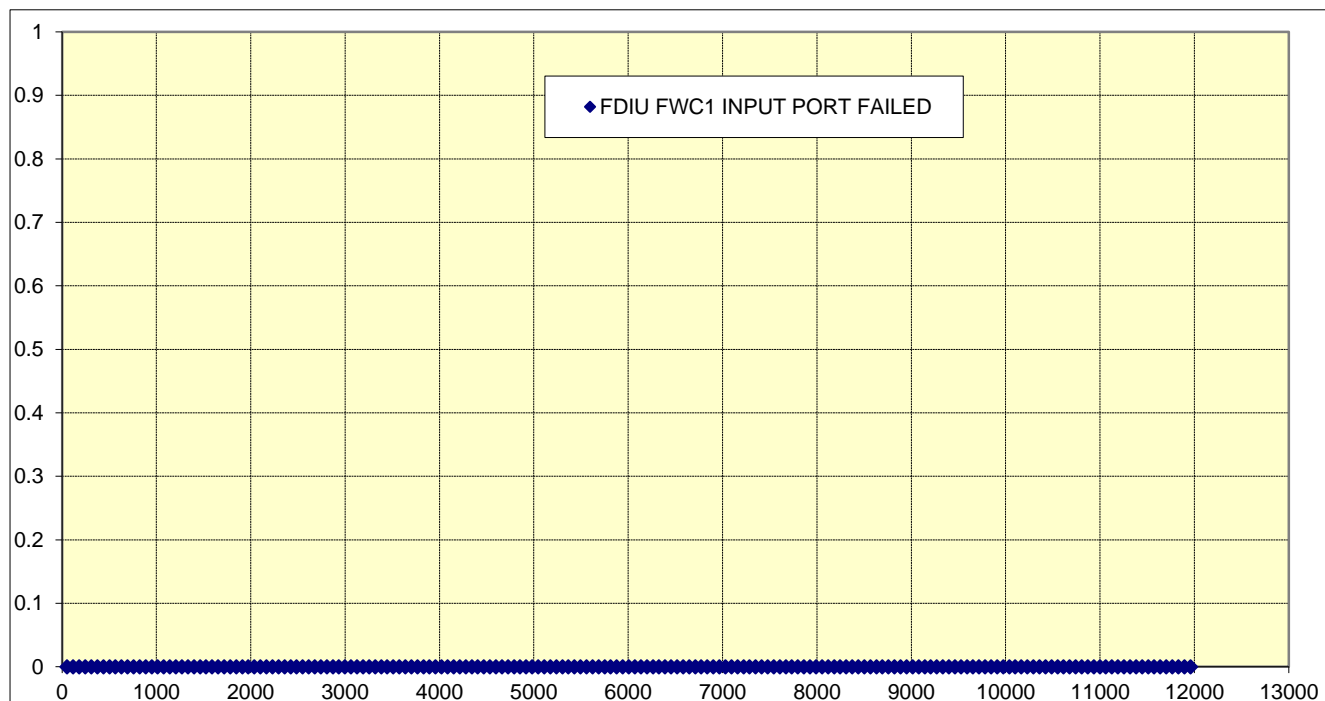
- FDIU FWC1 INPUT PORT FAILED (Flight Data Interface Unit Flight Warning Computer 1 failed)

- No detected failure up to the end of the valid data

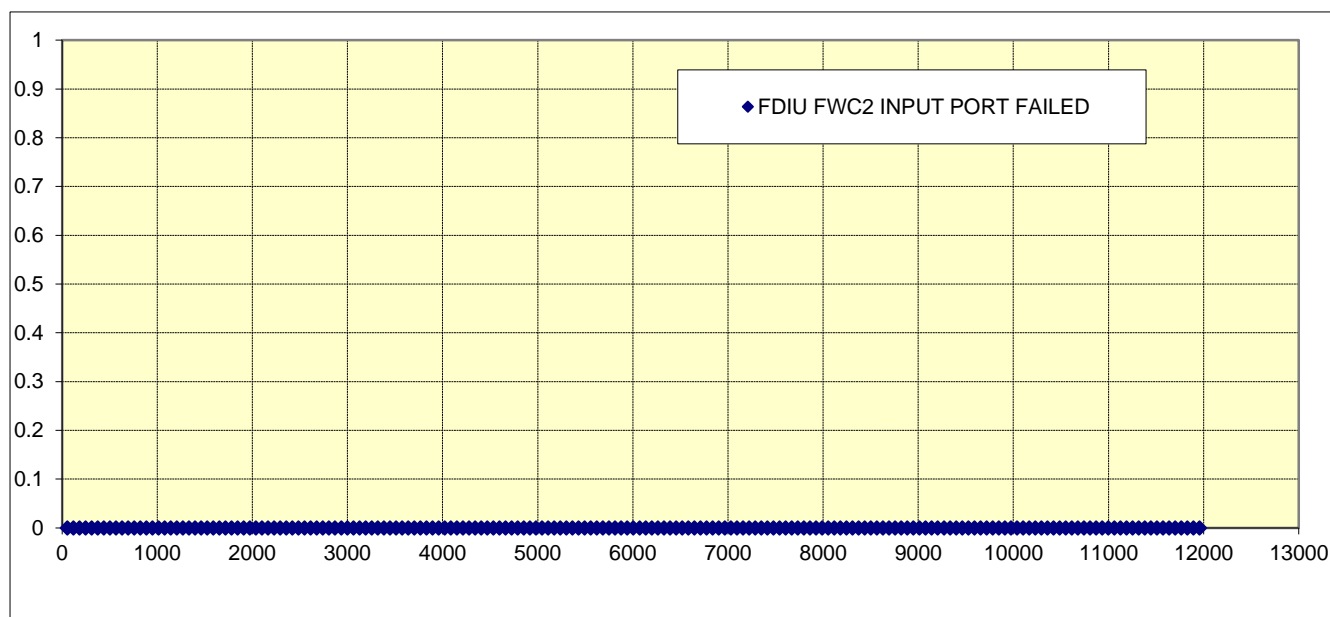
- FDIU FWC2 INPUT PORT FAILED (Flight Data Interface Unit Flight Warning Computer 2 failed)

- No detected failure up to the end of the valid data

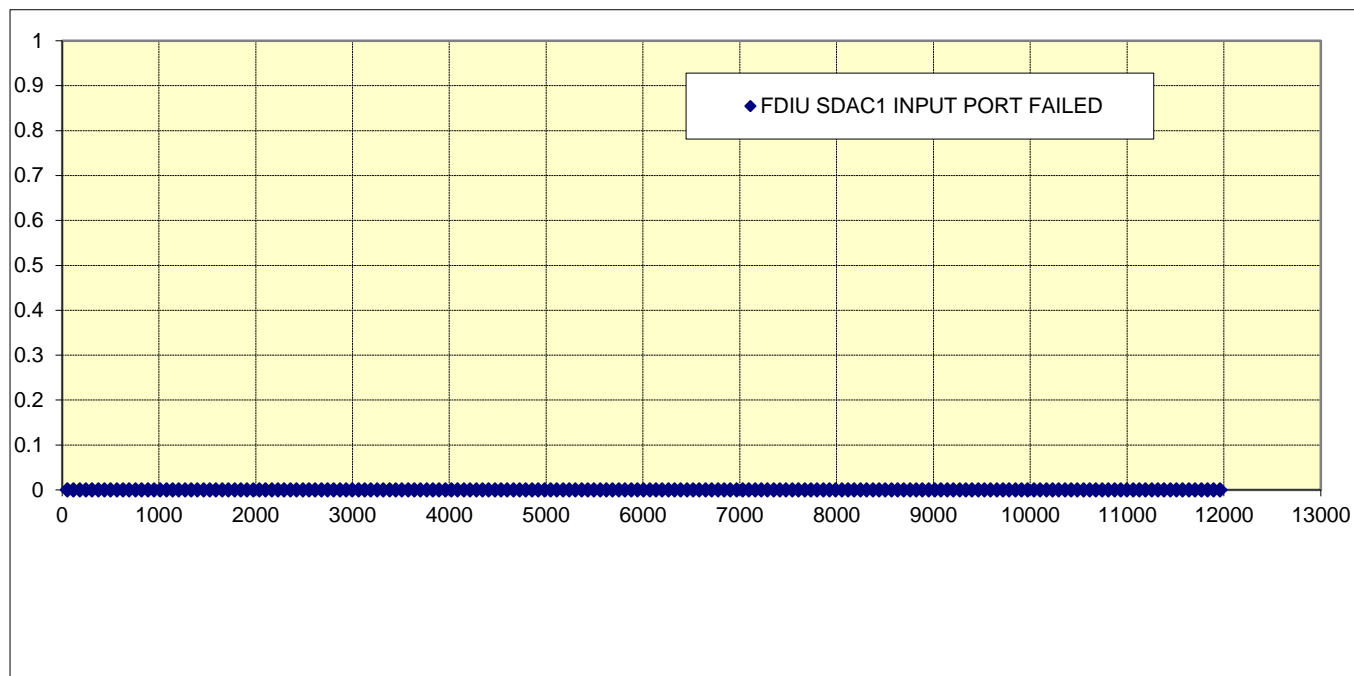
- FDIU SDAC1 INPUT PORT FAILED (Flight Data Interface Unit System Data Analog Converter 1 failed)

- No detected failure up to the end of the valid data
- FDIU SDAC2 INPUT PORT FAILED (Flight Data Interface Unit System Data Analog Converter 1 failed)

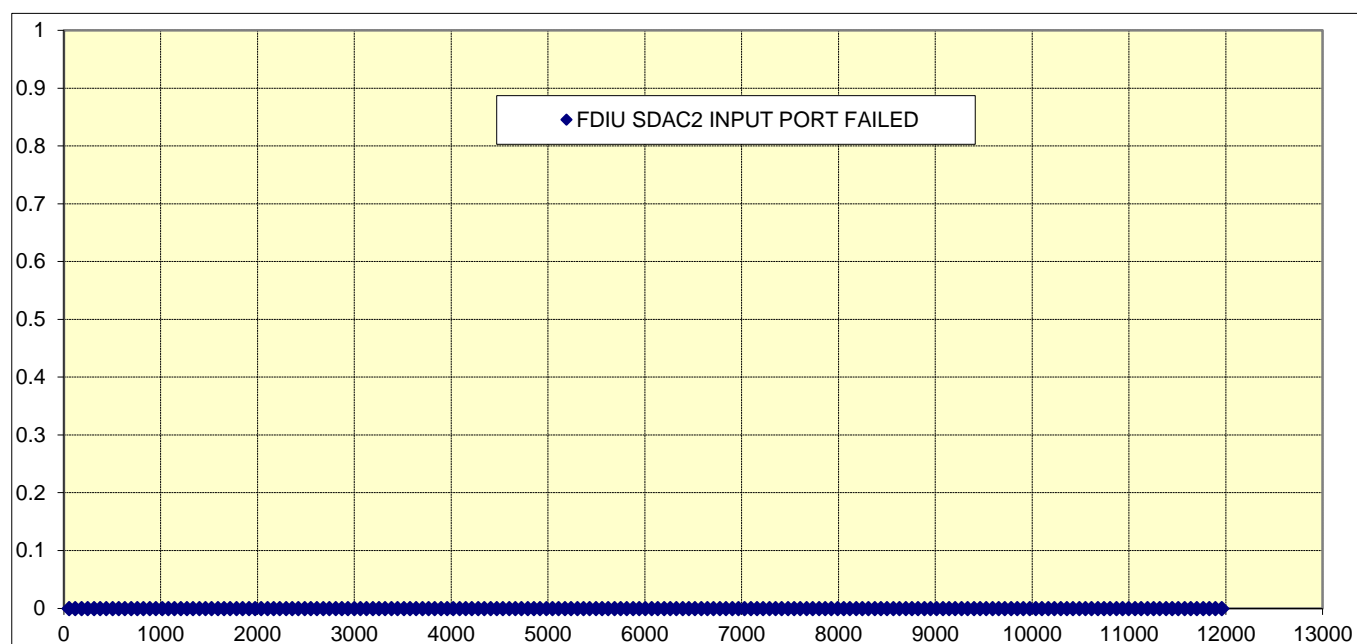
- No detected failure up to the end of the valid data

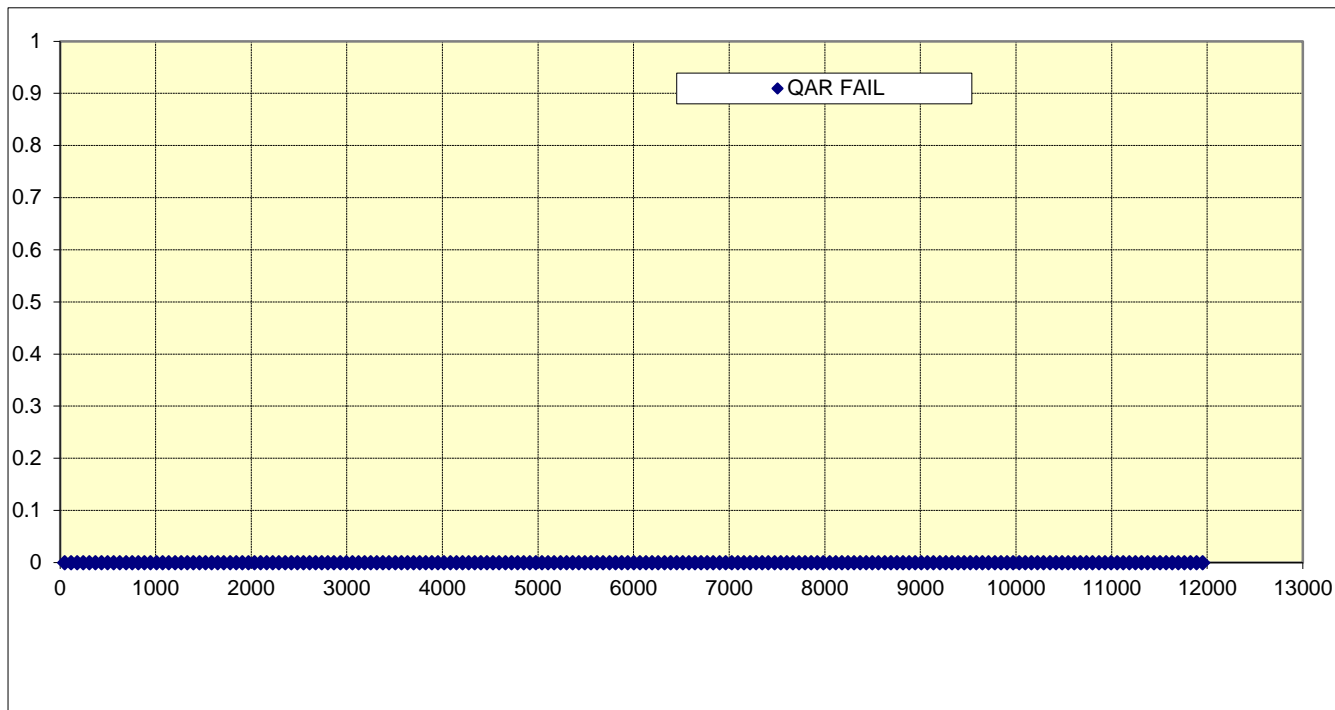
- QAR FAIL (Quick Access Recorder)

- No detected failure up to the end of the valid data

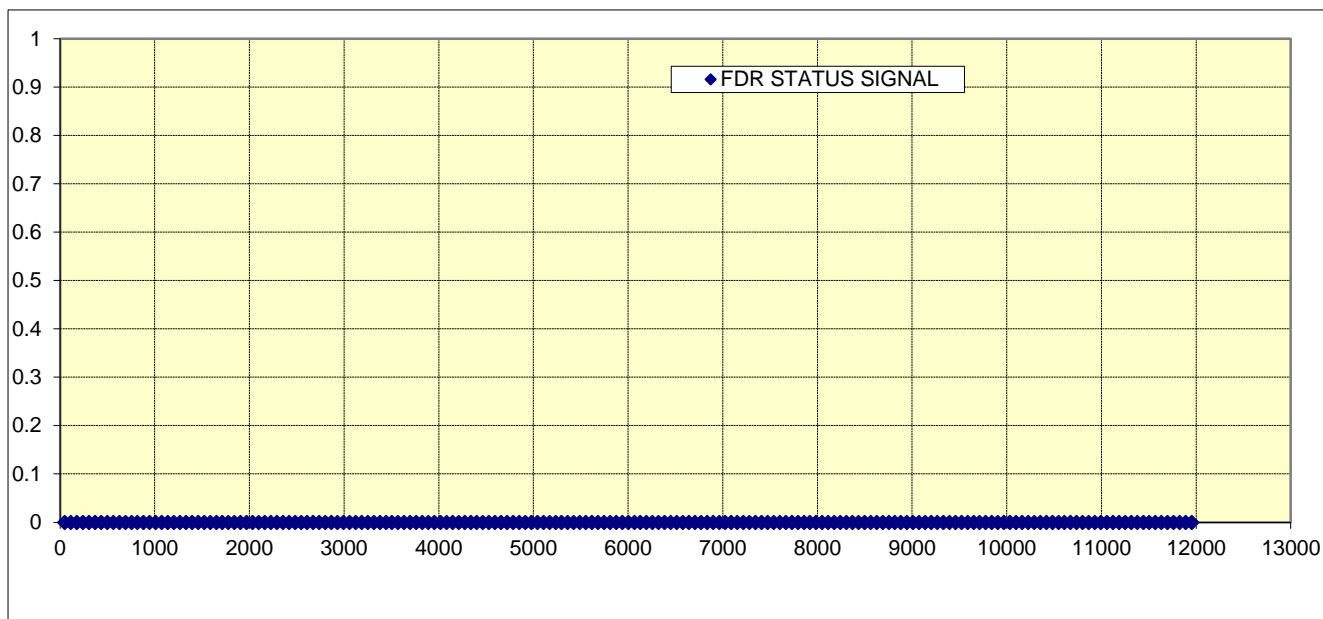
- FDR STATUS SIGNAL (Flight Data Recorder Status Signa)

- No detected failure up to the end of the valid data

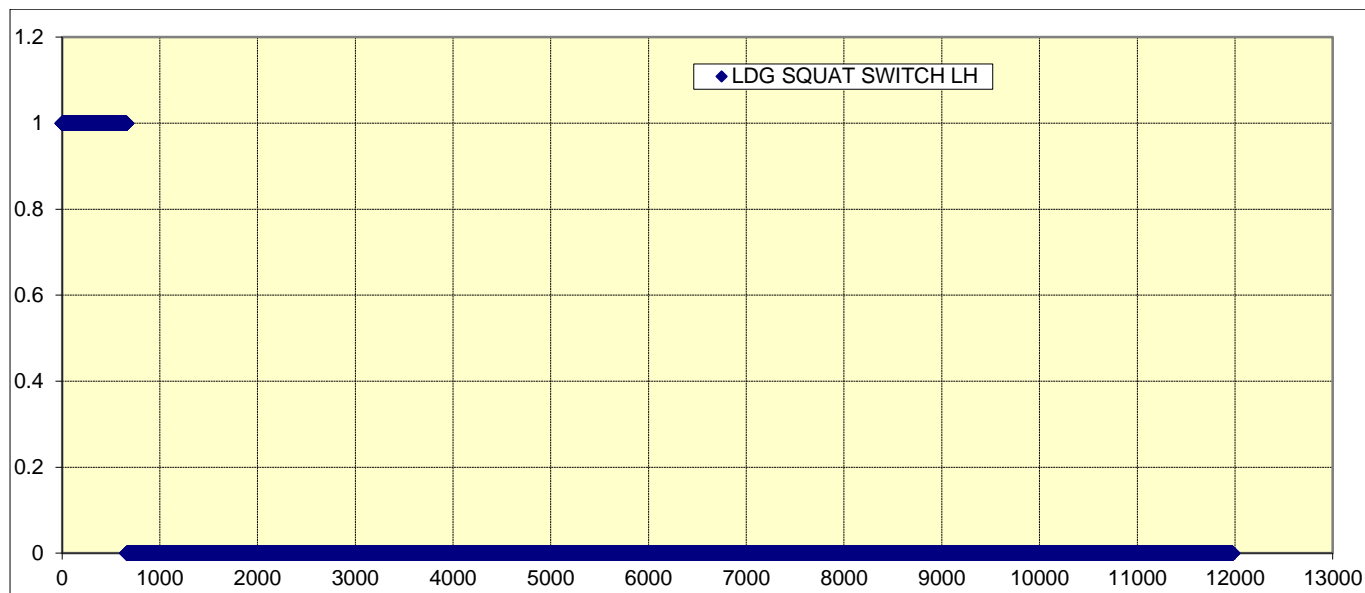
– LDG SQUAT SWITCH LH

LDG LH Squat switch changed status from ground to flight at 21:21:10 UTC (661 seconds on the plot)

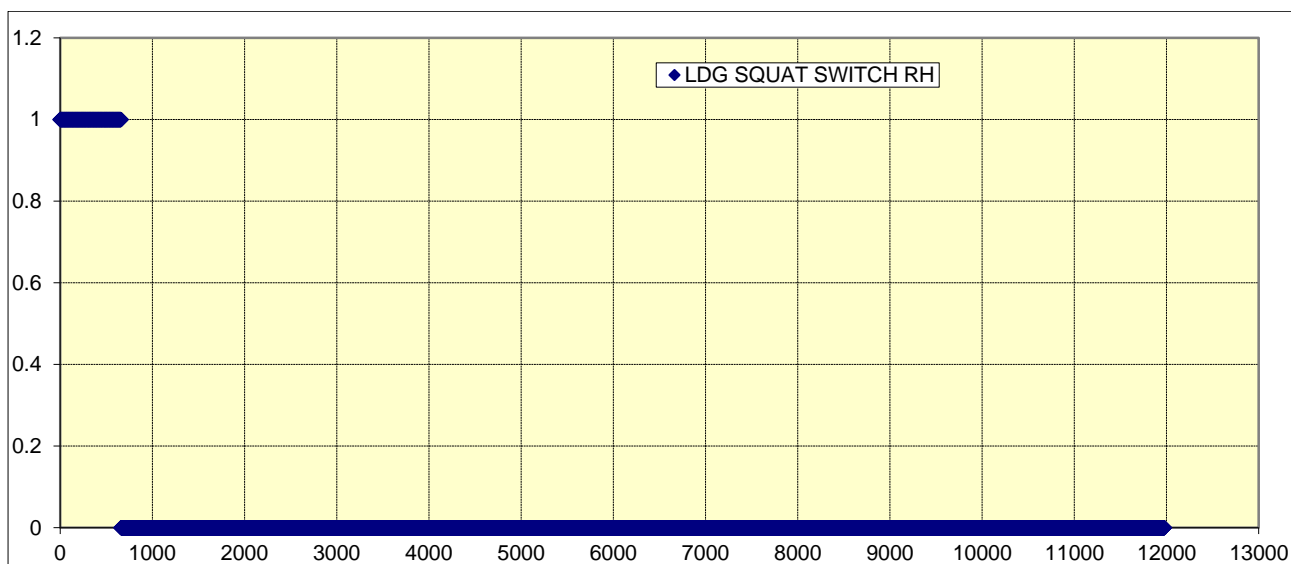
- LDG SQUAT SWITCH RH

LDG RH Squat switch changed status from ground to flight at 21:21:09 UTC (660 seconds on the plot)

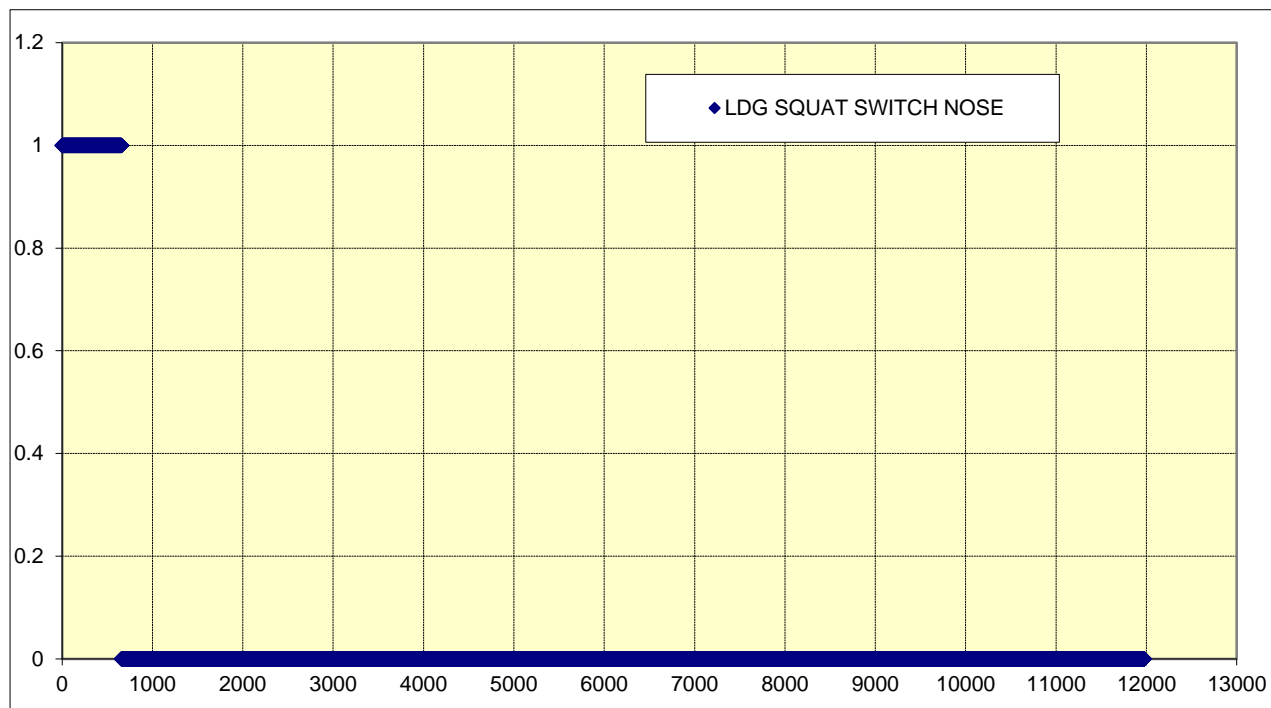
- LDG SQUAT SWITCH NOSE

LDG NOSE Squat switch changed status from ground to flight at 21:21:06 UTC (657 seconds on the plot)

No anomalies detected with the landing gear position

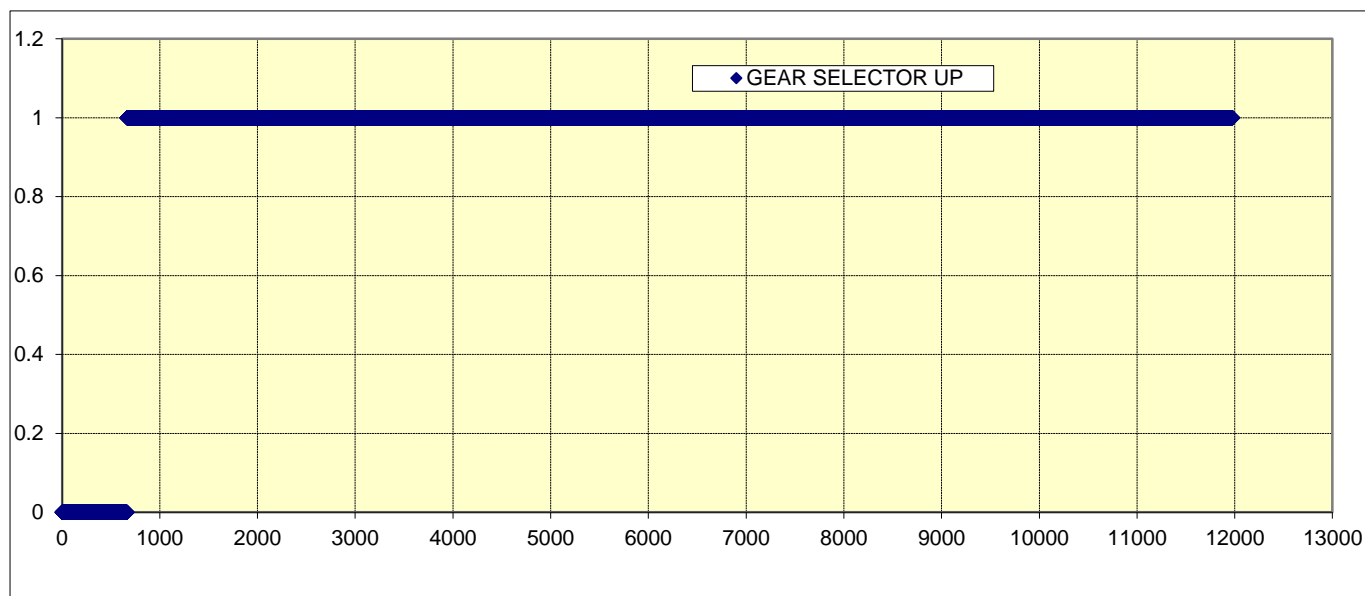
- GEAR SELECTOR UP

The L/G lever was selected up at 21:21:14 UTC (665 seconds on the plot)

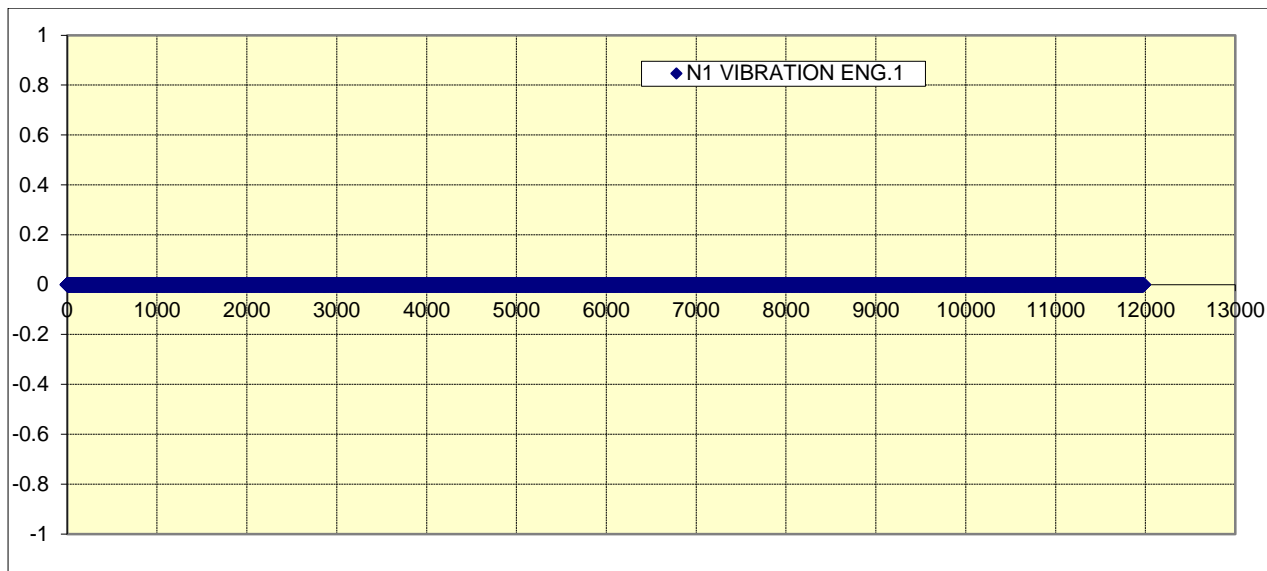
(4 - N1 VIBRATION ENG.1

N1 VIBRATION ENG.1 was 0 throughout the whole recording

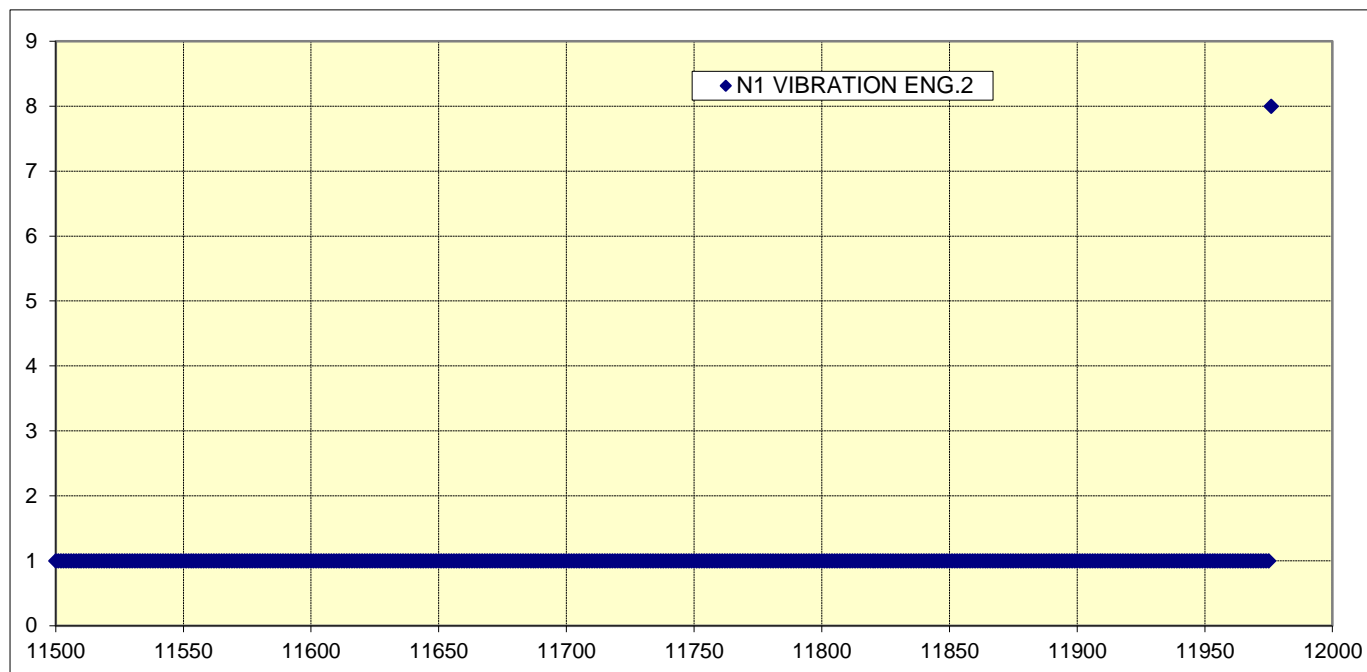
(5 - N1 vibration Engine 2

ENG 2 Vibration N1 shown at the end portion of the recording

Only at one point 00:29:45 (11976 seconds on the plot) the ENG 2 Vibration N1 value changed from 0 to 8

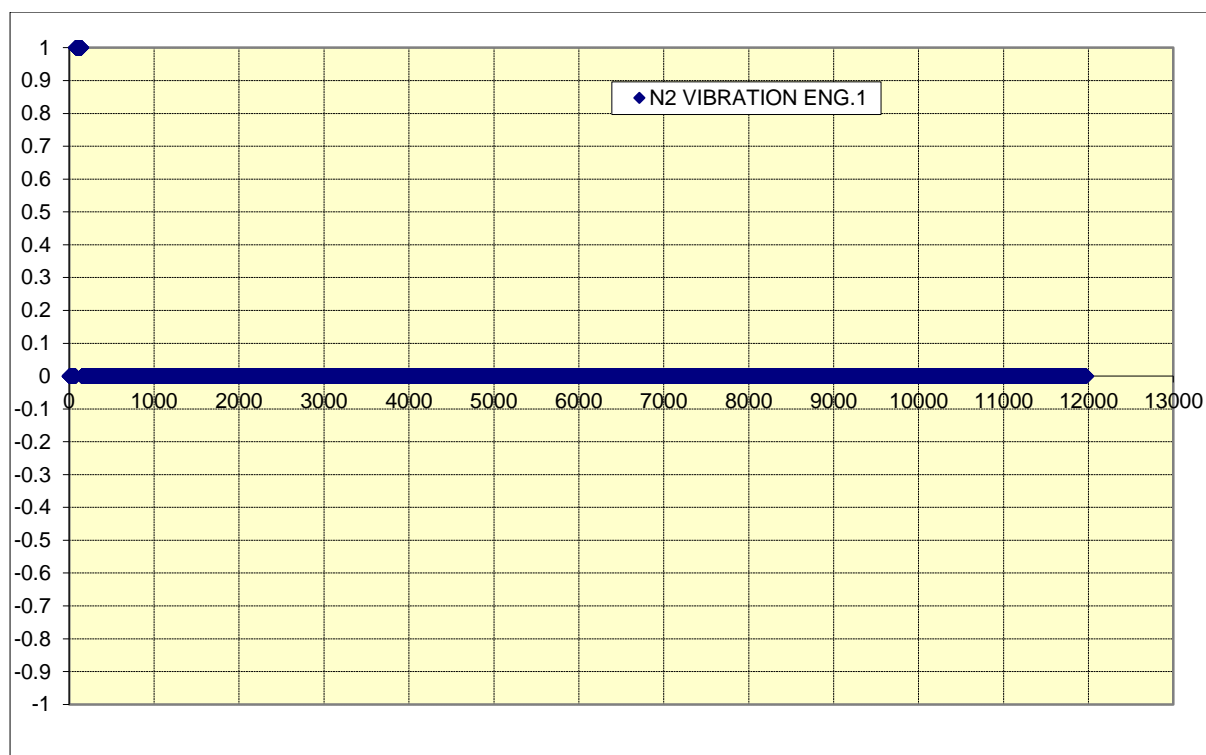
(6 - N2 VIBRATION ENG.1

N2 VIBRATION ENG.1 was 0 throughout the whole recording
