Final Report

**EgyptAir A320 Aircraft crash in the Mediterranean, registered SU-GCC,
flight number MSR804, from Charles De-Gaulle Airport, Paris to Cairo
International Airport, on 19/05/2016**

EGAI2016-01

October 2024

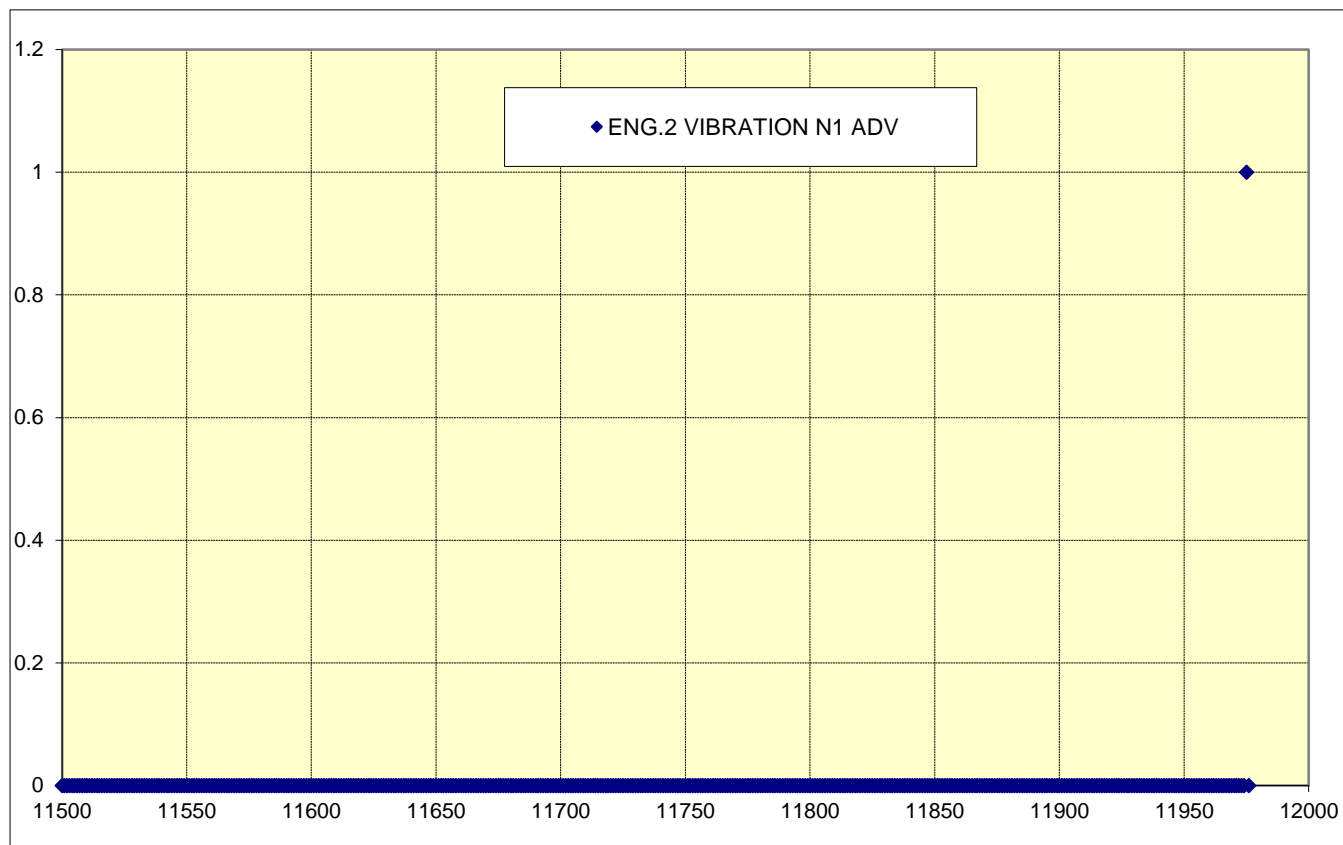
(8 ENG 2 VIBRATION N1 ADV

ENG 2 Vibration N1 ADV shown at the end portion of the recording

Only at one point 00:29:45 (11975 seconds on the plot) the vibration value changed from 0 to 1

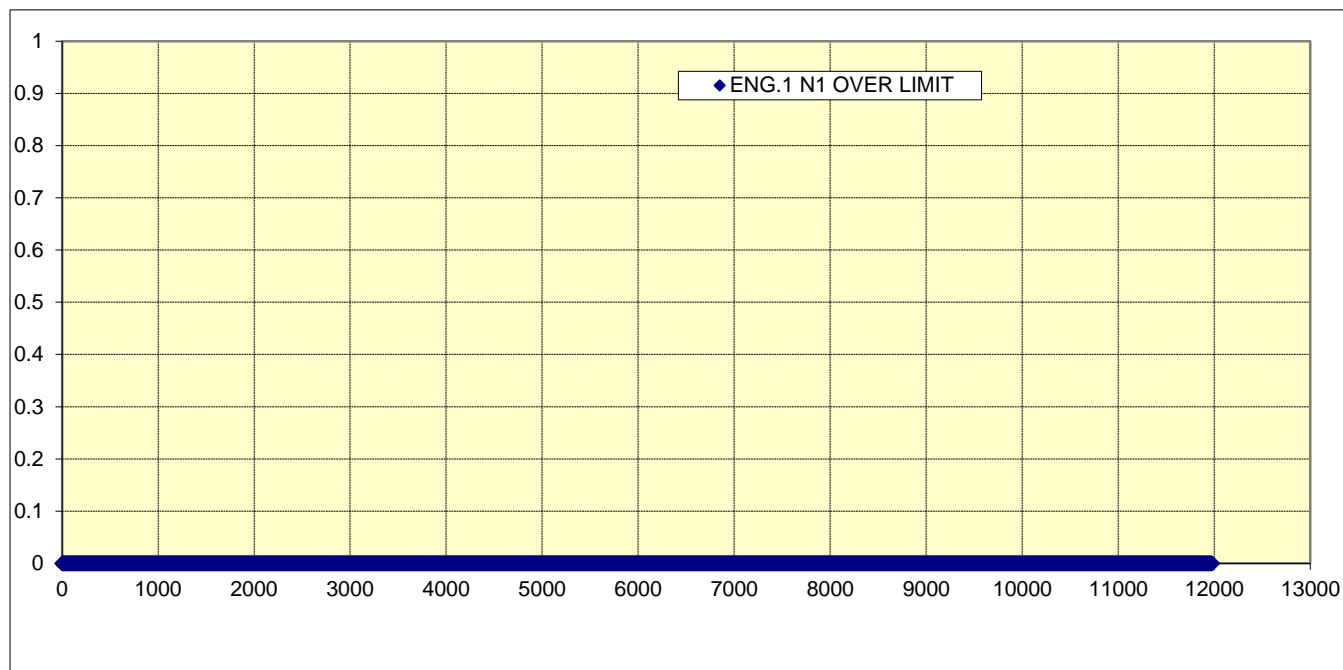
(9 Engine 1 N1 over limit:

No engine 1 N1 over limit

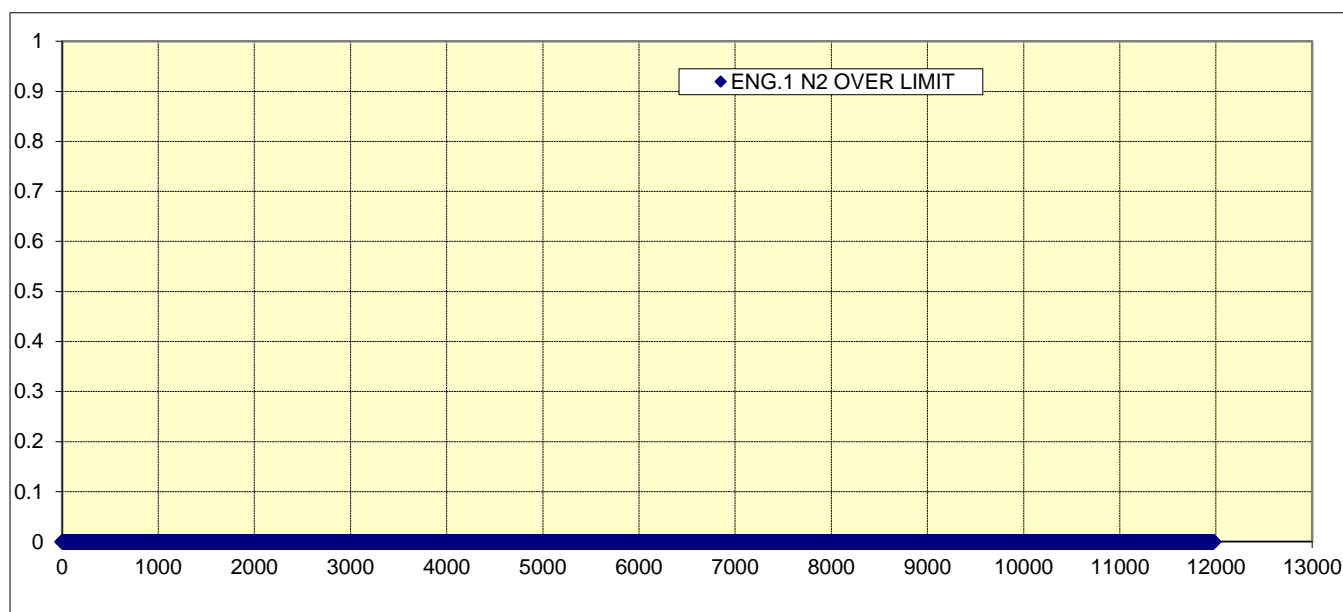
(10 Engine 1 N2 over limit:

No engine 1 N2 over limit

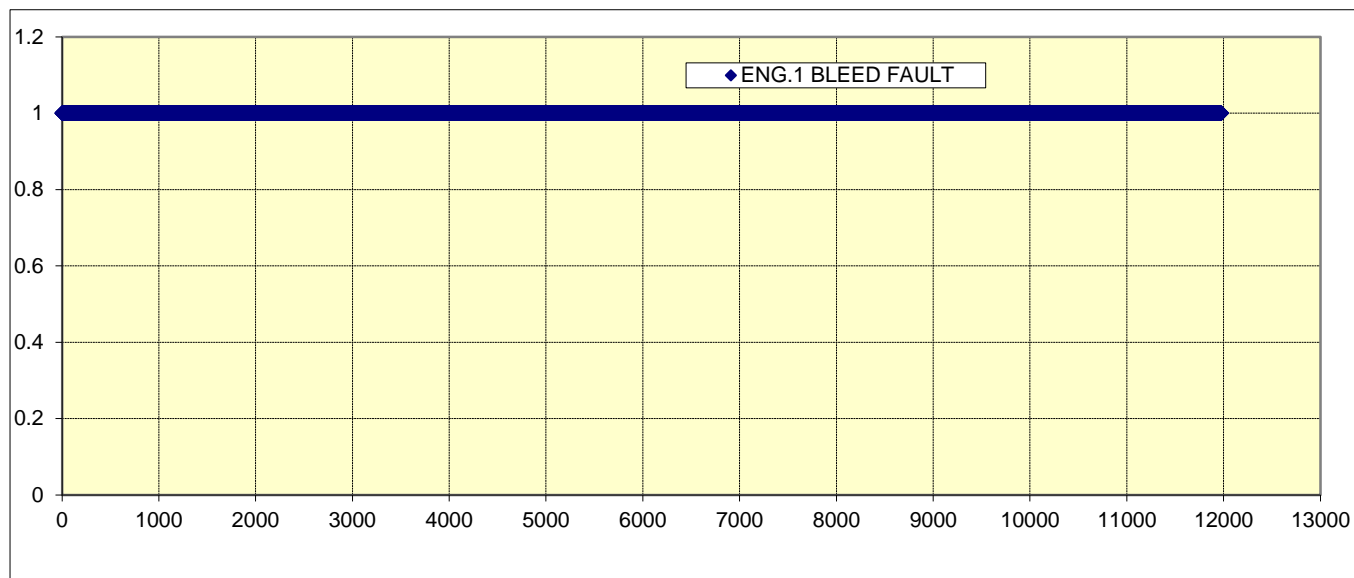
(13-ENG.1 BLEED FAULT

No ENG.1 BLEED FAULT

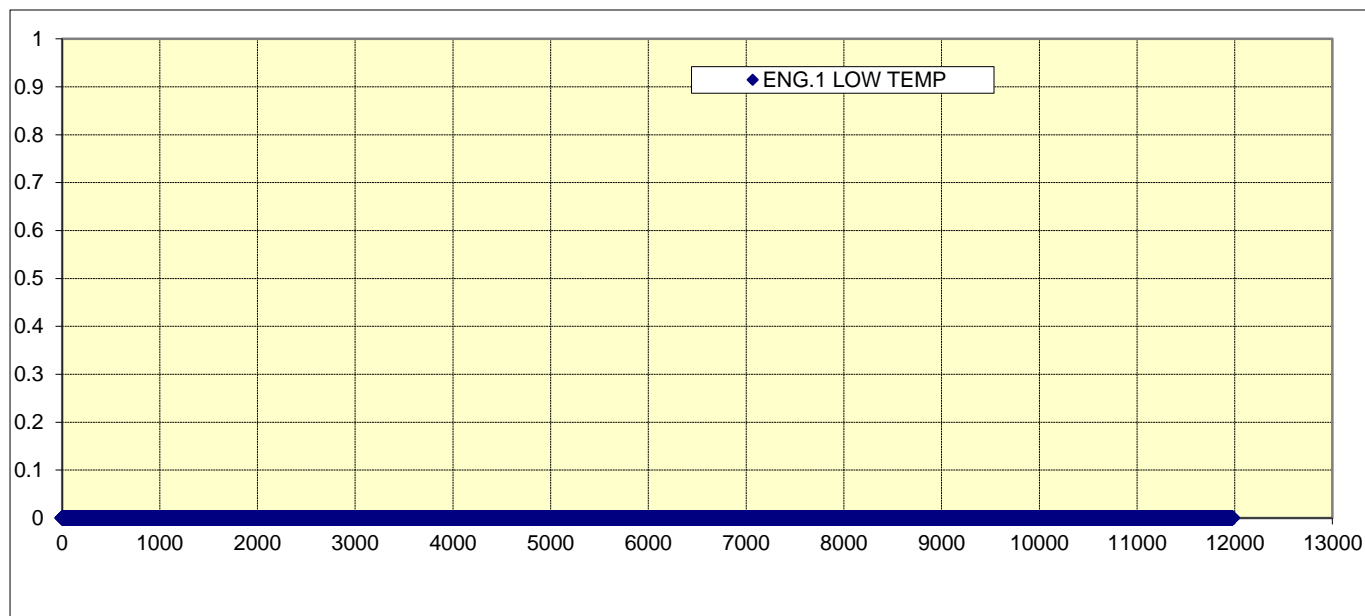
(14-ENG.1 LOW TEMP

No ENG.1 LOW TEMP

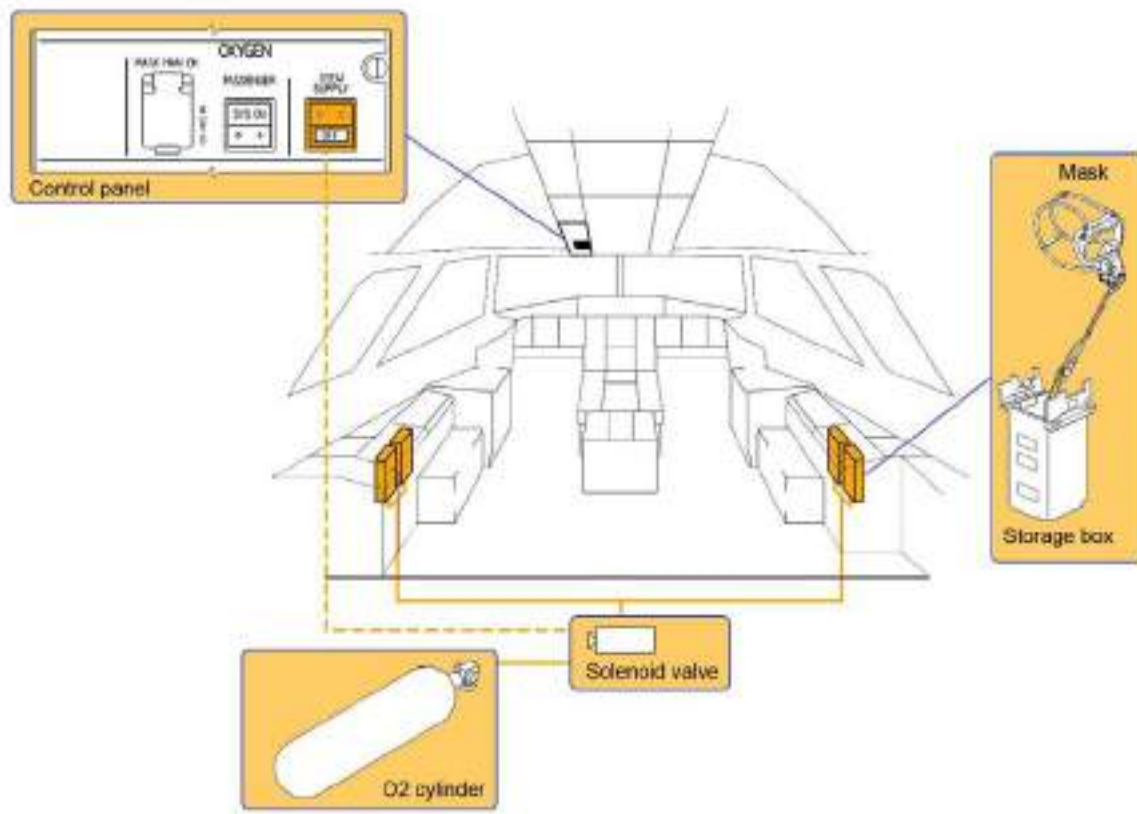
Figure 1: description of cockpit oxygen system of a commercial air transport aeroplane

The masks are composed of a visor and a regulator to supply oxygen at a pressure close to the ambient pressure each time the pilot breathes in. An *EMERGENCY* knob on the mask regulator can be used to produce a continuous overpressure of a few millibars in the oronasal cavity and a continuous flow of a few litres of oxygen in the ocular cavity and thus prevent the ingress of contamination (smoke).

Some aeroplanes are equipped with flow fuses in the oxygen system, located close to each mask storage box. These flow fuses close and cut off or limit the oxygen flow to the associated mask when a leak is detected downline.

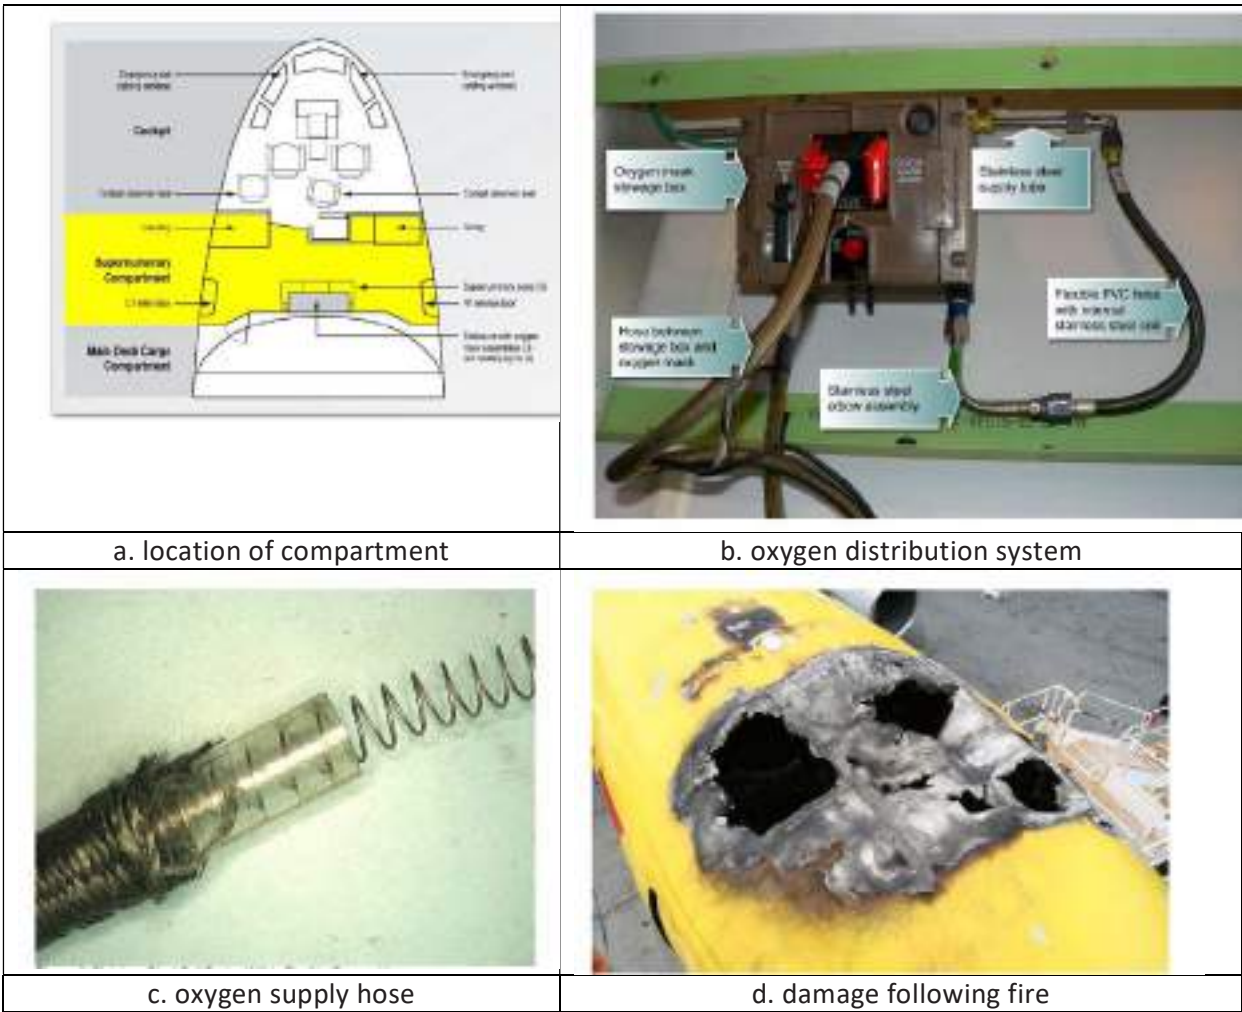
Figure 7: images from investigation report (source: NTSB)

The fire broke out during flight preparation, in the compartment between the cockpit and the cargo area (see Figure 7a).

The captain and co-pilot evacuated the aeroplane through the cockpit windows after closing the cockpit door and calling in the aircraft rescue and firefighting service. The aeroplane was considered destroyed due to the extent of the damage (see Figure 7d).

The mechanism involved in the accident to N799AX was an internal ignition in the system (linked to the design of the hoses) which caused a rupture in the oxygen hose and consequently a fire fuelled by an oxygen leak which led to the destruction of the aeroplane. The crew evacuated the aeroplane without trying to put out the fire.

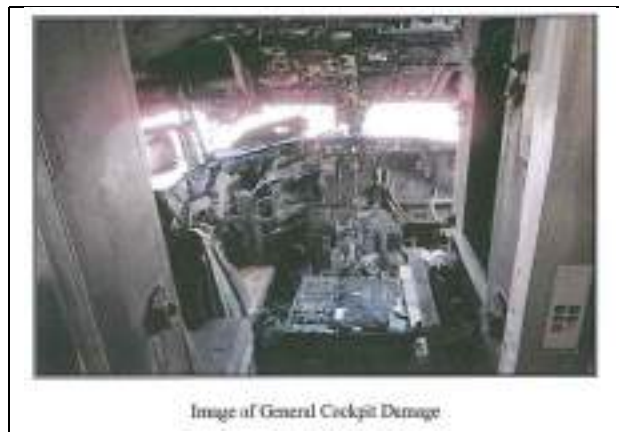
Figure 9: photo from draft investigation report (source: safety investigation authority)

An oxygen leak and fire broke out in the cockpit on the captain's side. It is said that two seconds after the start of the leak, the co-pilot reported the problem and called out "cologne". The captain asked the pilots to leave the cockpit and asked for a fire extinguisher. A fire extinguisher was activated one minute later. The passengers were evacuated and the aircraft rescue and firefighting service intervened to bring the fire under control. The fire caused substantial damage in the cockpit as well as in the electronic and avionics bays along with heat damage to the outer skin.

It is believed that the crew reported seeing a ball of sparks heading towards the captain's oxygen mask and that the mask and its surroundings burst into flames accompanied by the noise of escaping oxygen. The fire was out of control and the flames very high within approximately five seconds. Thick black smoke escaped from the cockpit.

It is thought that the event began with an initial continuous leak of pure oxygen, this oxygen leak then spreading into the cockpit. The fire started as a result of a perfume and a burning cigarette meeting. The fire then spread inside the cockpit after the captain opened the mask storage box in order to fight the fire.

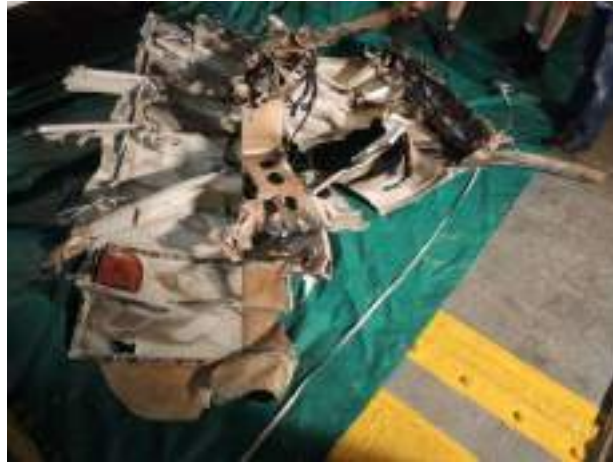
Figure 16: cockpit debris showing black deposits (source: BEA/EEAID)

Some debris showed signs of having been subject to high temperatures, and traces of soot. In particular, soot was visible on the side of the cockpit between frames 4 and 8 as illustrated in the image below.

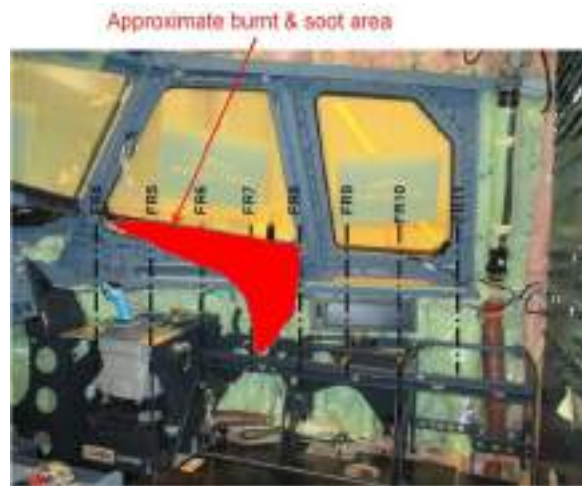
Figure 17: corresponding area on an A320 (source: BEA/EEAID)

The figure below roughly shows the corresponding area.

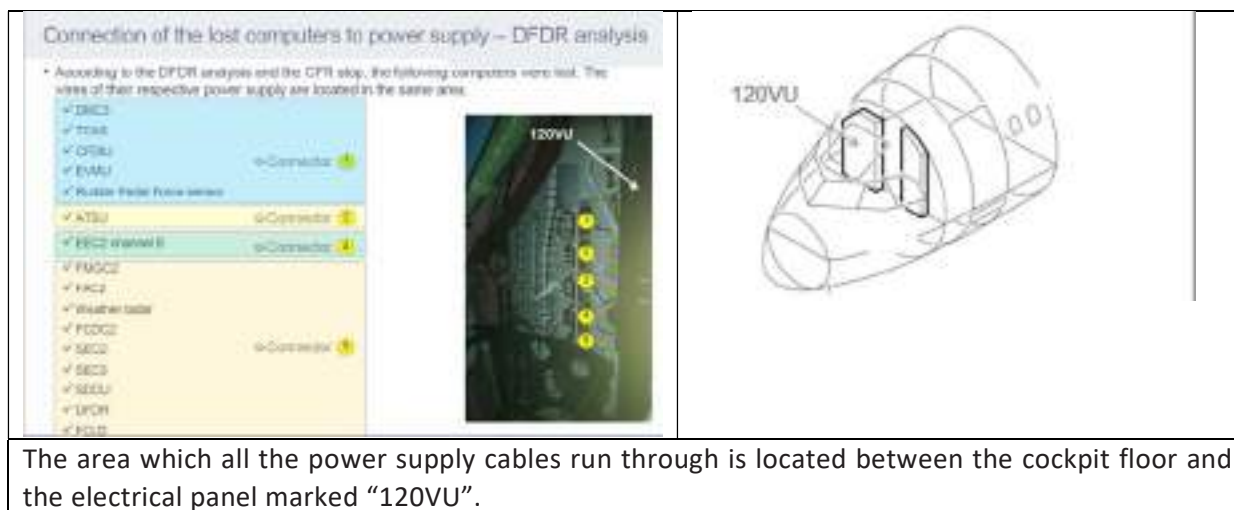
The read-out of the FDR showed that several on-board computers failed successively from 00:29:26 within an interval of 30 s.

These computers are located at various points on the aeroplane. However, the power supply cables for these computers are all connected in the same place, in an area at the rear right of the cockpit.

The area which all the power supply cables run through is located between the cockpit floor and the electrical panel marked “120VU”.

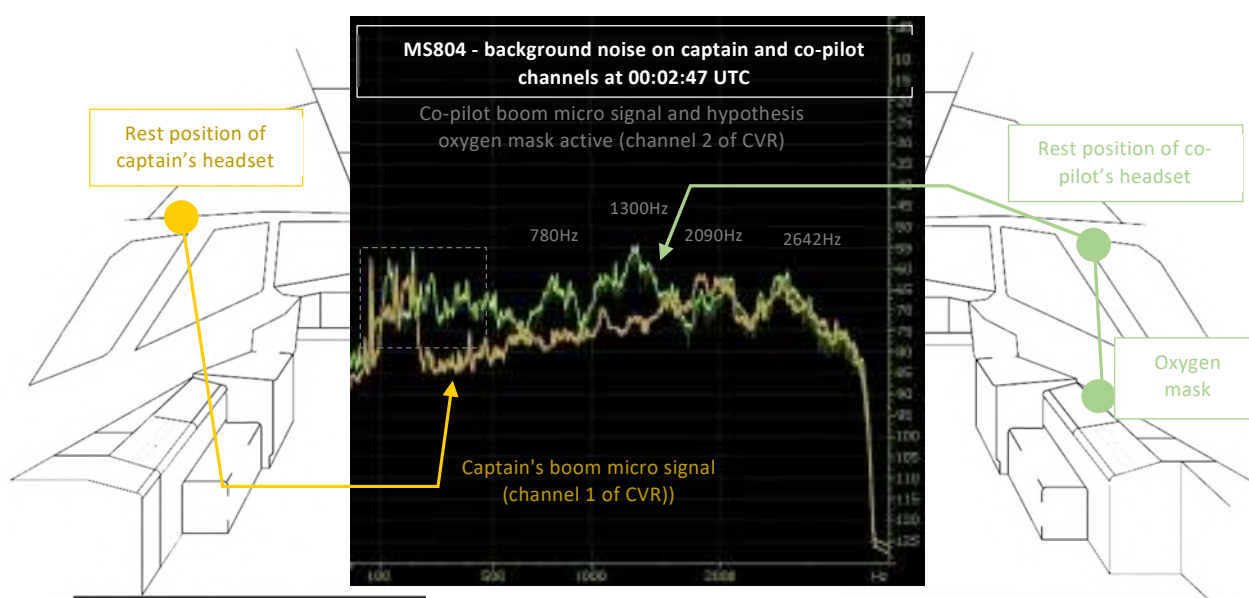
Figure 19: comparison of noise spectrum picked up by captain's and co-pilot's boom mikes

The sound picked up by the oxygen mask microphone had an acoustic signature consisting of the emergence of five characteristic noise bumps. The appendix Sound pick-up by the oxygen mask microphone presents the comparison made with a series of audio samples taken from the BEA's audio database. The spectral view below shows the comparison between the signal recorded by the captain's CVR channel and that recorded by the co-pilot's CVR channel.

The low-frequency noise bump (from 100 to 500 Hz) and the four broadband bumps (780 Hz, 1300 Hz, 2090 Hz and 2640 Hz) confirmed that the microphone of the co-pilot's oxygen mask was active.

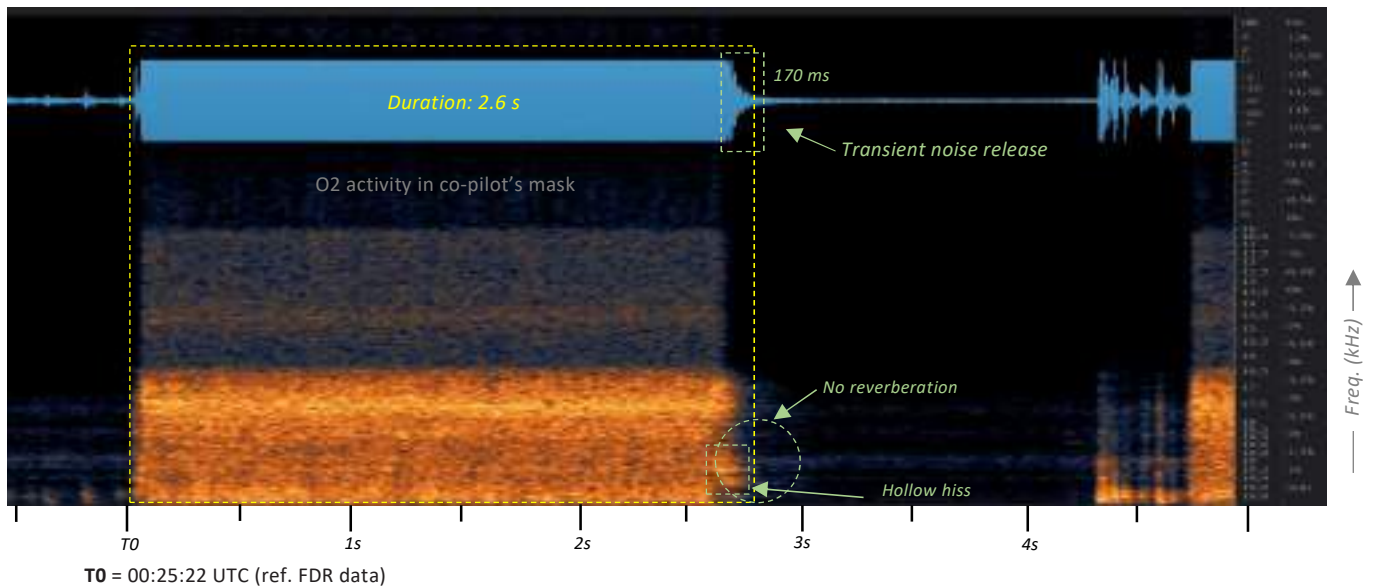
Figure 21: first oxygen flow activity in co-pilot's mask (spectral view – source: BEA)

4.7.3 EVT2: A very loud, short (2.6 s) leaking noise recorded on the co-pilot's CVR audio channel

This sequence was compared with various sound recordings made during the handling of oxygen masks and mask storage boxes (see appendix EVT2).

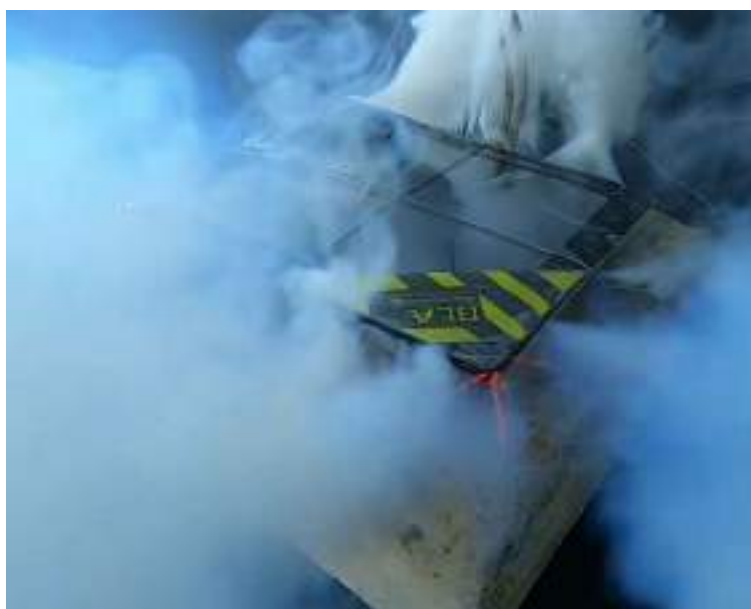
Figure 24: example of release of smoke during thermal runaway of battery (Lithium_Battery_04 test)

During the tests, the thermal runaway of the batteries was visually characterised by a sudden release of thick white smoke. No sudden loud sound (snapping, detonation) was produced; only a whooshing sound or hiss could be heard during the ejection of gases. The ejection of incandescent particles was often observed during these tests, but the combustion of these particles proved to be very rapid and insufficient to spread the fire to the environment. The runaways were all preceded by the release of smoke over several minutes.

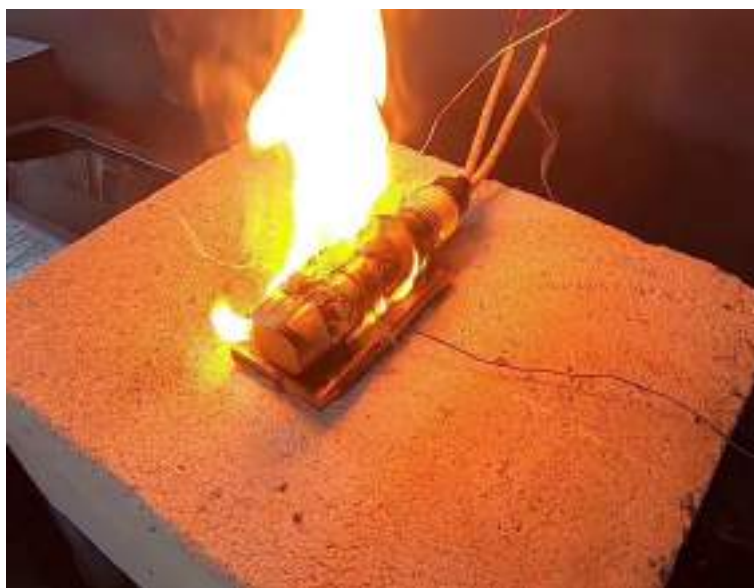
Figure 26: visible flames during Lithium_Battery_07 test

The appearance of flames was observed only once, during a test carried out on an electronic cigarette in the free field (Lithium battery_07 test). It is likely that the fire broke out due to the presence of adhesive tape affixed³¹ to the body of the cigarette, which burst into flames during the test.

In the conditions of the tests, only one element external to the electronic cigarette (adhesive tape) probably contributed to the outbreak of fire after the thermal runaway of the battery.

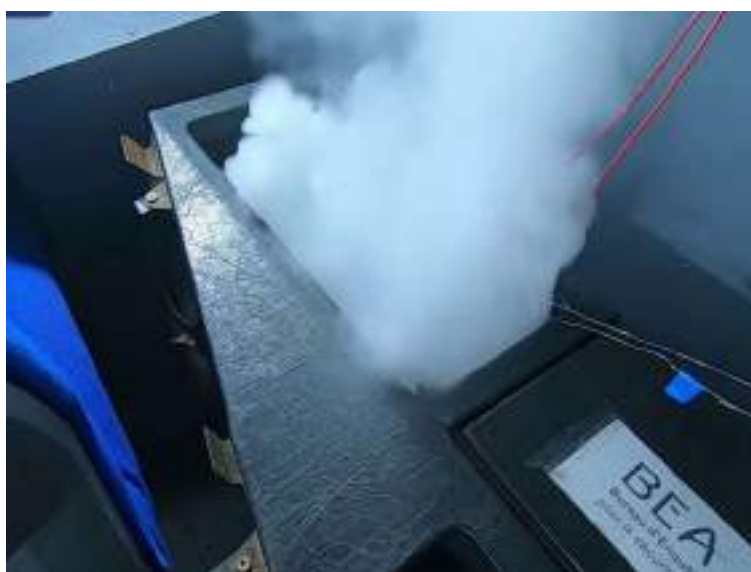
Figure 27: release of smoke during Lithium_Battery_05 test

During the tests carried out on the equipment placed in the document storage compartments, no outbreak of fire was observed. Only the release of dense white smoke was seen.

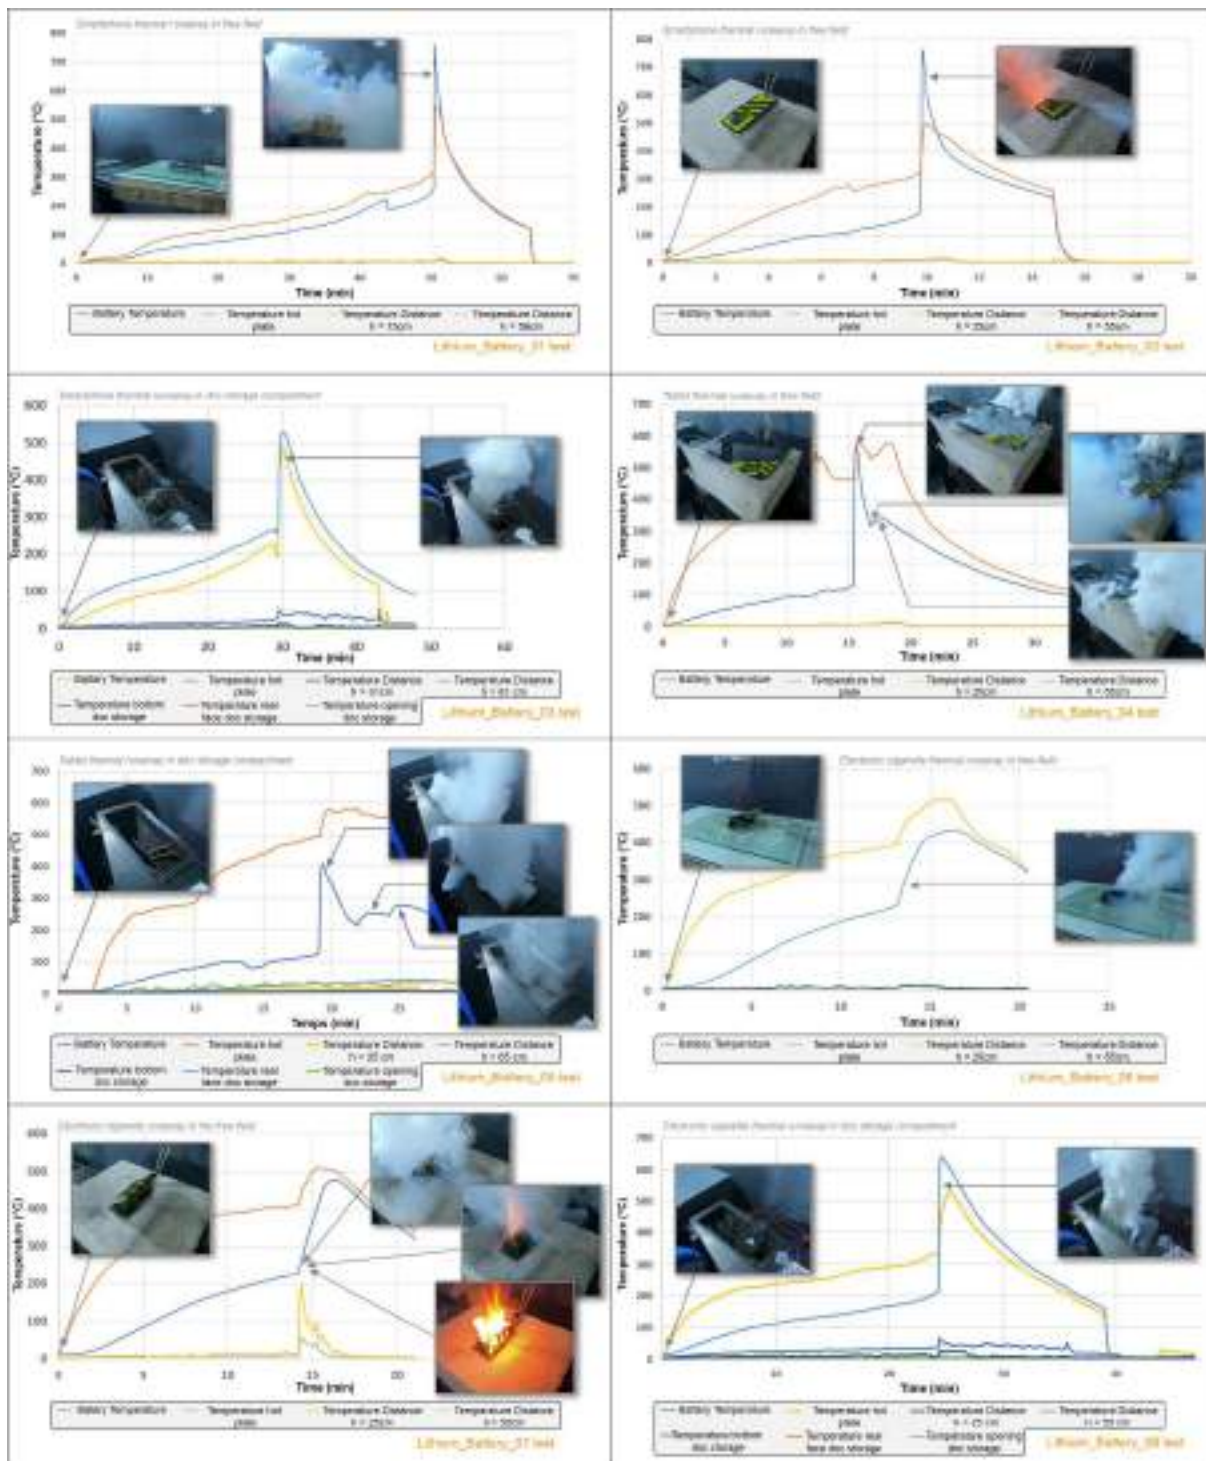
Figure 28: temperature curves - Lithium battery tests (source: BEA - INERIS)

Thermal runaway occurred at battery temperatures of between 100°C (tablets) and 250°C (smartphones), depending on the device. The battery temperature then rose almost instantaneously to an average of 550°C, with values as high as 750°C (in the case of smartphones). No significant rise in temperature in the air surrounding the batteries was measured. During tests carried out in the document storage compartment, the temperature inside the compartment rose without exceeding 50°C.

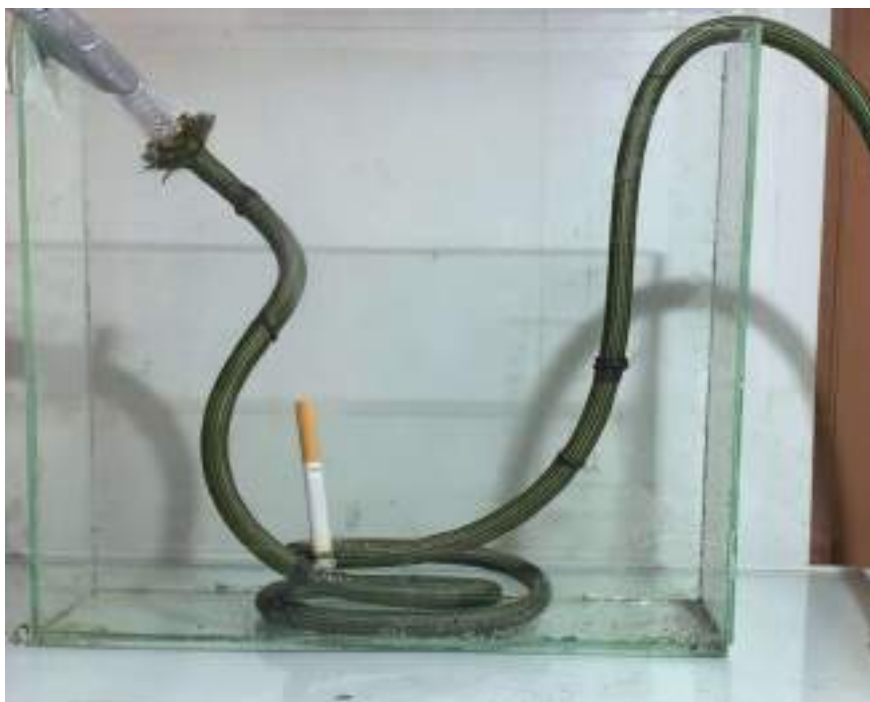
Figure 29: open-air test (source: BEA)

The cigarette went out after about ten seconds. The braided outer protection of the hose and its core (a flexible silicone tube) were not damaged or impaired.

Thus, in the test conditions, a glowing cigarette placed in an open-air enclosure in contact with a pressurised oxygen hose did not damage the system or start a fire. The absence of damage is consistent with the certification, which requires equipment manufacturers to use fire-resistant materials to limit the outbreak and spread of fires.

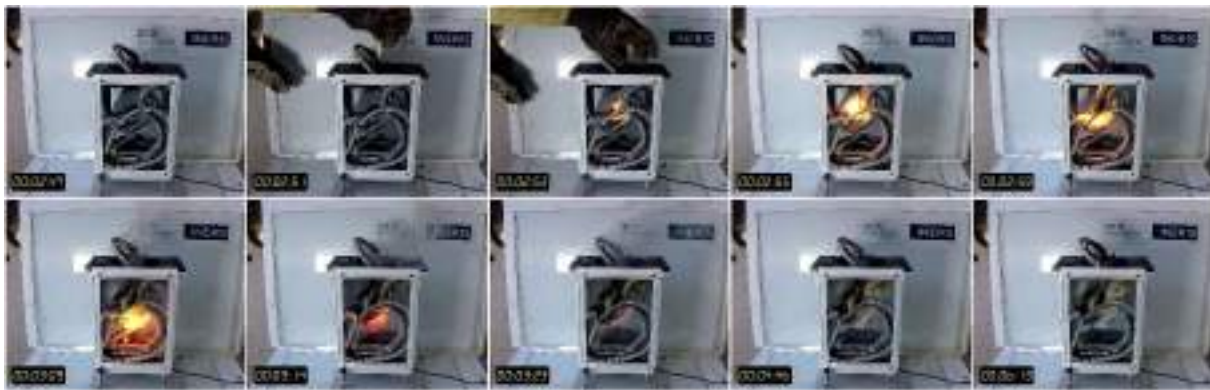
During the first test (Cigarette_01), the cigarette landed on the mask's harness and perforated it. The fire did not spread to other parts of the mask and extinguished.

Figure 31: cigarette_01 test - video sequence (source: BEA)

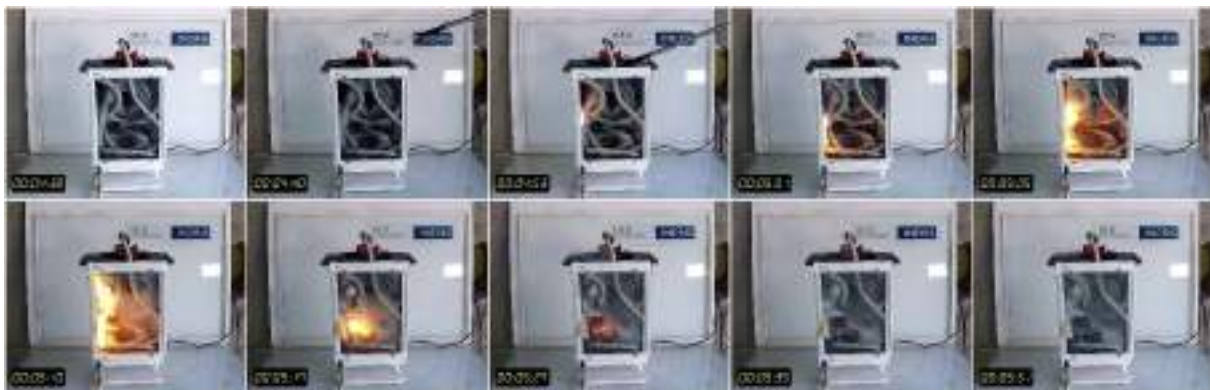
During the second test (cigarette_02), the cigarette landed on the silicone envelope of the oxygen mask nose cup and began to consume this part of the mask. When the oxygen contained in the box was consumed, the intensity of the fire decreased and the fire went out.

Figure 32: cigarette_02 test - video sequence (source: BEA)

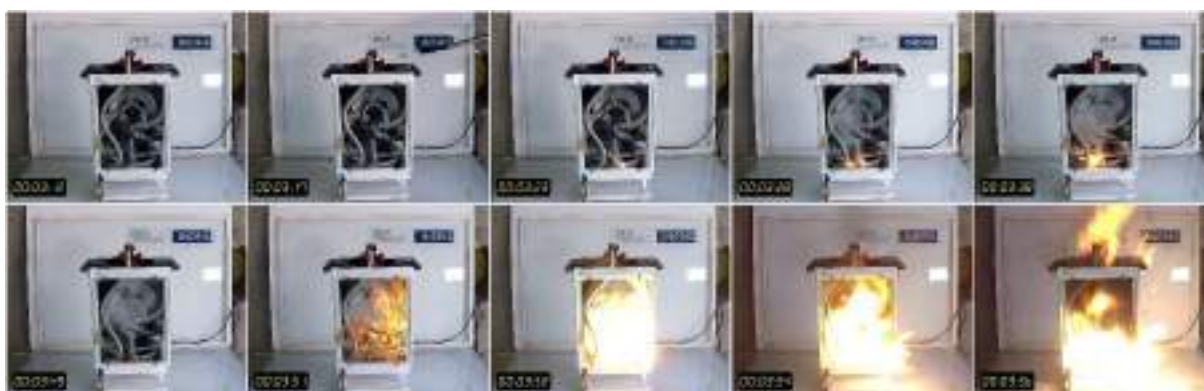
Cigarette_03 test: crackling noises for 28 s were audible on the recording, corresponding to the combustion of the hose casing. The subsequent piercing of the hose produced a broadband noise. 1 s later, the mask ignited, causing a sound runaway. The mask microphone stopped working 6 s after the mask ignited.

Figure 33: cigarette_03 test - video sequence (source: BEA)

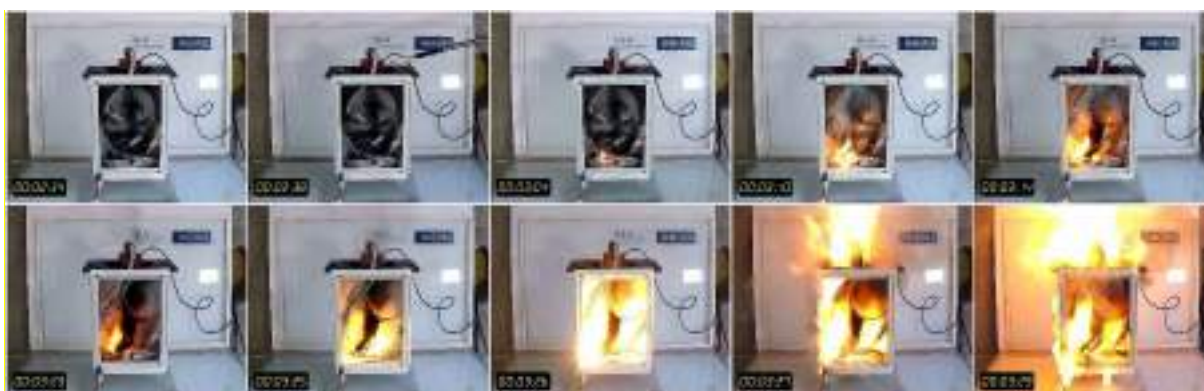
Cigarette_04 test: crackling noises for 22 s were audible, corresponding to the combustion of the hose casing. The subsequent piercing of the hose produced a broadband noise. The mask ignited 0.5 s later, causing a sound runaway. The oxygen supply was cut off before the mask microphone was damaged.

Figure 34: cigarette_04 test - video sequence (source: BEA)

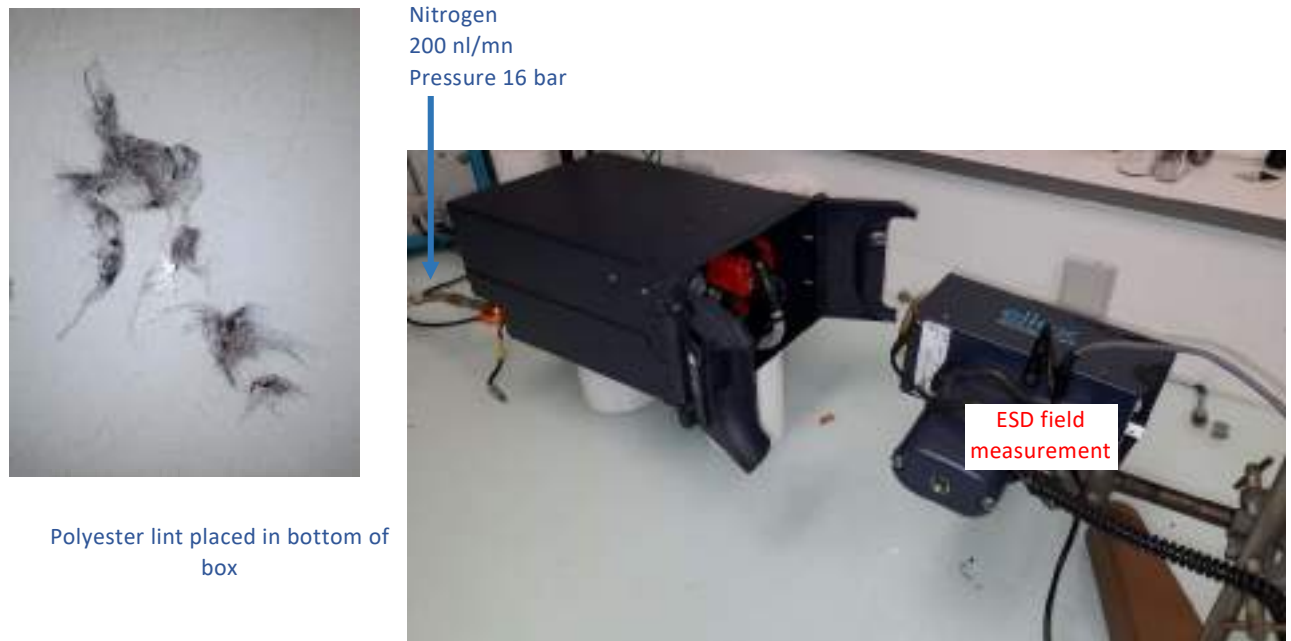
Figure 44: measurement of electrostatic fields created on accumulated synthetic debris at bottom of storage box (source: INERIS)

The maximum voltage observed was 255 V; this voltage was too low to generate an electrostatic charge likely to produce sparks capable of igniting dust or metal particles. In an explosive environment, the formation of dangerous sparks is considered for a value greater than 2 kV.

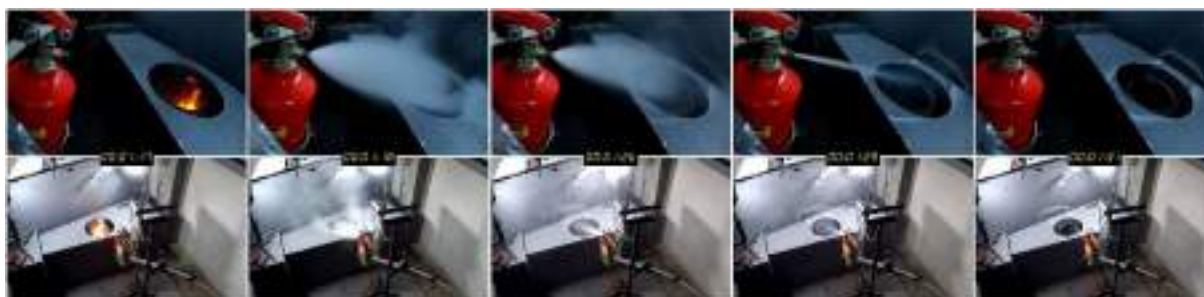
A first test was carried out without the addition of oxygen (Extinguisher_01 test); the flames disappeared as soon as the extinguisher was activated. The fire did not restart again. There was no change in visibility in the room.

Figure 49: extinguisher_01 test - video sequence (source: BEA)

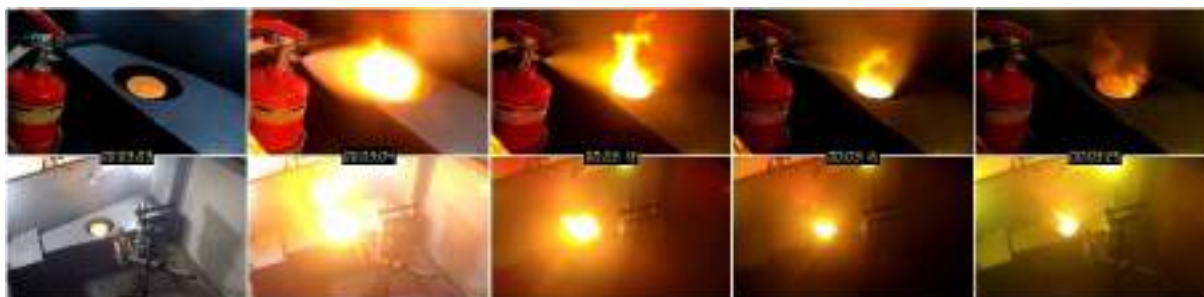
During the fire extinguisher_02 test, the fire was enriched with oxygen. The halon extinguisher was unable to extinguish the fire. No effect on the flames was observed. On activation of the extinguisher, thick smoke appeared, significantly reducing visibility.

Figure 50: extinguisher_02 test - video sequence (source: BEA)

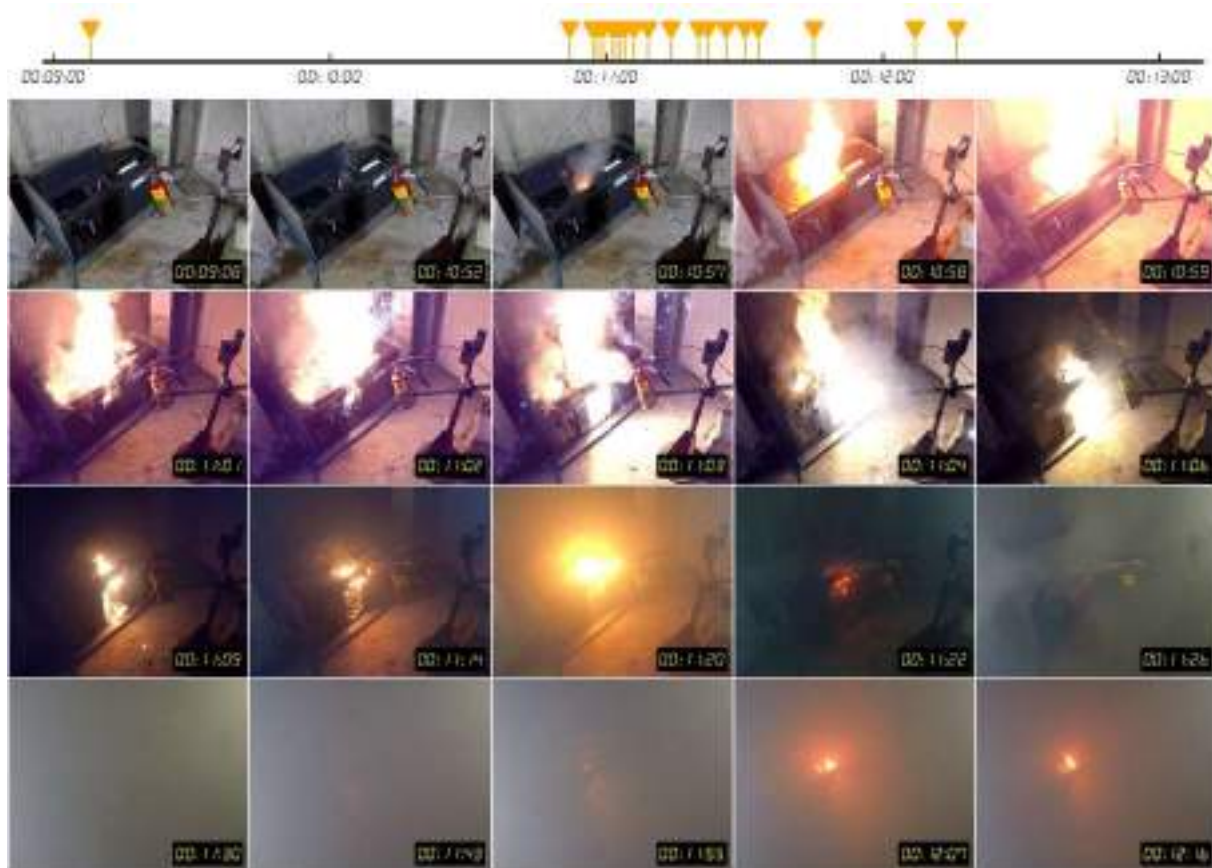
Audio elements: the piercing of the mask hose 13 s after the reactivation of the fire was preceded by crackling noises (picked up by the microphone on the oxygen mask). The piercing of the hose produced a broadband noise (leaking noise). The mask microphone stopped working 5 s after the hose of the oxygen mask was pierced.

The fire that followed the piercing of the hose spread rapidly to the surrounding components. No sound runaway or interruption in the leaking sound was observed.

Figure 55: Propagation_02 test - video sequence (source: BEA)

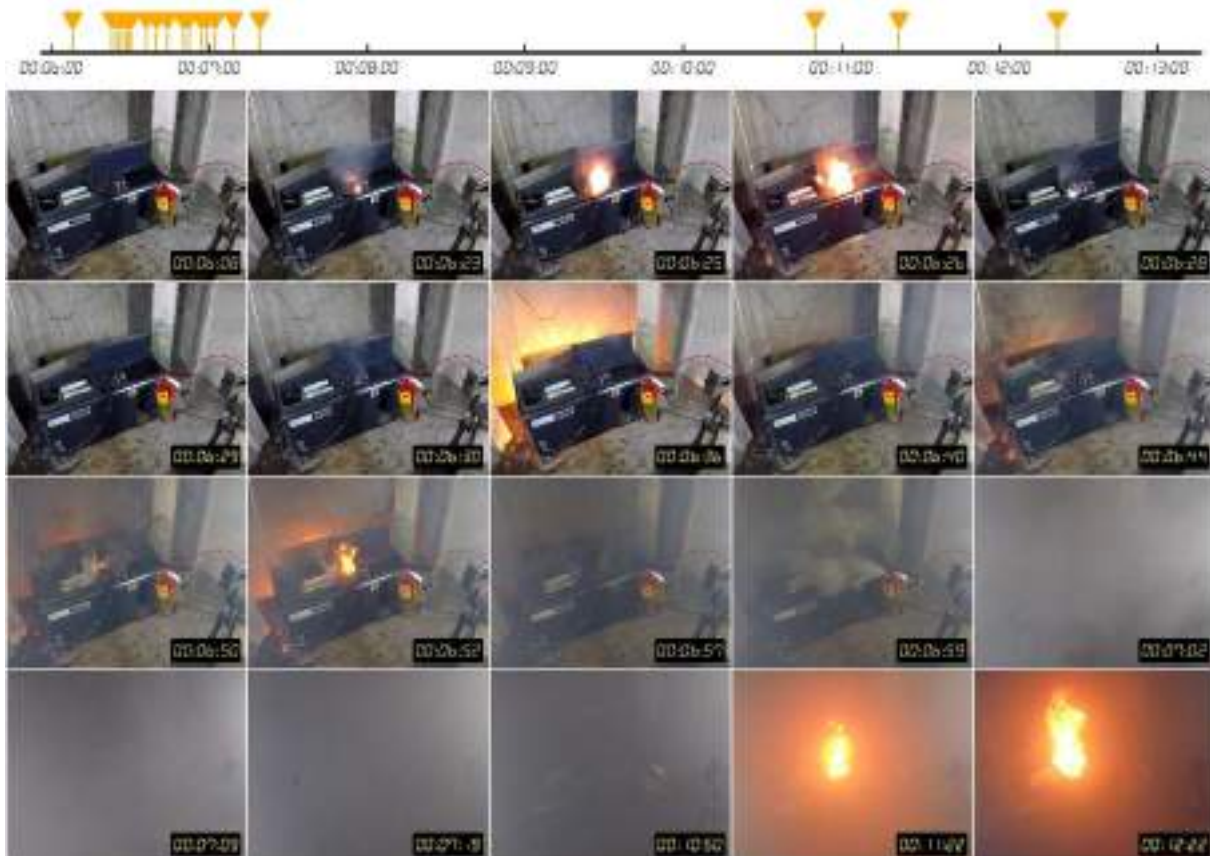
minutes (at 10:50). No flames or red glow were visible; crackling noises were present and smoke escaped from the mask storage box. Flames reappeared in the vicinity of the mask storage box four minutes after the activation of the fire extinguisher.

Audio elements: the piercing of the mask hose 14 s after the fire was started was preceded by crackling noises (picked up by the microphone of the oxygen mask). When the hose was pierced, there was a broadband noise (leaking noise) followed 0.5 s later by a sound runaway. Cutting off the oxygen supply - which preceded the use of the extinguisher - interrupted the leaking noise.

Figure 56: Propagation 03 test - video sequence (source: BEA)

During the test, the fire was concealed in the lateral compartment. The technique of fighting the fire with a halon fire extinguisher could not be applied. It is recommended to aim at the base of the flames, and if necessary, when the flames are inaccessible, to perforate the vertical wall of the compartment and slide the nozzle of the extinguisher into it before activating it. As the extinguisher was activated from the outside, it was not possible to accurately direct the extinguishing jet onto the flames, which may explain why the fire started up again after several minutes.
