Final Report

**EgyptAir A320 Aircraft crash in the Mediterranean, registered SU-GCC,
flight number MSR804, from Charles De-Gaulle Airport, Paris to Cairo
International Airport, on 19/05/2016**

EGAI2016-01

October 2024

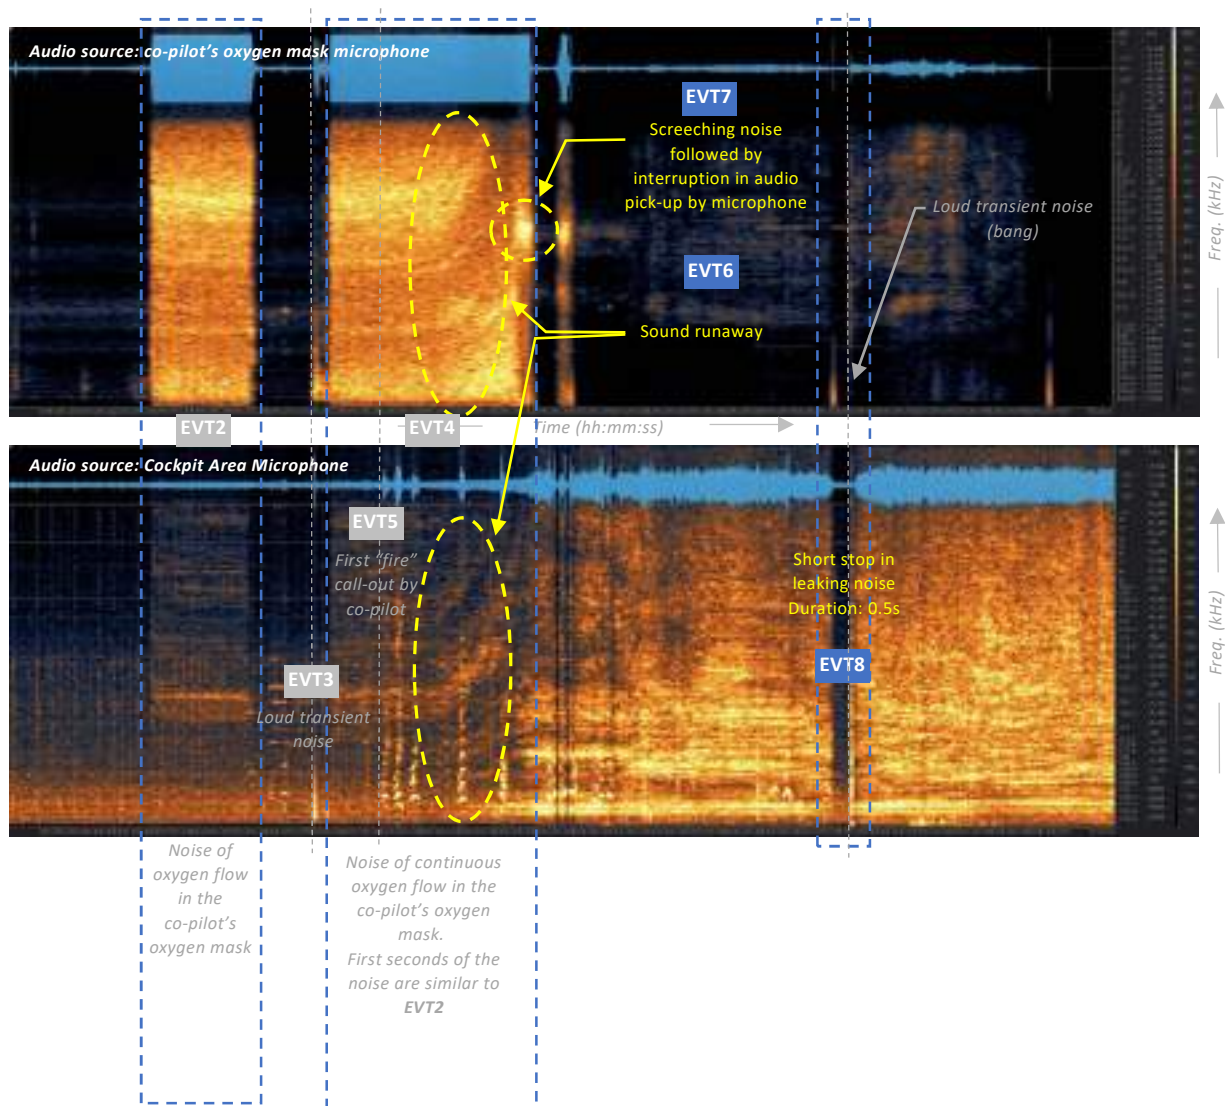
- no crackling noise was present in the mask microphone recording;
- a sound runaway could be heard on the co-pilot mask microphone and CAM channels at 00:25:31 (EVT6);
- a screeching noise preceded the loss of the co-pilot mask microphone signal at 00:25:33 (EVT7);
- a momentary interruption (510 ms) in the oxygen leaking noise occurred at 00:25 :42 (EVT8).

Figure 57: part of spectrum - waveform - flight MS804 (source: BEA)

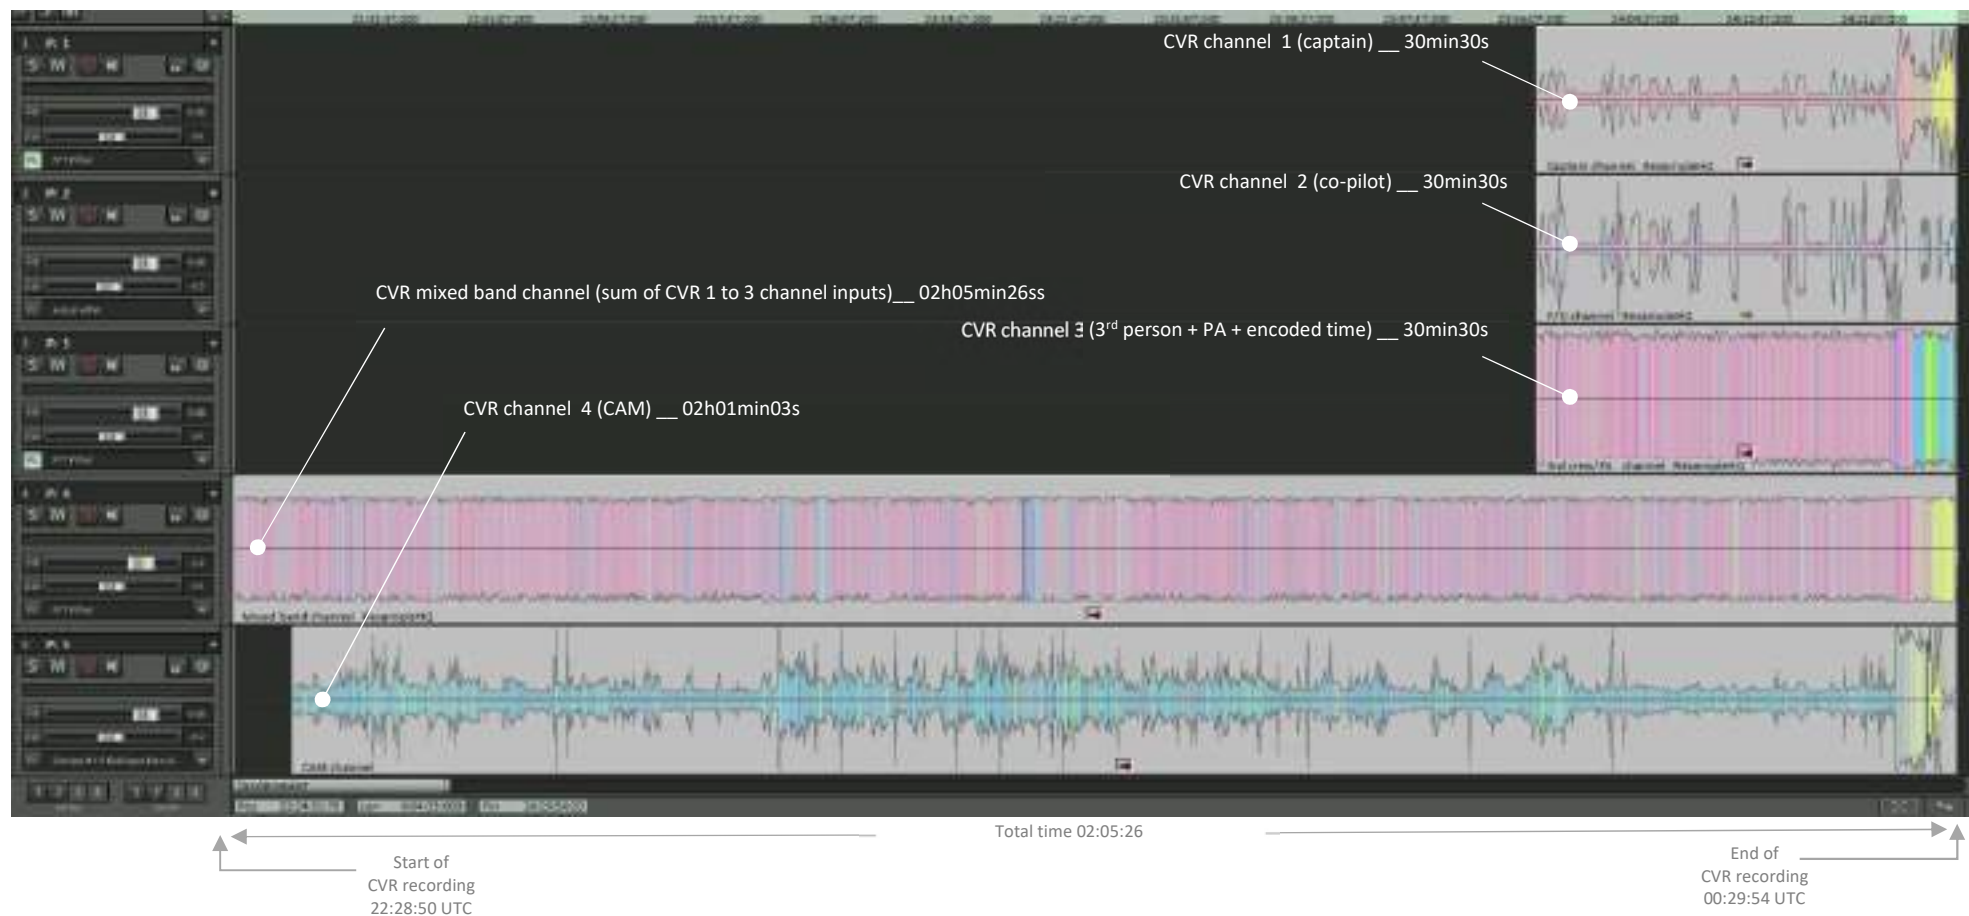
View of multi-track audio based on the CVR data:

Note: the CVR data was synchronised (using the UTC time of the FDR) based on the information triggering the various warnings and the radio communication times recorded by the control services (ATC).

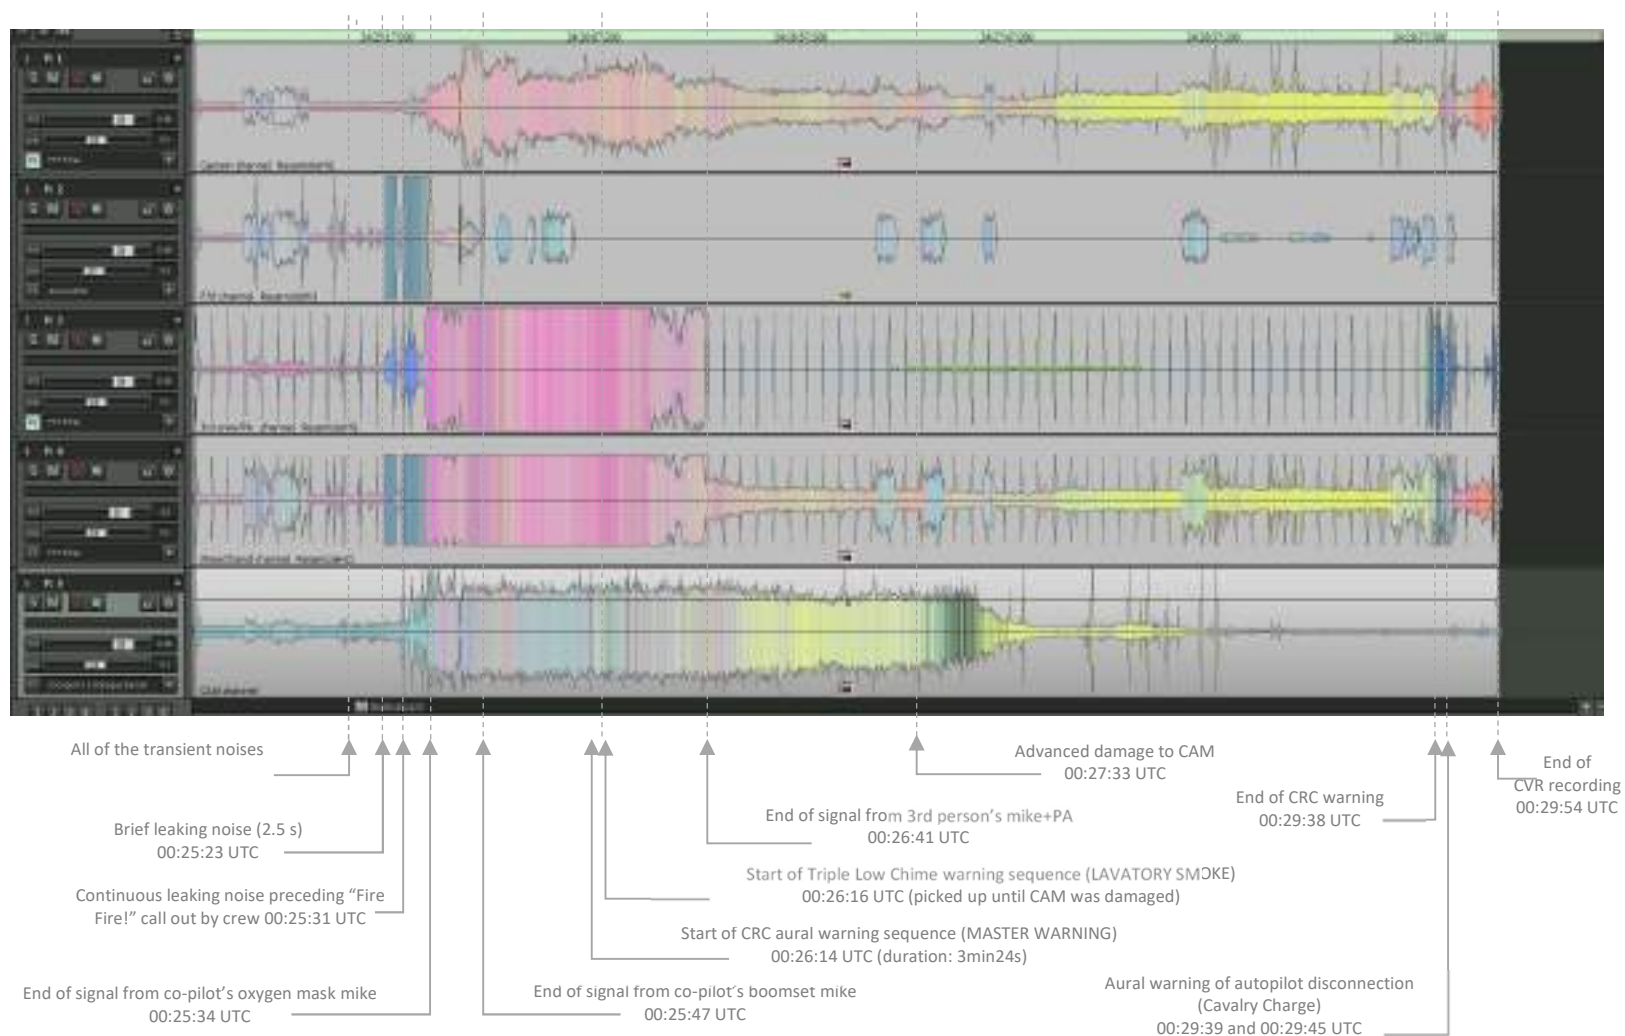
The view below shows the waveform of the last 5 minutes of the audio recording:

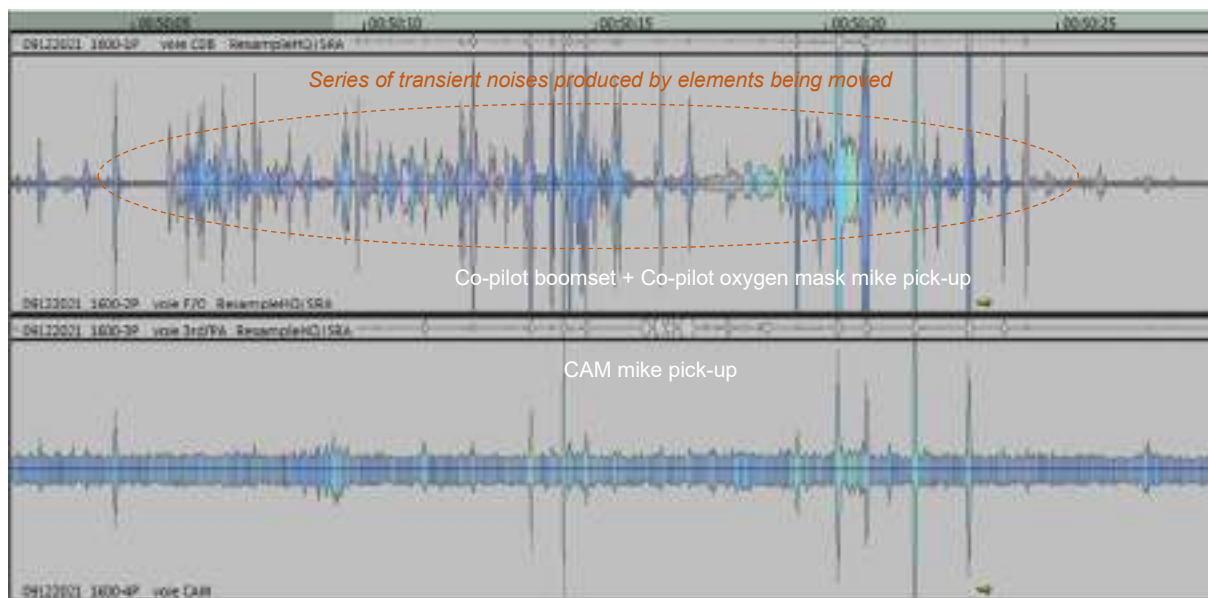
The waveform below shows, for the audio signal of the co-pilot channel, the predominance of transient noises produced by these different actions.

The noise from elements being moved (transient noises) were broadcast on the co-pilot's LS and were perceptible by an operator sat in the co-pilot's seat. They were picked up to a small extent or not at all by the CAM microphone (with the exception of those which were loud). This phenomenon can possibly be explained by the position of the CAM at the base of the overhead panel, set back from the vertical of the instrument panel (i.e. the FCU console masks the sound cone of the loudspeakers).

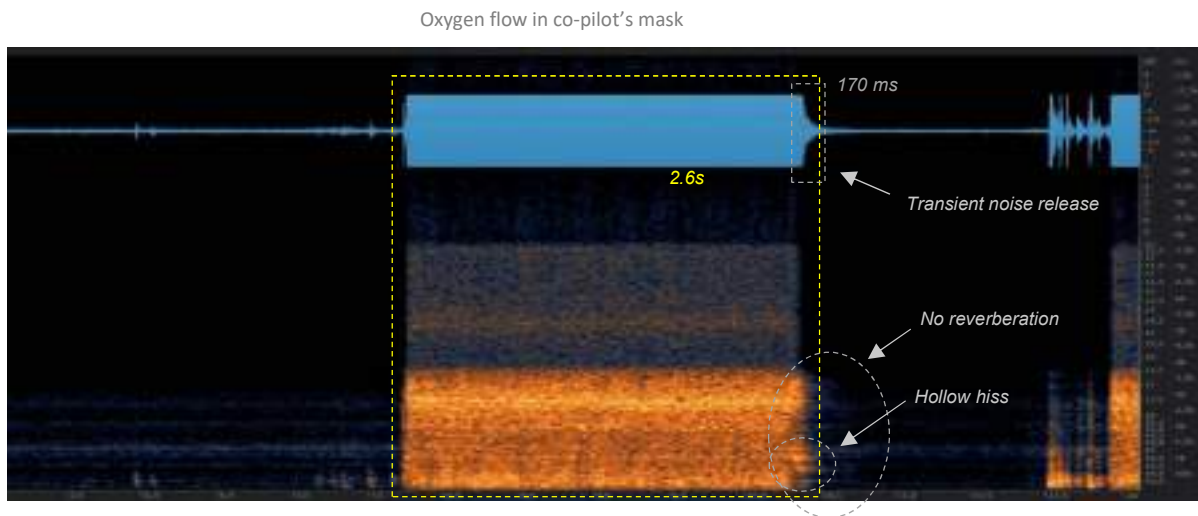
SU-GCC – CVR event sequence (first oxygen activity noise / co-pilot's mask)

Note 1: audio pick-up by oxygen mask microphone

Note 2: the co-pilot's fixed oxygen equipment on flight MS804 was composed of an MF20 oxygen mask and an MXP801 mask storage box.

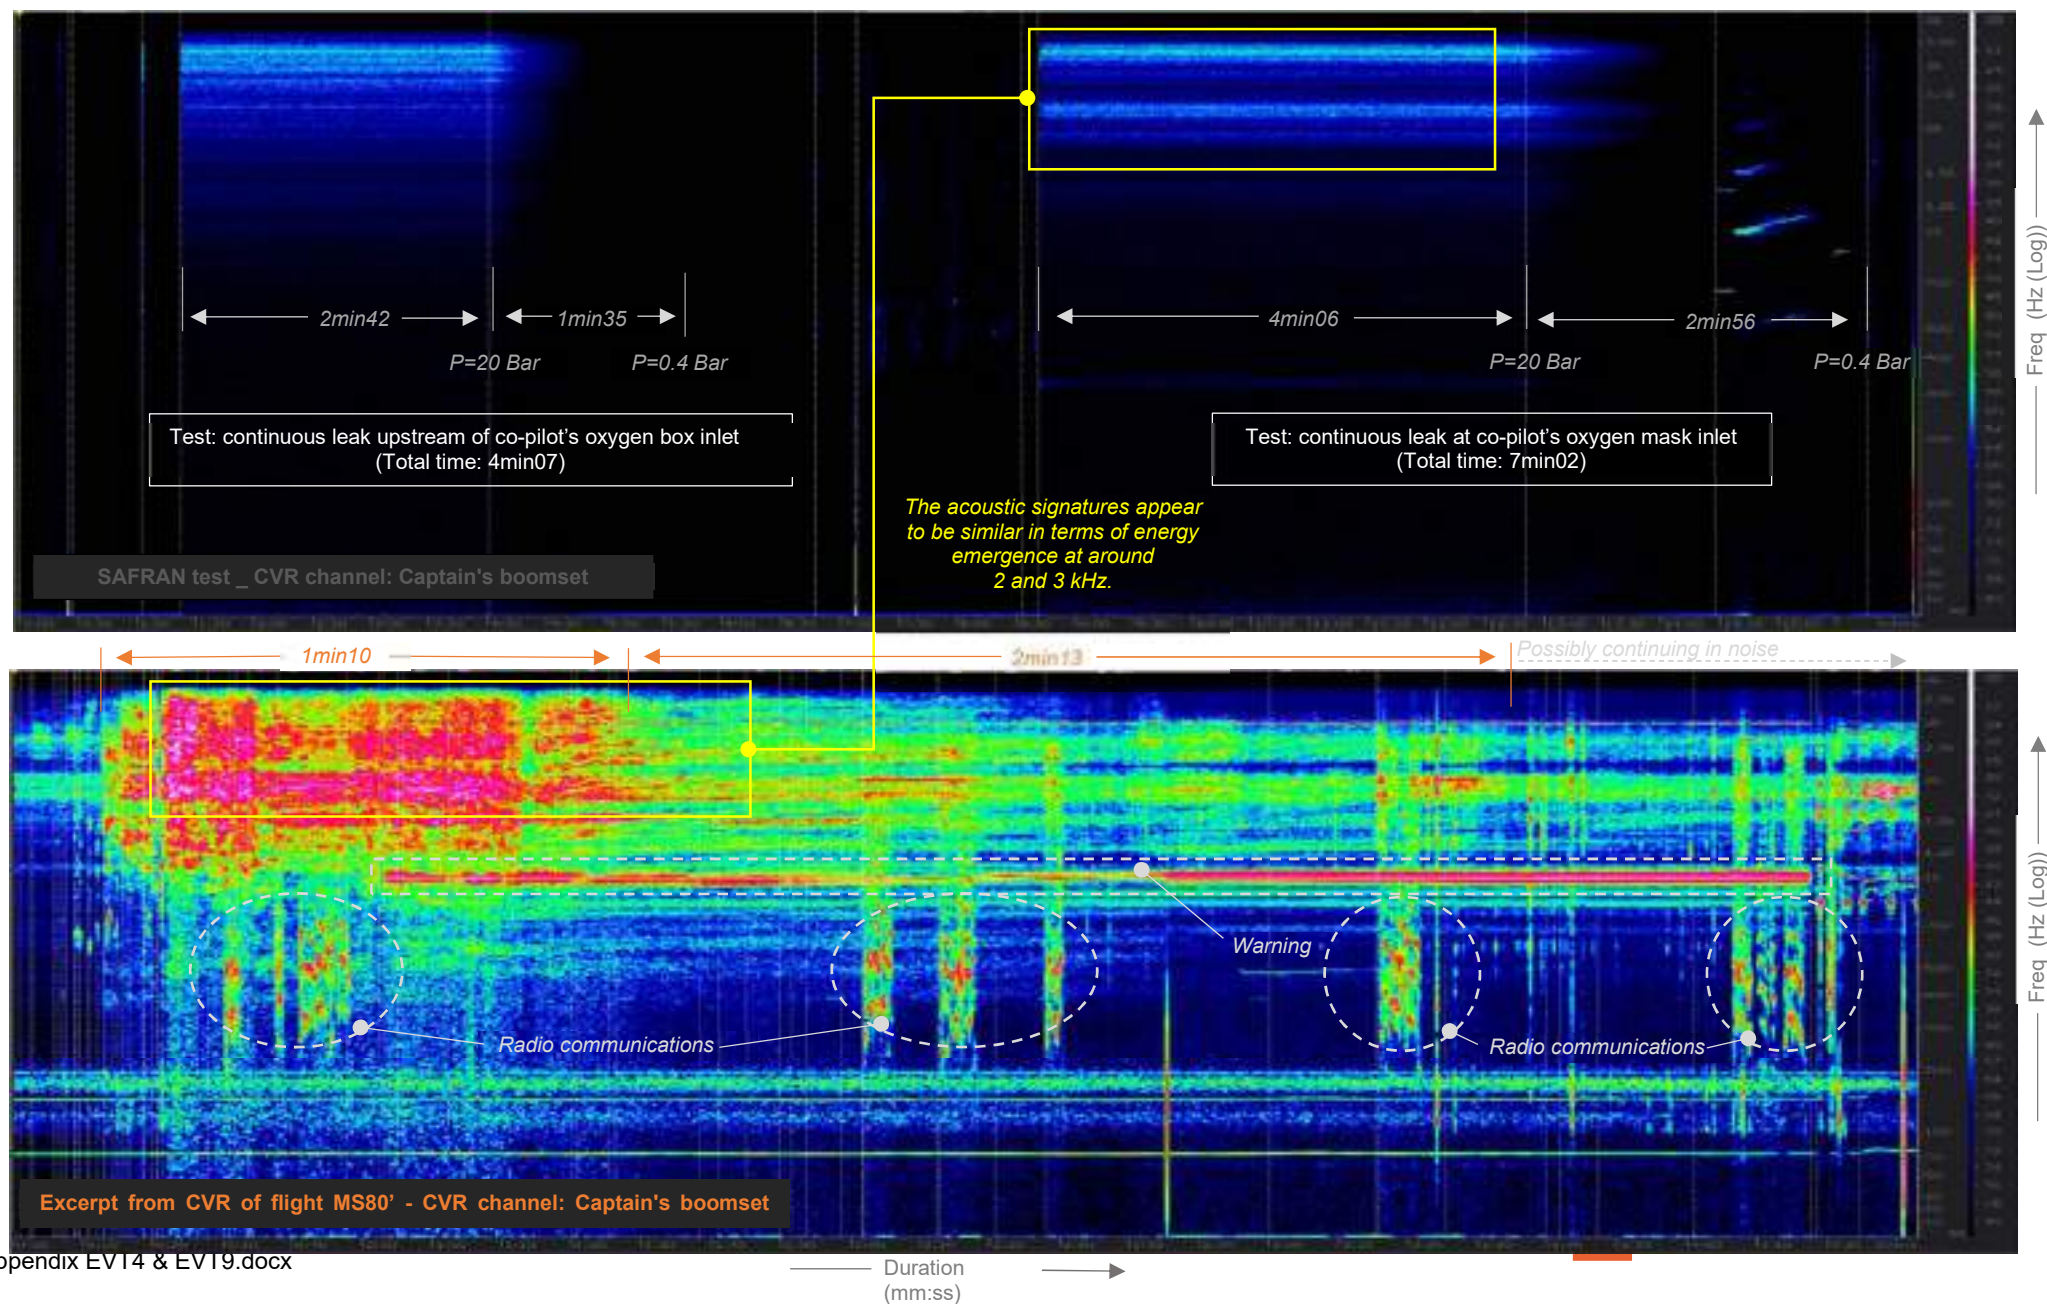
The metrics (duration, acoustic signature, etc.) observed on the signals are illustrated in the example below:

Continuous leak sequence	Source of leak	Total leak time	Noise bumps	Leak time before 20 bar threshold	Leak time after 20 bar threshold
Test 1	In oxygen box	6min53s	Reinforced between 2 and 3 kHz	3min53s	3min
Test 2	Outside oxygen box	4min16s	Several swathes distributed from 1 to 2.8kHz	2min42s	1min34s
Test 3	Outside oxygen box	4min17s	Several swathes distributed from 1 to 2.8kHz	2min42s	1min35s
Test 4	In oxygen box	7min02	Reinforced between 2 and 3 kHz	4min06s	2min56s
Flight MS804	Undetermined	Estimated at 3min23s	Reinforced between 2 and 3 kHz	Estimated at 1min10s	Possibly 2min13s (difficult to determine due to background noise in cockpit).

An oxygen leak produced by the rupture of a hose, either upstream of the oxygen box or upstream of the mask generated a broadband noise lasting several minutes, the sound level of which decreased progressively when a remaining pressure of less than 20 bar was reached.

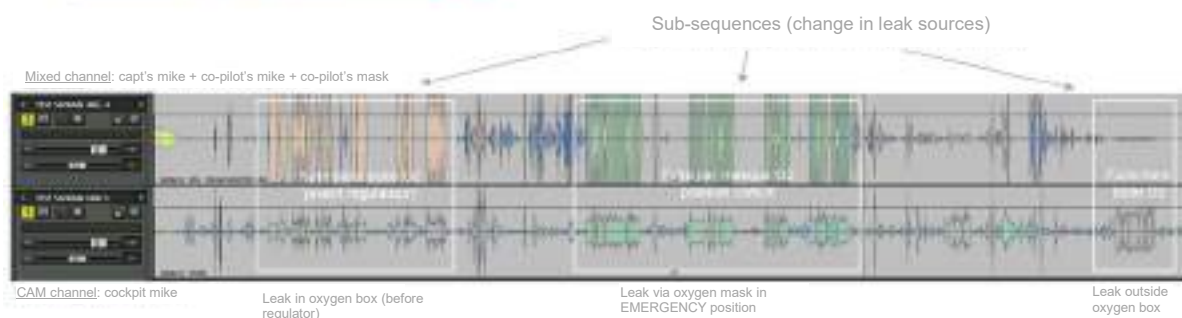
Electrical control of oxygen supply valve

Pressing the pushbutton twice in quick succession generated in all the cases, a **minimum interruption of 0.9 s** in the leaking noise to within the accuracy of the measurement.

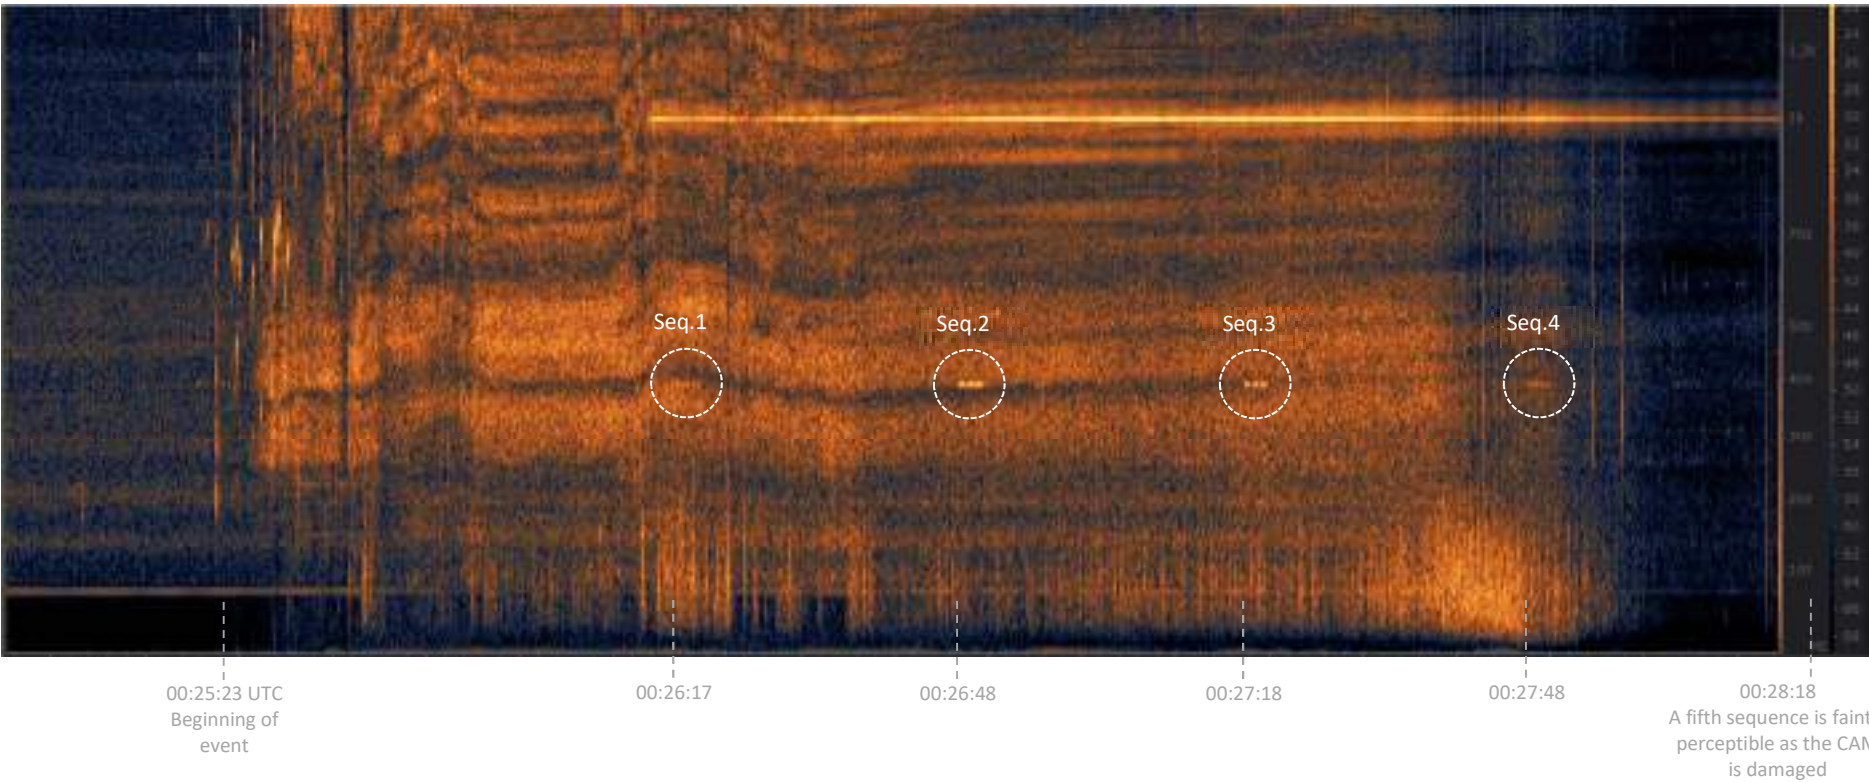
View of the Lavatory Smoke warning sequence picked up during the event:

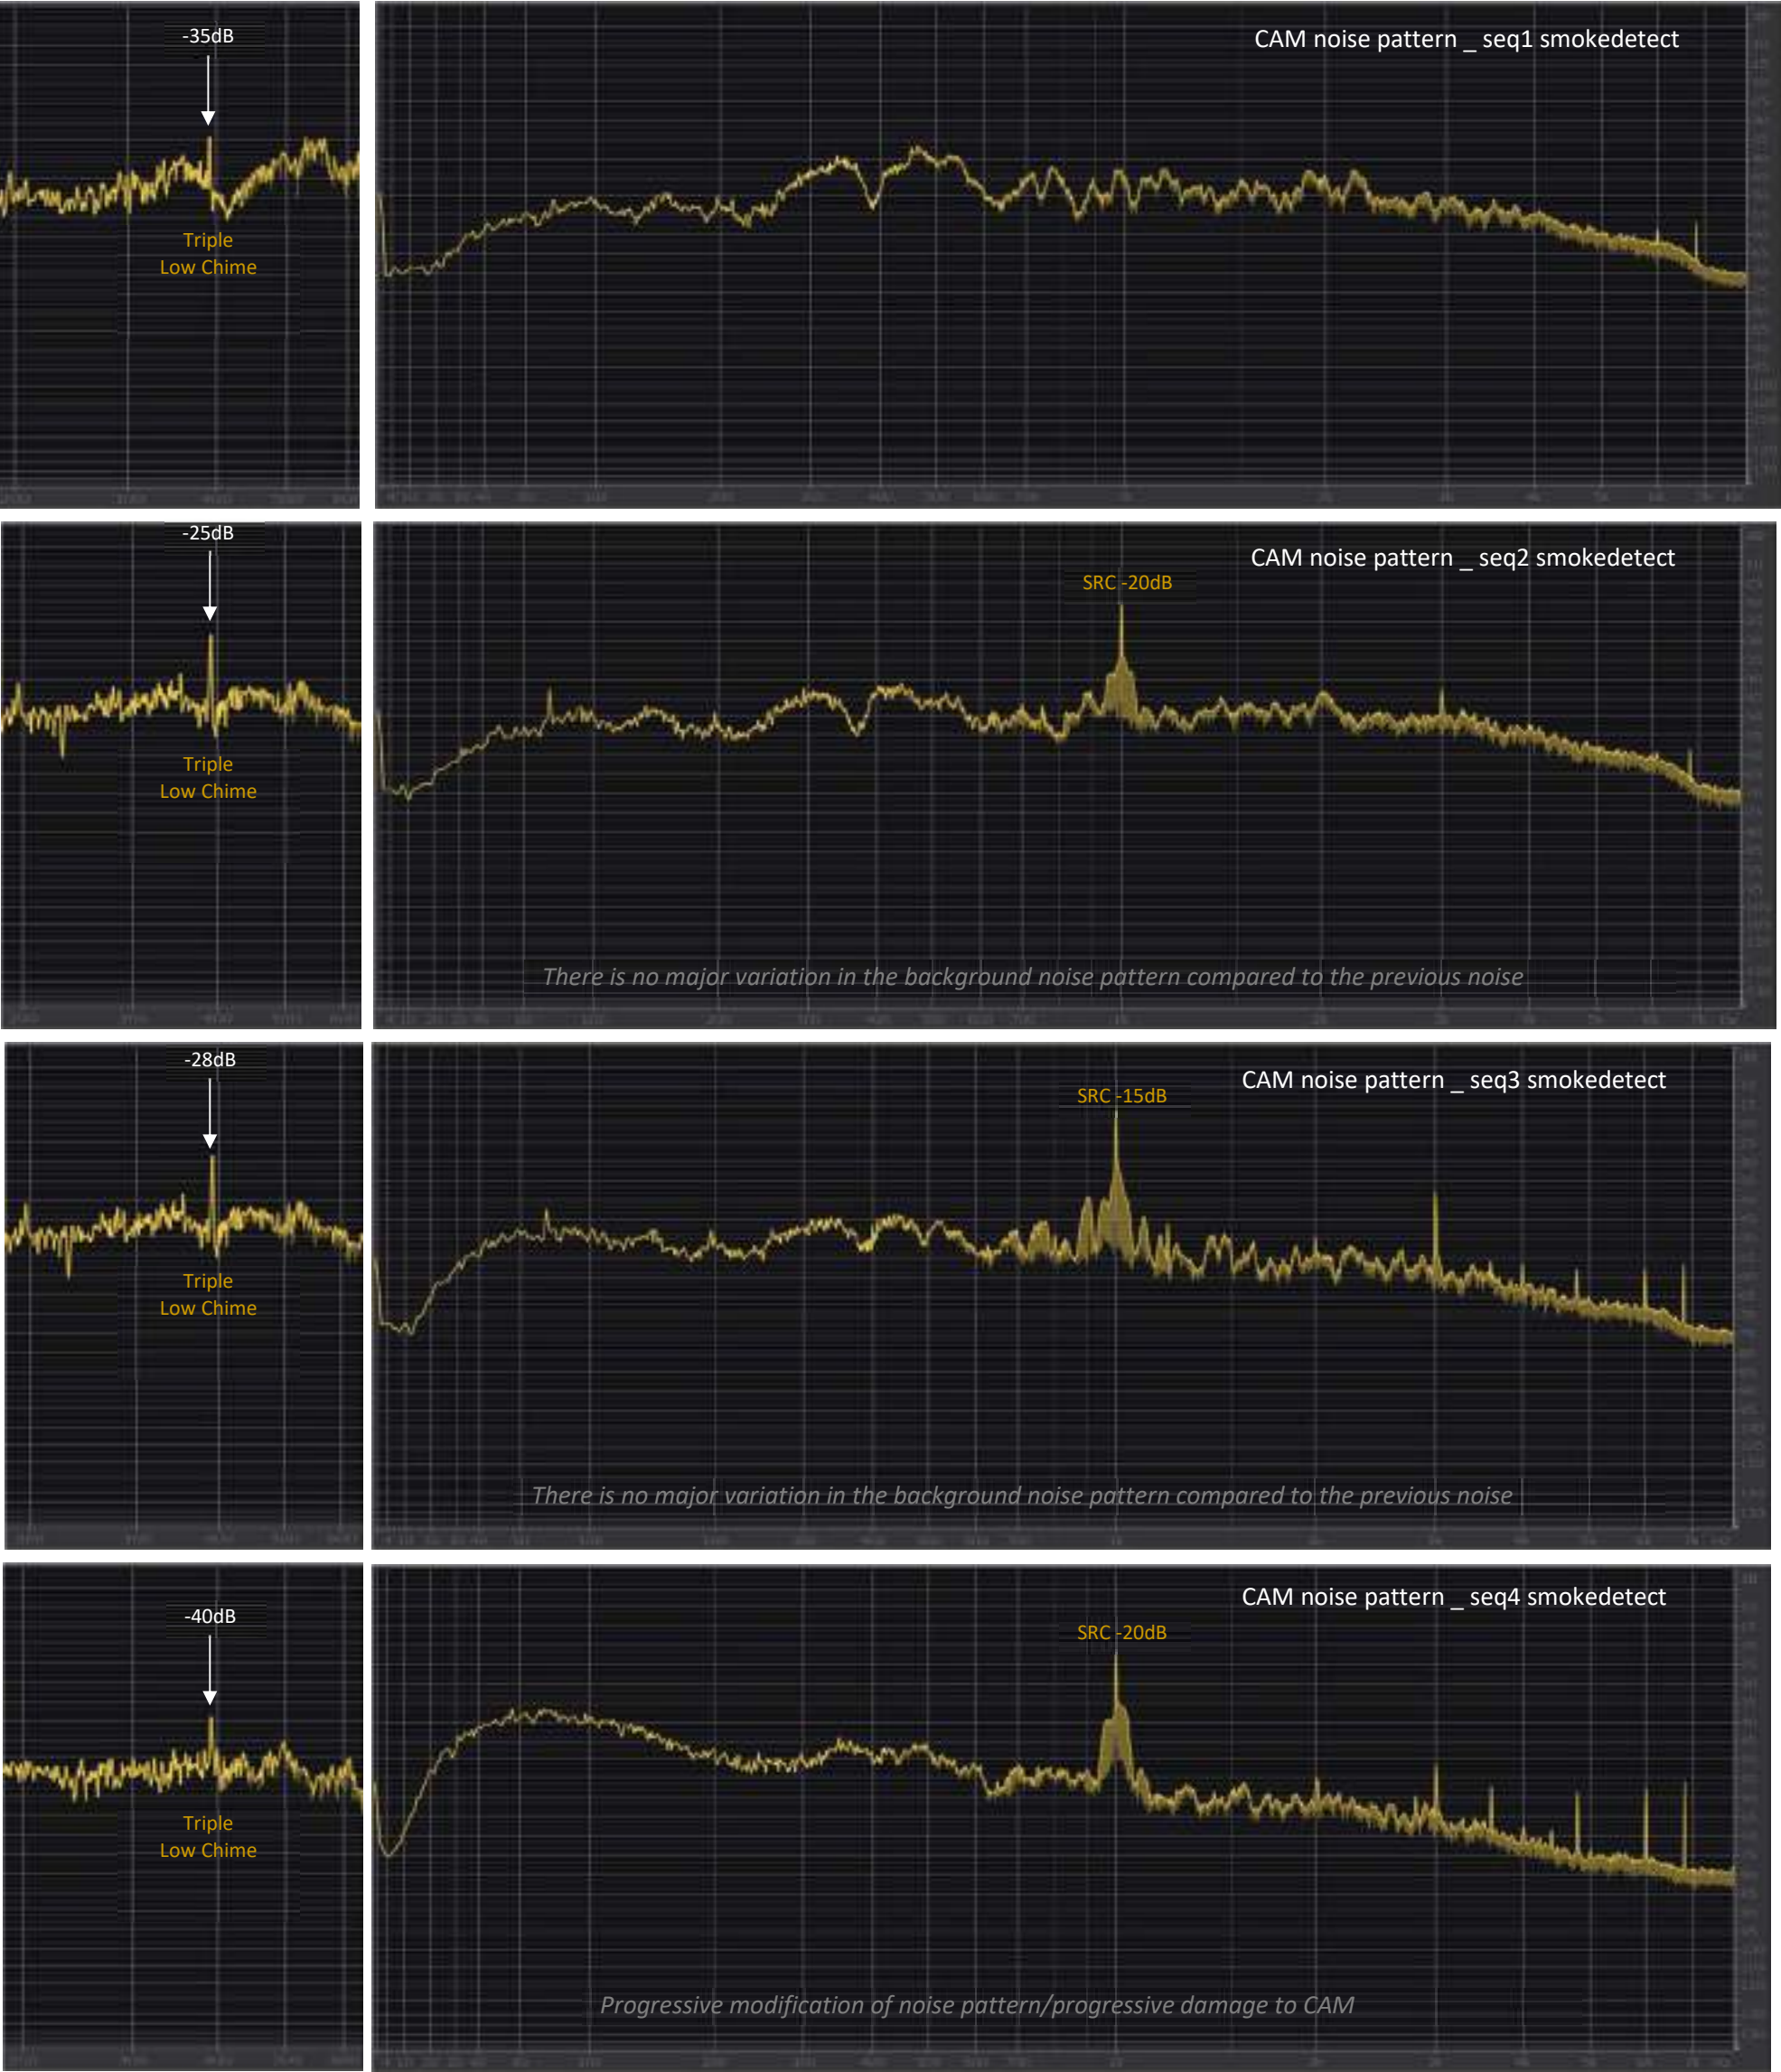
Chronology and pick-up level of “triple low chime” signal via the CAM in the cockpit

A 10 dB increase in the "triple low chime" signal was measured for sequences 2 and 3 (perceived at 00:26:48 and 00:27:18 UTC). This increase was compatible with the warning being picked up when the cockpit door was open.

De facto, sequences 1 and 4 were probably recorded with the door closed.

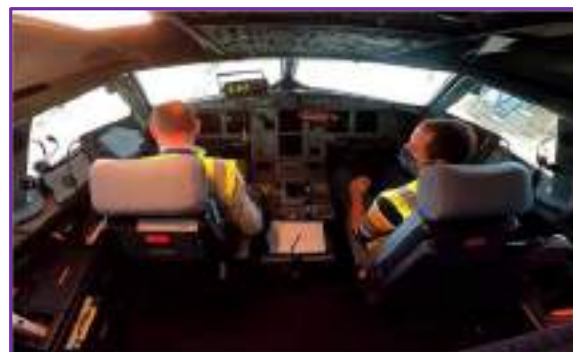
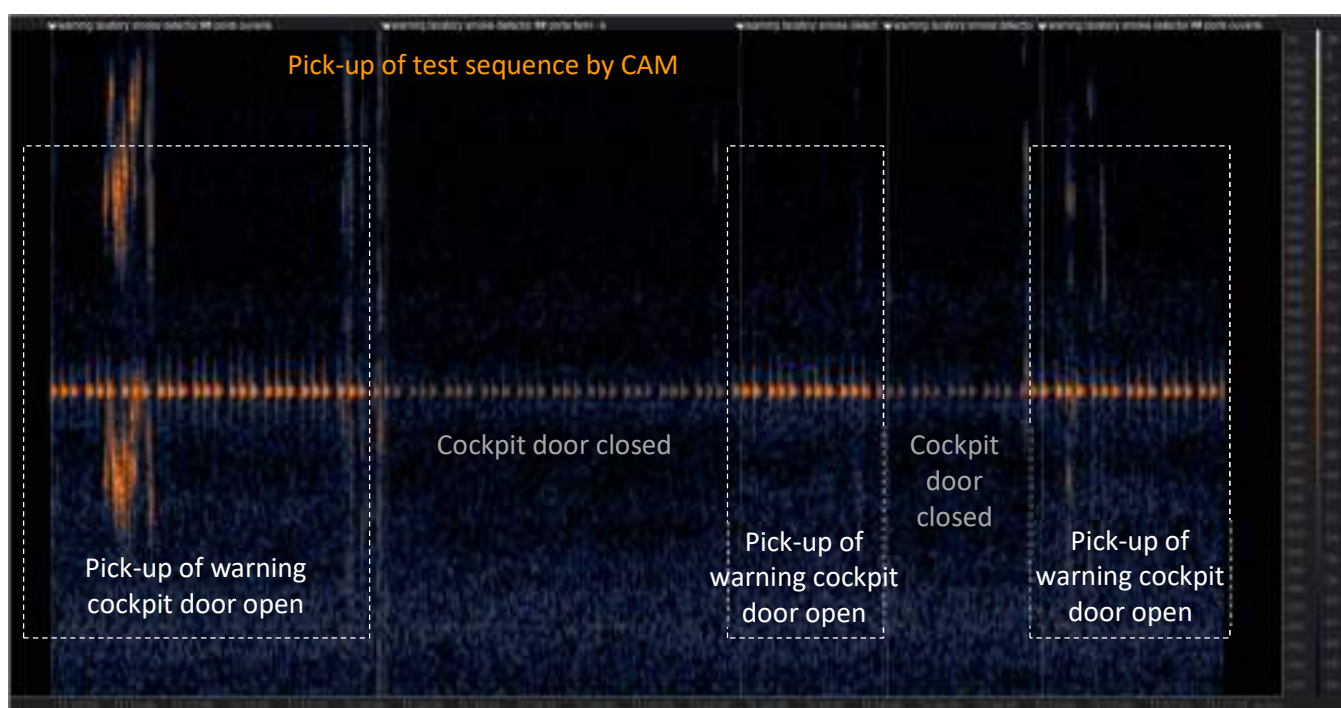
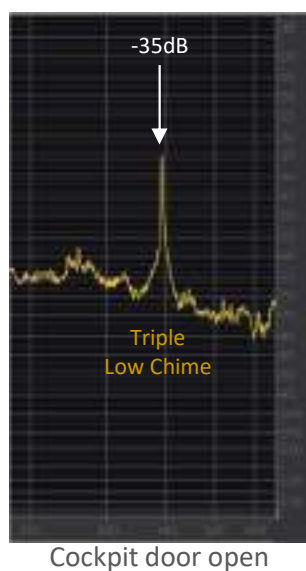
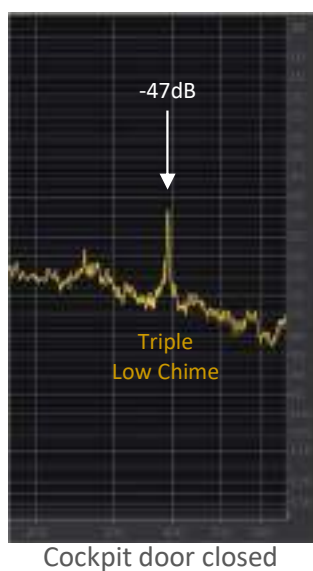
Lavatory Smoke Detector warning emission test carried out on the ground on an Airbus A319

Note: The Lavatory Smoke Detector warning test was activated via the CDIS test page. The "triple low chime" sequence was emitted continuously for the duration of the test.

The cockpit door masked the warning shown by a reduction in the signal level of the "triple low chime" of -10 to -12 dB.

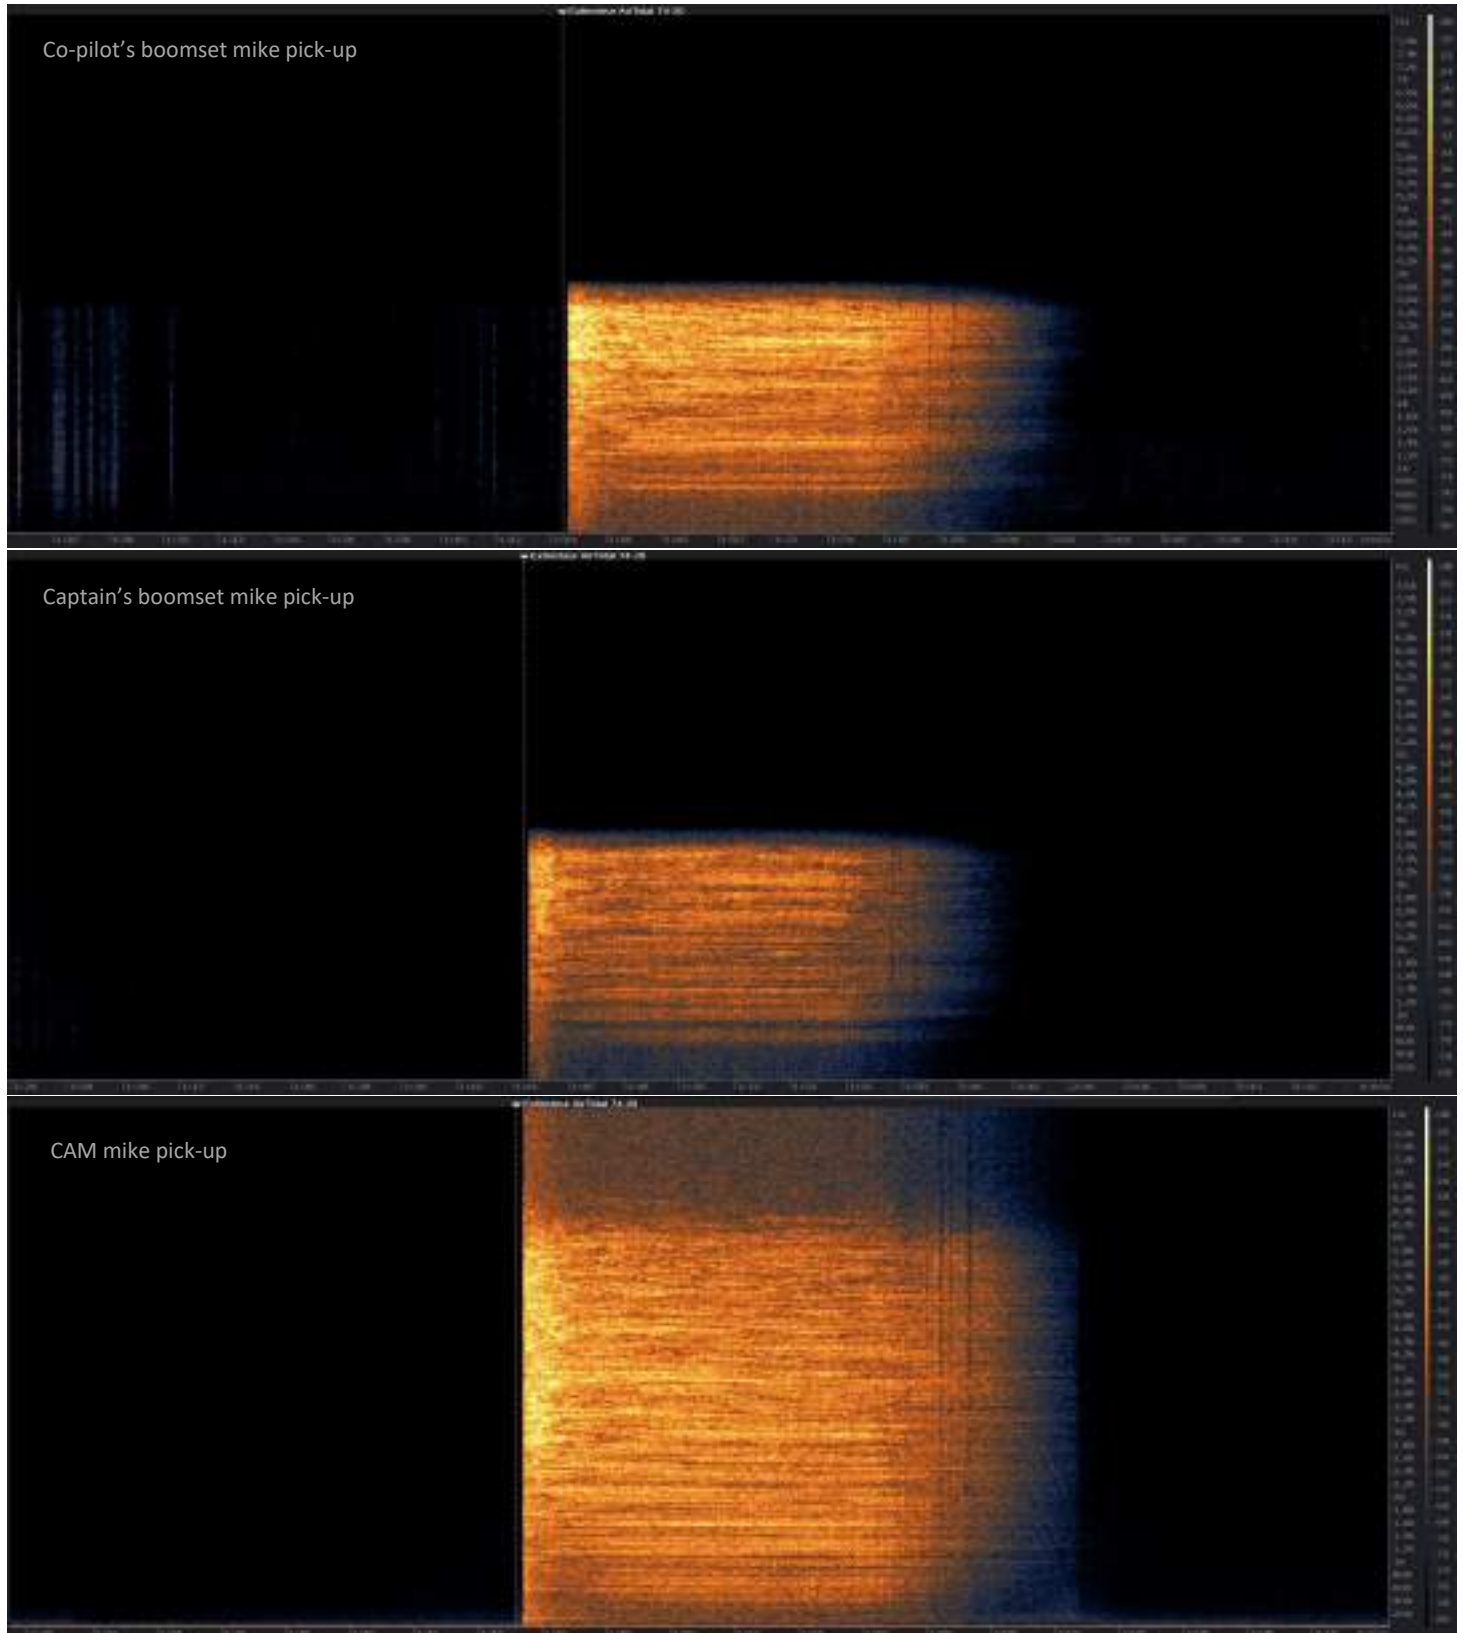
Activation and emptying of an Air Total 74-20 halon fire extinguisher
 (A340 cockpit - fire extinguisher directed towards the co-pilot's doc storage compartment)

Summary Total time = 15 s

- Flight crew boomset channels: broadband noise from 800 Hz to 3.8 kHz, fairly pronounced between 2 and 3.8 kHz
- CAM channels: broadband noise over the entire bandwidth of the CVR CAM channel

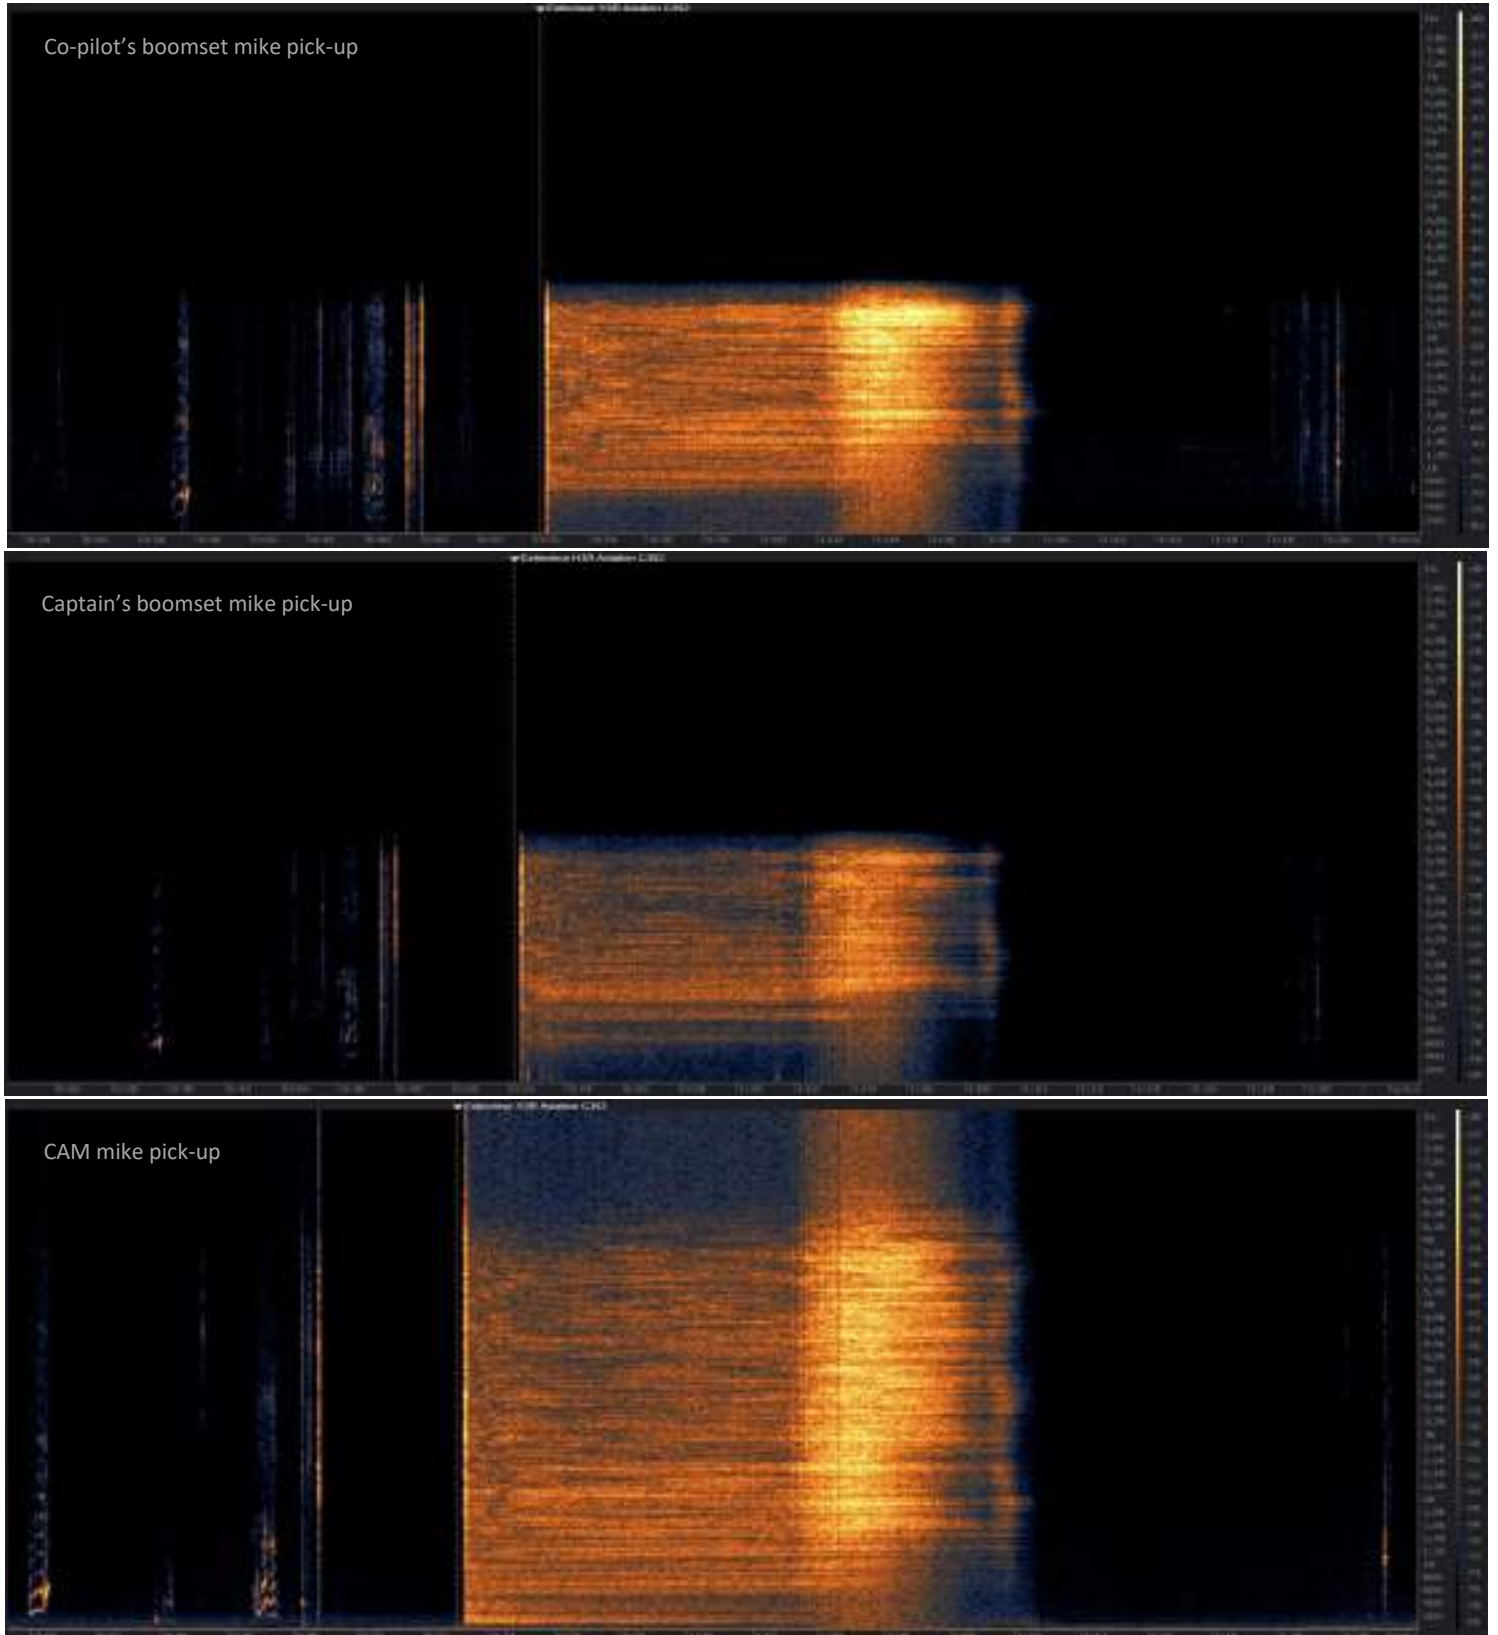
Activation and emptying of an H3R Aviation C352TS halon fire extinguisher (A340 cockpit - fire extinguisher directed towards the co-pilot's doc storage compartment)

Summary Total time = 19.4 s

- Flight crew boomset channels: broadband noise from 800 Hz to 3.8 kHz. Noise reinforcing between 1.4 and 3.8 kHz when cylinder emptied of two-thirds of the content.
- CAM channels: diffuse broadband noise over the entire bandwidth of the CVR CAM channel. Noise reinforcing between 1.4 and 3.8 kHz when cylinder emptied of two-thirds of the content.
