Final Report

**EgyptAir A320 Aircraft crash in the Mediterranean, registered SU-GCC,
flight number MSR804, from Charles De-Gaulle Airport, Paris to Cairo
International Airport, on 19/05/2016**

EGAI2016-01

October 2024

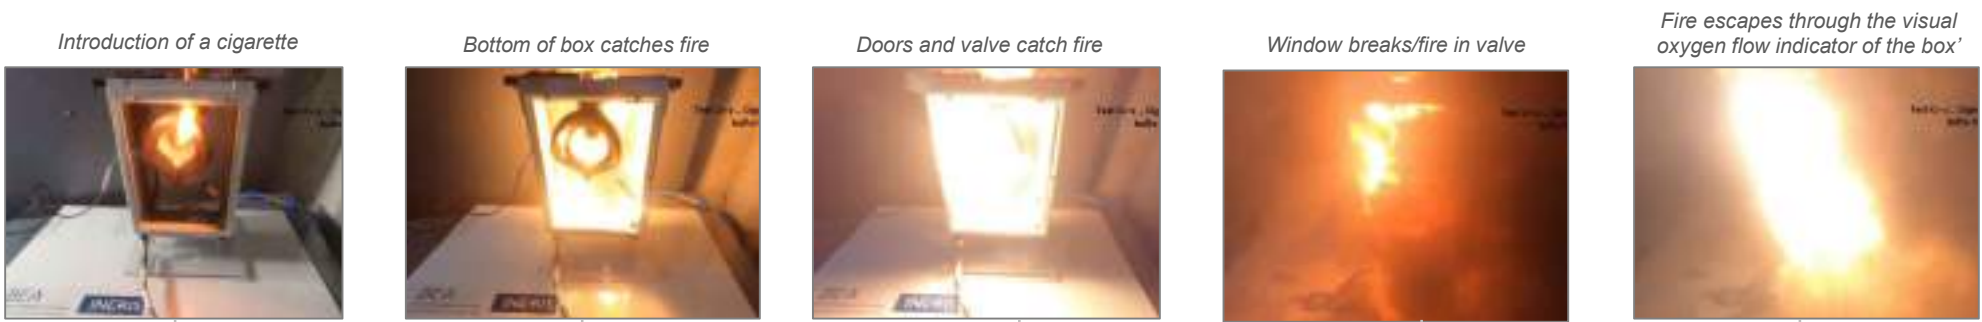
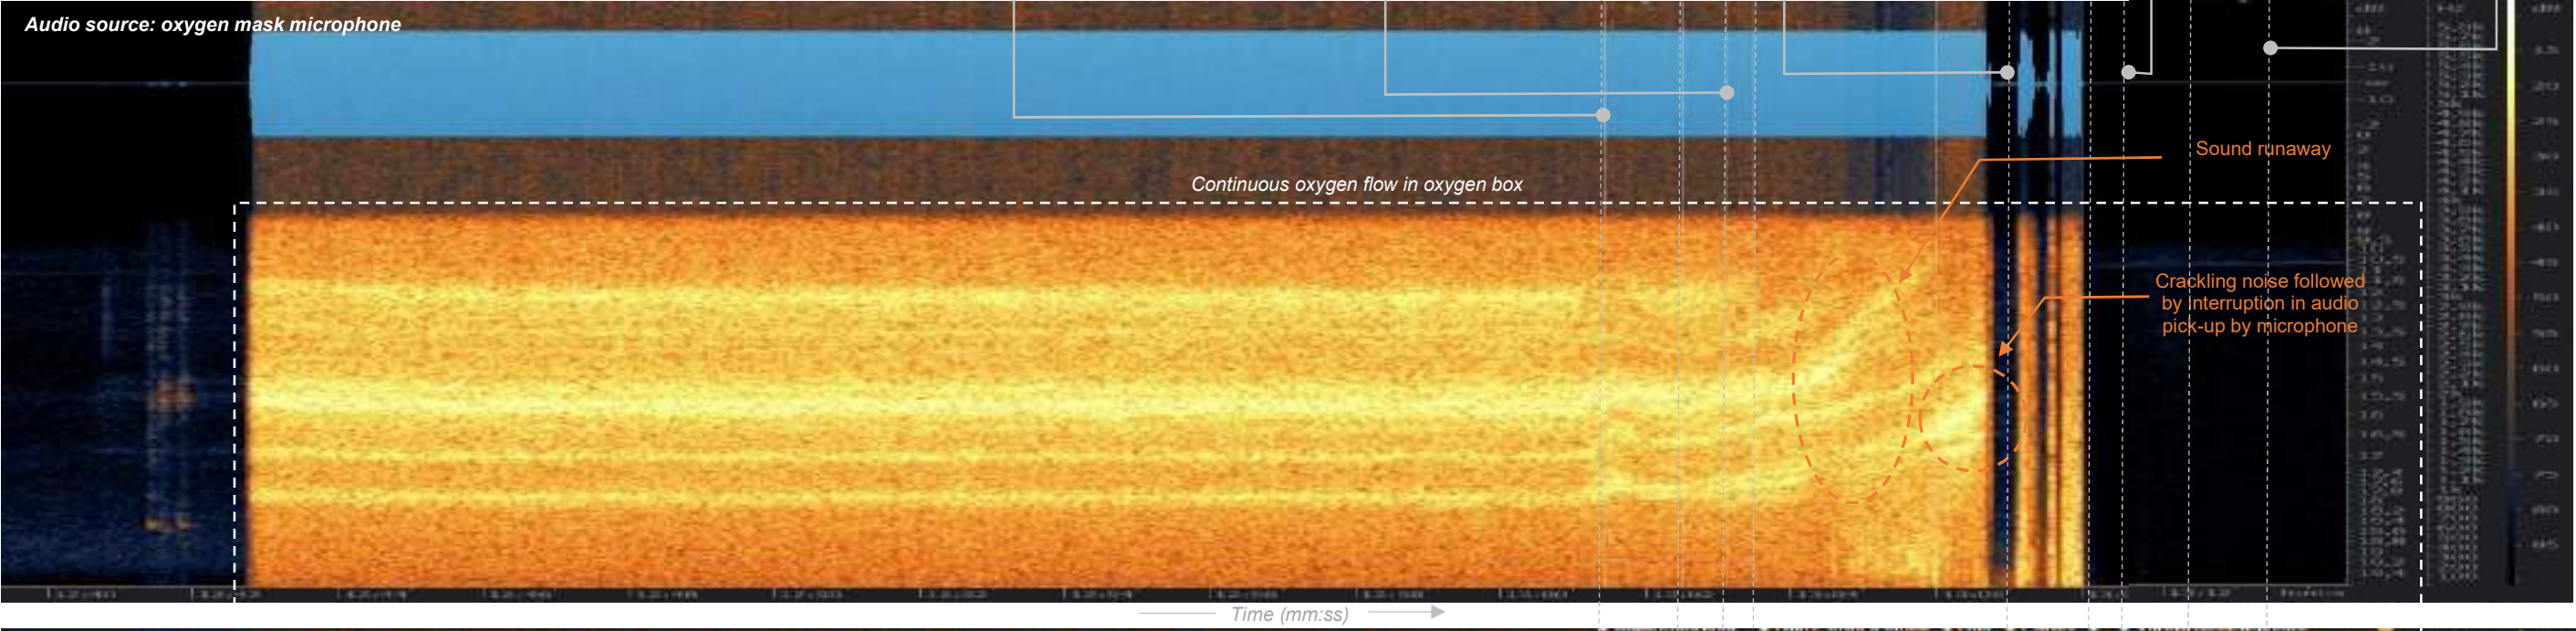
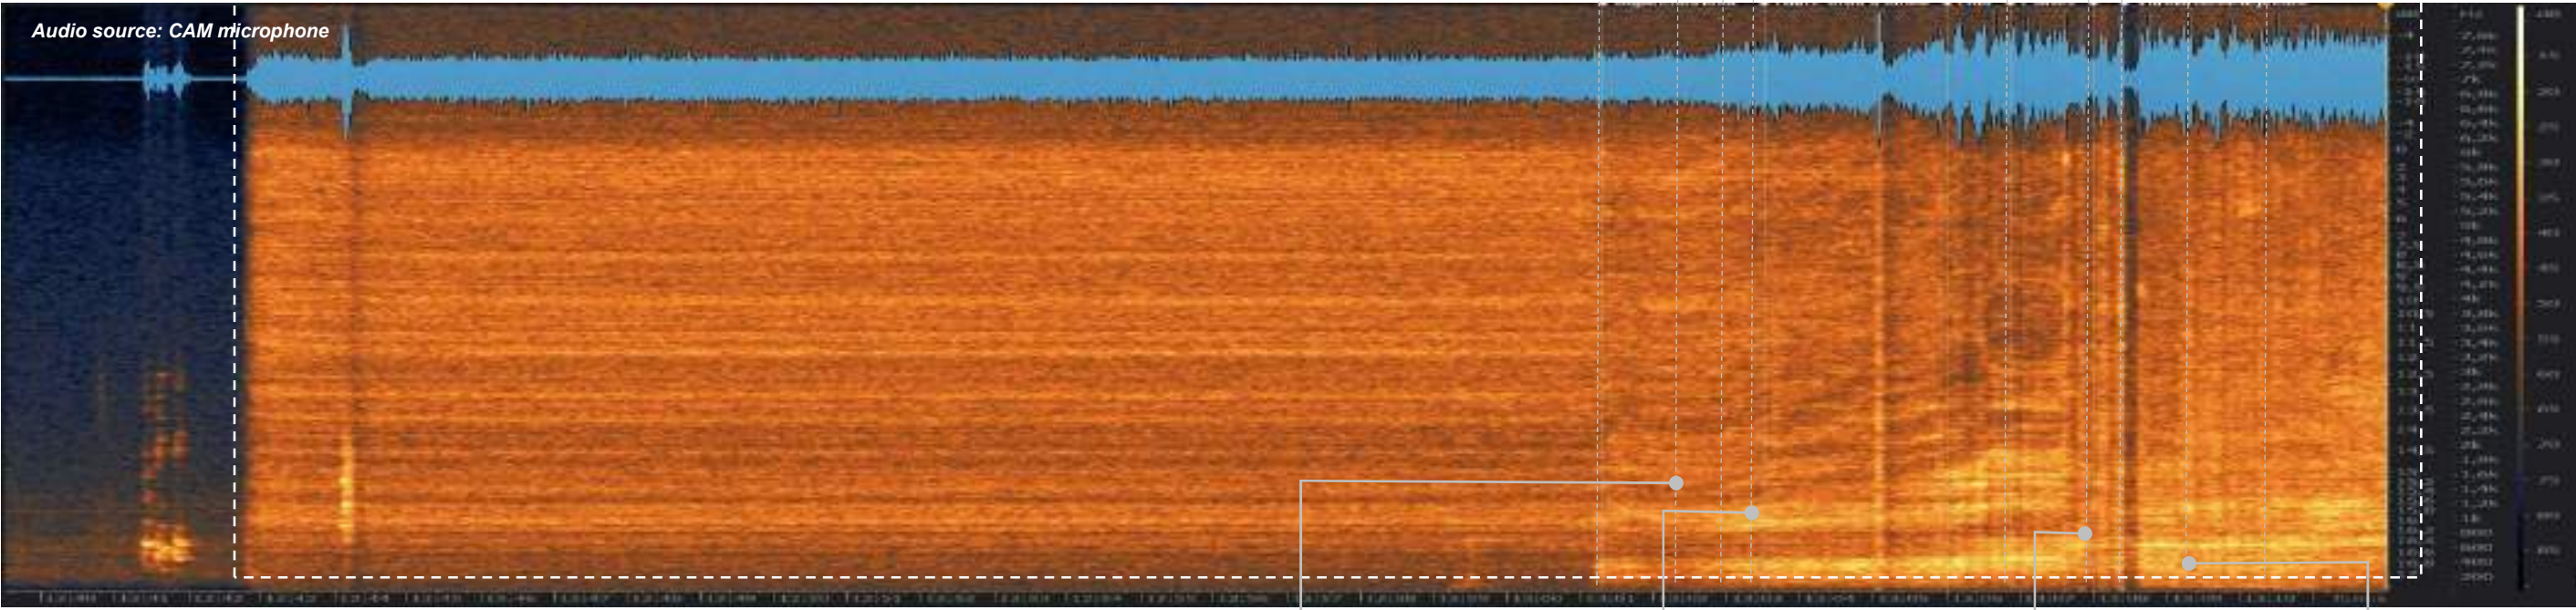
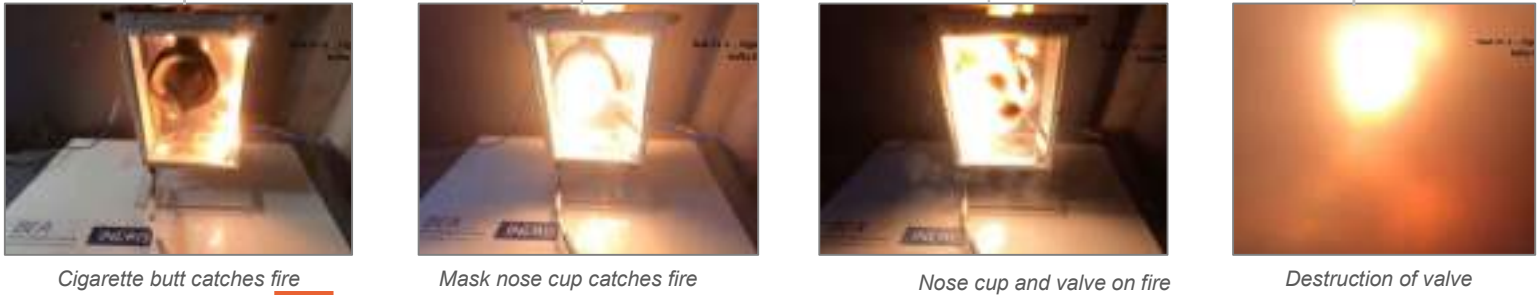
1 — Spectrum and waveform of audio recording of “Cigarette_00” test

- Page #1 shows the waveform of the audio recording (oxygen mask microphone signal and CAM signal) during the "Cigarette_00" test and the associated sequence of images. In the presence of an established oxygen leak, the cigarette introduced into the box immediately ignited, and very quickly set fire to the entire box and its contents (oxygen mask). There was a sound runaway 2.5 s after the cigarette was introduced and the microphone on the oxygen mask stopped working 3.5 s after the mask ignited.

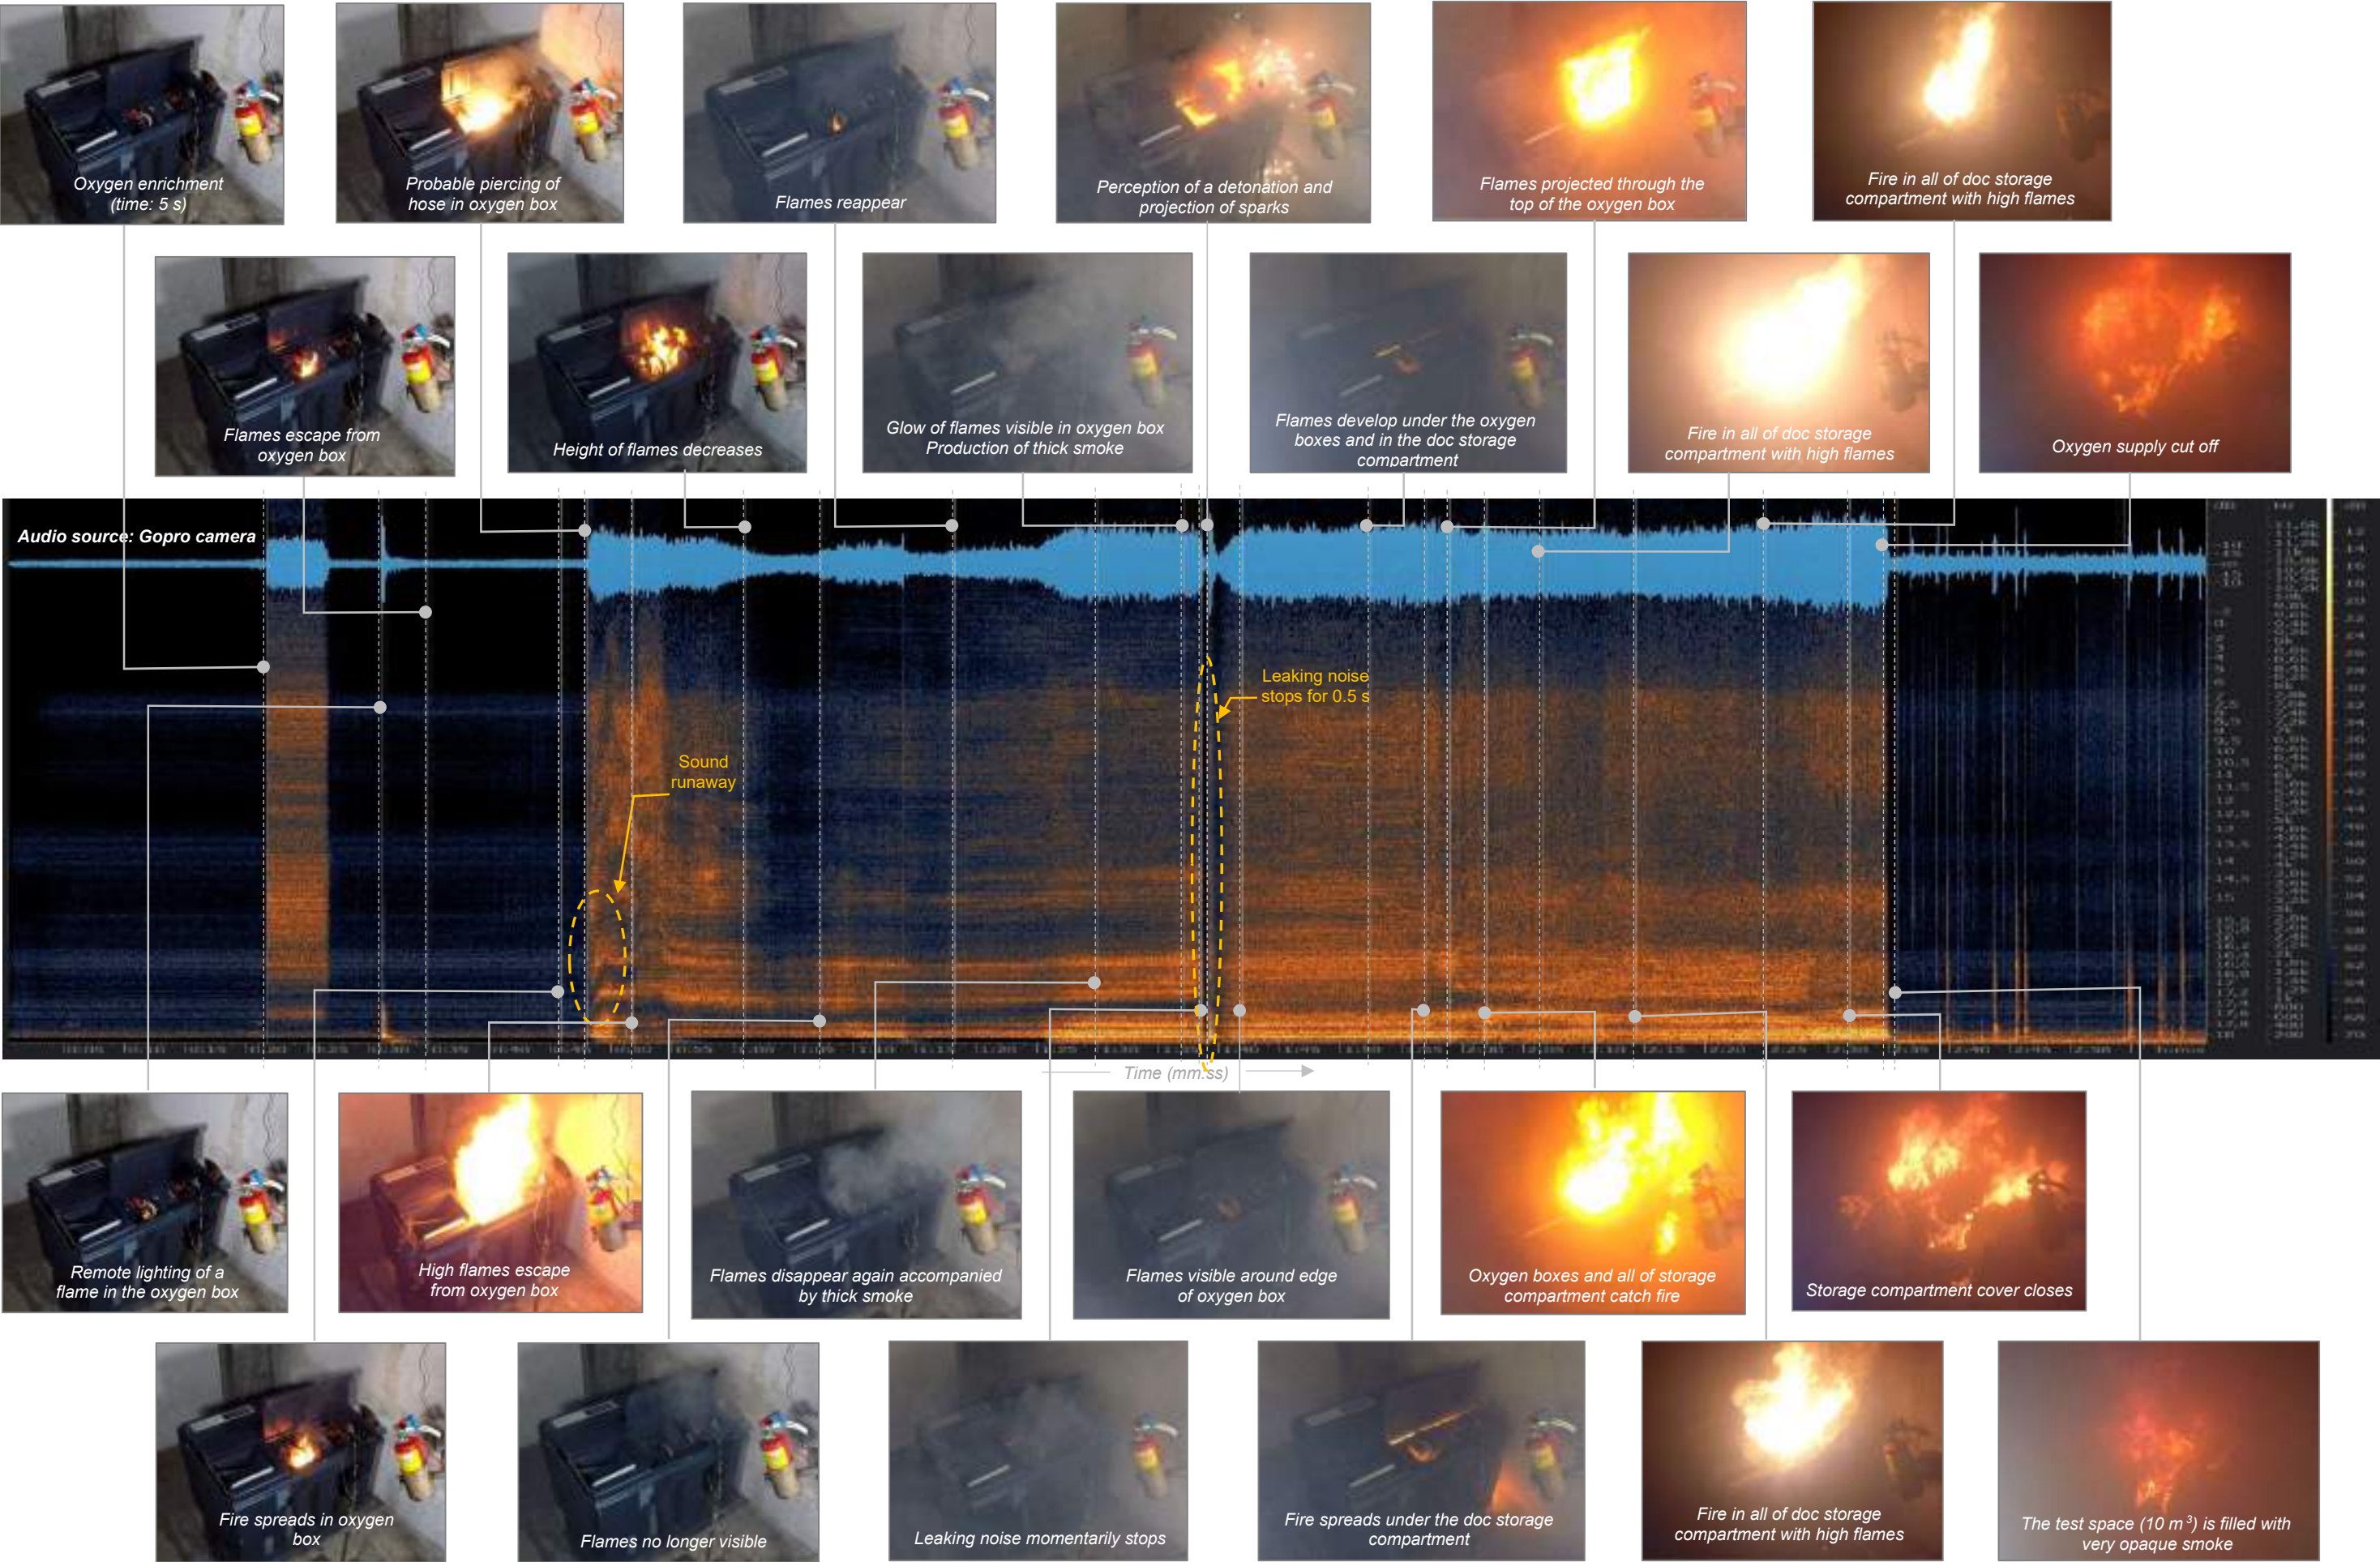
4 ____ Spectrum and waveform of audio recording of “Propagation_01” test

- Page #4 shows the waveform of the audio recording (GOPRO camera sound band) during the "Propagation_01" test and the associated sequence of images. Smoke and flames could be seen coming out of the oxygen box 5 s after the remote lighting of a cotton pad placed in the bottom of the oxygen box. The mask hose was probably pierced 18 s after the start of the fire. This was shown by a broadband noise followed 1s later by a sound runaway. The fire that followed the piercing of the hose spread rapidly to the surrounding elements. The leaking noise suddenly stopped for 0.5 s - without any action by the test operators - 50 s after the mask hose was probably pierced. This short interruption in the leak preceded a detonation, the resumption of the leak and the enrichment of the fire.

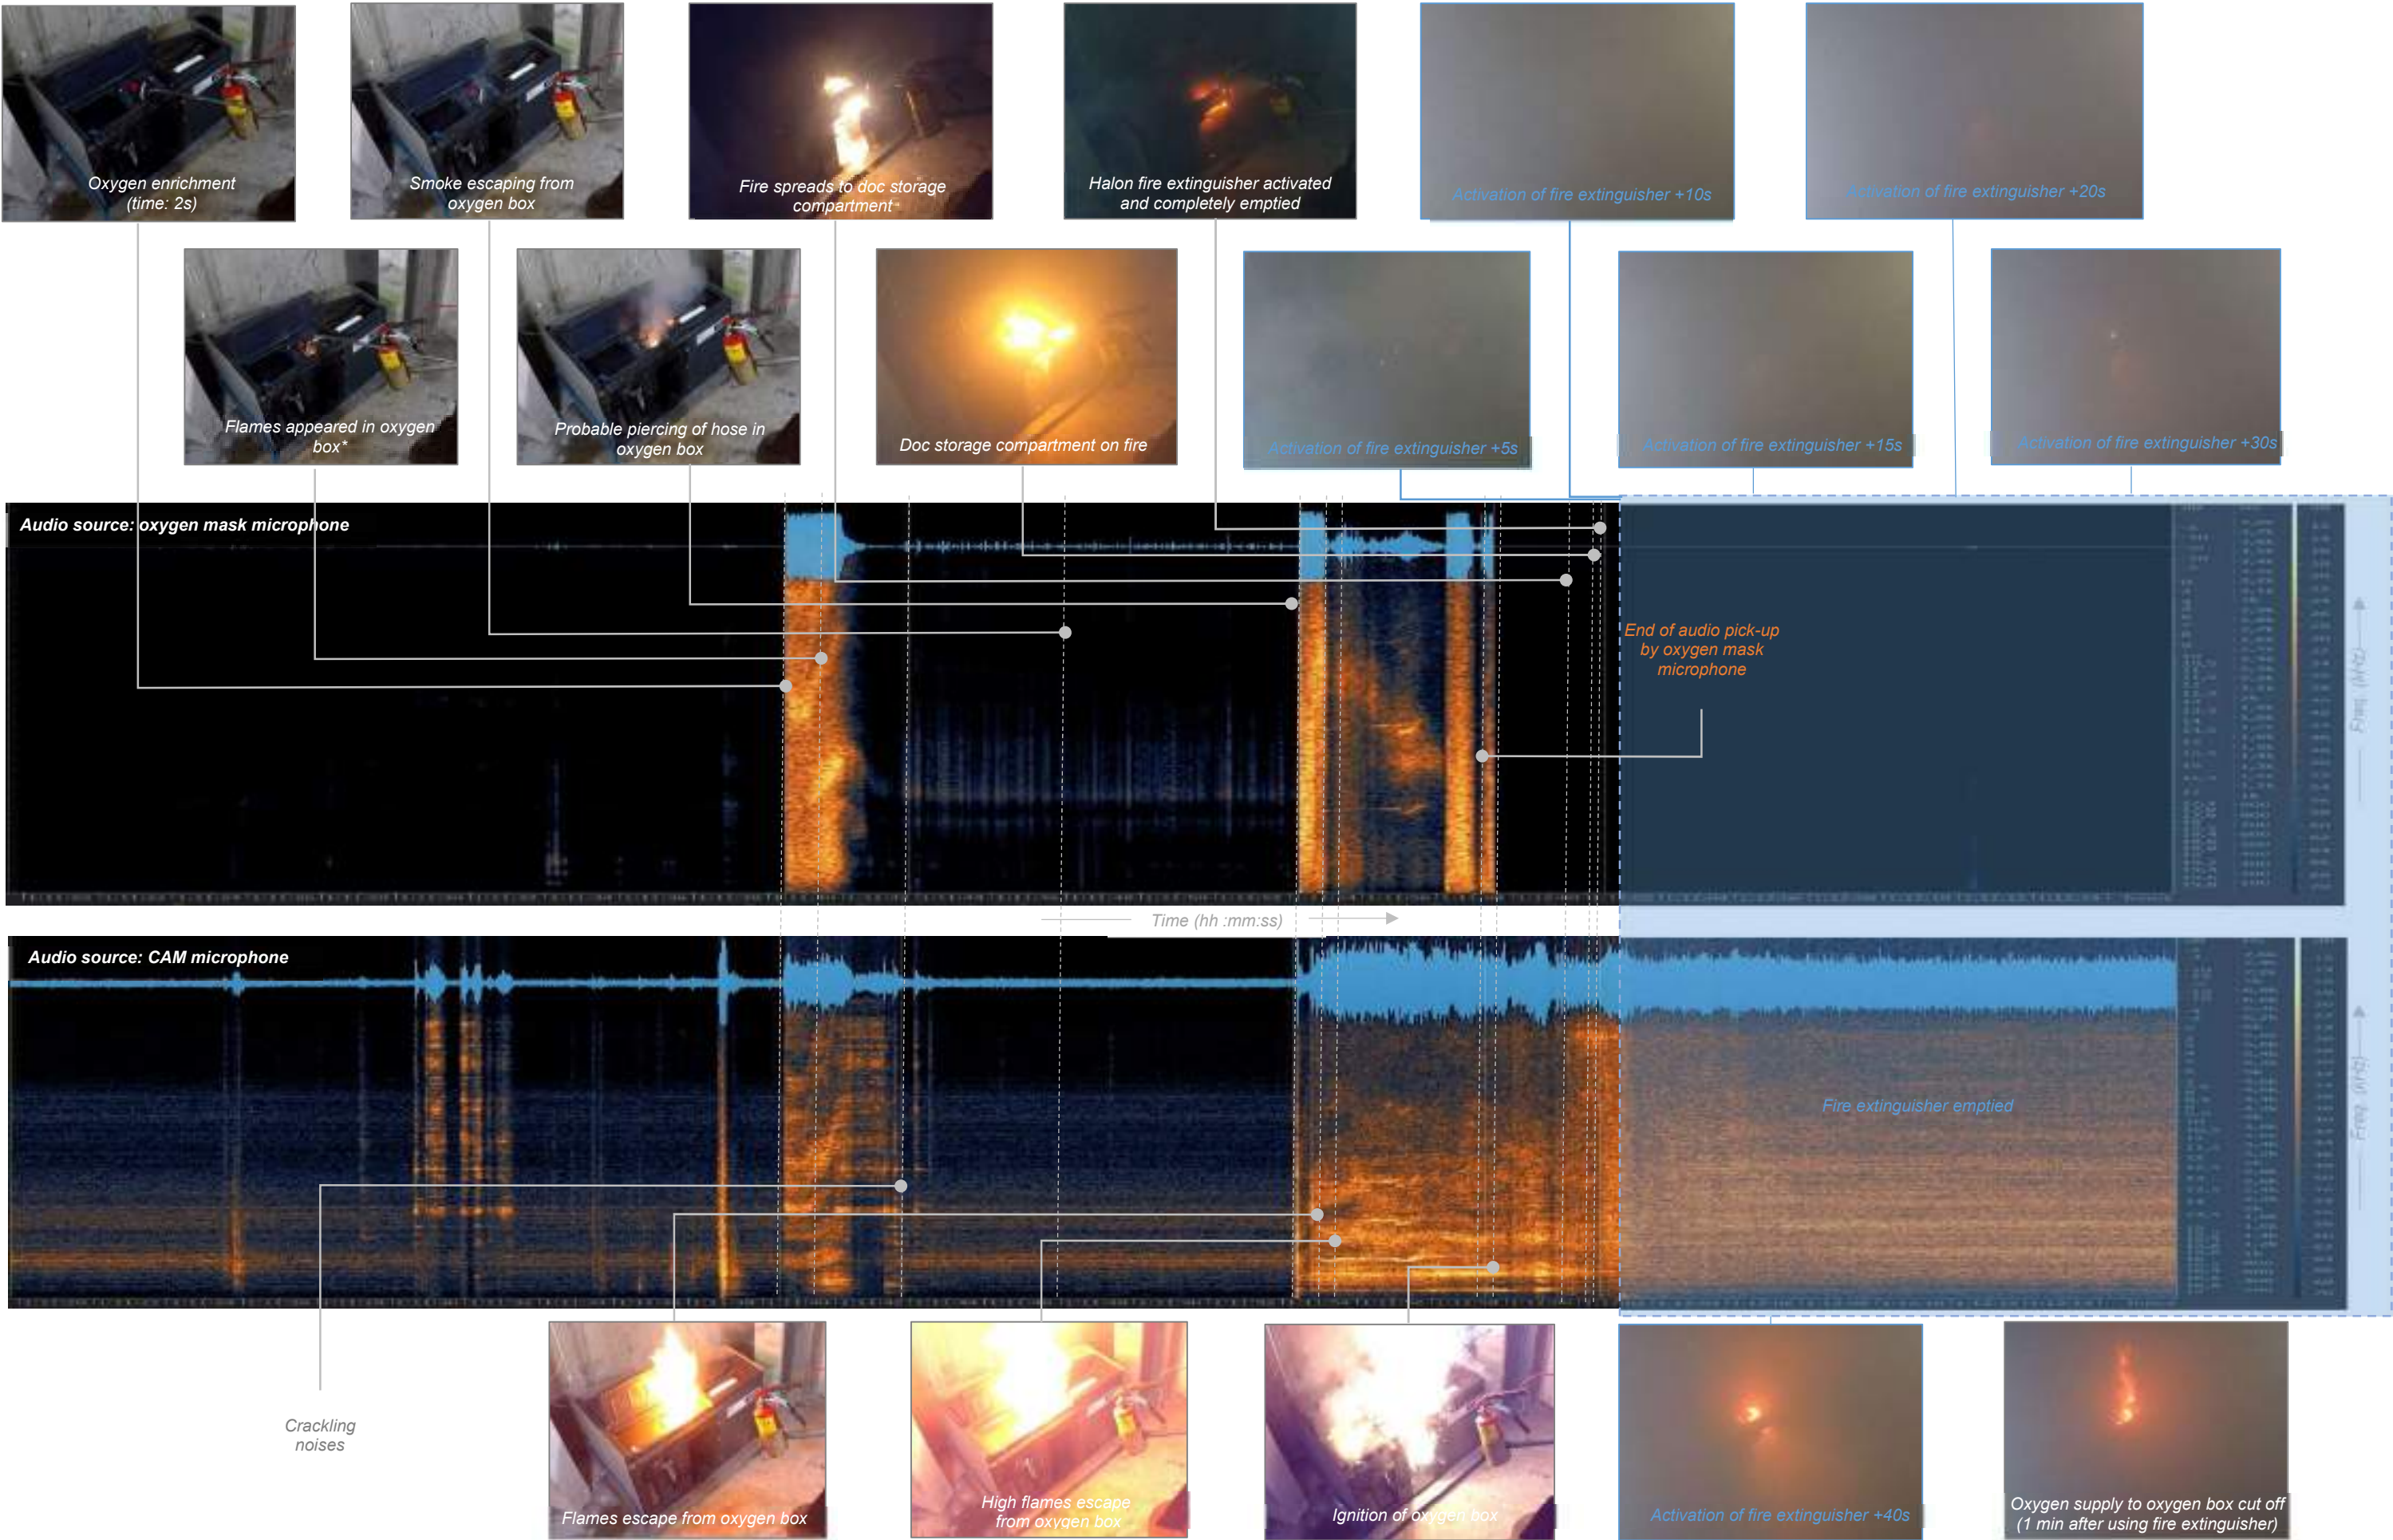
5 ____ Spectrum and waveform of audio recording of “Propagation_02” test

- Page #5 shows the waveform of the audio recording (oxygen mask microphone signal and CAM signal) during the "Propagation_02" test and the associated sequence of images. Smoke and flames could be seen coming out of the oxygen box 6 s after the remote reactivation of the cotton pad fire in the bottom of the oxygen box⁴. The mask hose was probably pierced 13 s after the reactivation of the fire. It was preceded over the same period by cracking noises picked up by the oxygen mask microphone. The probable piercing of the hose produced a broadband noise. The sound runaway described for the previous tests was not perceived. The fire that followed the piercing of the hose spread rapidly to the surrounding elements. The leaking noise was continuous until the oxygen supply of the test set-up was cut off.

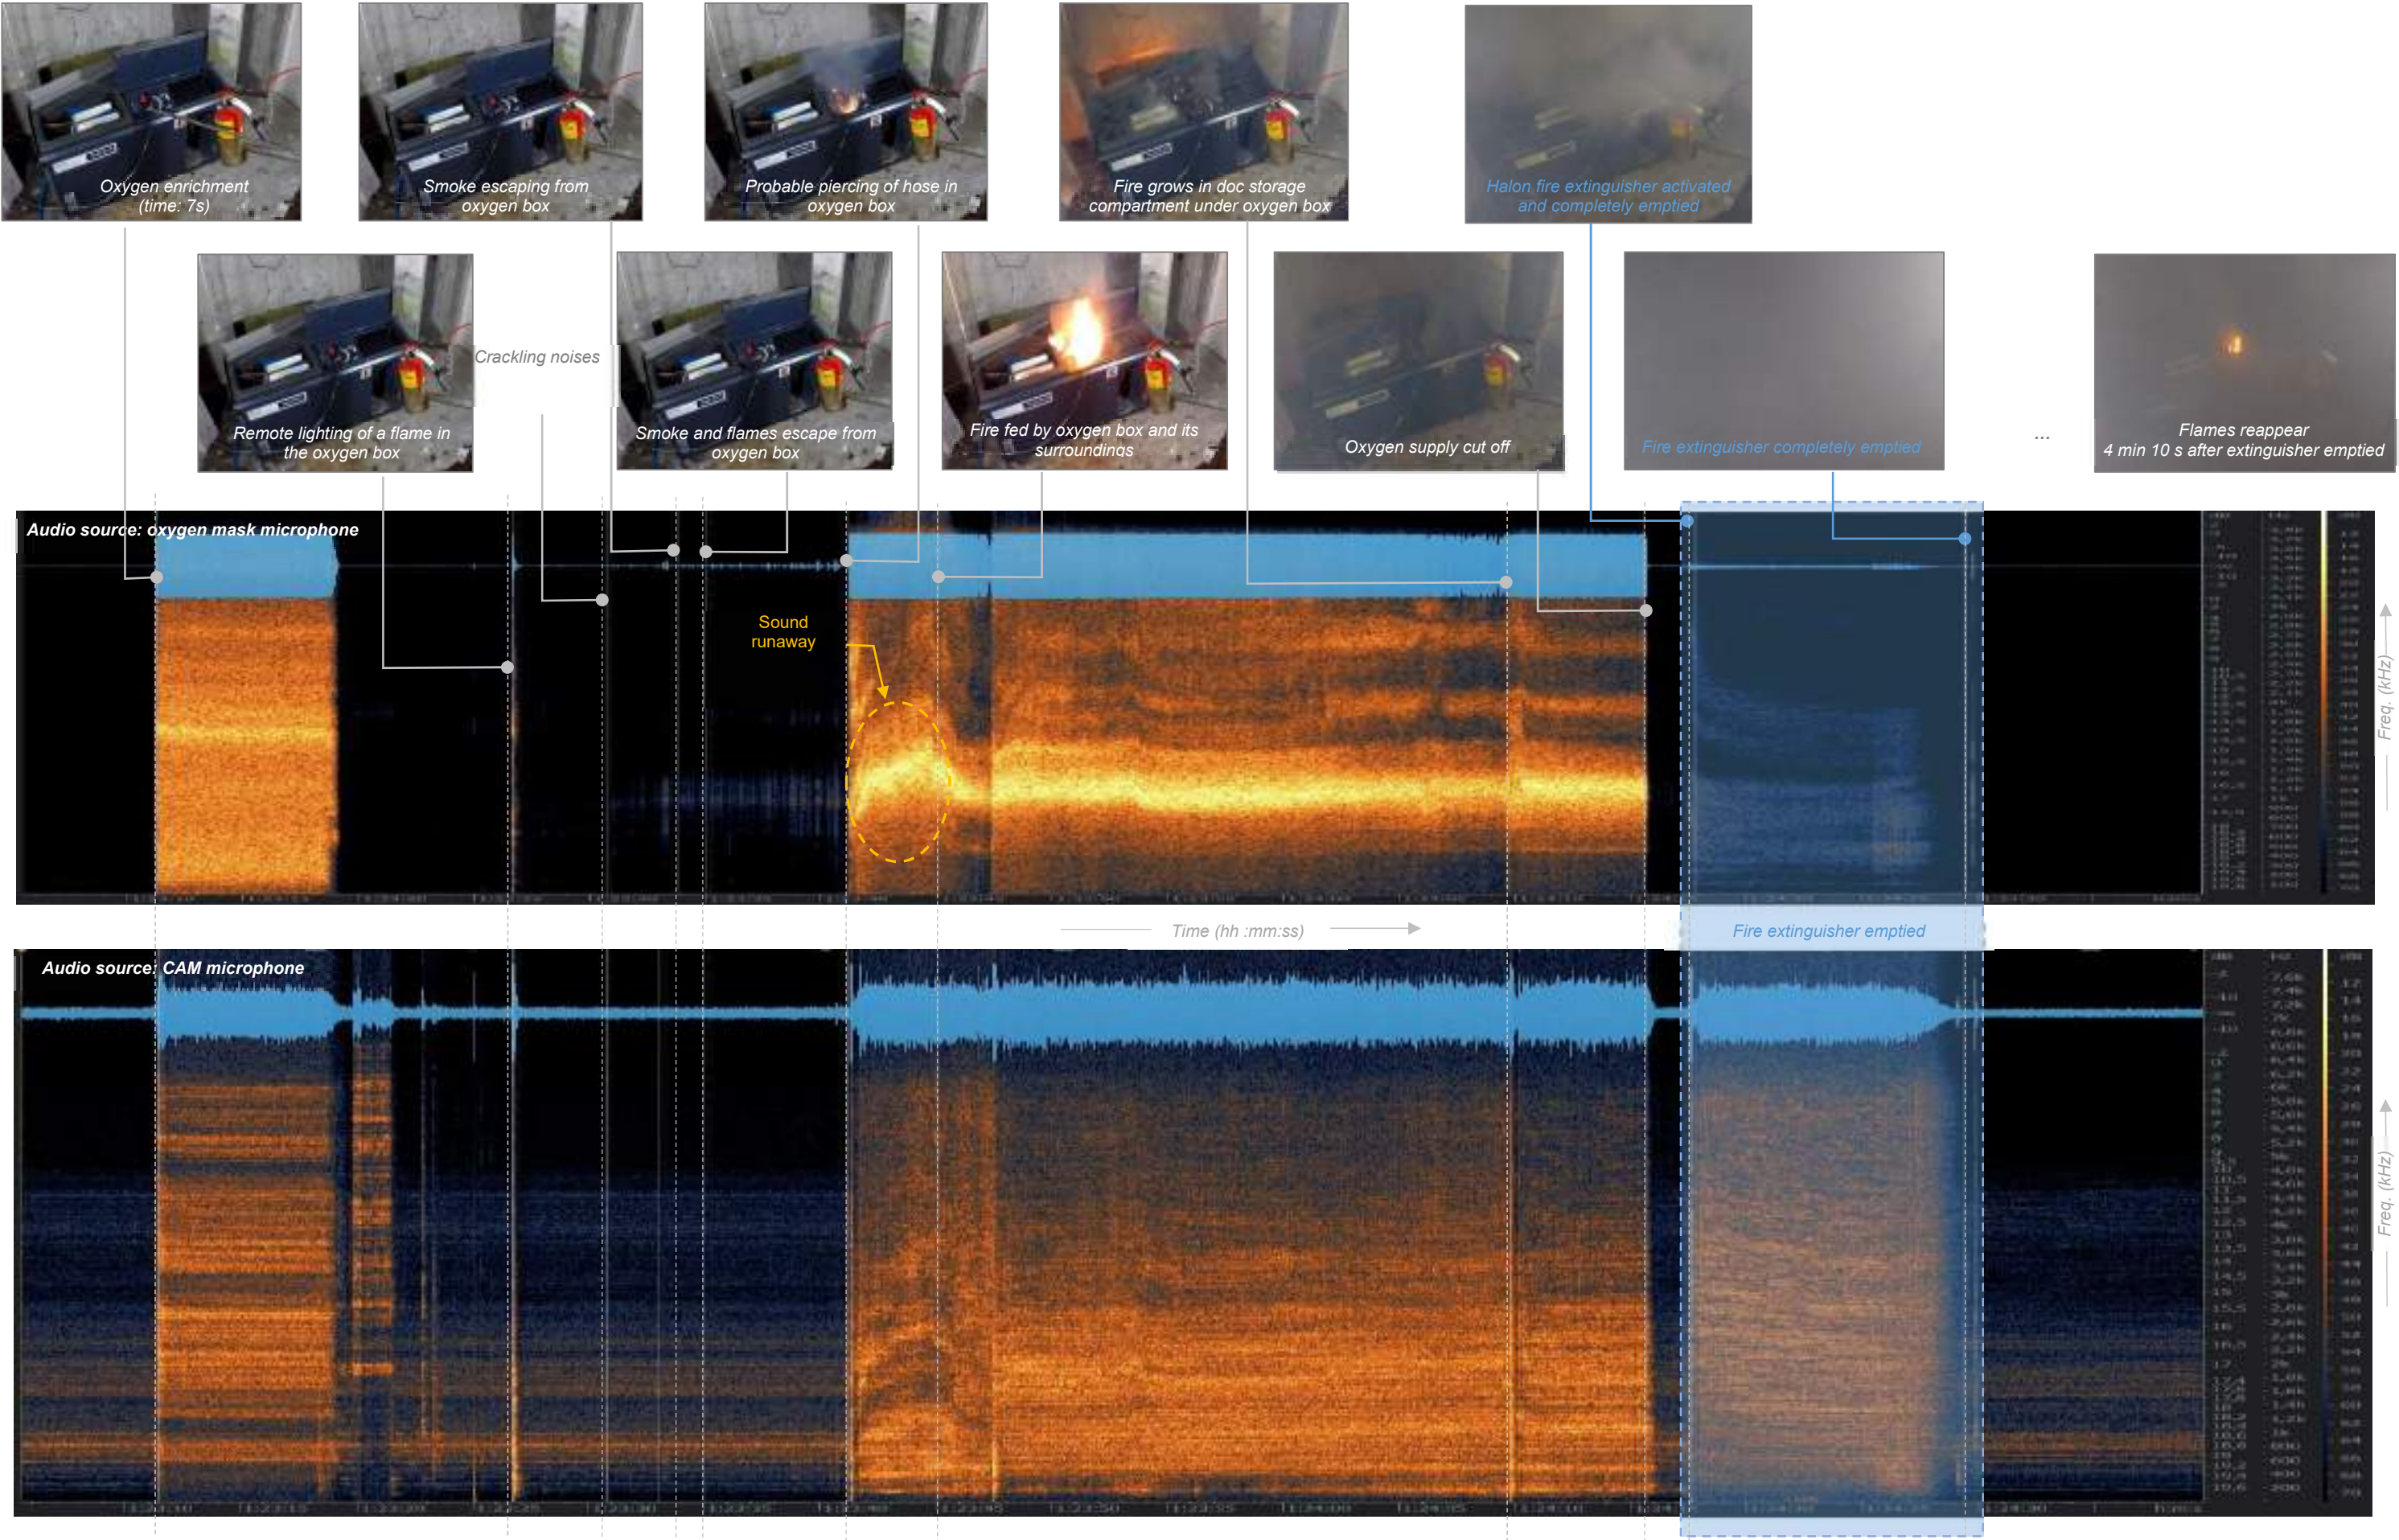
6 ___ Spectrum and waveform of audio recording of “Propagation_03” test

- Page #6 shows the waveform of the audio recording (oxygen mask microphone signal and CAM signal) during the "Propagation_03" test and the associated sequence of images. Smoke and flames could be seen coming out of the oxygen box 7 s after the remote lighting of a cotton pad placed in the bottom of the oxygen box. The mask hose was probably pierced 14 s after the start of the fire. It was preceded over the same period by cracking noises picked up by the oxygen mask microphone. The probable piercing of the hose produced a broadband noise followed 0.5 s later, by a sound runaway. The fire that followed the piercing of the hose spread rapidly to the surrounding elements. Cutting off the oxygen supply - which preceded the use of the fire extinguisher - stopped the leaking noise.

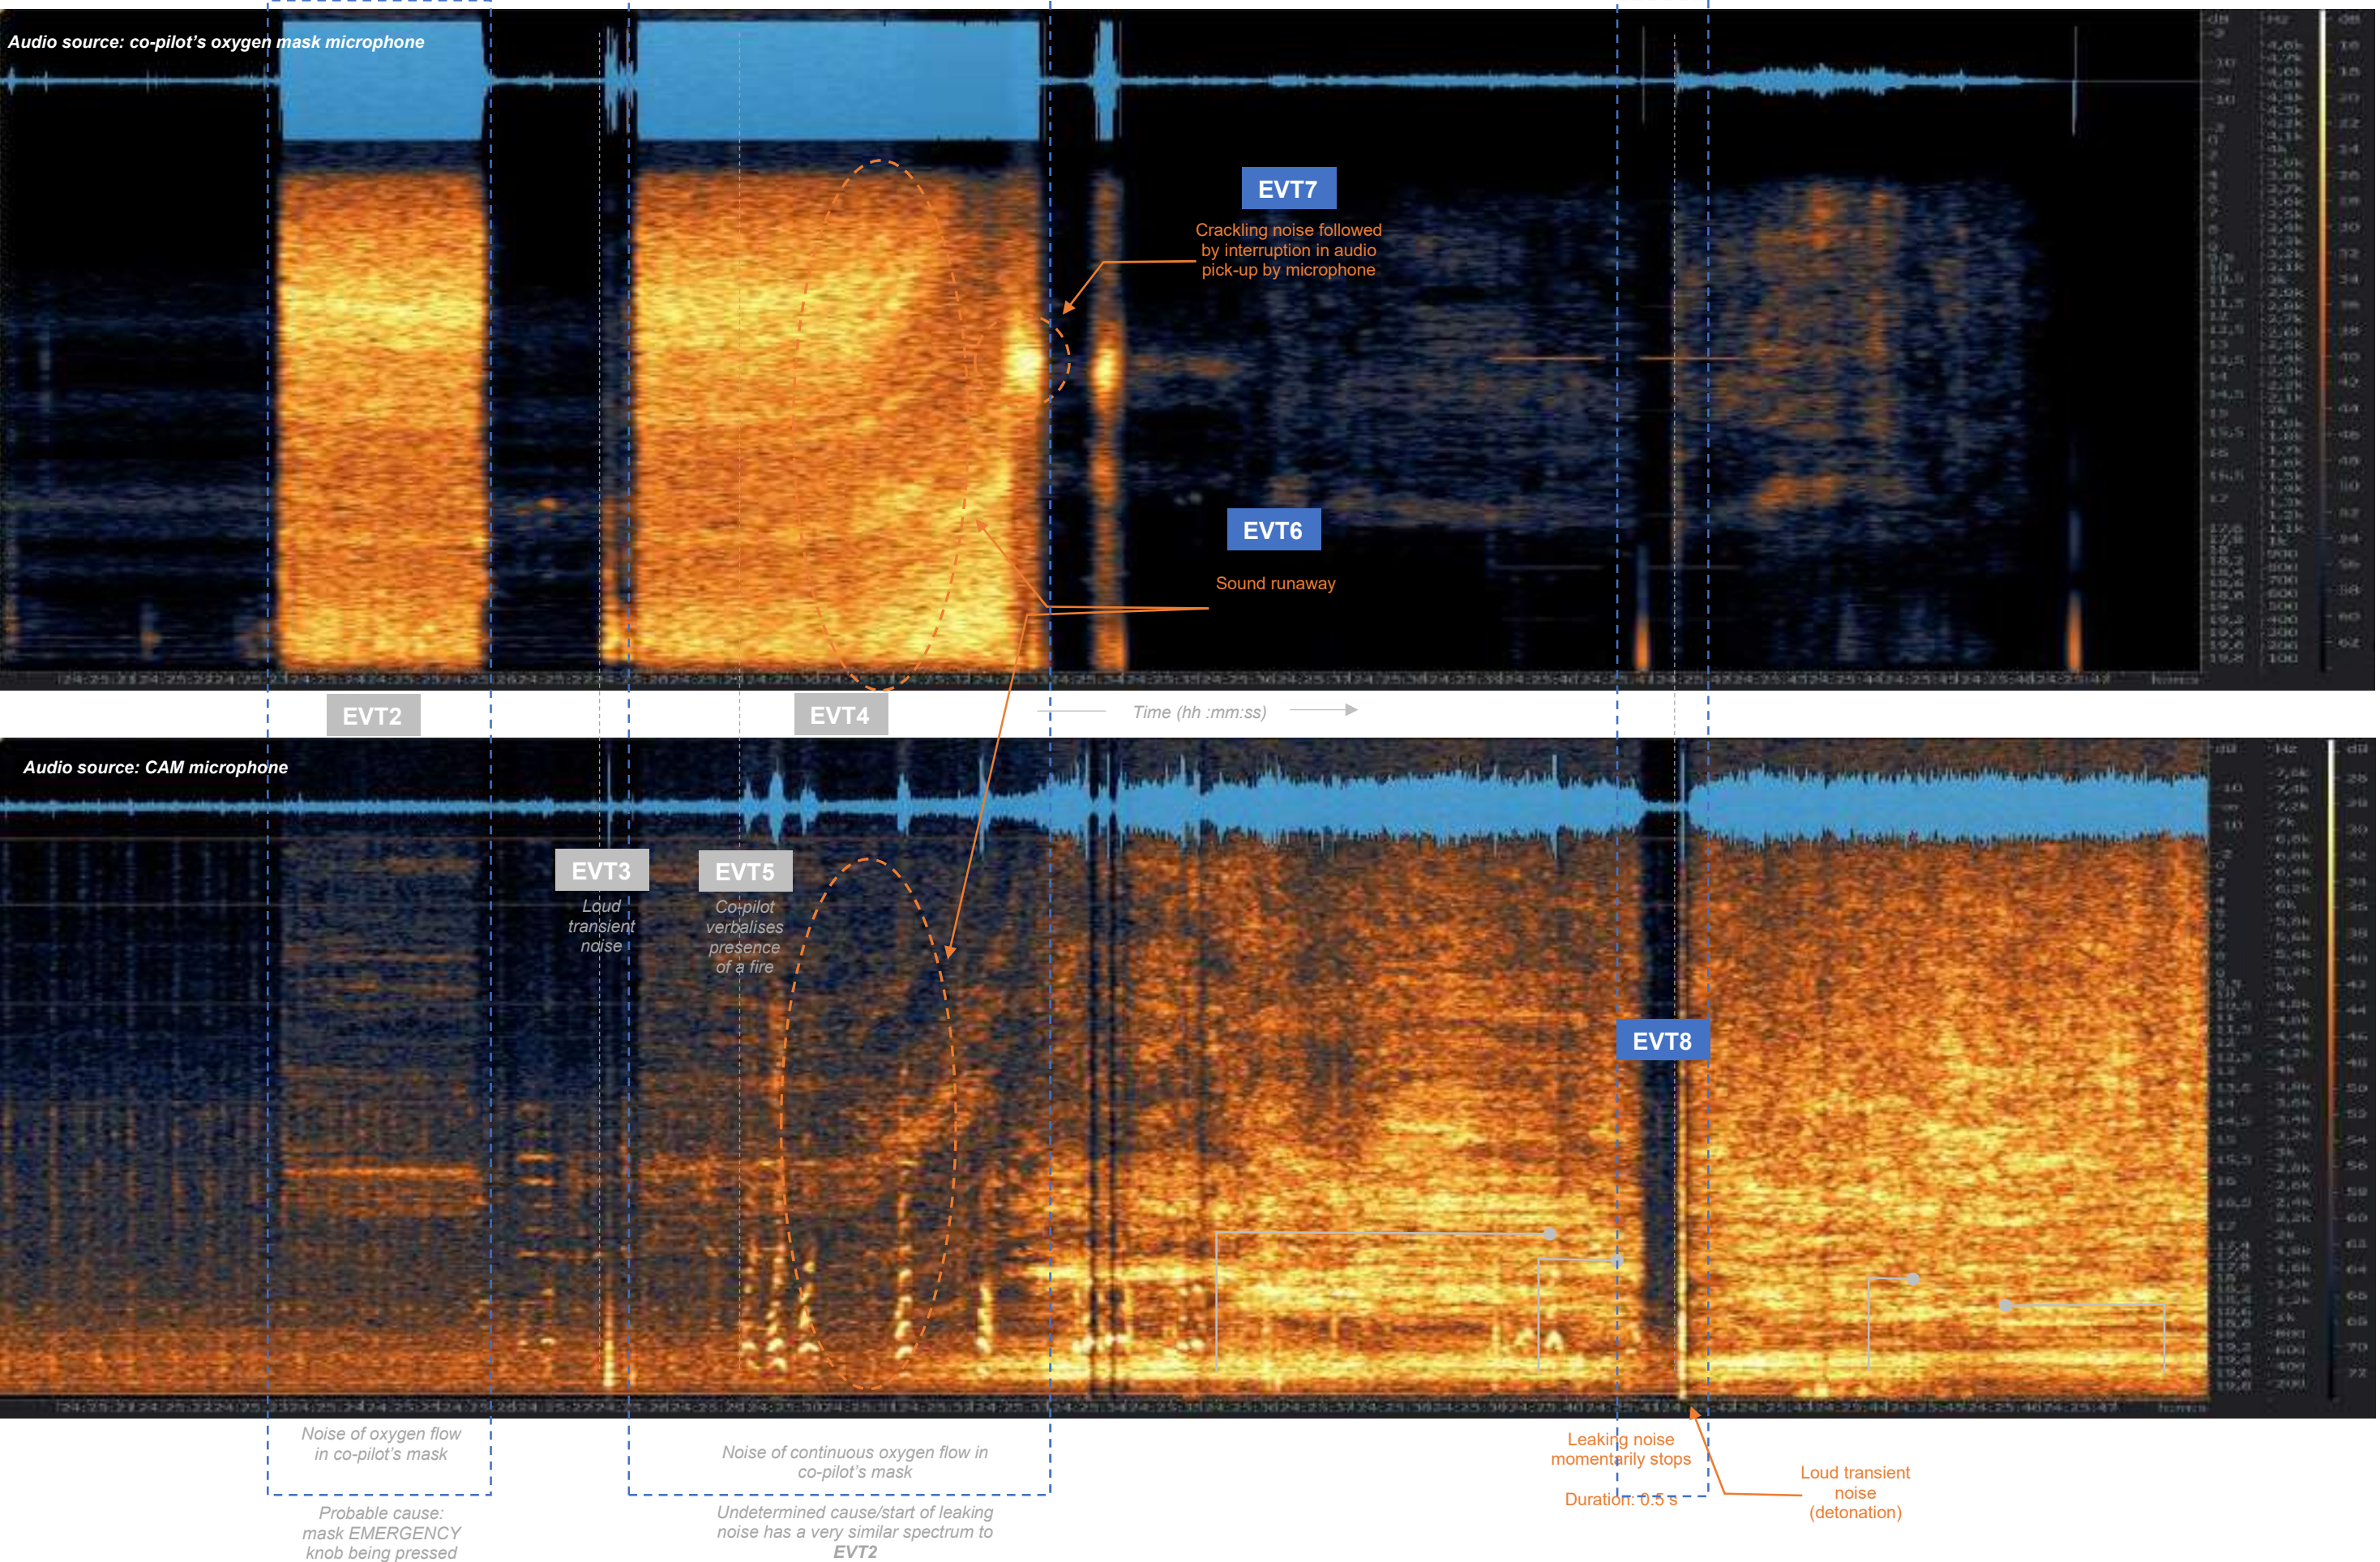
7 ___ Spectrum and waveform of occurrence recorded on CVR of MS804

- No crackling noise can be perceived in the recording from the co-pilot's oxygen mask microphone.
- A sound runaway was present on the co-pilot's oxygen mask microphone and CAM channels at 00:25:31(EVT6). This noise can probably be attributed to the co-pilot's oxygen mask catching fire.
- The screeching noise that preceded the loss of the microphone signal from the co-pilot's oxygen mask at 00:25:33 (EVT7) was probably produced by the destruction of the mask microphone by the flames.
- The momentary interruption (510 ms) of the oxygen leak at 00:25:42 (EVT8) was probably produced by damage to the oxygen assembly⁵ located in and/or under the lateral storage compartment.

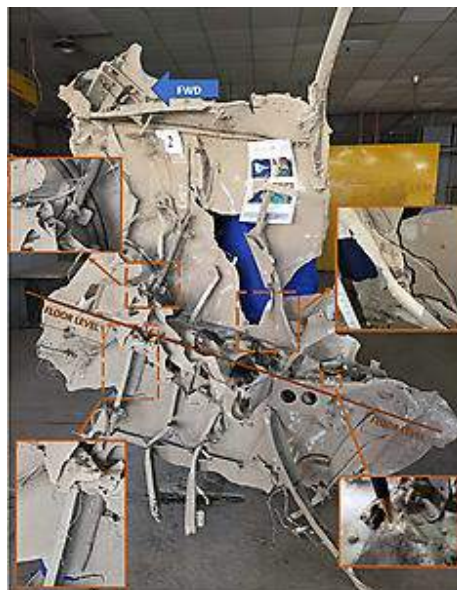
Photo of the debris below, shows the intact insulation wire immediately below the RHS window side console significantly above cockpit floor level. (Refer to Draft final report item 2.11 (sub-item 3).

BEA contribution report page 11/29 Fig. 3, Airbus Debris survey –part identification page 49, Pic. 4/5 nose fuselage frame 3 to 8 area (D149) show the intact wire insulation above floor level.

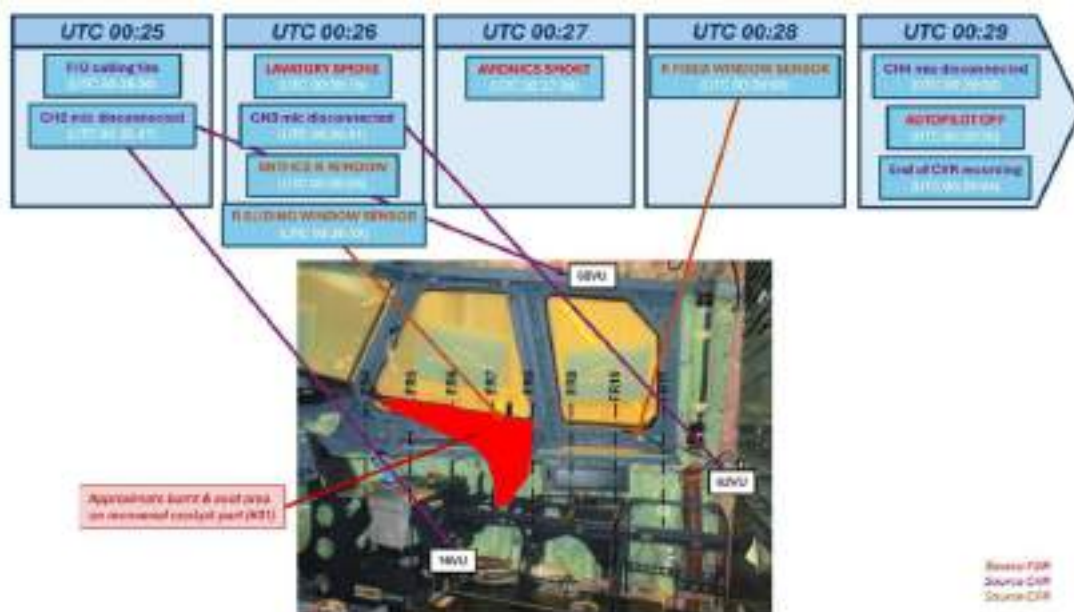
As mentioned above, the warnings sequence, the CVR sequence and the wreckage description are partial and contain inaccuracies that lead to the misinterpretation of the data.

The following figure summarizes the main data relevant to establishing the sequence of events:
