In-flight pitch disconnect involving ATR 72 aircraft, VH-FVR

47 km WSW of Sydney Airport, New South Wales on 20 February 2014

ATSB Transport Safety Report
Aviation Occurrence Investigation
AO-2014-032
Interim Report – 15 June 2016

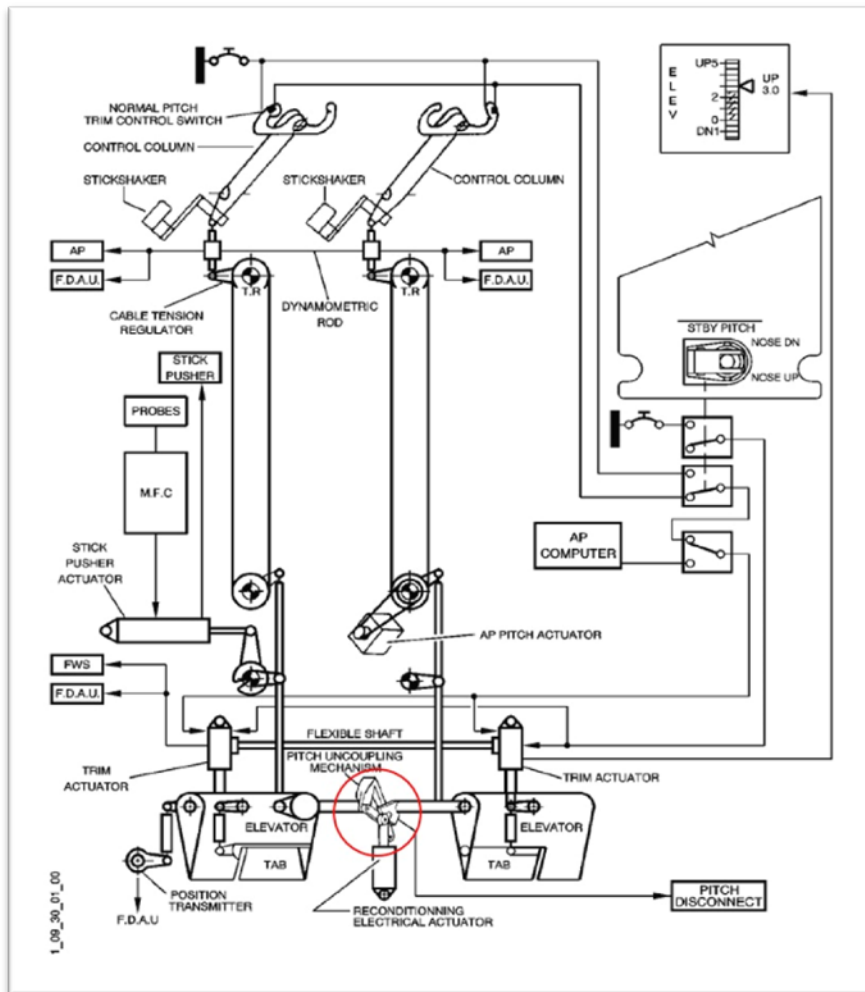
The forces applied on one side of the pitch control system are transmitted to the opposite side as a torque or twisting force through the pitch uncoupling mechanism. The pitch uncoupling mechanism activates automatically when this torque reaches a preset level, separating the left and right control systems. When set correctly, the activation torque is equivalent to opposing forces of 50 to 55 daN (about 51 to 56 kg force) being simultaneously applied to each control column.

Figure 4: ATR 72 elevator/pitch control system with the pitch uncoupling mechanism circled in red

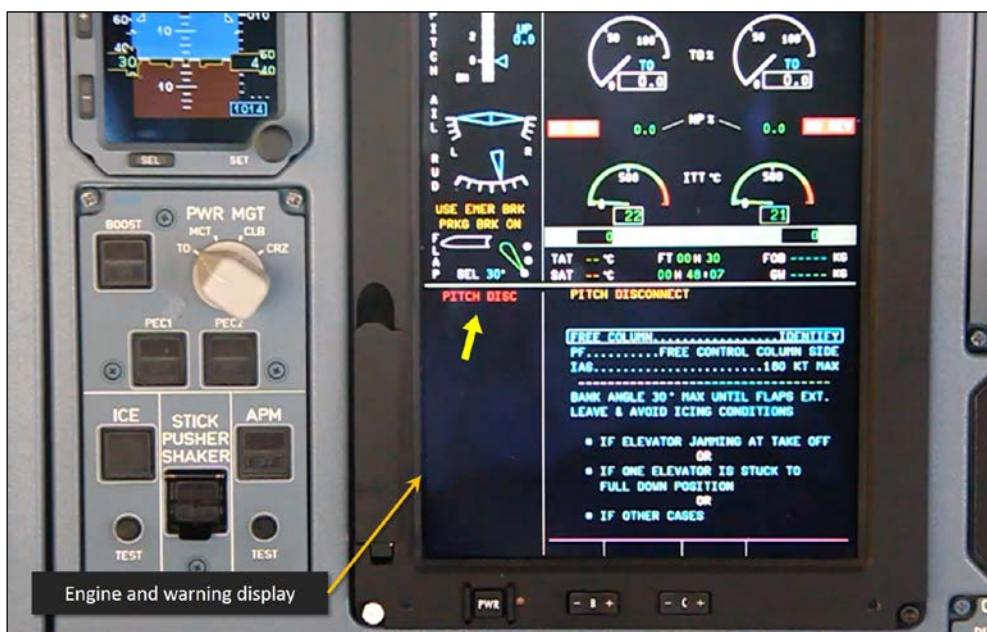
Activation of the pitch uncoupling mechanism is signalled in the cockpit by the master warning light flashing red, a continuous repetitive chime aural alert and a flashing red PITCH DISC message on the engine and warning display (Figure 5).¹¹ The associated procedure to be followed in response to activation of the pitch uncoupling mechanism is presented to the right of the warning message.

Figure 5: Pitch disconnect warning presentation on the engine and warning display. The red PITCH DISC warning message, indicated by the thick yellow arrow, is located on the lower left of the screen. The pitch disconnect procedure is displayed to the right of the warning message
