Inquiry AO-2013-007: Boeing 737-838, ZK-ZQG,
stabiliser trim mechanism damage, 7 June 2013

Final Report

Boeing 737-838, ZK-ZQG
stabiliser trim mechanism damage

7 June 2013

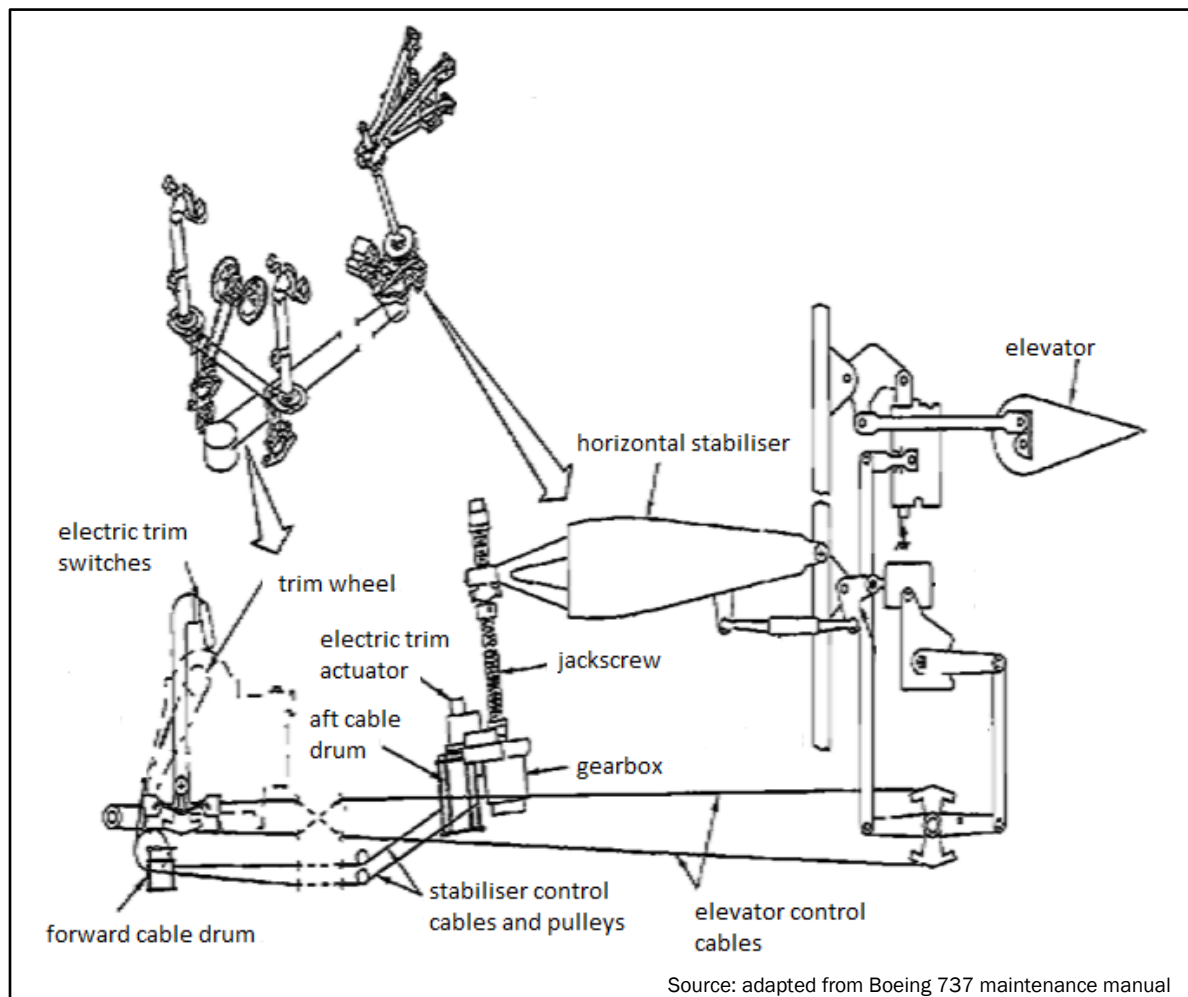
Figure 1
Schematic of B737 stabiliser trim system

- 3.1.2. The stabiliser trim system on the B737 series aircraft consisted of a moveable horizontal stabiliser⁶ on the tailplane, which was adjusted to trim the aeroplane aerodynamically in flight. Manual adjustment was achieved through a cable and pulley system between the trim wheel in the cockpit and a jackscrew⁷ actuator that moved the stabiliser. The cables were wound onto two cable drums, one aft and one forward. The forward cable drum was located in the electronics and equipment compartment under the flight deck. A separate electric control system consisting of an electric motor actuator and control switches could be used to move the horizontal stabiliser independently of the manual system (see Figure 1 and the glossary for more detail).
